Mariners' Alerting and Reporting Scheme

MARS Report No 354 April 2022

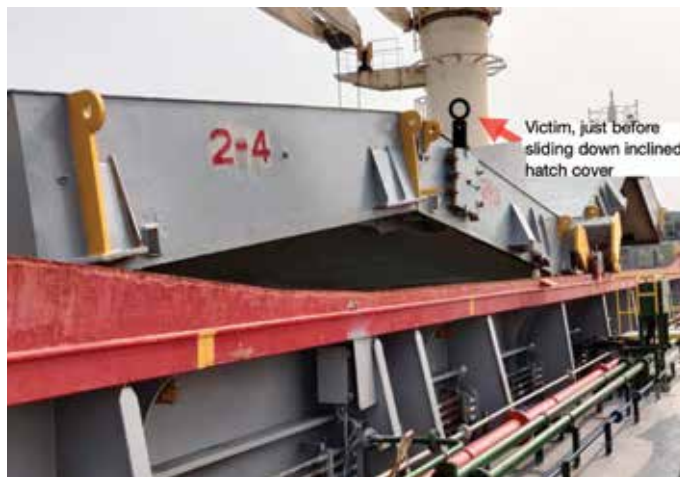
After cleaning the forward panels, the washing crewmember came down on to the hatch coaming to hose down the water to the middle cross joint area of the hatch cover. Then he went up again, this time

to the aft panel No.2-3 (indicated by an arrow in the photograph), and started cleaning at the starboard side of panel No.2-3. While moving toward the port side, out of sight of the crewmember tending the hose, he slid down the incline, through the gap in the hatches, and fell at least 17 metres to the hold tank top. A cry was heard and the crewmember tending the hose began searching, only to see his colleague lying on the tank top of the hold in the middle of the hatch area.

The official investigation found, among other things, that there was no responsible officer supervising or assessing the safety of the work. The Bosun was supposed to supervise both teams of two crew, who were working at different places. Instead, the Bosun went down to hold 1 with one of the teams. The Chief Officer was busy in the deck office preparing the loading plan for the next port, so there was no effective supervision of the team washing the hatch covers.

Additionally, crew did not use fall arrest equipment while working and climbing on top of the partially opened hatch covers.

- In an environment dominated by a weak safety culture, even such a dangerous situation as standing at the top of an open inclined hatch without fall protection does not dissuade people from 'getting the job done'.

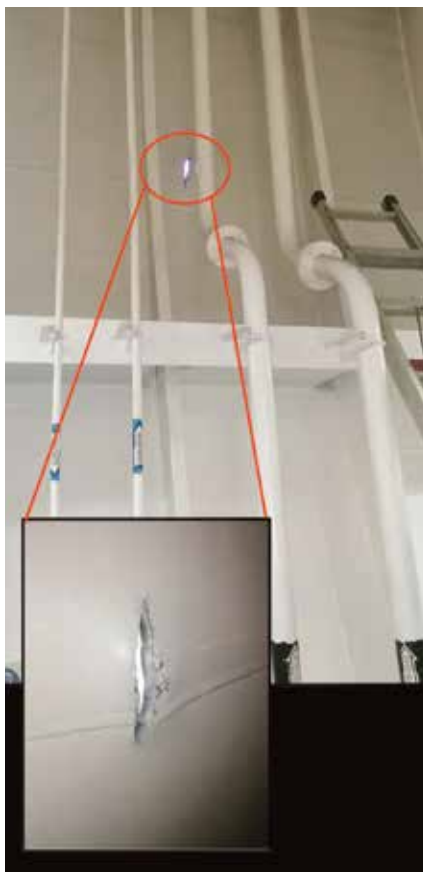
➔ A tanker discharged its cargo and left the berth without apparent incident. While drifting near the harbour and awaiting orders, routine inspections discovered a puncture in the hull above the waterline.

After investigation, it was deduced that the damage had occurred during the previous berthing and remained unnoticed since.

During that berthing, two tugs were used to push the vessel on the jetty's fenders during the mooring operation. Although everything appeared normal at the time, it was later suggested that the upper edge of the fender was unprotected. Although the impact while berthing and from the tugs pushing was so minor that no one noticed, it was still enough to pierce the hull.

- An inspection of the fendering after berthing to ensure proper cushioning is a good practice.

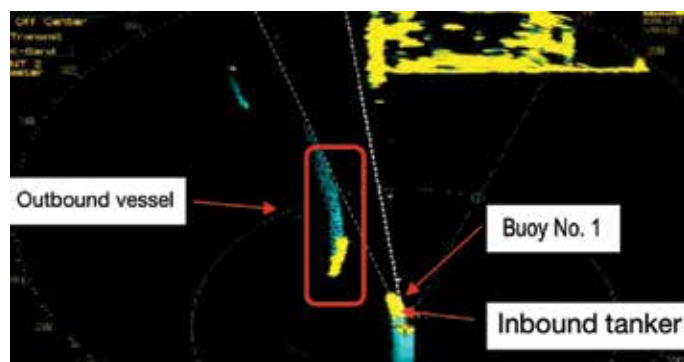
As the inbound tanker was conned more to starboard by the pilot to allow the outbound vessel to safely exit the port, it approached the righthand side of the channel and, due to weather and lack of manoeuvrability at slow speed, made soft contact with buoy number 1. The tanker continued its inbound passage and safely berthed thereafter.

- When entering port, the bridge team and Master often have little time to evaluate the proposed manoeuvre suggested by the pilot. In this case, although not immediately evident as unsafe, the meeting of the two vessels at the narrow port entrance was less than optimal.
- Be aware that in some jurisdictions, pilots can disembark before the vessel has actually exited the port due to various factors such as weather conditions on the outside rendering departure there too dangerous.

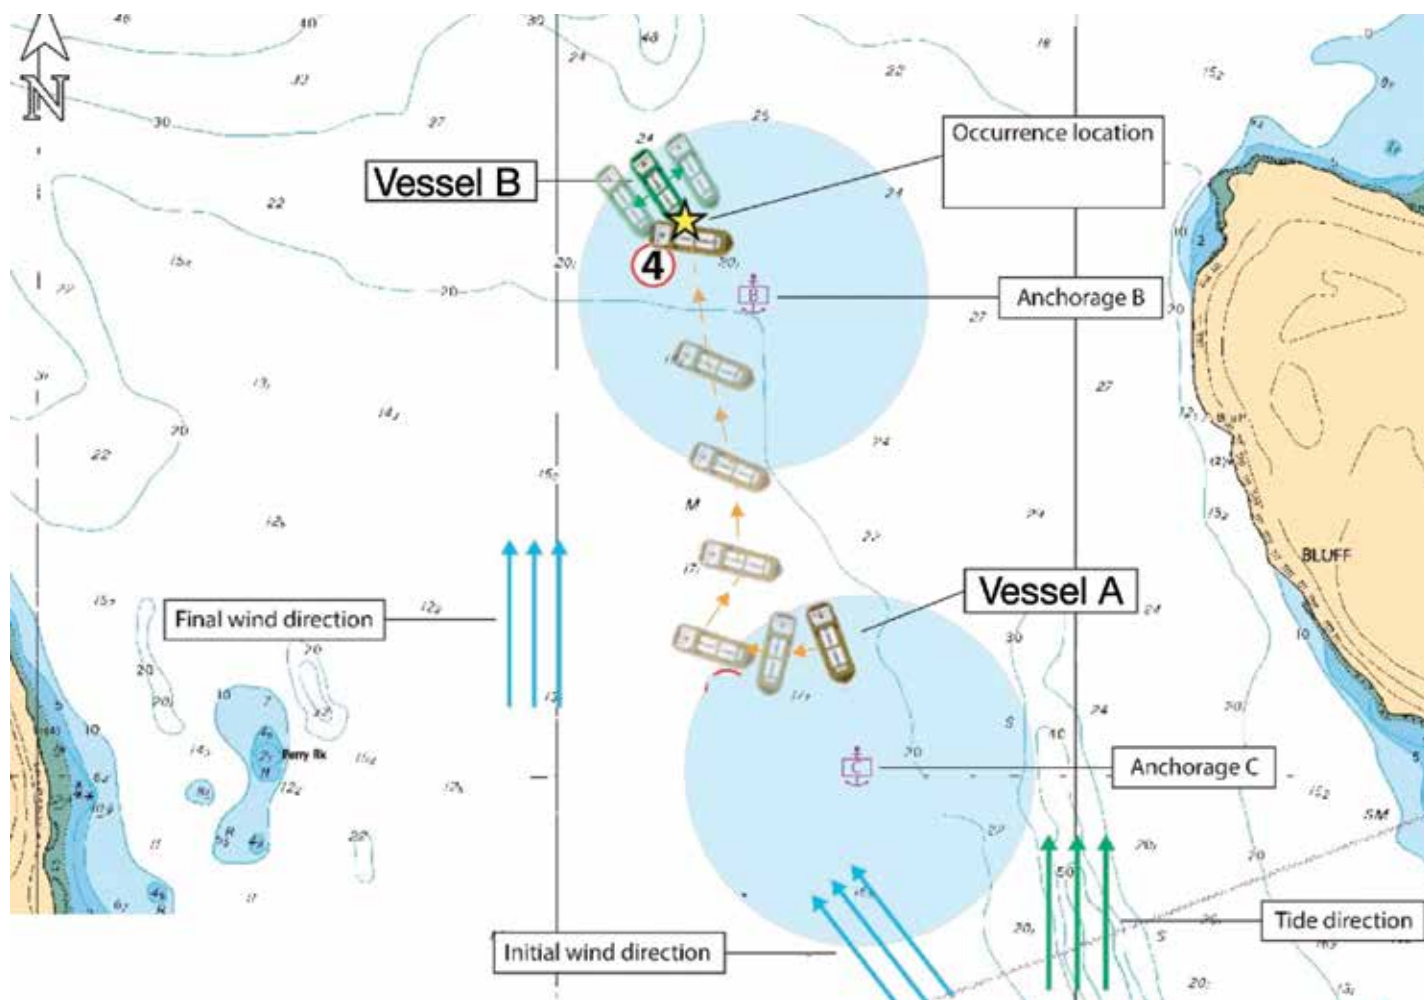
Vessel A's dragging anchor alarm activated, and the officer of the watch (OOV) noticed on the radar that his vessel was drifting towards vessel B. The Master and the engine room were informed of the situation and the anchor team went forward. An additional two shackles were released on the starboard anchor chain and the team attempted to deploy the port anchor too, but it would not release.

By now, vessel A was drifting towards vessel B at a speed of about 1.4 knots under the influence of the wind on its high freeboard and the tidal flow. Meanwhile, vessel B's crew were informed of the oncoming vessel A. They paid out a total of 11 shackles on the anchor chain in order to allow more room and avoid contact between the vessels.

The anchor team on vessel A eventually managed to release the port anchor from its stowed position and deployed about 12 shackles. By now, the main engine was also available and was used in an attempt to move away from vessel B. Nonetheless, vessel A's port mid-section collided with the starboard bow area of vessel B (position 4 on diagram).

The official investigation found that, among other things, the crew of vessel A had not collected the local weather forecast for the day of occurrence from the VHF radio, weather fax, and MF broadcast, nor had they obtained an up-to-date weather warning from local authorities. As a consequence the vessel and crew were unprepared for the impending adverse weather conditions.

- This is not the first MARS report where a lack of situational weather awareness has led to a vessel dragging anchor. Weather awareness should be a priority of all OOWs and Masters while at anchor.
- Even with engines and anchors, limited space in some anchorages can easily trump these options when winds are strong. Vessels are safest at sea in these circumstances.
