# Mariners' Alerting and Reporting Scheme

MARS Report No 357 July 2022

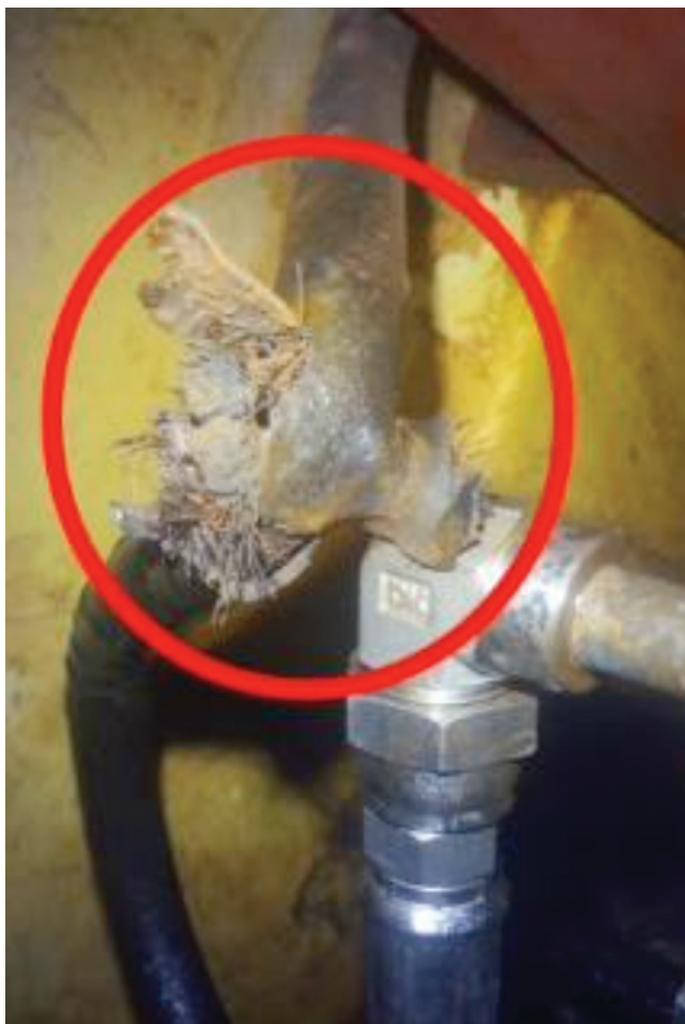
→ A deck officer was tasked to escort an accredited technician to inspect the free fall lifeboat air cylinders while the vessel was in port. The technician requested that the officer assist him by opening the air cylinder valves one by one to check the pressure. The first valve was opened without incident but when the second valve was opened, the high-pressure hose burst near the officer's face. Compressed air, dust and particles from the damaged hose hit his eyes, causing irritation.

This incident is a good example of why protective eyewear should be in common use on board, much as hard hats and steel-toed boots already are.

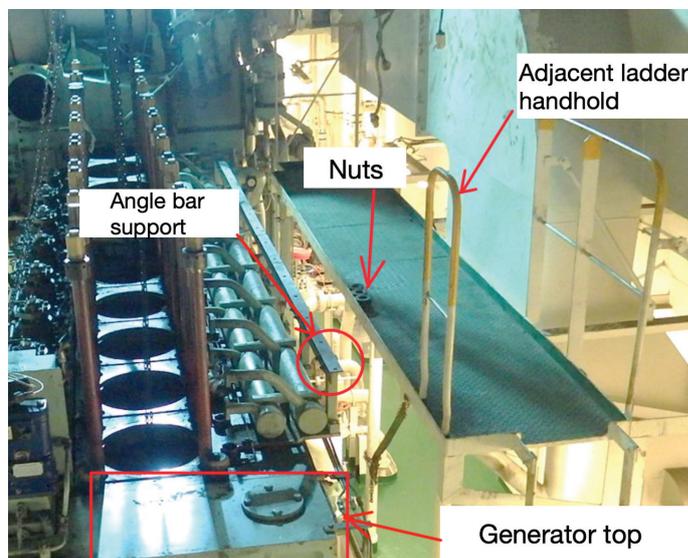
As the work progressed, one of the engineers was standing on top of the generator. There was a walking platform adjacent to the generator top, at the same height but separated by a gap of 40 cm. The engineer required some nuts that were lying on the platform, but were out of his reach. He attempted to step onto the platform from the top of the generator. He steadied himself with his right hand on the adjacent ladder handhold and stepped onto the platform with his right foot. As he brought his left leg forward he slipped. His leg struck the edge of an angle bar supporting the exhaust manifold with some force.

The blow resulted in a cut 15 cm long and 3 to 5 cm deep on the calf of his left leg. He was given first aid and later disembarked for shore treatment. He was declared fit for work about three weeks later.

- We are often tempted to overreach when accomplishing a job. Better to have help.
- Proper PPE is important. In this case, the engineer was wearing only a light cloth coverall. It is likely a more robust coverall would have afforded better protection.
- Permits to work and workplace inspections before beginning work are good risk reduction measures but they cannot remove all risks. Careful attention to our actions and common sense are needed throughout the task.

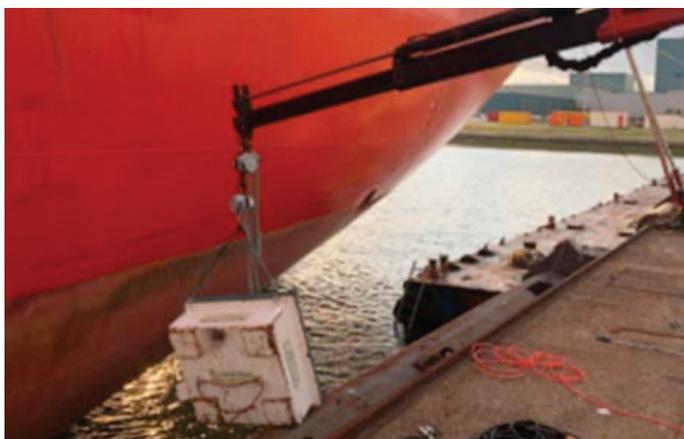
The investigation revealed that heat from welding could have caused deformation of the ship's side plating, causing the cofferdam to lose watertight integrity. Also, the flat cofferdam did not form a perfect seal with the hull due to a slight curvature at that location.

Cofferdam being positioned

- The task was executed by an external team, resulting in limited crew participation. Close coordination and supervision of contractors by crew provides an added layer of safety.
- In an emergency, pumping bilge water and ballast directly overboard is allowed within MARPOL and the International Convention for the Control and Management of Ships' Ballast Water and Sediments.

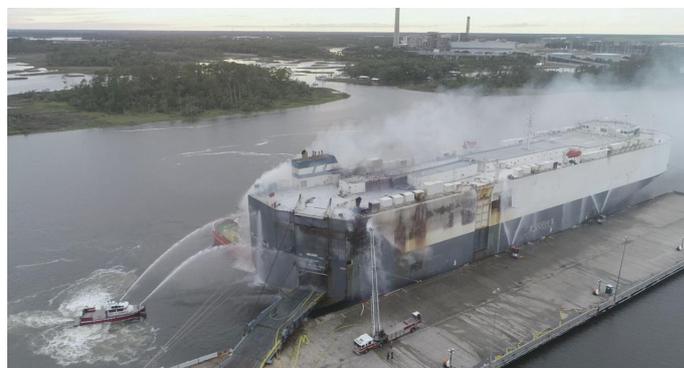
The CO<sub>2</sub> was ineffective for a number of reasons; not least that the dampers for decks 7/8 were ineffective or not adequately secured. This gave the fire continued access to oxygen, negating the effectiveness of the CO<sub>2</sub>. The fire continued to spread to higher decks and the accommodation. Shoreside firefighters entered cargo decks with fire hoses in an attempt to douse the flames. Suddenly, an explosion occurred and nine firefighters were injured, five of them seriously. Responders subsequently adopted a defensive strategy, cooling external exposed surfaces. The fire was finally extinguished eight days later.

The fire was likely caused by an electrical arc or component fault in one of the vehicles. The company's established vehicle loading and battery securement procedures call for a properly disconnected and secured battery for all vehicles loaded on the vessel. These procedures were not followed by the longshoremen preparing and loading vehicles onto the car carrier. Neither vessel crew nor shore supervisory personnel corrected this deviation.

- As with most accidents, there must be a failure of several layers of the safety regime for there to be negative consequences. In this case these failures were both ashore and on board.
- Procedures are meant to be an administrative barrier to negative consequences. They should not only describe the hazards but provide the process by which the hazards are actually mitigated.
- Extinction of a fire using a fixed extinguishing system such as CO<sub>2</sub> relies on two conditions:
  - 1) Timely release of the extinguishing agent before the fire can spread elsewhere on the vessel
  - 2) The securing of vents and ventilation so that the extinguishing agent can be effective and air cannot continue to feed the fire.

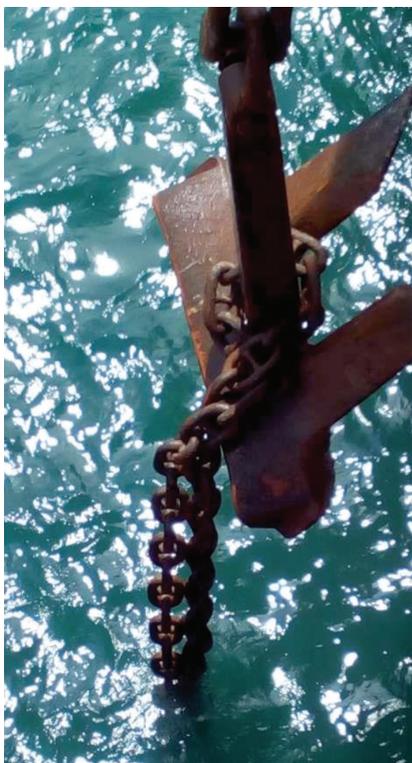
The port anchor chain was then heaved up. It was found that the anchor was not, in fact, lost; the bitter end had remained secured. However, when the port anchor was heaved up, it could not be secured because it had become entangled with the starboard anchor chain.

The company investigation found that the port anchor brake was not working properly; it did not move before the brake reached the 90% open position. If the equipment had been in good condition, the anchor chain could have been controlled.

- Anchor brake maintenance is a crucial element in safe operations. The uncontrolled descent of an anchor chain can not only pose a significant risk of losing an anchor, but also poses a lethal hazard to crew.
- During and after an incident it is sometimes difficult to assess and communicate the state of affairs – yet this is what is needed for ships' leaders to make the right decisions going forward.

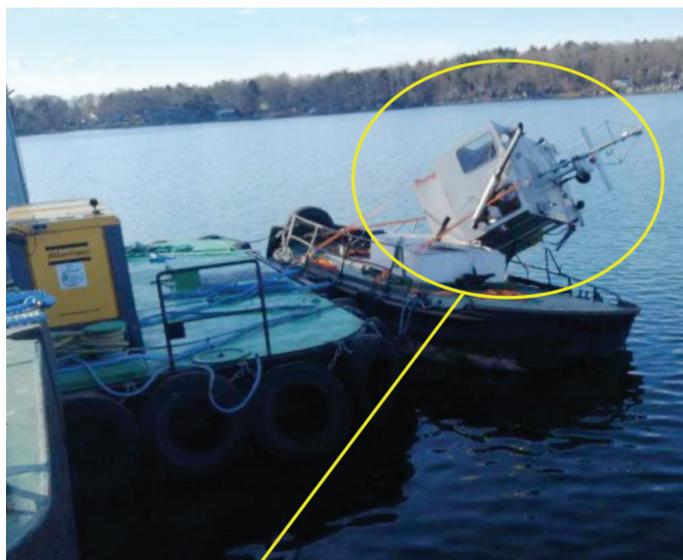
The vessel gained speed astern, and was closing on the dredging units. The officer on the quarter-deck warned the bridge team that the vessel was now 20 metres from the dredging units and continued to give the distances, which were closing quickly as the ro-ro was now making about two knots astern. At some point, full ahead was applied on the engine controls but the effect was too late. The stern of the ro-ro continued to sweep over the attending dredging tug. The tug wheelhouse was torn from its attachments, and was left hanging over the starboard side of the tug.

Tug wheelhouse torn from attachments

- Controlling a vessel that is moving in two directions (swinging and fore/aft movement) is harder than controlling a vessel that is moving in only one. The fact that the vessel was turning at the same time as it was reversing probably affected the bridge team's situational awareness.
