# Mariners' Alerting and Reporting Scheme

MARS Report No 358 August 2022

## Two anchors are not always enough

As edited from NTSB (USA) MAB-21/15

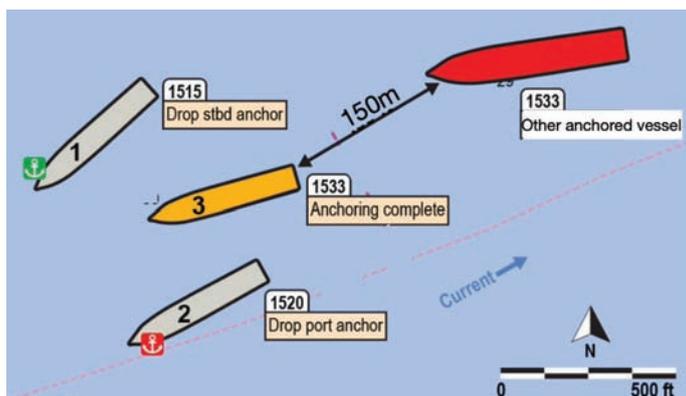
The starboard anchor was let go (position 1 in the diagram). The vessel then manoeuvred to port and, five minutes later, the port anchor was also let go (position 2). The starboard anchor was heaved to four shackles on deck and the port to three shackles in the water. About 15 minutes after the port anchor was let go the pilot informed the Master that the anchoring was finished. The pilot was satisfied with the situation (position 3), but recommended keeping the engine on short standby due to the inclement weather that was due to arrive and the strong river current. Another issue was that the vessel's stern was only 150 metres from the bow of another ship anchored astern (shown in red in the diagram).

The pilot left the vessel a few minutes later. Unknown to him, the vessel was not in a stable condition and continued to yaw between the anchors.

Even though the vessel astern was only 150 metres away, the OOW set the anchor watch alarm on the ECDIS for a radius of 180 metres. Soon, the vessel was moving astern at a speed over the bottom of about 1.8 knots. At 1602 there was a watch handover; the relieving officer, unfamiliar with the vessel's ECDIS because he was new, asked why the ship was not in the middle of the ECDIS 'anchor watch' circle. The officer being relieved offered to help familiarise the relieving officer with the ECDIS, but they did not further discuss the vessel's position at anchor as they went on to other business. About 10 minutes later, the OOW aboard the vessel anchored astern called on VHF radio giving a warning – he had noticed that the general cargo vessel was moving astern toward his vessel.

- The first minutes after anchoring are important. Special attention should be given to ensuring the vessel's anchors are indeed holding and the vessel is stable.

- Given the distance of just 150 metres from the stern of the vessel to the bow of the other anchored vessel, the anchor watch alarm radius setting of 180 metres was too large to provide a timely alarm of the ship dragging.

- When at anchor, all means to detect vessel movement should be employed. In particular, the radar should be used to crosscheck ranges to shore or other anchored vessels.

- In this case, there were four shackles on deck on the starboard anchor and three in the water on the port anchor. Best practice with opposing forces ahead (such as in a river current) would be to have equal amounts deployed on each chain to avoid unequal distribution of stress. Unequal distribution of stress could result in one anchor taking the load, then dragging and putting the load on the other anchor, which in turn takes the load, and then drags. This in effect nullifies the advantages of deploying two anchors.  
Readers may remember another recent MARS report where dragging anchor in a crowded anchorage caused problems; M202216.

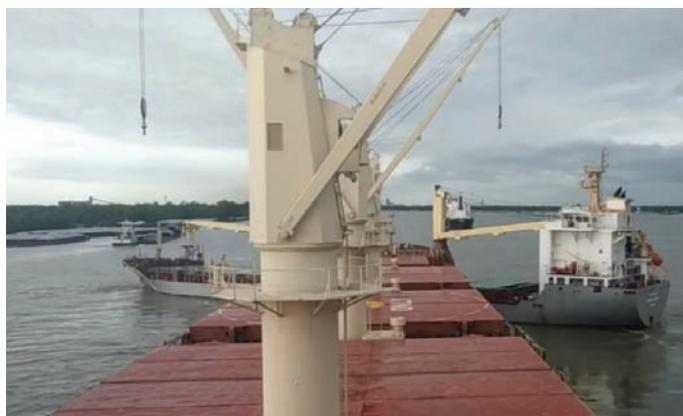
At 1639, the OOW became aware that they were now too close to the other anchored vessel. He contacted the engine room and engine control was received on the bridge nine minutes later. The Master began using full ahead engine, along with the bow thruster and rudder, to reduce the swing and bring the ship ahead. By this point, the ship was unable to turn to starboard away from the other anchored ship. At 1655, with the first vessel now broadside to the current and pushing on the bow of the other anchored vessel, both vessels were now dragging anchor.

Tugs were requested to help hold and stabilise the vessel. The first tug arrived on scene about 30 minutes later. A further 30 minutes passed before pilots arrived on both vessels, but more tugs were needed to extricate the vessels from their position. Although these arrived some time later, the vessel nonetheless hit a shore dock at a speed of 6 knots before its bow grounded on the river bank. Damage to the two vessels and the dock were estimated at \$16.9 million.

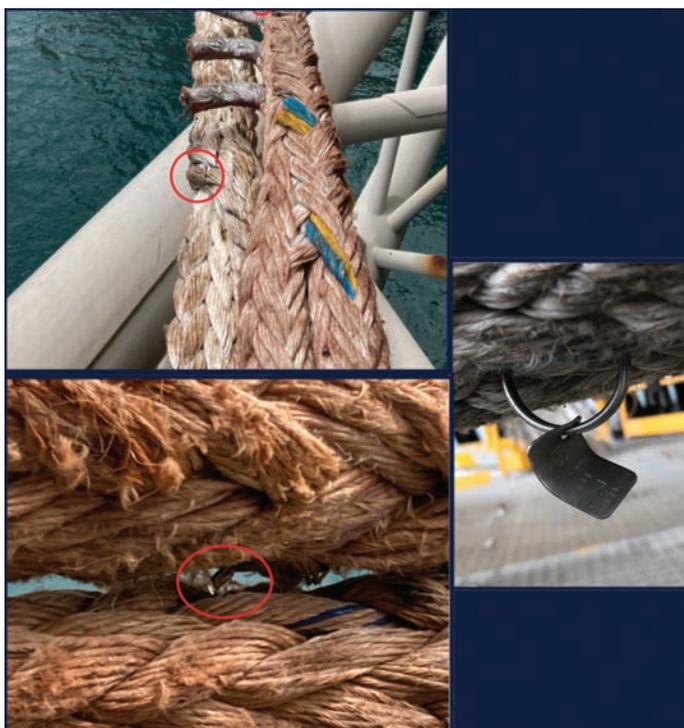
➔ During berthing operations at a loading terminal, the line-handling crew were surprised to find metal rings and tags entwined within the yarns and strands of a vessel’s lines. These objects present a potential catch point and/or finger entrapment hazard for anyone handling the lines. There is also a risk that these objects could detach and become projectiles when lines are under load or when lines are being run. This was the fourth vessel in six months to have lines with such hazards. The terminal authorities grew concerned and made a MARS report.

It is likely that the rings and tags are items associated with materials used to pack the lines themselves. It is also possible that these objects could have become embedded within the lines during usage.

- When bringing a new line into service, ensure all packing and extraneous materials are removed from the line before use.
- It is good practice to observe and inspect berthing lines at every use; as they go out and when they come on board. The inspection should cover the general state of the line, but be aware of any objects that may embed themselves into the fibre of the rope during usage.

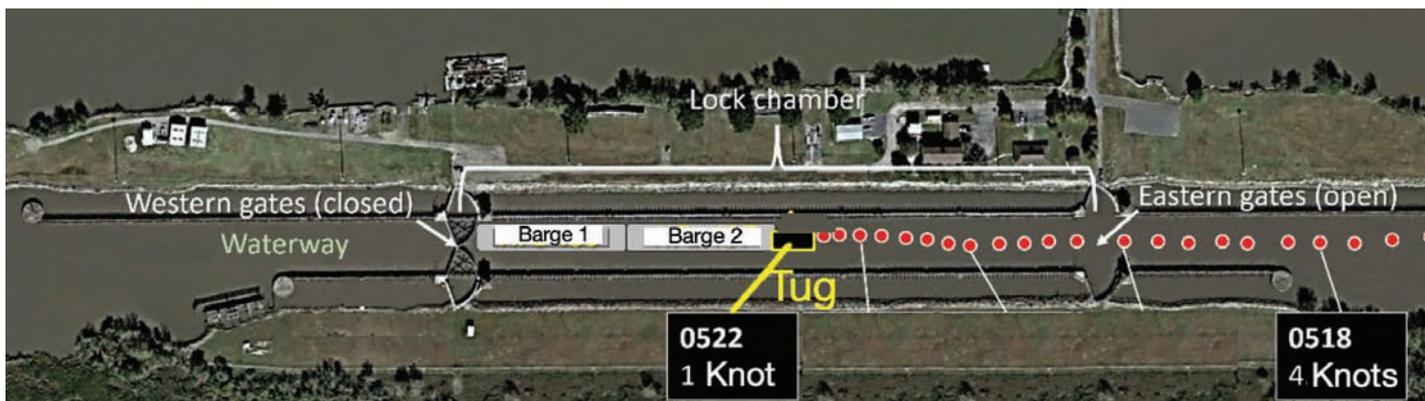
With the tug and barges now at a speed of about two knots, the Master received a distance report from the deckhand and, realising they were close to the front of the lock, put the engines to full astern. The tow continued to slow but was still making about one knot when the starboard bow of the forward barge (1 in picture) struck the closed western lock gate.

The official investigation found that the Master’s performance and decision making were probably negatively affected by sleep inertia. Sleep inertia can be a factor for 30 minutes or more after waking, especially in demanding situations that require high levels of attention and cognitive demand. Further, waking during a circadian low, such as in this case at 5am, and partial sleep deprivation, can amplify the effects of sleep inertia.

- The company operations manual required that a change of watch was not to occur during ‘a critical move’. Examples included operations involving ‘bridges, locks, and docking operations’. The requirement is one of common sense and, in this case, does seem fully justified.

- Fatigue has many negative effects on performance and is notoriously hard to objectively assess by its victims. Sleep inertia is a silent companion to fatigue and mariners would be well served to be aware of its existence.

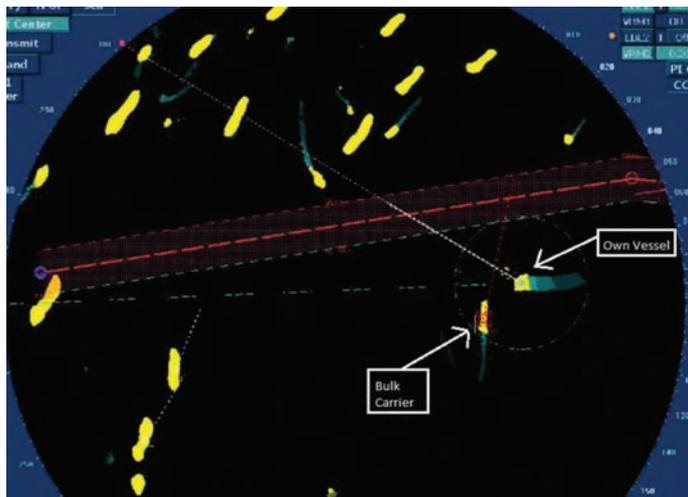
➔ In darkness, a vessel was proceeding to a busy anchorage under the con of a pilot who had just boarded. The pilot and the Master engaged in small talk as they proceeded and there was also an OOW and a lookout on the bridge. Another vessel underway in the vicinity had recently altered course to port and, unknown to the bridge team or pilot, was now in a potential close quarters situation. Almost 10 minutes passed before the potential close quarters situation was observed by local VTS and the bridge team alerted to the danger by VHF radio.

Only now, with the other vessel just 0.3 nm away, was it plotted. There was initially some confusion as to the speed of the other vessel as the value was changing; but this was to be expected in the first minute after plotting as the ARPA target acquisition algorithm needs to refine the calculations. Emergency course alterations were made and the bridge team tried to communicate with the other vessel by VHF radio. As the distance decreased between the two vessels, the bridge team, now under some stress, sounded a long blast on the fog horn. Finally, the other vessel passed astern only 35 metres away.

- A common mistake when a pilot boards is for the bridge team to relax; the unstated assumption is that the pilot has everything under control. Not so! The bridge team must continue to do their jobs in full support of the pilot and visa versa.
- As part of a bridge team, never assume that someone else will see it. It is possible for any member of the bridge team to make an error or miss a cue. YOU may be the only one that identifies a potentially hazardous situation, and for this reason, every bridge team member should be alert.
- The danger signal is at least five short blasts.
