# Mariners' Alerting and Reporting Scheme

MARS Report No 359 September 2022

MARS 202237

## Hold access fatality/lack of oxygen

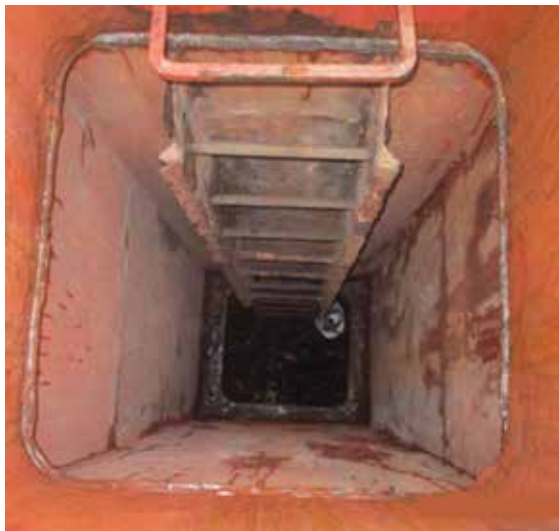
The bosun and fitter opened the aft access hatch to cargo hold 1 but the bosun told the fitter to wait at least 20 minutes before entering. Some time later, the deck cadet walked by the cargo hold and looked into the open hatch. He saw the fitter lying motionless below on the coal close to the access ladder. He immediately notified the bosun using his portable radio. The bosun quickly arrived on scene and, without raising the alarm, went directly down the access ladder in an attempt to rescue the fitter. Shortly after entering the cargo hold, the bosun lost consciousness.

Among other things, the investigation found that: The Company's enclosed space entry procedures were not followed. In particular, the ship's officers had not been notified of the need or intention to enter the hold. The first, failed, attempt to rescue the fitter without initiating enclosed space rescue procedures was a grave error that not only delayed the recovery of the fitter but put the bosun's own life in danger.

There was a distinct lack of awareness on the part of certain crewmembers on the hazards of entering a cargo hold containing coal without first complying with the Company's enclosed space entry procedures.

Locking devices were fitted to the access hatches for all cargo holds and other enclosed spaces on board the vessel.

The Company's SMS was updated to require permanent signs at the entrance to enclosed spaces warning of the risk of asphyxiation if entered without taking proper precautions.

A training initiative was implemented to increase awareness of the hazards of entering enclosed spaces without taking proper precautions.

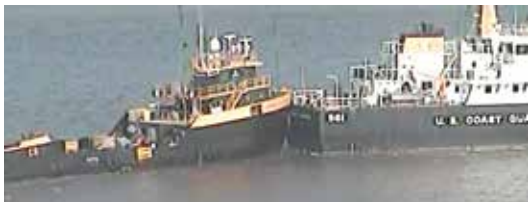
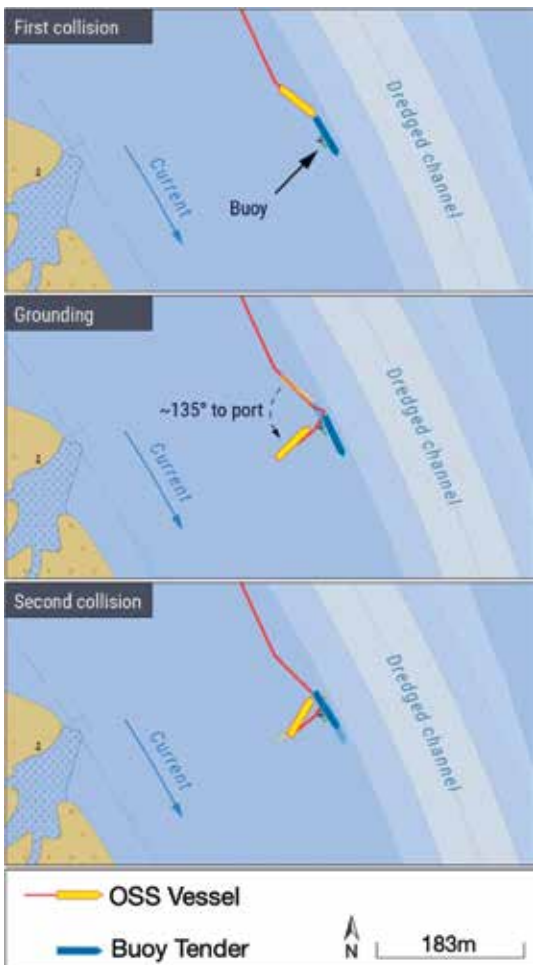
At 1544, the bow of the OSS vessel collided with the stern of the stationary buoy tender while making 6 knots. The OSS vessel then pivoted and slid down the tender's starboard side and grounded on the mud banks to the starboard of the buoy tender. Some 45 minutes later, with the buoy tender still in the same position, the OSS vessel re-floated. The Master of the OSS vessel attempted to manoeuvre around the stern of the buoy tender but the ebb current set it onto the stationary Coast Guard vessel. Recognising that a second collision was imminent, the buoy tender's Master made another ship-wide announcement warning the crew to brace for impact. The offshore supply vessel's starboard bow struck the tender's starboard quarter.

The OSS vessel's Master had assumed that the stationary buoy tender's position was not at the edge of the channel. This led to his decision to pass the buoy tender on its starboard side. Last minute manoeuvres, initially to avoid grounding and then to avoid collision with the buoy tender were unsuccessful. Another factor contributing to the collision was that the buoy tender crew did not question the passing arrangement proposed by the OSS vessel's Master.

The buoy tender remained connected to the heavy buoy anchor on the sea bottom and was therefore unable to manoeuvre and evade the OSS vessel. If the crews had communicated more fully with each other, they might have agreed for the OSS vessel to wait until the buoy tender could move on.

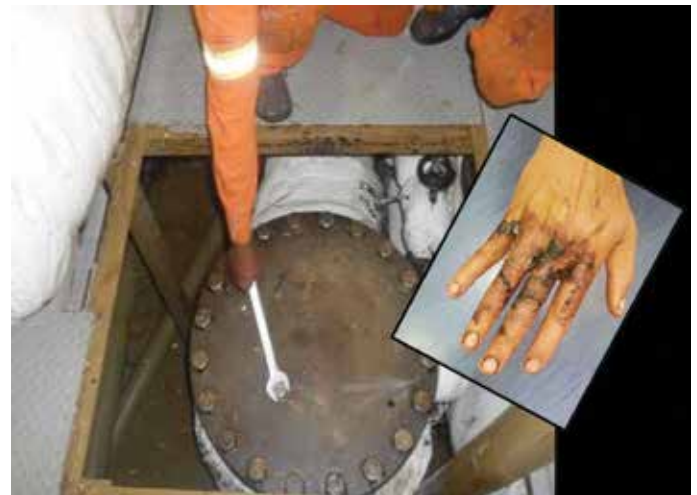
To begin, one crewmember used a spanner to loosen the vent nut on the strainer. As the nut came loose, hot liquid bitumen was ejected from the vent. The bitumen hit the crewman's right hand causing burns; the crewmember was not wearing work gloves. He was immediately brought to the accommodation and given first aid. After consulting the company doctor, he was started on a course of antibiotics as a precautionary measure.

- Wearing proper personal protective equipment (PPE) is a minimum precaution in any work space.
- Over and above wearing proper PPE, risk assessments, even if ever so cursory (what could happen?), should be done to prior to executing a task. In this instance, given the preheating of the bitumen, it would seem common sense to assume that hot bitumen would excrete from the loosened vent nut.
