Mariners' Alerting and Reporting Scheme

MARS Report No 361 November 2022

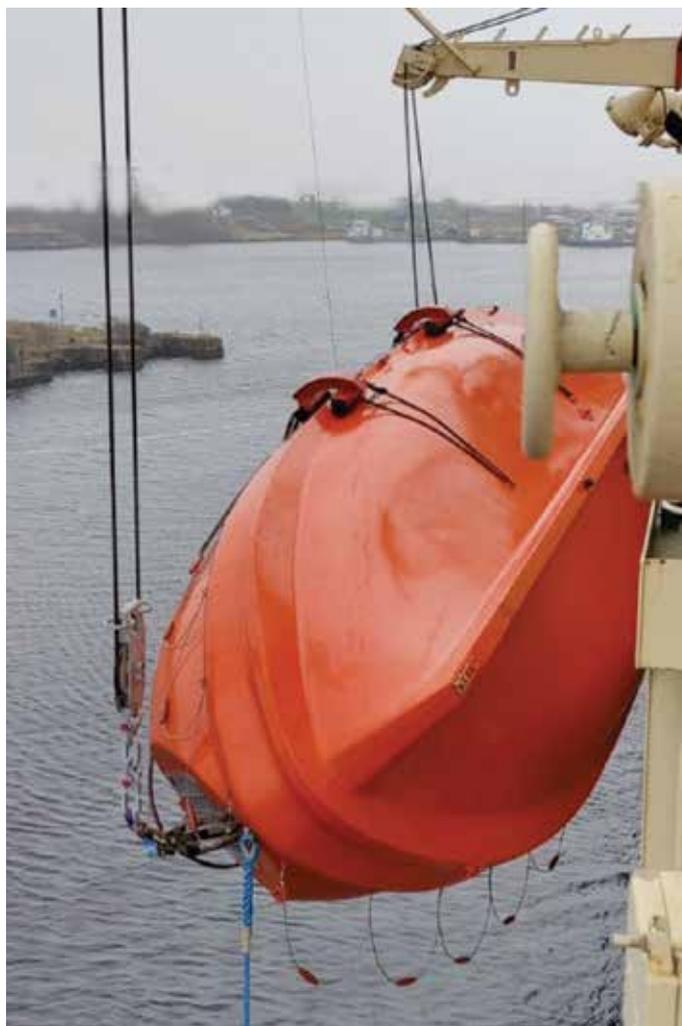
→ A vessel's lifeboat with crew on board was being lowered to the water when the remote control lowering wire suddenly parted. Poor winch wire spooling under the outer layers led to a wire kink, creating a weak spot that contributed to the wire failure. The consequences in this instance were not serious, as the broken wire simply meant the brake was re-applied. However, had this been a real abandon ship, the consequences could have been more serious.

The remote control wire was replaced with an extra wire found on board, and another test was carried out the next day. The lifeboat crew boarded and the coxswain used the remote control wire to lift the brake and begin the descent. Again, the control wire failed to spool smoothly, and an unexpected pay-out of the control wire led to the winch brake prematurely engaging. The lifeboat stopped lowering and swung erratically above the embarkation deck. Seconds later, the swinging motion caused the wire to regain tension. This lifted the winch brake arm and caused the lifeboat to lower again, still swinging. As the lifeboat swung, the skeg keel caught on the deck edge, and the lifeboat listed by more than 90°, as seen in the photo. A crewmember on deck quickly activated the winch brake lever to save the situation. Had the lifeboat inverted further the consequences could have been catastrophic.

Ship's crew should conduct a thorough visual inspection of lifeboat launching systems and perform a test lowering before carrying out operations with crew on board. Pay special attention to the following inspection points:

- Verify the proper spooling of the remote control wire, expand inspection as necessary.
- Verify that the remote control wire weight is in the correct position. If the weight is very close to the top of the lifeboat, this may indicate the remote control wire is too long.
- Verify the material condition of the shackle that connects the pull cable to the remote control wire within the lifeboat. These steel shackles can corrode and may be overlooked during weekly/monthly/annual inspections.

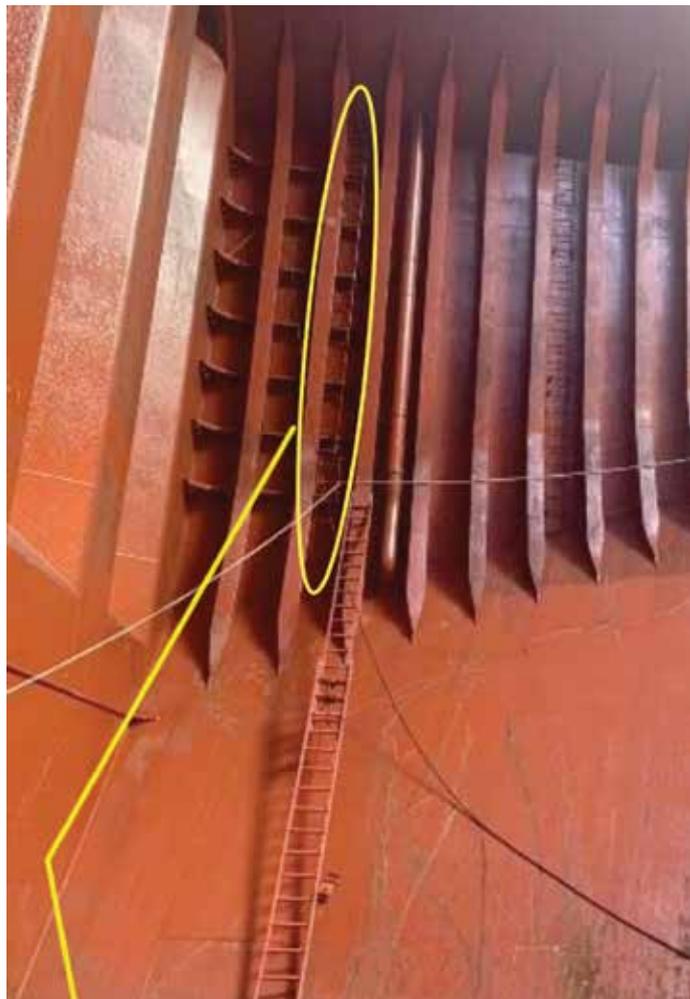
Area of work aloft

Two crew were working aft while the other crewmember aloft was forward, standing on one of the stiffeners at a height of about 7.5 metres above the tank top. He was using a power washer and a hand-held broom to wash off coal residues that had remained in this area.

Suddenly, the two crewmembers aft were alerted by a loud scream. They saw the victim had fallen from the stiffeners and was lying on the tank top, and rushed to aid him. The victim was conscious, bleeding slightly from the head, and complaining of severe chest and back pain. The accident was reported to the bridge and first aid was administered. The victim was then carefully evacuated from the cargo hold and taken to the ship's hospital, where his condition was continuously monitored. At the time, the vessel was approximately 150nm off the coast. Following communication with shore medical authorities, the Master altered course and proceeded towards the coast. The following morning

The victim confirmed during the post-accident interview that at one point just before the fall, both of his safety lines had been unsecured. The investigative agency found, among other things, that the actions of the victim were similar to several other instances on file where the need to 'get the work done' seems to override safety concerns, even where the situation was not an emergency. It would appear that if the person in question perceives that they have 'control' of the situation, this influences their decision making process and evaluation of risk.

- Qualitative risk evaluation is subjective and can be affected by factors such as the person's perceived control over the situation, the familiarity or even 'shock value' of the risk. Mundane tasks are a breeding ground for misplaced judgement, even those that present severe risks.
- Safety harnesses are equipped with two lanyards for the express purpose of always having one connected while the other one is repositioned. Make sure you and your crewmates use them correctly.

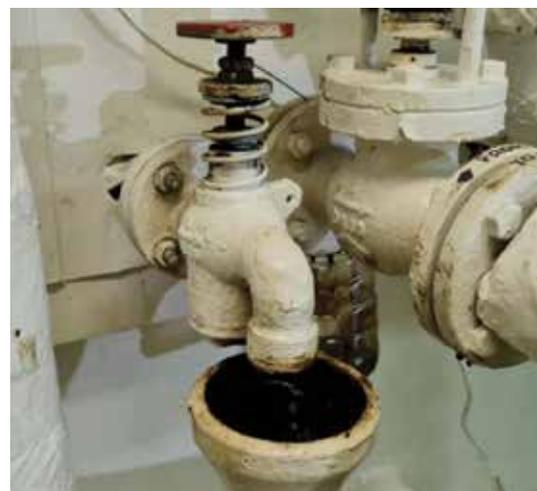
FOST-1 drain valve

The fourth engineer was directed to open the lower manhole of FOST-1 before starting the transfer, to verify that there was no sludge that could contaminate the bunkers. Before doing this, he checked the fuel oil gauge, and opened the FOST-1 drain valve. Both actions indicated that FOST-1 was empty, much as he and other engine crew had previously assumed. He noticed that the temperature in FOST-1 was elevated (about 78° C), which was unusual for an empty tank, but assumed that heat conducted from adjacent tanks accounted for this.

After the accident, it was found that the oil level gauge and its drain valve were partially clogged with sludge. Once cleaned, the oil level gauge worked correctly. The fuel level in FOST-1 was found to be at the lower edge of the manhole; a volume estimated to be nine cubic metres. It is estimated that eight cubic meters were lost into the engine room.

- Always try to be aware of confirmation bias in your daily work and life; question your assumptions and double check the facts.
- Fuel gauges and drain valves can become blocked with sludge and not indicate the correct level of fuel or drain as designed. Sounding pipes, which in this case were not fitted to the FOST-1, are an efficient and reliable double check on liquid levels within tanks.

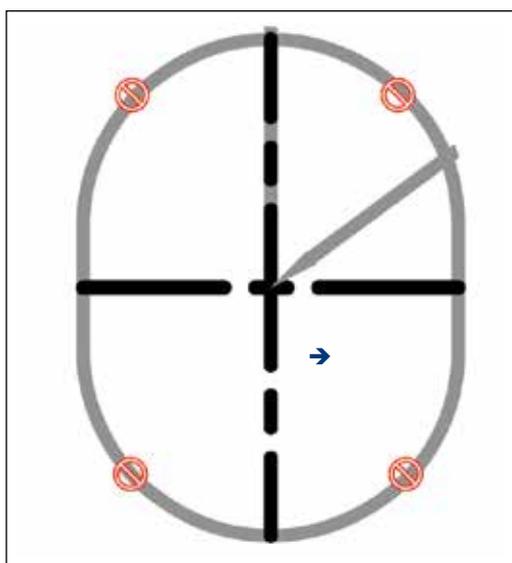
without incident, leaving four opposite each other still tightened, as shown in the diagram. The engineer proceeded to loosen these last ones, starting from the bottom nuts. At this stage, he noticed a small amount of fuel oil seeping out of the manhole. Assuming that this was the expected seepage of fuel oil which normally remains stuck to the tank sides, he continued undoing the nuts. As he loosened the last two bolts, fuel oil started to seep out in larger quantities. Now concerned about the increasing seepage, he attempted to reinstall and retighten the nuts. However, the flow and high temperature of the fuel oil spilling on his hands and torso were too much for him, and he had to abandon the area, as did the oiler helping him.

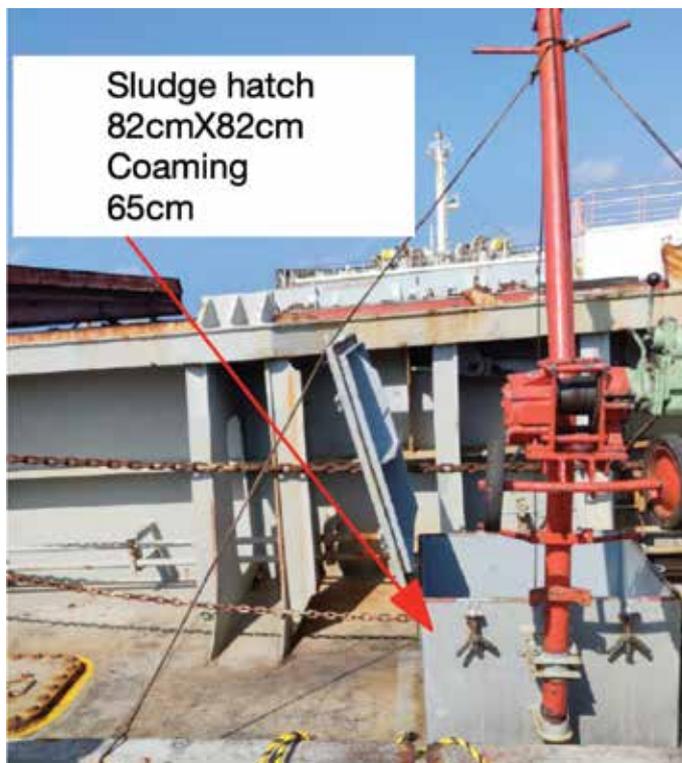
Sludge hatch and mucking winch

The bosun hoisted the wire back up and prepared a large bucket of tools weighing about 10kg to lower into the hold. The deck around the sludge hatch was dry and free of cargo residues or other debris – but the Bosun was singlehandedly attempting to attach a heavy load to a hook that was suspended over an open hatch. As the bosun was holding the bucket of tools over the open sludge hatch and trying to connect it to the hook he lost his balance. He fell through the hatch, falling about 18.5 metres to the tank top below.

The two crew who were already in the hold heard the Bosun yell, followed by a loud noise. They turned to find the Bosun lying motionless on the tank top, with his head on one of the portable ladders. The alarm was raised and assistance given. The Bosun was conscious and responsive but he had multiple injuries to his torso and extremities. He was taken to the ship's hospital and arrangements were made to evacuate him to the nearest shore hospital. Unfortunately, within three hours he had succumbed to his injuries.

- Certain jobs can lose the appearance of risk when they are commonplace to workers and/or have become repetitive tasks.
- Any workplace where a potential fall from height is possible should be treated with great caution and proper measures taken to mitigate falling.
- Trying to lift a weight that is on the limit? Ask for help.
