MARS – Lessons Learned

MARS Report No 379 May 2024

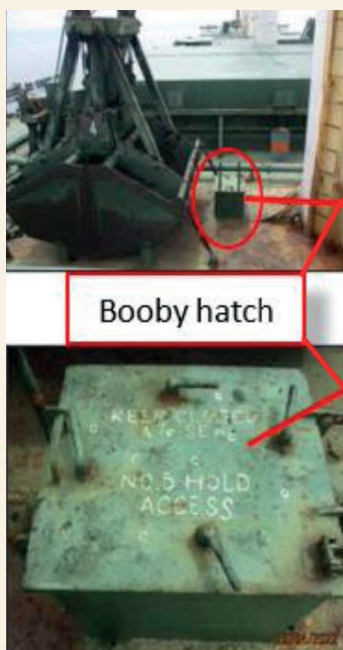
Four crew members were working to free the dog handles at one of the booby hatches. The booby hatch was open while they were doing this, and a disassembled dog handle fell down the hatch. One man climbed down to retrieve it. As he climbed back up with the retrieved dog handle, he lost consciousness due to a lack of oxygen, fell and landed on the coal cargo about 3.5 metres below.

The alarm was immediately raised and the crew mobilised to rescue the victim. An officer arrived at the booby hatch with an Emergency Escape Breathing Device (EEBD) hood and entered the cargo hold through the booby hatch ladder. Meanwhile two air hoses were being connected to the air supply in an attempt to supply air to the hold. The officer that had entered the booby hatch with the EEBD soon came out, saying that it was difficult to breathe and hot in the cargo hold.

The chief cook, of his own accord, then took affairs into his own hands. He grabbed the two air hoses, a safety harness and ropes and descended into the hold to attempt a rescue. Within five minutes, the cook had managed to secure the safety harness below the arms of the victim and the crew on the main deck were able to pull him out; the cook exited the hold soon after. The victim was not breathing and there was no heartbeat or pulse. CPR was performed on the victim and he was evacuated ashore but to no avail – he was declared deceased.

- In an emergency rescue, the atmosphere of an enclosed space should always be considered unsafe unless confirmed otherwise.
- An EEBD should never be used to rescue a victim in an enclosed space. This equipment is only for escaping from a compartment that has a hazardous atmosphere and should not be used for entering oxygen deficient voids or tanks on board ships.

- Many enclosed space emergencies have claimed extra victims; persons attempting to rescue the initial victim have themselves succumbed to the lack of oxygen in the course of improvised and poorly executed rescue actions. In this case, the cook and the officer with the EEBD were just 'lucky'.

- Vessel leaders must take charge in situations such as this accident. The officer should never have entered the hold with only an EEBD and the cook should have been immediately stopped from entering the hold.
