MARS – Lessons Learned

MARS Report No 380 June 2024

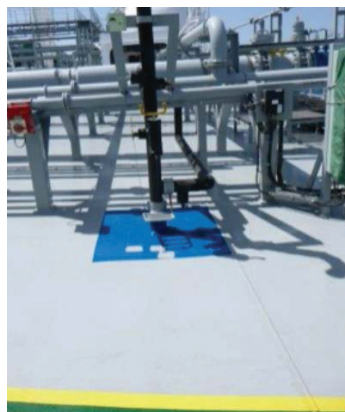
Before

➔ On a tanker during a Safety Observation Round it was found that there was no anti-slip paint applied to give safe access to the emergency shower station. Wet decks are notoriously slippery. Also, if an emergency shower station is needed, it is probably an emergency and victims will probably not be paying attention to the condition of the deck.

- Here, once again, is a good example of examining your ship with new eyes. We often become blind to hazards in plain sight because they have been in plain sight for so long.
- Good practice dictates all deck pathways are covered in non-slip coatings.

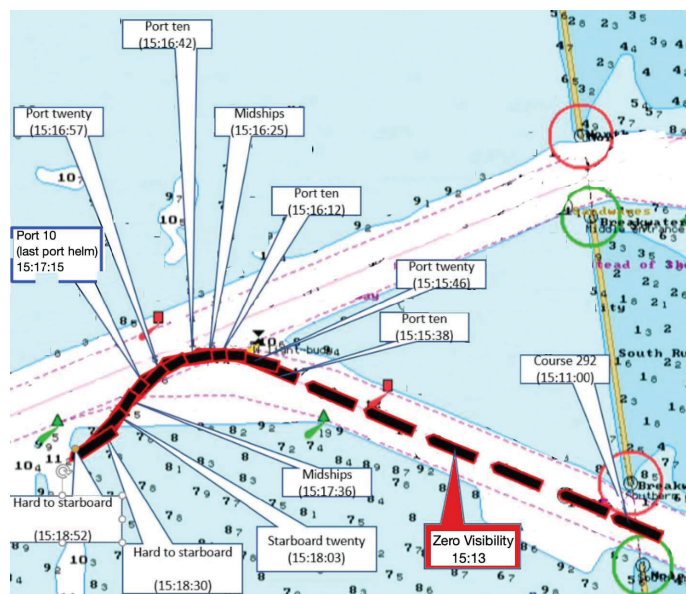
➔ A loaded cargo vessel was outbound under pilotage in daylight and moderate visibility. A tug was in attendance but was released once the vessel was past the port breakwaters. About seven minutes after the tug departed the vessel, visibility unexpectedly reduced to about 200m. The vessel was at a speed of six knots, and over the next two minutes the pilot gave helm orders to make a 44 degree port turn out to sea (see diagram).

The vessel turned further to port than desired. Once the pilot realised this, he gave starboard helm orders, but it was too late. The vessel grounded outside the buoyed channel about four minutes after the first port helm order was given. Attempts to use ship's power to return to the channel were fruitless and salvage tugs were needed.

The investigation found, among other things, that the vessel lacked a complete voyage plan to exit the harbour (ie courses, safety distances, clearing bearings, rate of turn etc.) and that the pilot was navigating primarily by visual means. When the visibility unexpectedly reduced, the bridge team were at a disadvantage. No one on the bridge was in control of the progress of the 44 degree port turn by electronic means such as ECDIS or radar.

- A shared plan is a safer plan. In this case, the plan was in the pilot's head, much as we saw in MARS 202153.
- Even with a pilot on board a Master should ensure courses are put on the chart or ECDIS and OOWs are closely following the progress of the vessel.
- Visual navigation in fog is a recipe for an accident.
- When in doubt, slow down if possible. In this case the vessel was

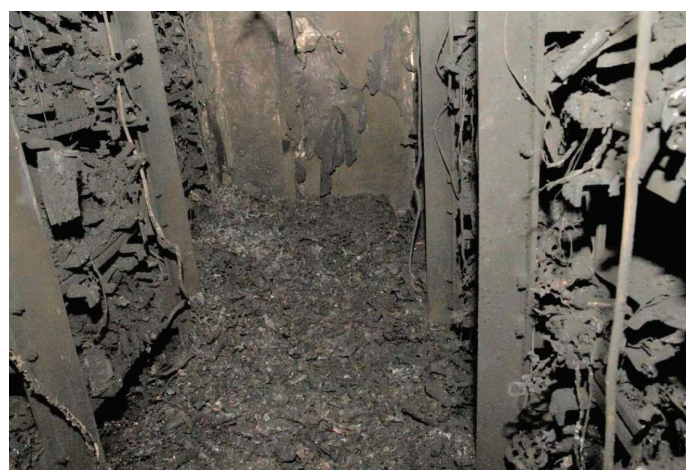
Fire damage to starboard battery room

Technical examinations showed that the fire started in a battery stack module. It is highly probable that seawater ingress through the ventilation outlet had leaked through the ventilation fan and down onto the batteries. This caused a short-circuit and electric arcs, which were considered to be the source of the fire.

Important information about flooding points from the ventilation system to the battery room was missing from the freeboard plan. This meant that the regulatory personnel responsible for approving the freeboard plan were unaware of the position of the ventilation outlet and the risk that it posed. After the accident, the vessel owners have made several changes to the ventilation system.

The investigation also showed that the battery system had a low ingress protection (IP) rating, so that when seawater entered the battery modules and high-voltage components there were severe consequences. A higher IP rating (and therefore a higher degree of protection) would have reduced the consequences of seawater ingress to the battery room. It would appear that the regulations do not sufficiently address the need for ingress protection of battery systems.

- Because the fire was incorrectly understood to be in the engine room, approximately seven minutes passed before the extinguishing agent was released to the battery room. In order to be effective, a fire suppression agent needs to be released quickly and, if possible, automatically.

- The ingress protection (IP) rating of marine battery systems should be carefully considered.
- Classification societies may have different requirements for battery safety, which can result in different vessels having different standards of battery safety. Based on current rules and regulations, the same error may occur again.
