# INSPECTION REPORT

For the Property at:  
**1 ANY STREET, A**  
OTTAWA, ON

Prepared for: JOHN SMITH  
Inspection Date: Saturday, July 1, 2023  
Prepared by: Michael Francis

RE: Report No. 1507

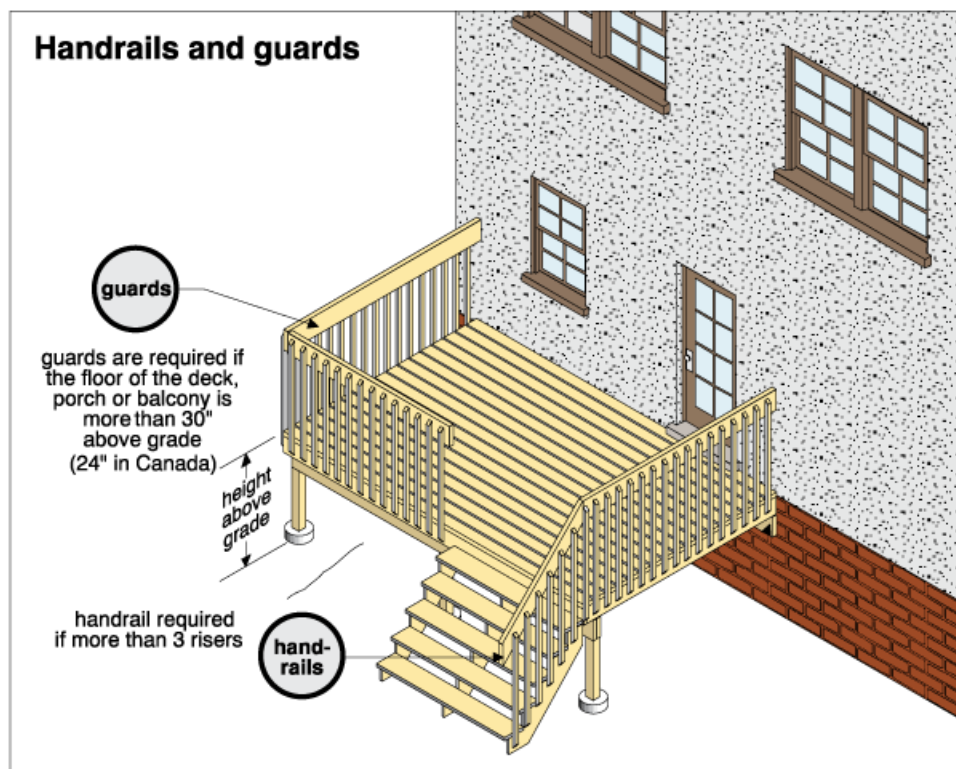
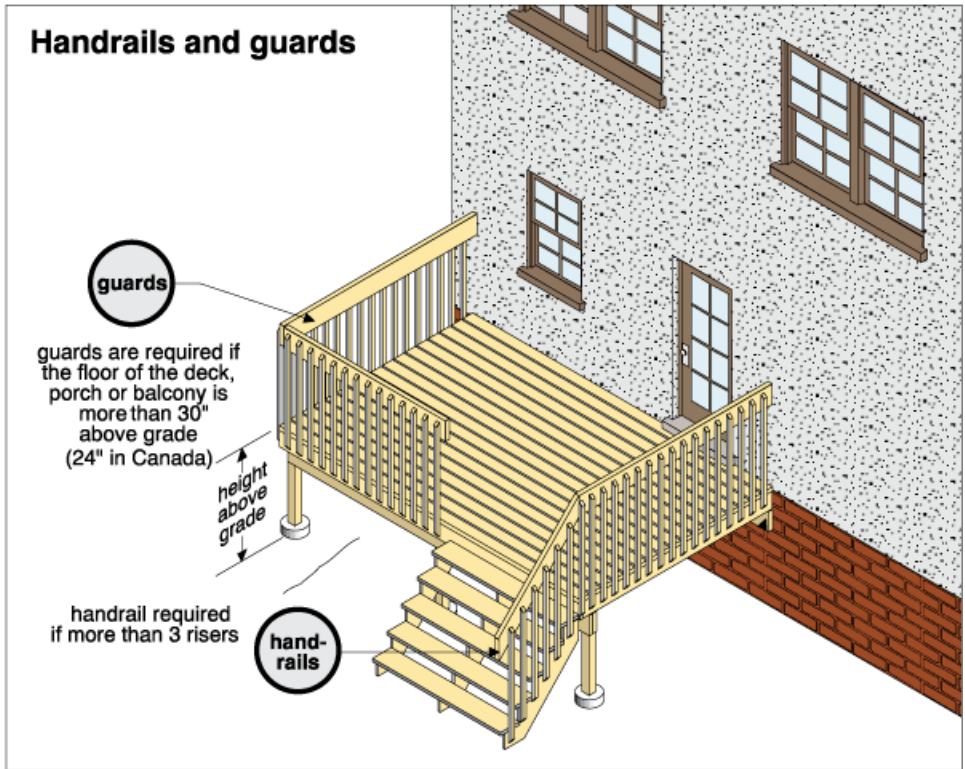
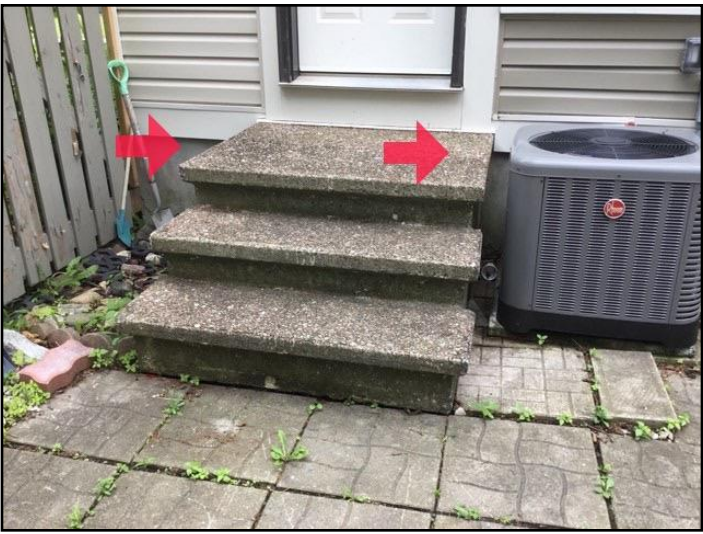
8. Missing

2. Condition: • Missing

Location: Rear

Task: Provide

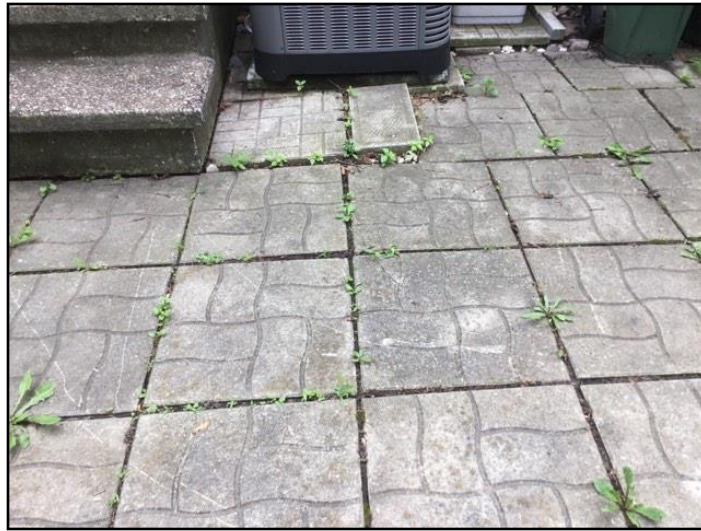
3. Condition: • Uneven (trip hazard)  
Location: Rear  
Task: Correct

**9. Uneven (trip hazard)**

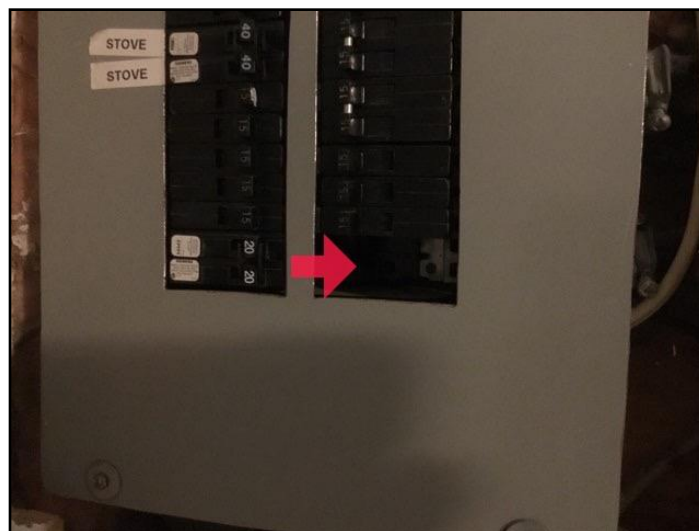
**4. Condition:** • Openings in panel

**Location:** Basement

20. Openings in panel

**Task:** Correct

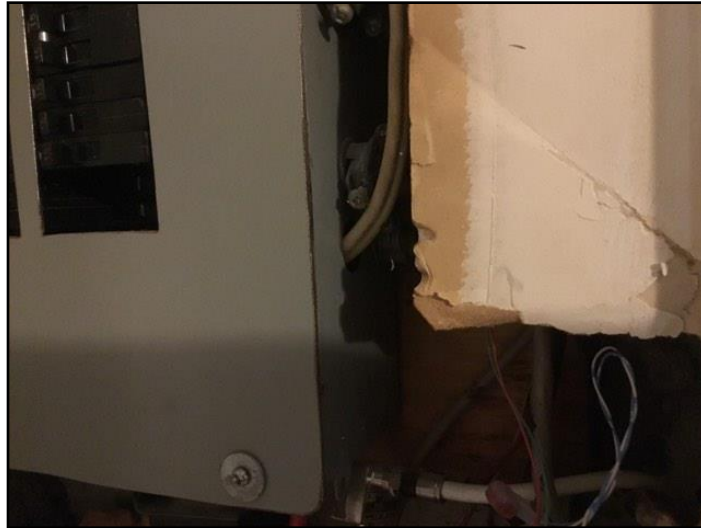
6. **Condition:** • Not well secured

No strain relief on wire

**Location:** Basement

21. *Not well secured*

**Task:** Correct

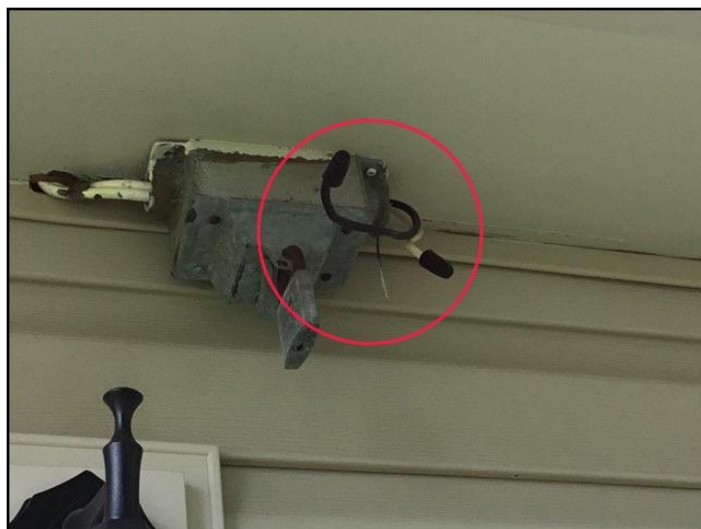
7. **Condition:** • Open splices

**Location:** Front

22. *Open splices*

**Task:** Correct

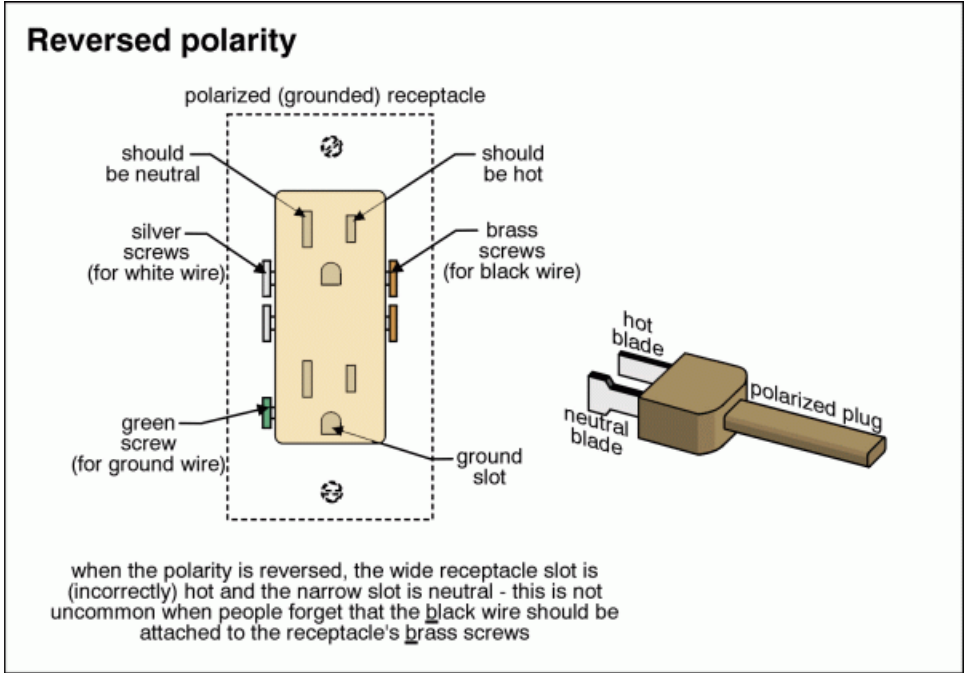
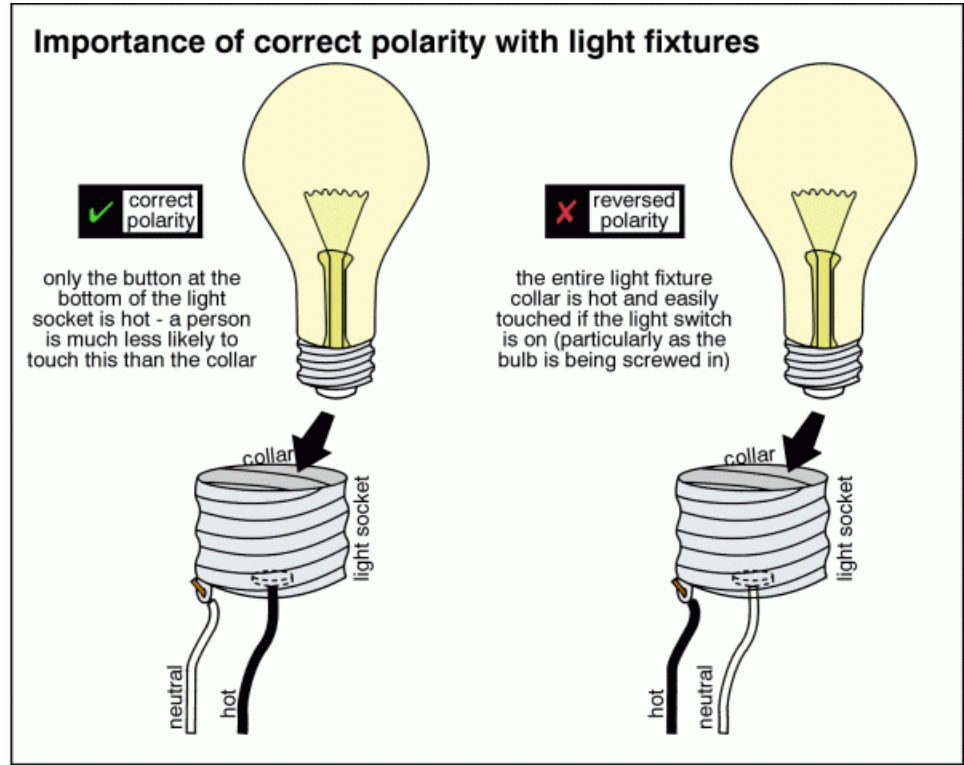
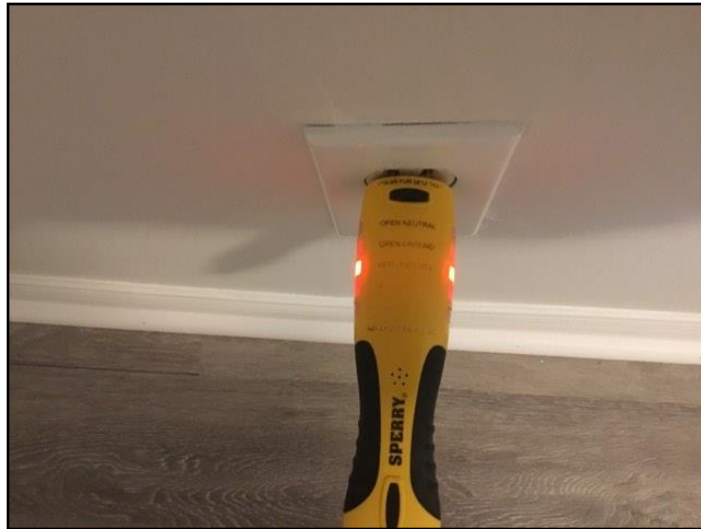
**8. Condition:** • Reversed polarity

**Location:** Basement

23. Reversed polarity

**Task:** Correct

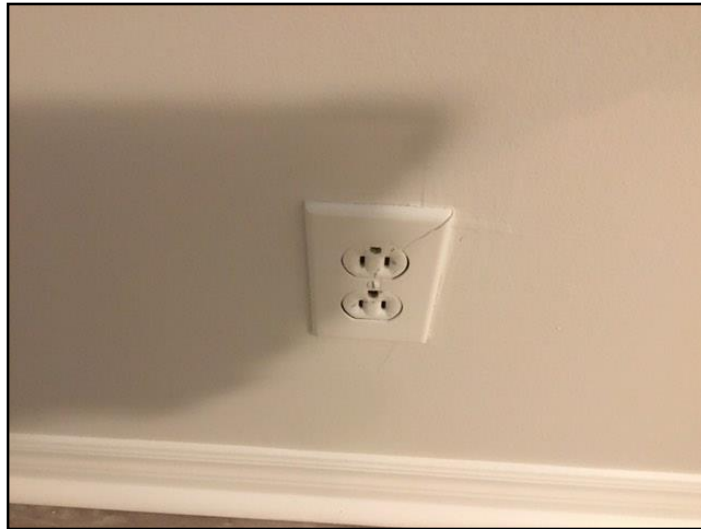
10. Condition: • Damaged

Location: Basement

26. *Damaged*

Task: Replace

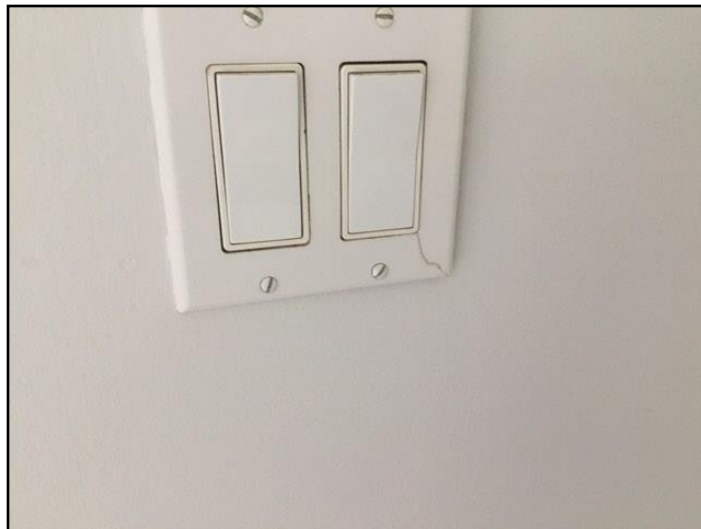
**11. Condition:** • Damaged

**Location:** Master bedroom

27. *Damaged*

**Task:** Replace

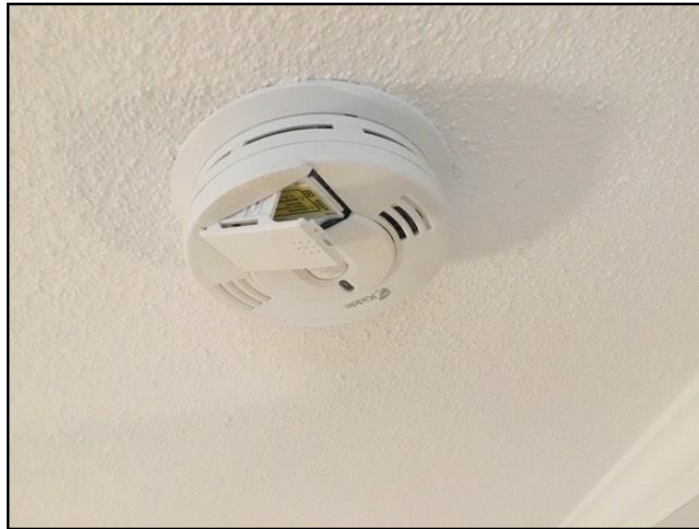
**12. Condition:** • Inoperative

Missed battery

**Location:** Throughout

28. Inoperative

**Task:** Provide

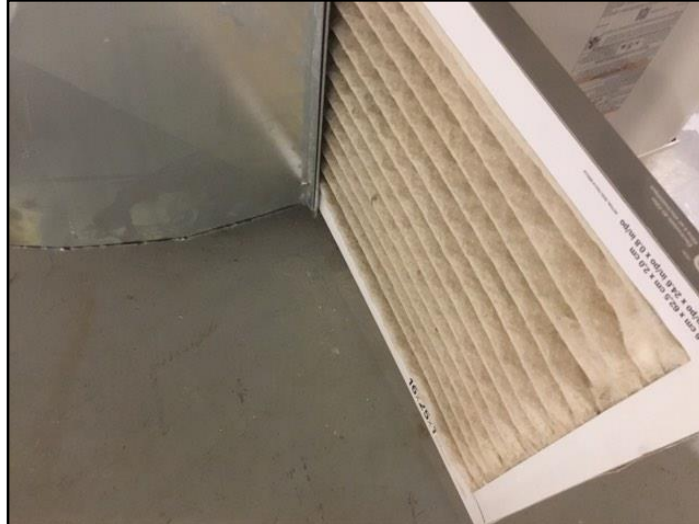
13. Condition: • Dirty

34. Dirty

Task: Replace

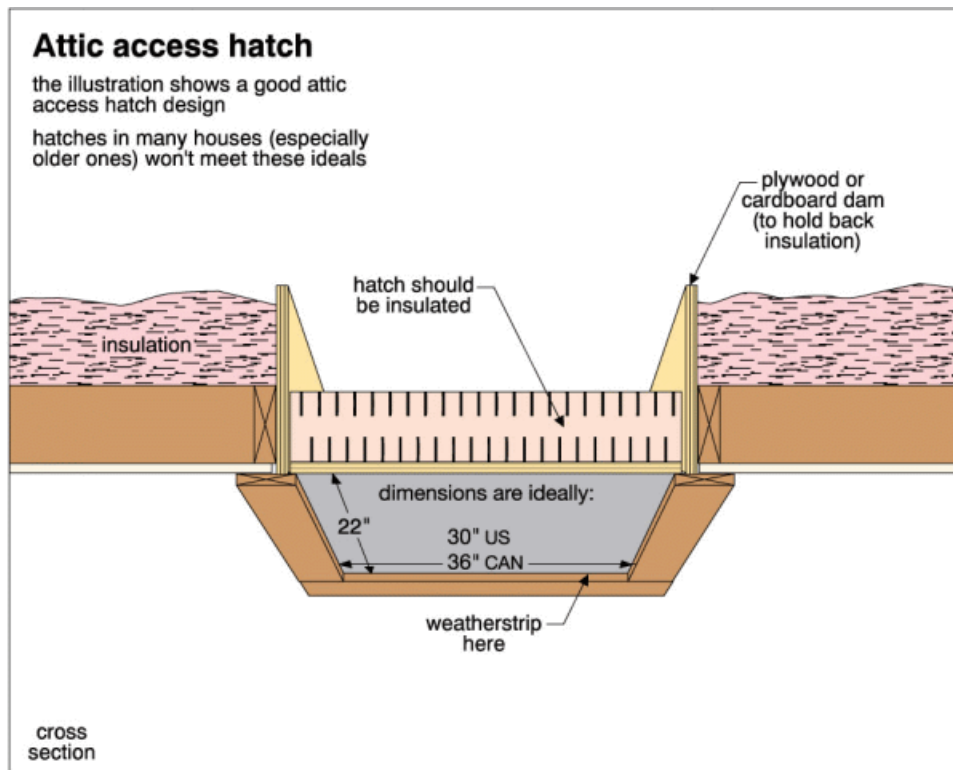
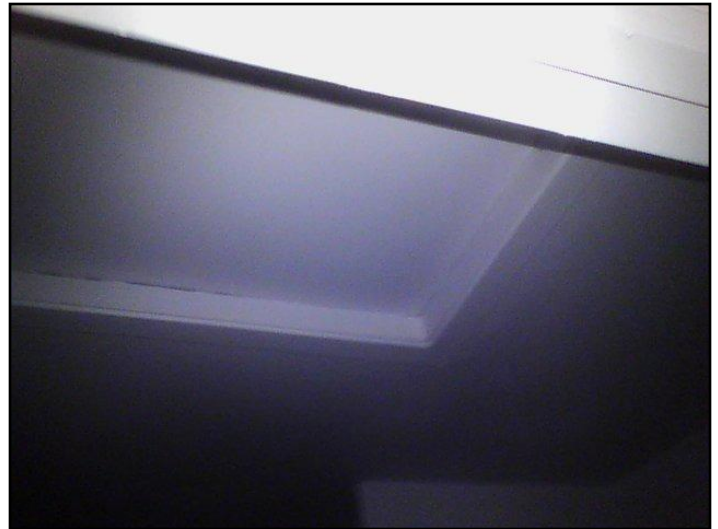
**14. Condition:** • Not weatherstripped

**Location:** Second Floor Bathroom

42. Not weatherstripped

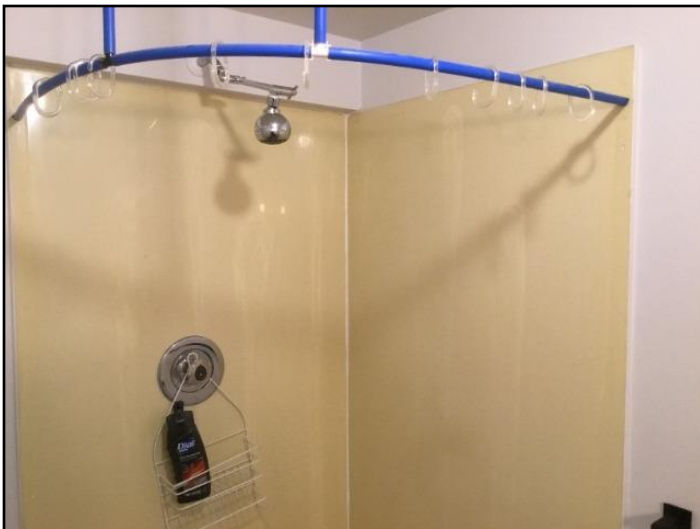
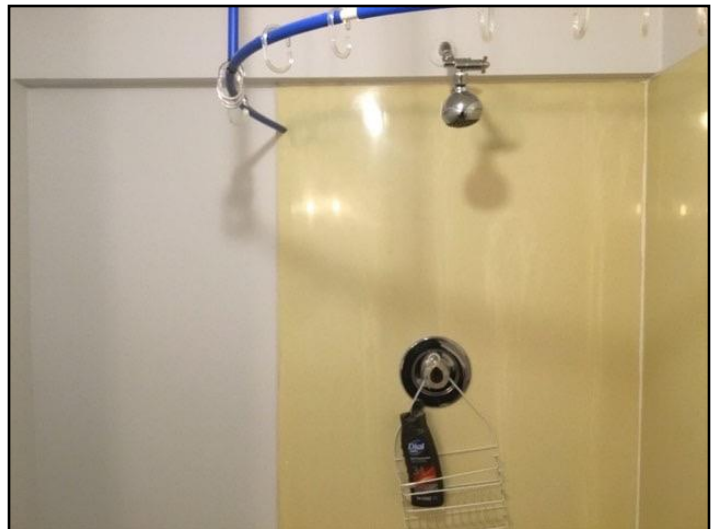
69.

15. Condition: • Missing shower enclosure

Location: Basement

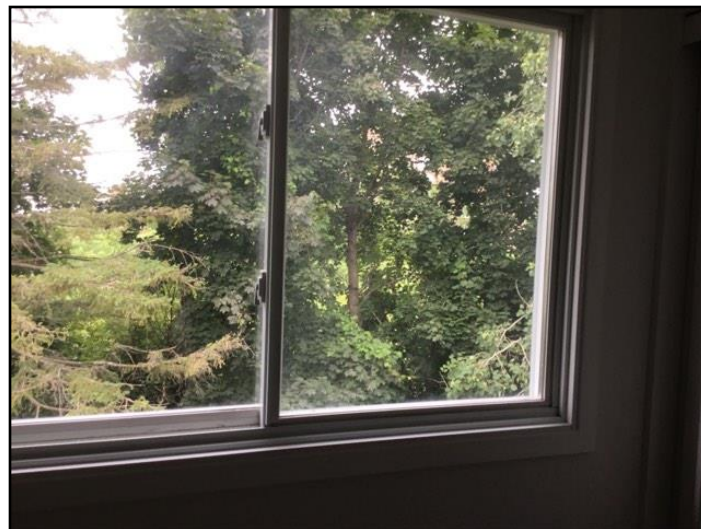
**16. Condition:** • Missing

**Location:** Master bedroom

78. Missing

**Task:** Provide

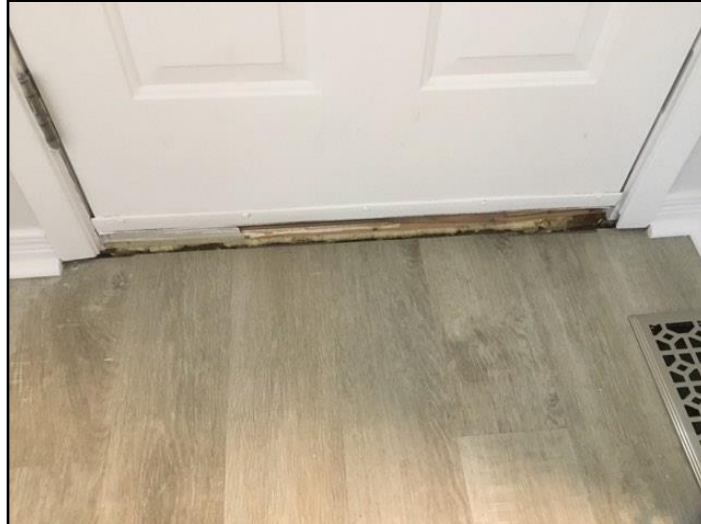
**17. Condition:** • Missing

**Location:** Front door

79. Missing

**Task:** Provide

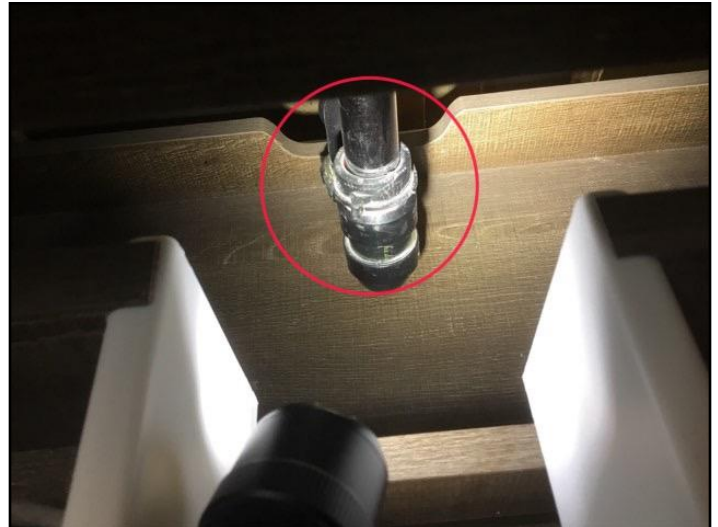
Bottom drawer in second floor bathroom will not open. Back of drawer is hitting drain trap

**18. Condition:** • Stiff or inoperative drawers

81. Stiff or inoperative drawers

**Task:** Correct

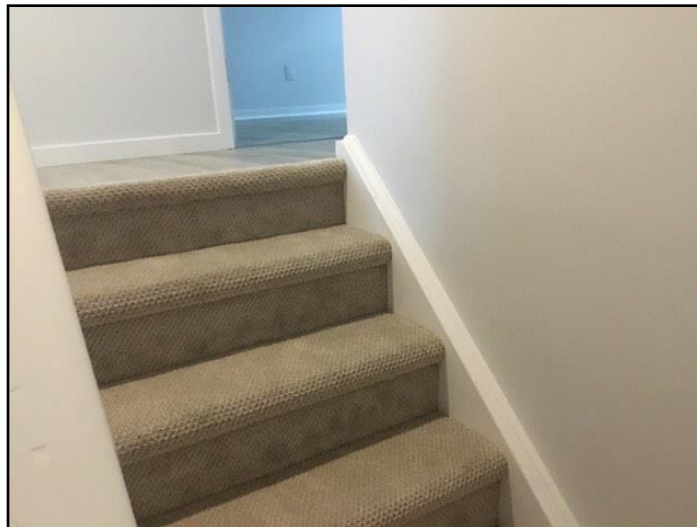
**19. Condition:** • Missing

82. Missing
