# Stormwater Construction Site Inspection Report

Rattlesnake Creek

CWS-201802602

26 Jun 2018 02:03 PM

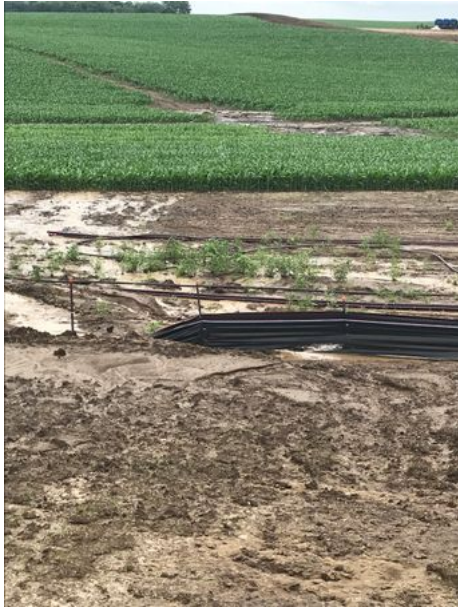
Appendix 1

<p>Appendix 1</p>		
Describe	Rainfall runoff discharging through a failed section of silt fence	
Are there any discharges at the time of inspection?	No

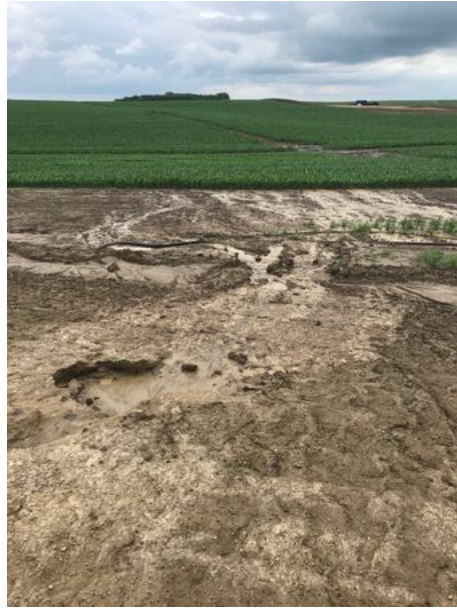
Appendix 2

Question	Response	Details
Corrective action needed, Notes	Berm diverting flows to silt fence failed. Wattles are required on slope.	
BMP 5		
BMP Number	T-line: wattles on stockpiles	
Is BMP Installed?	Yes	
BMP Maintenance Required?	Yes	
<div>

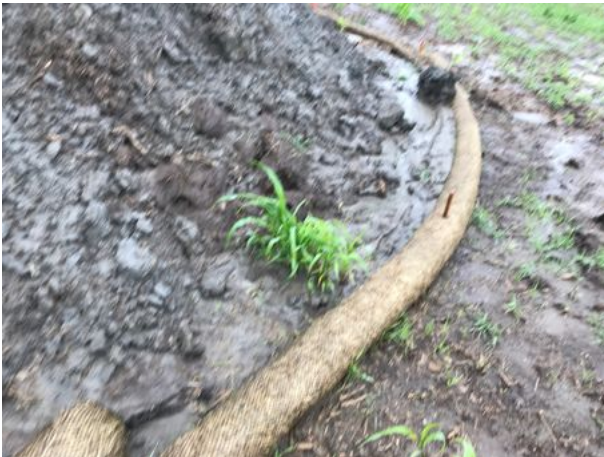
Appendix 3

</div> <div>Appendix 3</div>		
Corrective action needed, Notes	Silt is built up behind wattles around stockpile at structure 251B. Requires clearing of silt and replacement of wattle.	
BMP 6		
BMP Number	Substation: wattle	
Is BMP Installed?	Yes	
BMP Maintenance Required?	Yes	
Corrective action needed, Notes	It appears that construction traffic drove over wattle on southwest corner of Substation and requires replacement.
