Rattlesnake Creek Wind Project Stormwater Pollution Prevention Plan

INSPECTION AND MAINTENANCE REPORT FORM

Permit Numbers: CSW-201702291 Rattlesnake Creek Wind Farm CSW-201702293 Rattlesnake Creek Wind Substation and T-Line

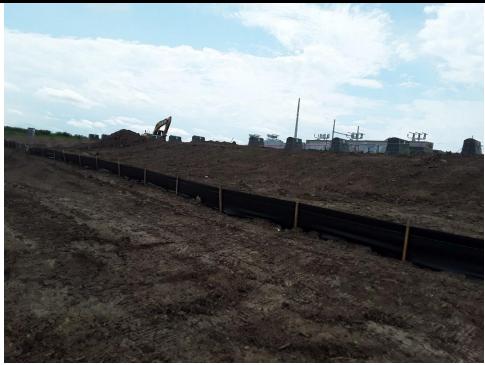
Perm. Vegetative Restoration: Slopes which had been previously seeded on the east side of the substation have been disturbed. Appropriate stabilization measures should be implemented.

Substation, Photo Point (PP-1): Slopes on the east side of the substation have been disturbed after having been previously seeded for stabilization.

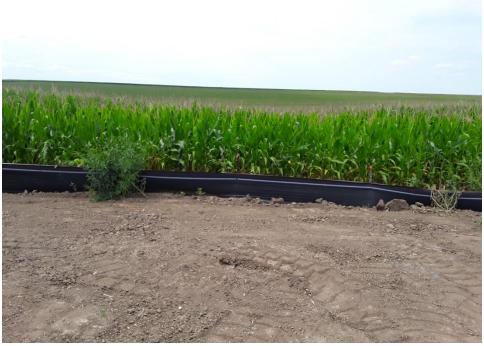
Substation, PP-2: Repaired silt fence on the west side of the substation. Silt fence is showing wear where attached to the supports. May need to be replaced if no longer efficient. Monitor in future inspections.

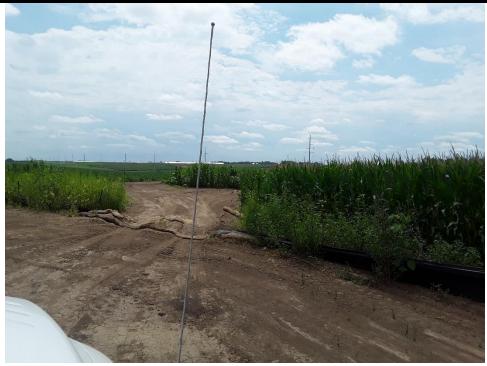
Filter Sock: Straw wattles placed across the access road being used to reach the transmission line portion of the project have been driven over and are no longer effective controls. They should be maintained, or new controls implemented.

Substation, PP-3: Inefficient BMPs should be removed. Wattle being placed across road when not working to prevent sediment from leaving the substation area.
