REPORT Phase One Environmental Site Assessment 1716 Main Street East, Port Colborne, Ontario

Rankin Construction Inc. 20 Corporate Park Drive Suite 100 - 101 St. Catharines, ON L2S 3W2

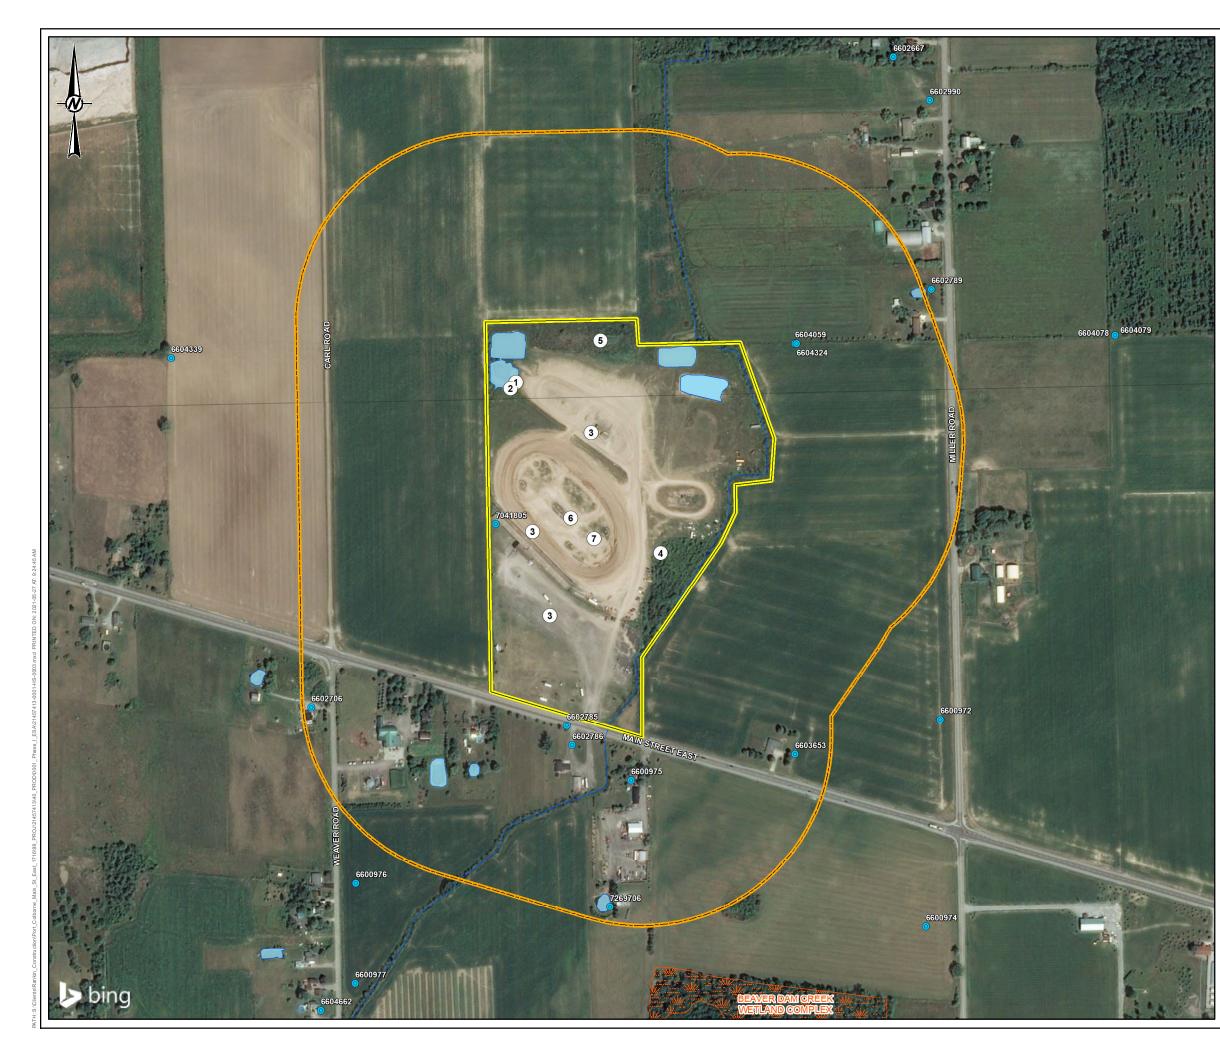
YYYY-MM-DD		2021-05-27		ŀ
DESIGNED		TZ		Ē
PREPARED		JT		Ē
REVIEWED		TZ		Ē
APPROVED				Ē
	REV.		FIGURE	E
	А		3	Ē

PCA	POTENTIALLY CONTAMINATING ACTIVITY
	#28 GASOLINE AND ASSOCIATED PRODUCTS STORAGE IN FIXED TANKS – ONE AST
4	CONTAINING DIESEL FUEL WAS LOCATED JUST WEST OF THE SEACAN BESIDE THE PIT
1	AREA, AND WAS USED FOR FUELLING THE TRACK MAINTENANCE EQUIPMENT. STAINING
	WAS NOTED BENEATH THIS AST ON THE GROUND SURFACE.

#27 GARAGES AND MAINTENANCE AND REPAIR OF RAILCARS, MARINE VEHICLES AND
	AVIATION VEHICLES - THE PIT AREA LOCATED ON THE NORTH PORTION OF THE PHASE
3	ONE PROPERTY, AND THE PARKING LOT SOUTH OF THE RACETRACK DURING OVERFLOW
	TIM ES, HAVE BEEN USED FOR VEHICLE MAINTENANCE ACTIVITIES FOR GREATER THAN 60
	YEARS. IN ADDITION, A RELEASE OF ANTIFREEZE WAS REPORTED WITHIN THE PIT AREA.

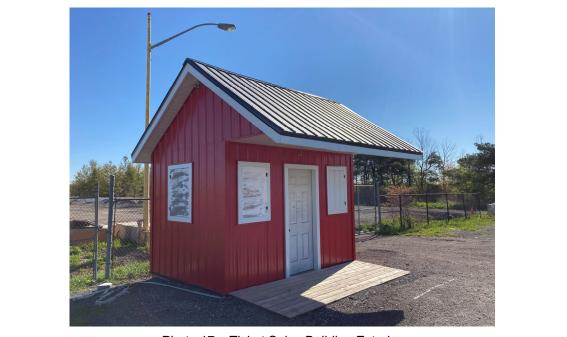
Photo 17 – Ticket Sales Building Exterior

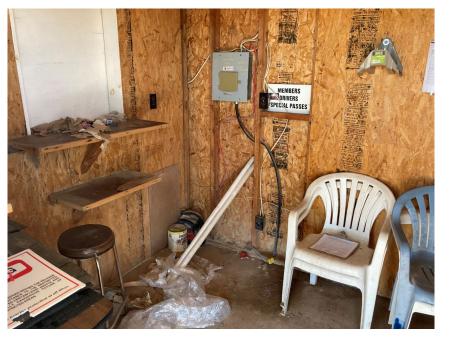
Photo 18 – Ticket Sales Building Interior
