AMP gauges at the dash are troublesome.

They should be by-passed, and then install a VOLT gauge.

by Mark Hamilton

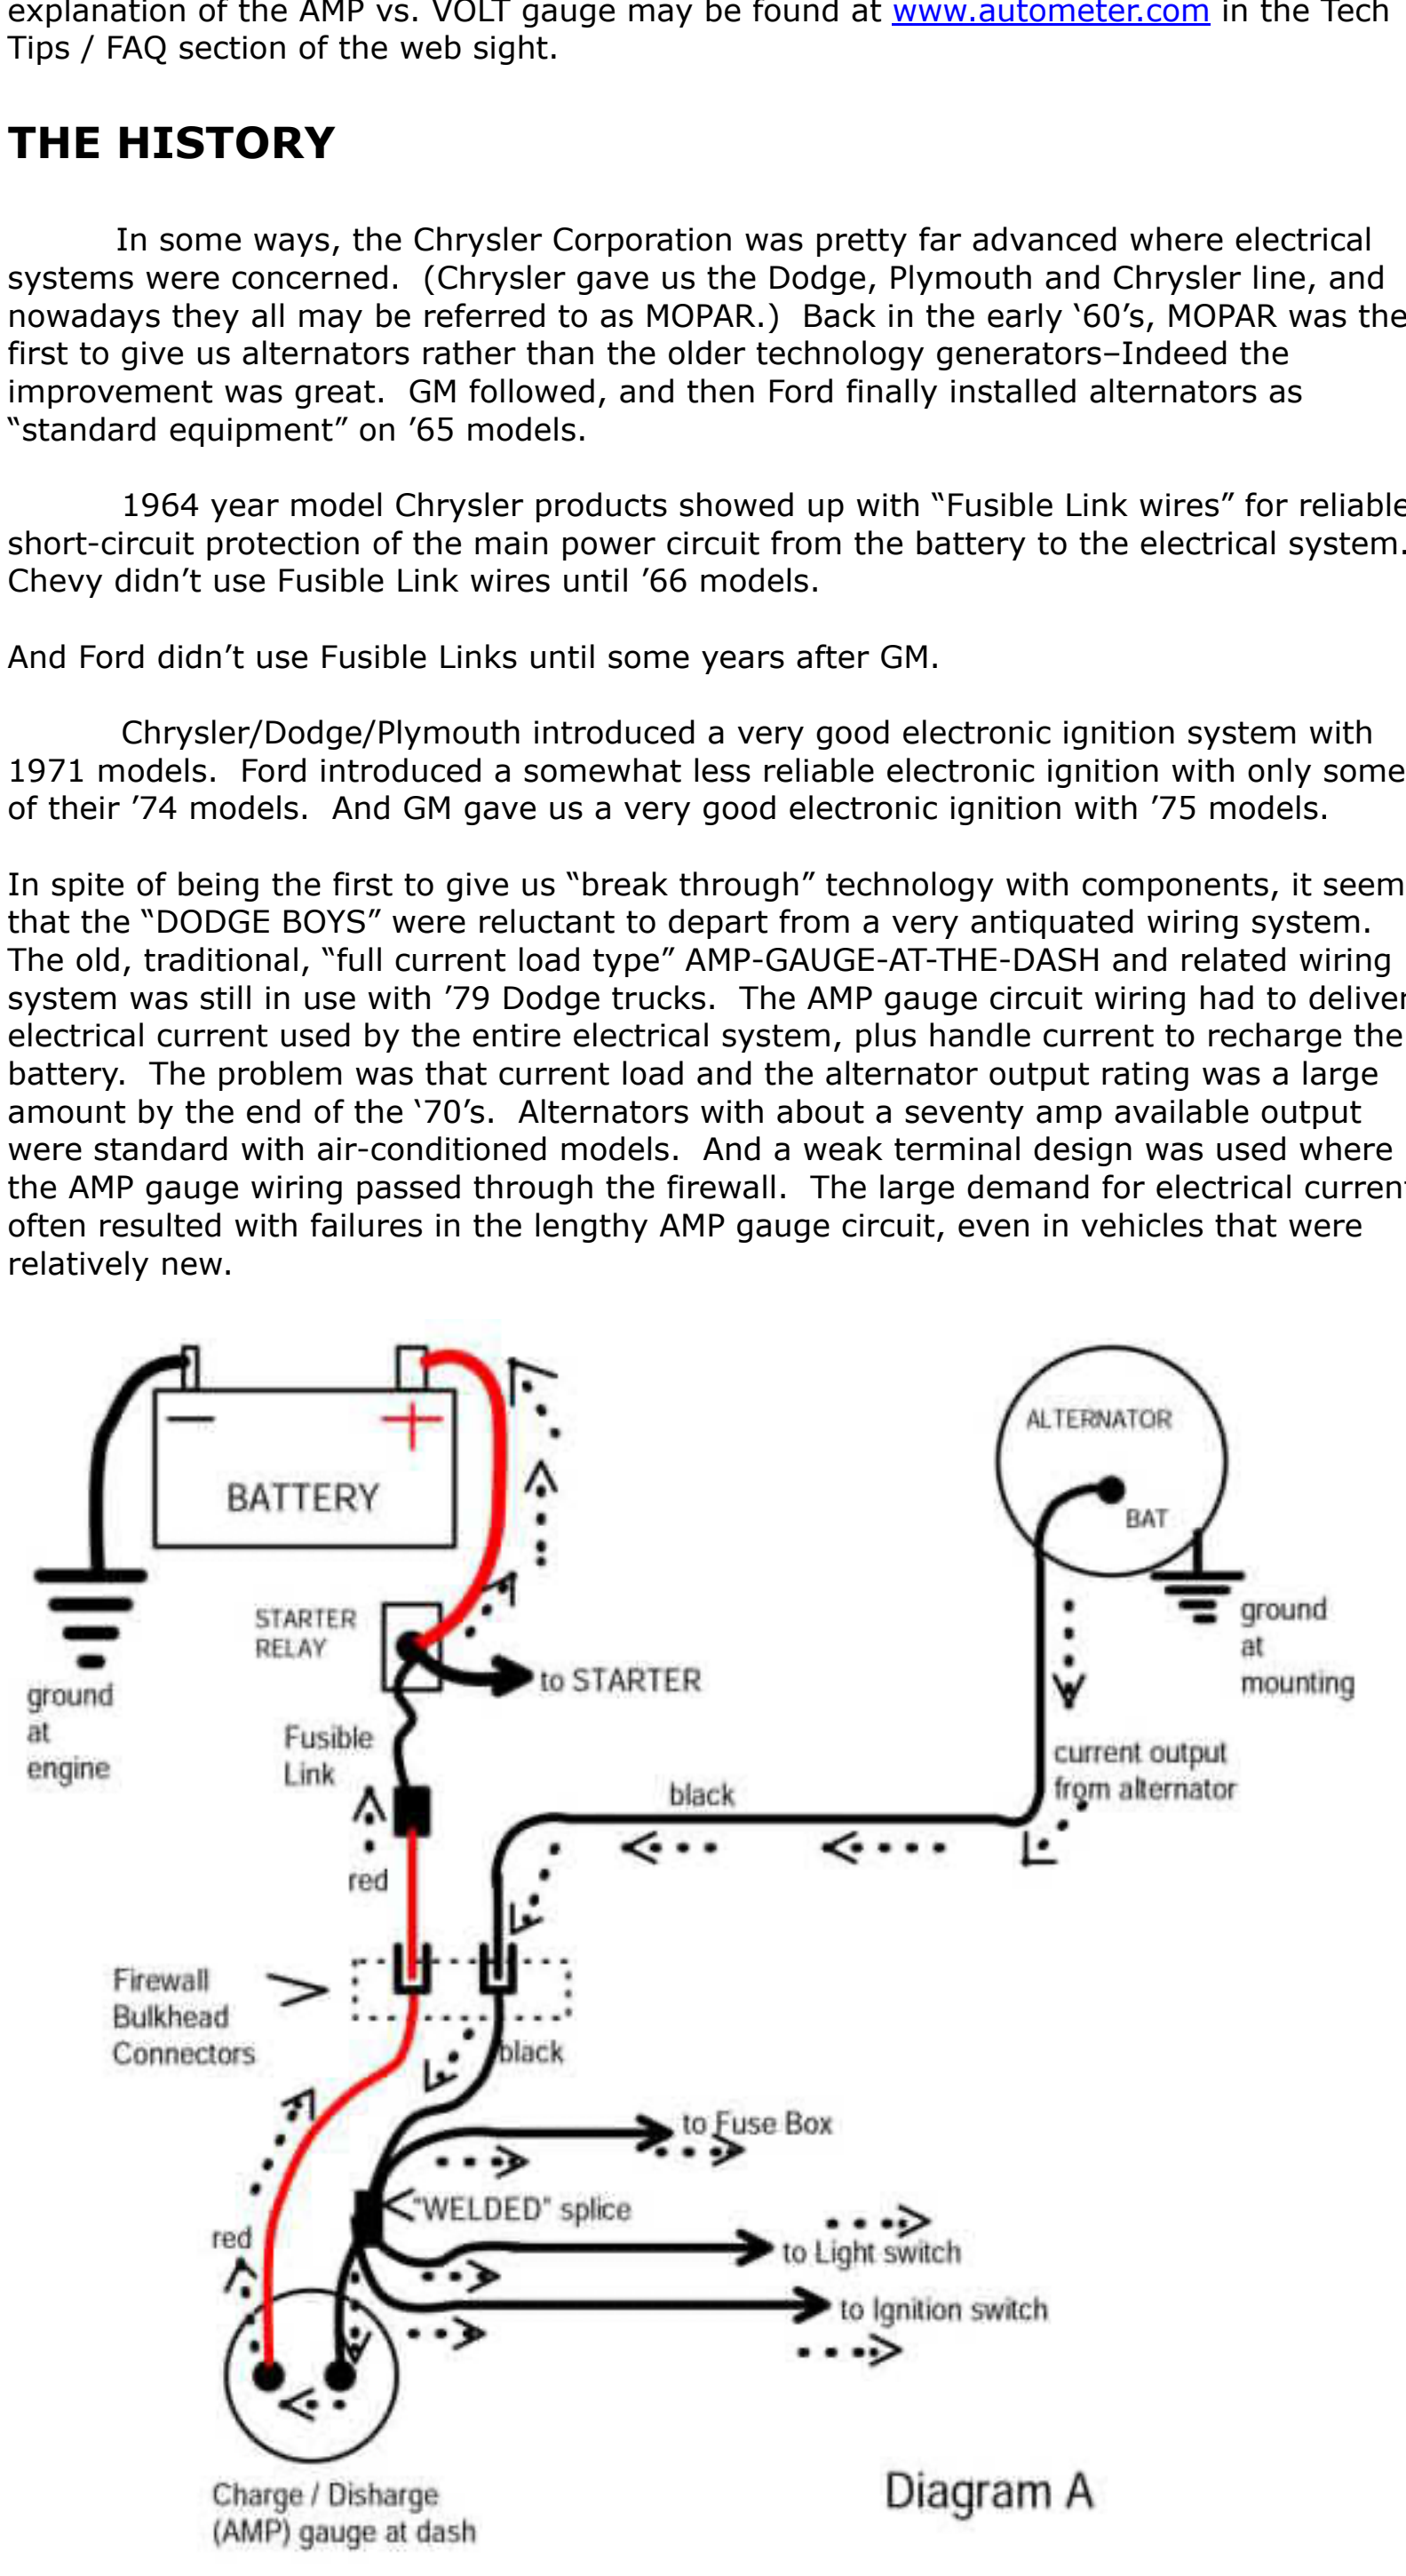
The original AMP gauge system served as the main power distribution system. This circuit is the power source for the entire electrical system. (see diagram A)

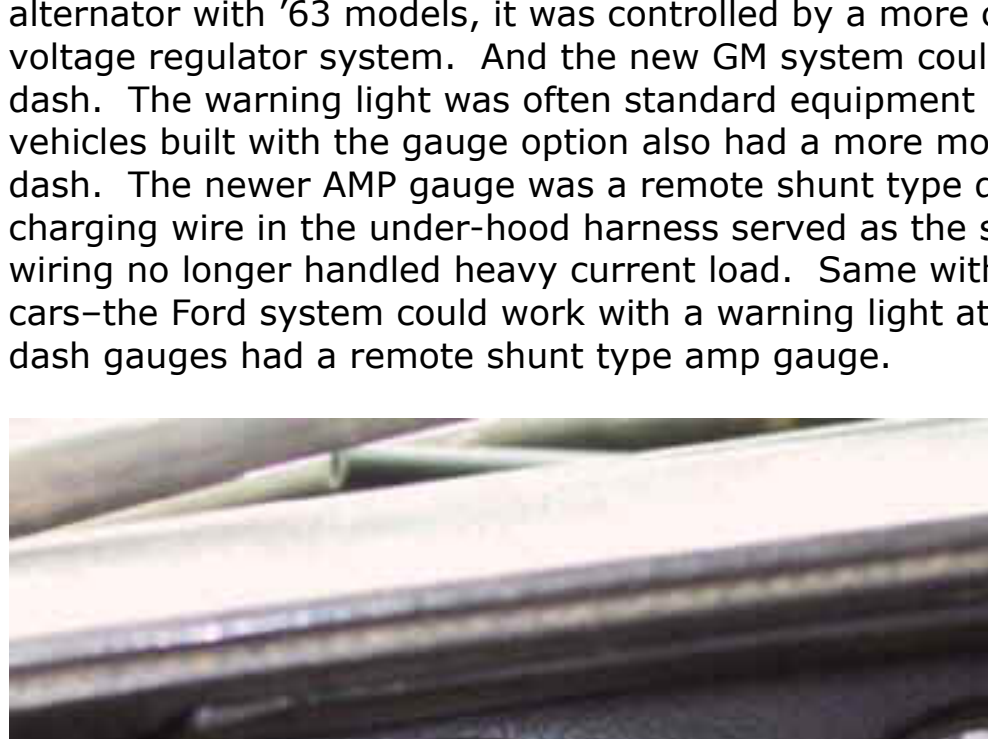
Large amounts of current flow through the AMP gauge will generate some heat too. The plastic cover at this gauge was only distorted by heat—but some Dodges have sizable holes burned in the dash where the AMP gauge used to be. Apparently, the shunt in the gauge has a sufficient amount of resistance to generate a damaging amount of heat with battery charging current flow.

The Dodge alternator/voltage regulator system had no provision to operate a warning light. And Dodge (trucks) stuck with the old antiquated "full load type" AMP gauge design, at least into the late 1980 models. As is typical of Dodge trucks that were used a lot, the AMP gauge in this '76 Dodge was burned out. The plastic mounting area behind the dash is completely melted, and the lens and plastic trim is shriveled too. (This gauge is included in Diagram A.)

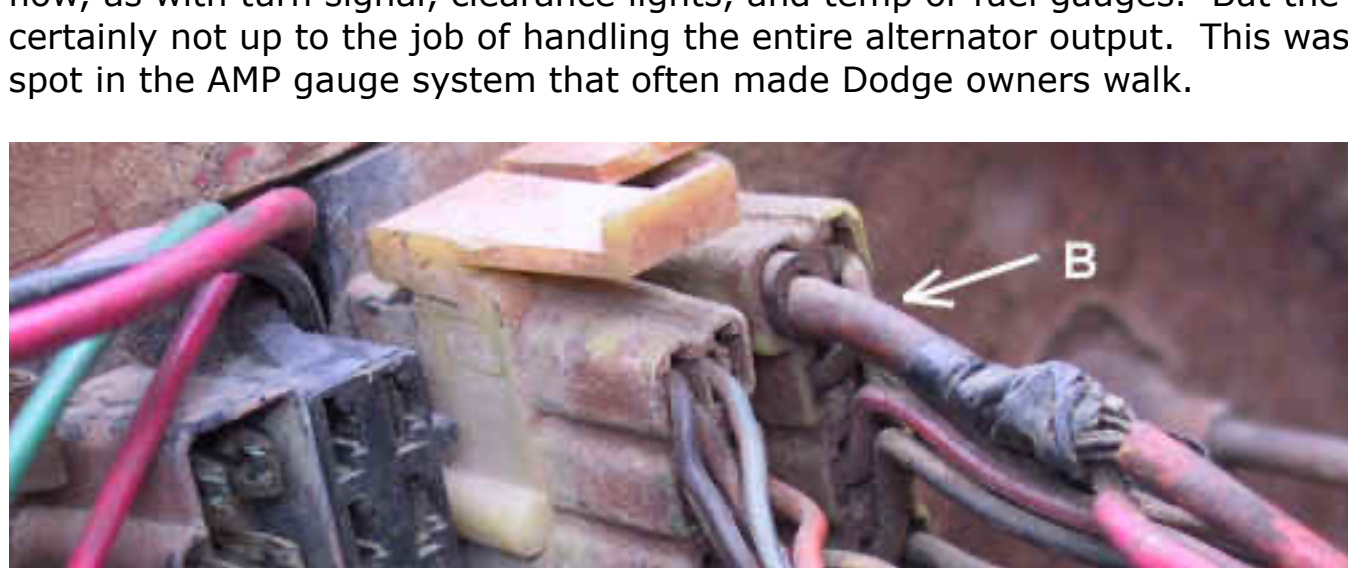
We have opened part of the dash wire harness, to show the factory "welded splice" where wires branch off to the ignition switch, light switch, and the fuse box. (This splice is shown in Diagram A.) The "welded splice" is insulated by a factory installed, sticky cloth tape.
