Fouries Home Inspection

COMPLETE HOME INSPECTION
Prepared Exclusively For: Sample Report

1234 Somewhere, County, TX,

Inspected by Paul Fourie, Lic.#: 22325 on 04/14/2018
Phone: (972)989-2479, Email: paul@fourieshomeinspection.com

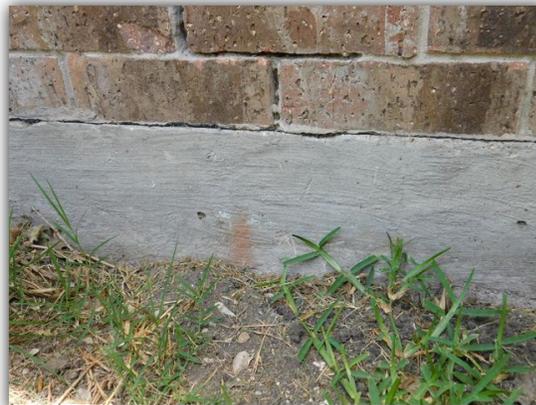
A cosmetic skim coat of mortar material has been installed over the exterior foundation perimeter beam that may conceal defects that would otherwise be observed. Foundation skim coats also create conducive conditions for wood destroying insects.

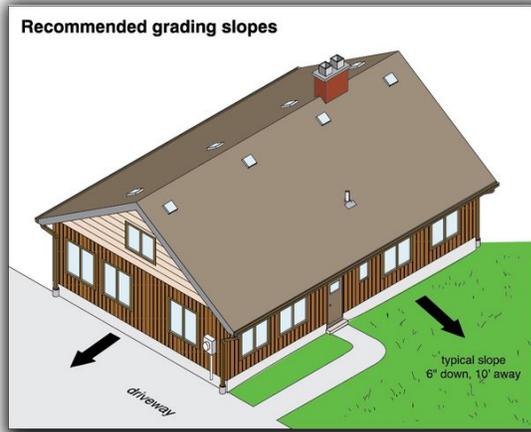
Inadequate grade slope away from the structure was observed. The recommended grade slope away from the structure is 6 inches per 10 feet. Improper grade slopes away from the structure create conducive conditions for water intrusion and inadequate foundation performance. Improper grade slope away from the structure is in need of repair.

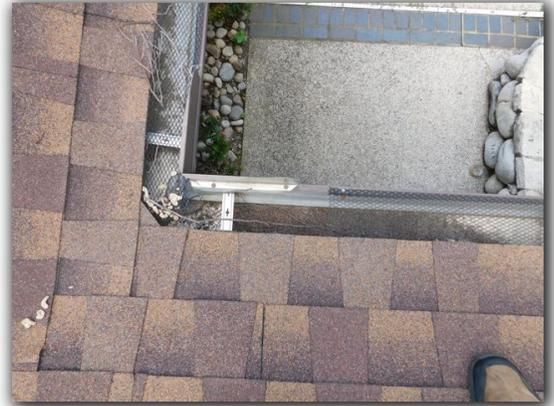
The gutters and downspouts contained leaves and other debris and should be cleaned out to allow for proper drainage.

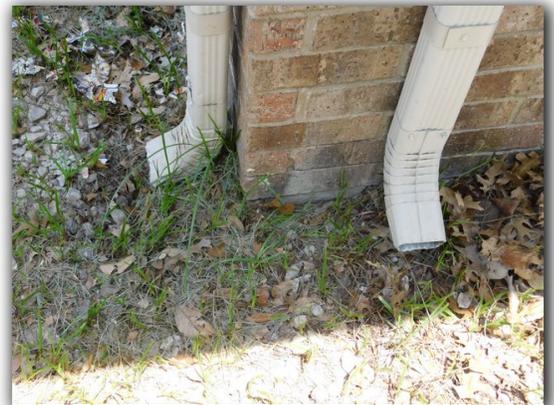
All gutter downspouts should have downspout extensions or splash blocks installed to move run off water away from the foundation and to prevent erosion. Missing splash blocks and downspout extensions should be replaced.

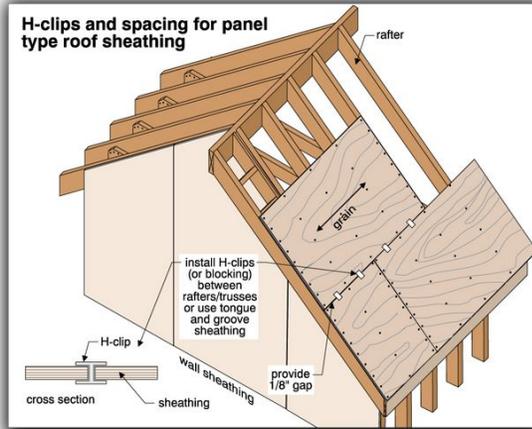
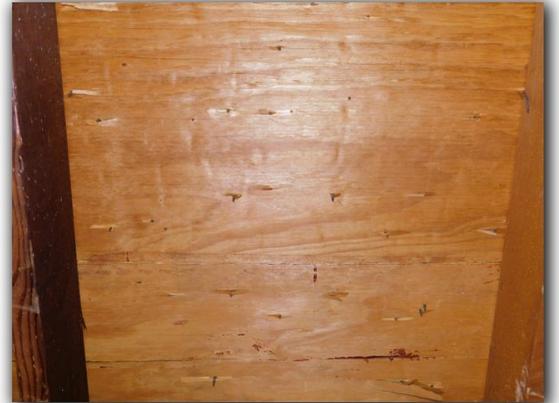
The lack of roof decking expansion clips was observed. The lack of roof decking expansion clips may be an indication of improperly installed roof decking.

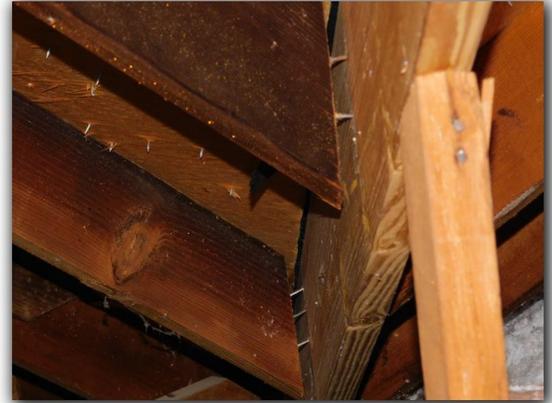
Separations between roof framing members was observed which is an indication of structural movement, settlement, inadequate workmanship or other defects. The cause of separations between roof framing members should be determined. The inspector recommends that an expert in this field be consulted for further evaluation of the structure and foundation and to provide suggestions as to what, if any, corrective actions should be taken.

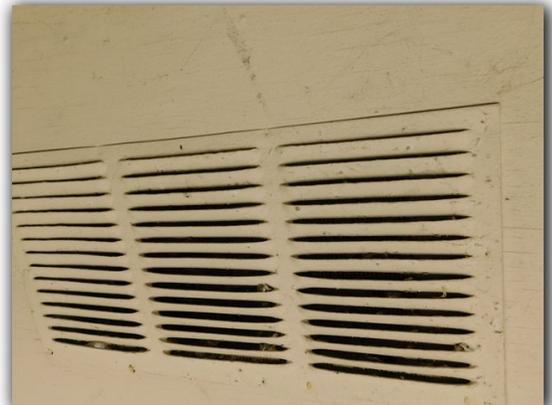
Soffit vents were observed to be dirty, blocked by insulation or debris. Clogged soffit vents are an indication of inadequate attic ventilation and should be repaired as needed.

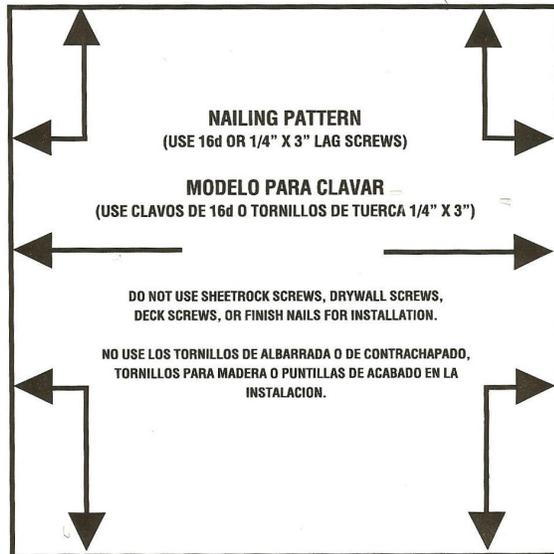
☑ The attic access ladder was installed with improper fasteners and is a SAFETY HAZARD. Attic access ladders should be installed with 16d or larger nails or bolts per manufacturer's instructions for reasons of safety.

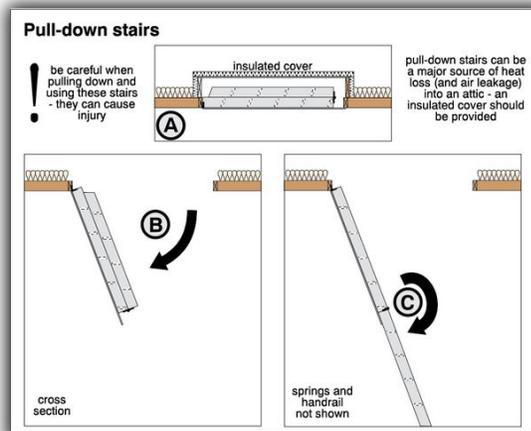
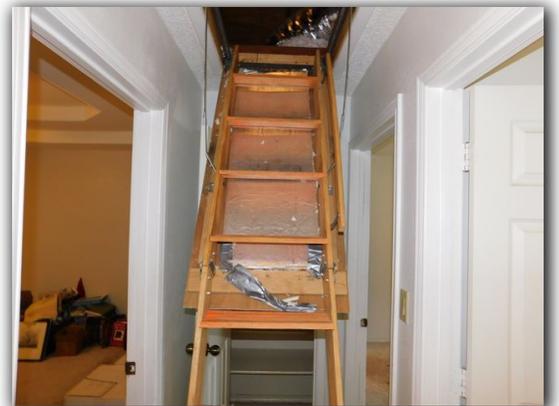
☑ Access doors from conditioned spaces to unconditioned spaces such as attics should be weather stripped and insulated to a level equivalent to the insulation on the surrounding surfaces. A wood framed or equivalent baffle or retainer should be installed when loose fill insulation is installed to assist in maintaining a consistent R-value.

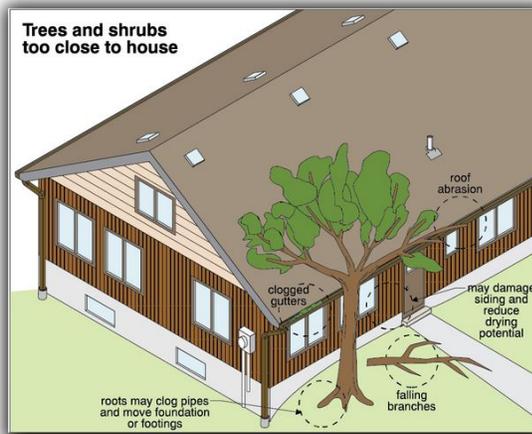
Heavy foliage growing on, over or around the exterior walls of the structure should be trimmed back at least 18-inches. Heavy foliage limits the Inspectors visual observation of the exterior surfaces. Heavy foliage at exterior walls creates conducive conditions for material damage, wood destroying insects and moisture damage. Heavy foliage may damage exterior wall cladding.

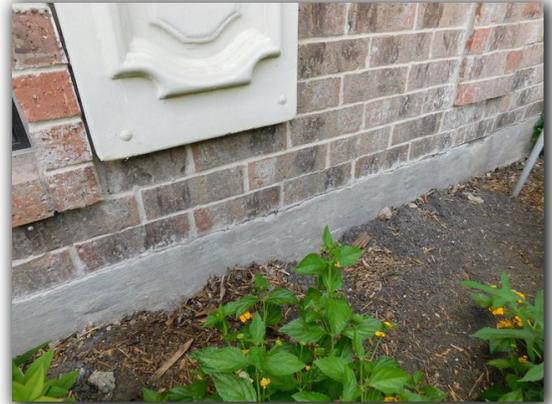
Weep holes were missing at the lower brick of the exterior walls. Weep holes should be installed and properly spaced to provide proper wall ventilation.

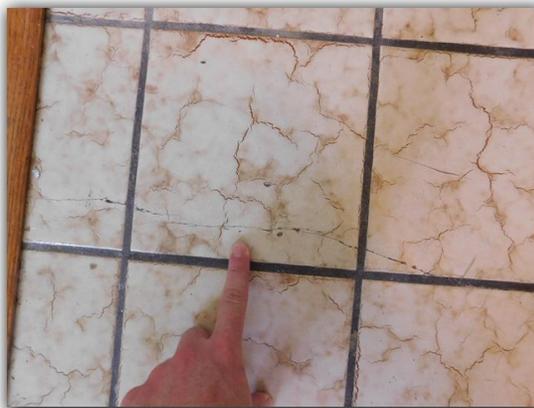
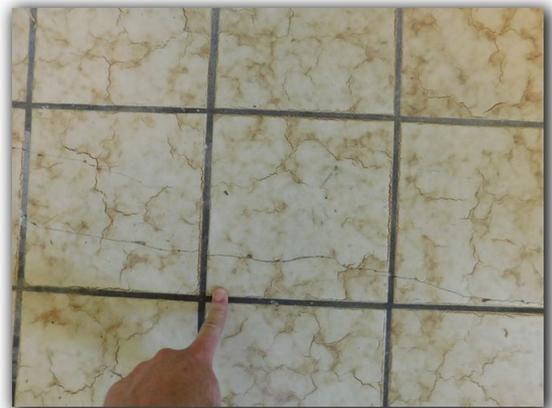
Linear cracks in floor tiles were observed. Linear cracks in floor tiles may be an indication of movement, settlement, improper installation or other defects. The cause of linear cracks in floor tiles and grout should be further evaluated and repaired as needed.

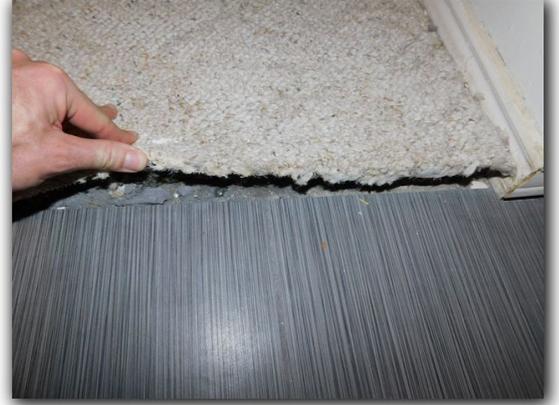
Missing floor covering transition strips should be repaired to avoid additional damage and trip hazards.

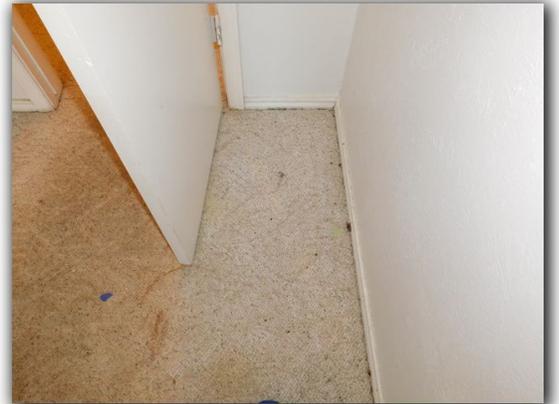
All interior doors should have door stops installed to prevent damage to adjacent interior wall coverings.

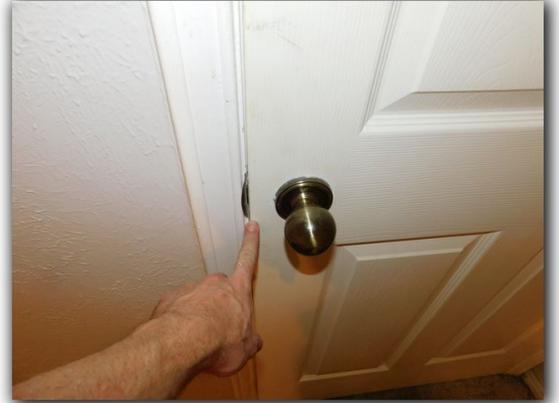
- Interior doors which do not latch as intended should be repaired.

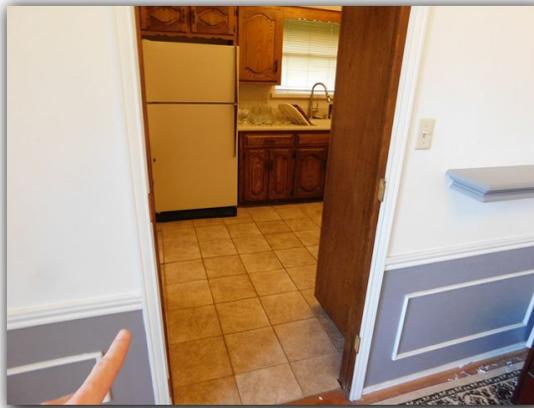
- There were missing interior doors. Missing interior doors should be replaced or the door frame should be repaired if a door has been permanently removed.

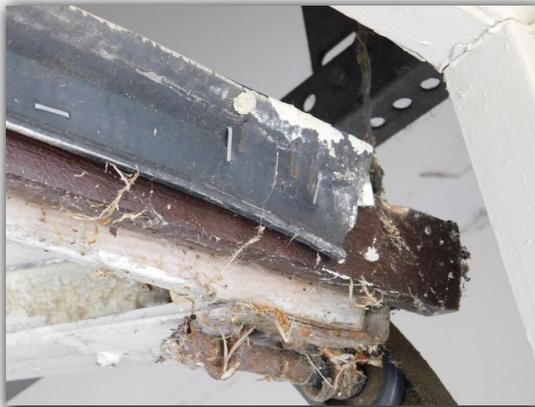
Damaged garage door weather stripping should be replaced.

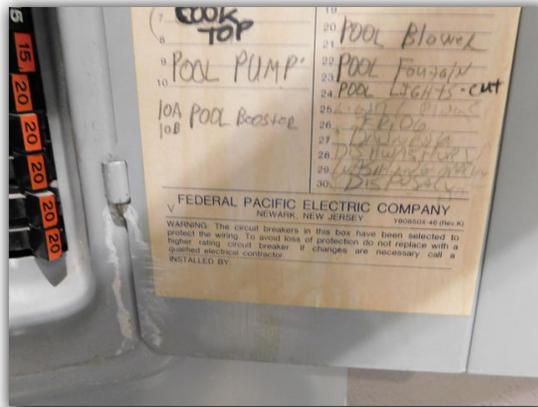
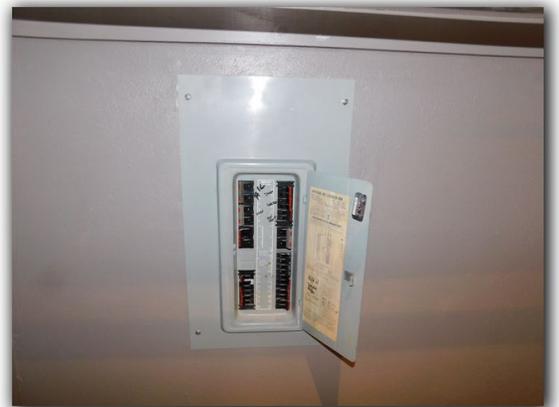
The main breaker panel was observed to be a Federal Pacific brand electric panel. Many of these panels were recalled due to electrical fire hazards and are considered a SAFETY HAZARD. The inspector recommends that all Federal Pacific brand electrical panels be evaluated, serviced, repaired and or replaced by a certified, licensed electrical specialist.

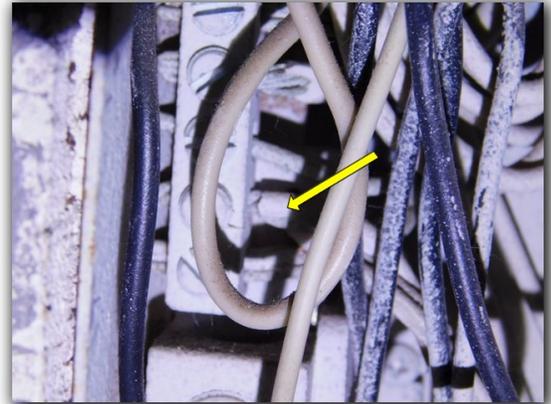
Neutral electrical conductors were observed to be “double tapped” on the neutral bus bar in the electric service panel. Each neutral electrical conductor in the electric service panel should terminate individually unless the terminals are made for more than one conductor. Double tapped neutral electrical conductors should be further evaluated and repaired as needed by a qualified electrical specialist.

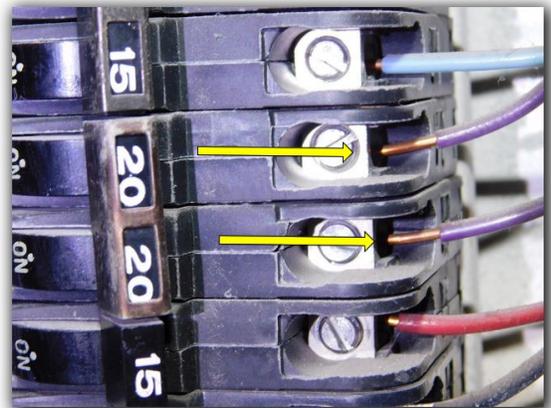
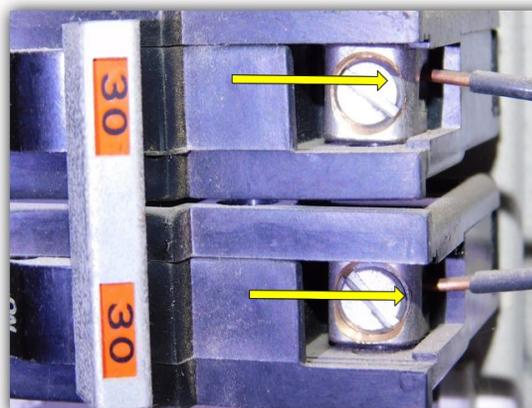
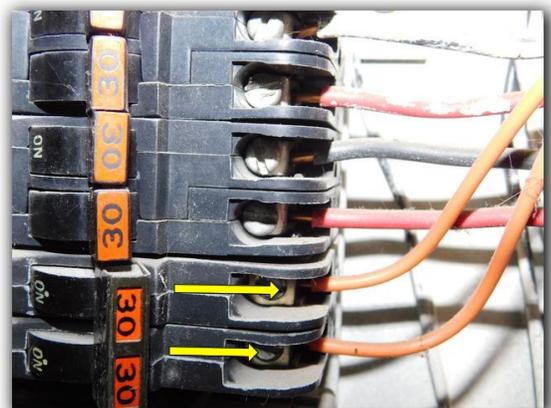
Incorrect electrical conductor sizes were observed to be connected to breakers in the electric service panel. Incorrect electrical conductor sizes are a SAFETY HAZARD and create conducive conditions for overheating and or breaker tripping. Incorrect electrical conductor sizes should be further evaluated and repaired or replaced by a qualified electrical specialist.

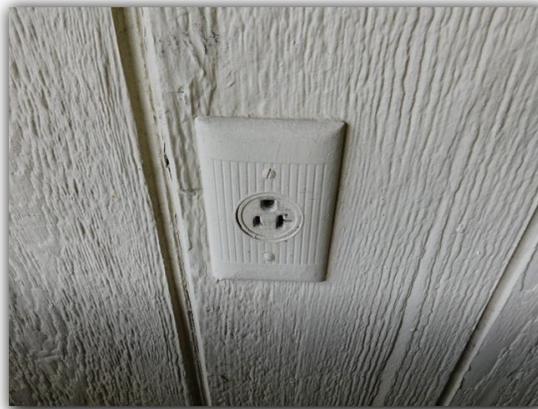
Exterior electrical receptacles in wet locations were observed to lack weather tight bubble covers. Lack of weather proof bubble covers at electrical receptacles in wet locations is a SAFETY HAZARD and should be repaired by a certified, licensed electrical specialist.

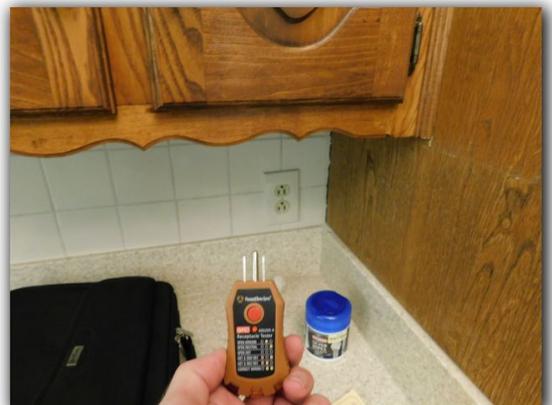
Kitchen counter top electrical receptacles were observed to lack ground fault circuit interrupter (GFCI) device protection. Under current electrical standards, all of the kitchen counter top receptacles should have GFCI protection. Lack of GFCI protection in required locations is a SAFETY HAZARD.

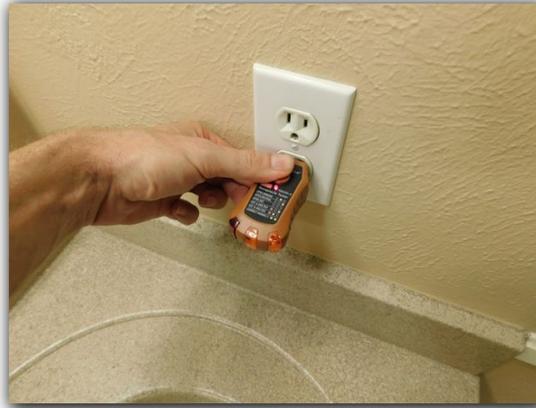
Bathroom electrical receptacles were observed to lack ground fault circuit interrupter (GFCI) device protection. Under current electrical standards, all of the bathroom receptacles should have GFCI protection. Lack of GFCI protection in required locations is a SAFETY HAZARD.

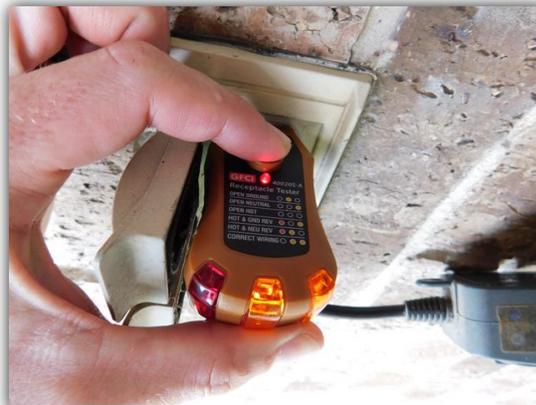
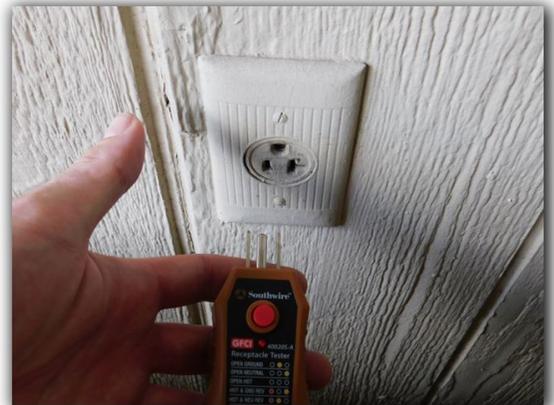
Exterior electrical receptacles were observed to lack ground fault circuit interrupter (GFCI) device protection. Under current electrical standards, all of the exterior receptacles should have GFCI protection. Lack of GFCI protection in required locations is a SAFETY HAZARD.

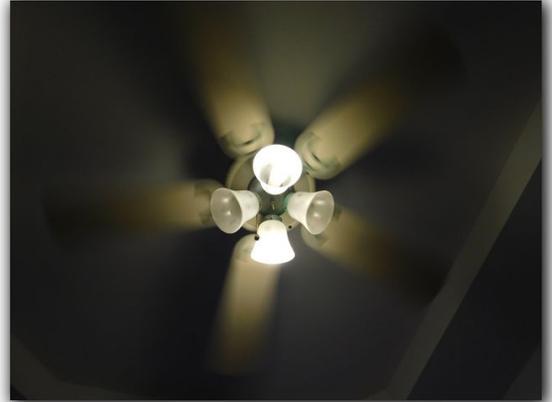
Light fixtures that are inoperative, missing bulbs or have burned out bulbs should be repaired or replaced as needed.

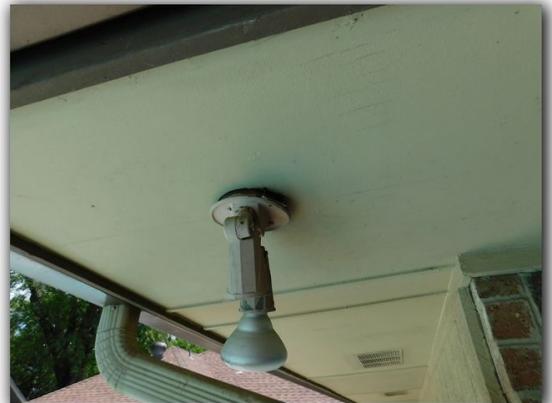
Exterior light fixtures should be sealed at the wall to prevent water intrusion for reasons of SAFETY.

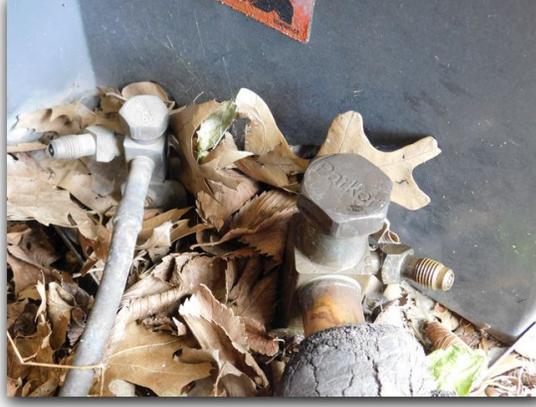
- The HVAC cooling line service valve caps were missing. The service valve caps prevent dirt, debris and damage to the service valves and should be replaced.

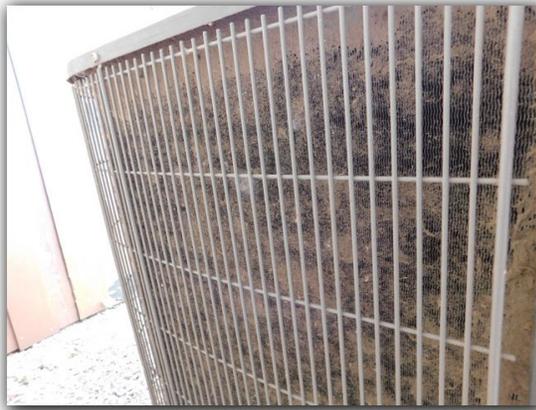
- The HVAC condenser unit coil fins were dirty and in need of service, repair or replacement. Dirty or damaged HVAC equipment coil fins may result in equipment damage, inadequate performance, reduced equipment life or other defects.

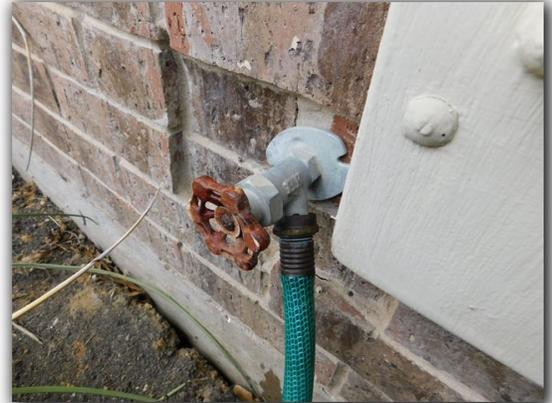
Exterior water supply faucets were missing an anti-siphon device to prevent contaminants from entering the water supply. Lack of anti-siphon devices at exterior water supply faucets is a SAFETY HAZARD. Current building standards require non-removable vacuum breakers on all hose faucets.

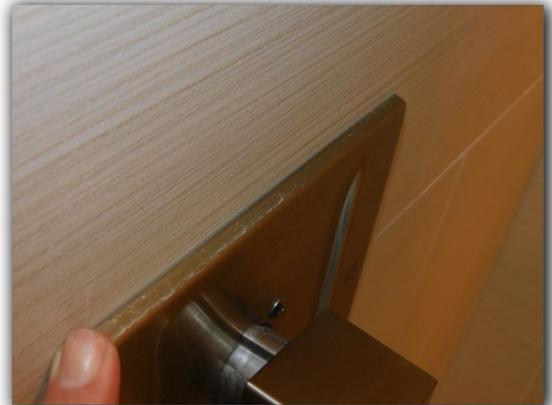
The tub/shower water supply fixtures lacked adequate sealant at the wall. Tub/shower water supply fixtures should be properly sealed at the wall to prevent water damage.

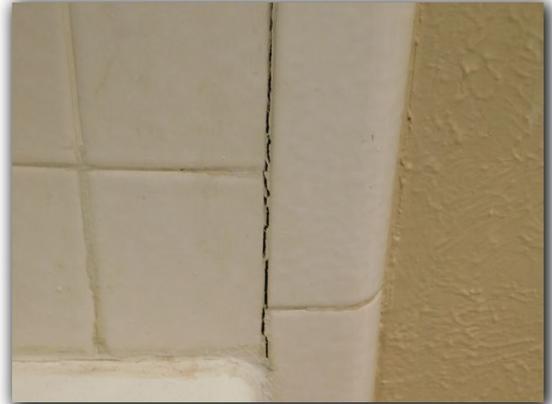
The tub/shower tile grout and sealants were observed to be in need of repair or replacement to prevent water penetration at interior walls. When tub/shower tile grout and sealants are damaged, there may be concealed water damage and or wood destroying insect damage.

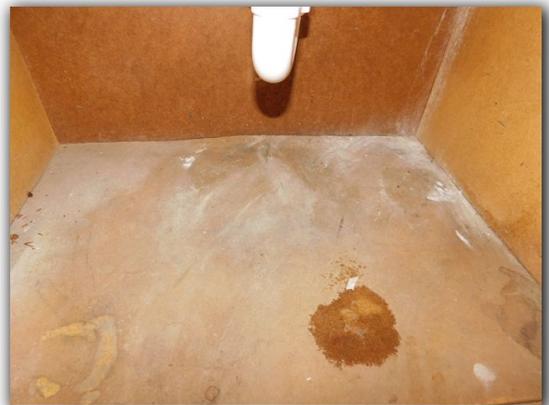
Water damage inside of sink cabinets was observed. The cause should be determined and repaired as needed.

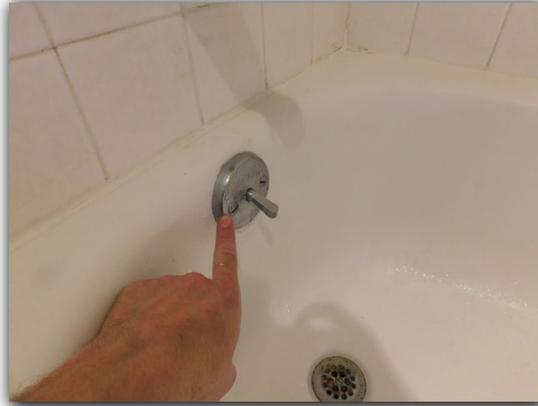
- Missing, damaged or inoperative mechanical drain stops at the sinks/tubs should be repaired.

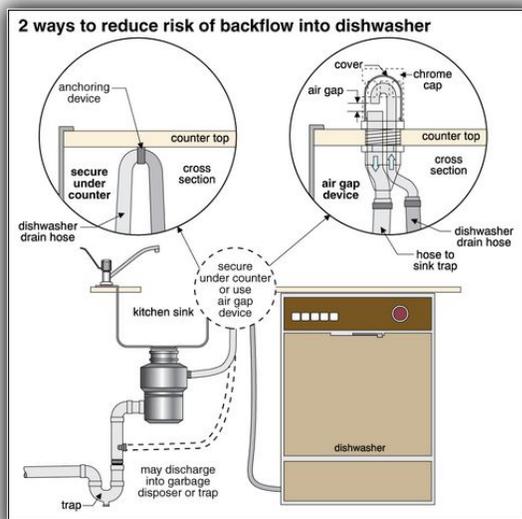
A visible anti-siphon loop or back flow prevention device was not installed at the dishwasher drain line. Some newer dishwashers may have built in anti-siphon devices that are not visible. The buyer is encouraged to consult the owner's manual or contact the manufacturer if an anti-siphon device is not visible. Lack of an anti-siphon device at a dishwasher is a SAFETY HAZARD.

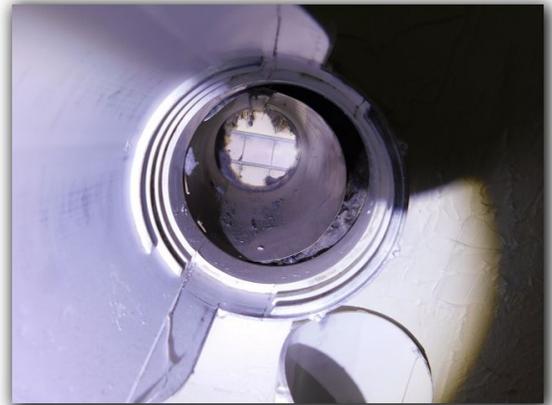
The dryer vent and duct were in need of cleaning. Flammable lint and other debris should be removed from the dryer vent and duct for reasons of SAFETY.
