Fouries Home Inspection

1 YEAR WARRANTY HOME INSPECTION

1234 Somewhere, , TX,

Inspected by Paul Fourie, Lic.#: 22325 on 06/05/2018
Phone: (972)989-2479, Email: paul@fourieshomeinspection.com

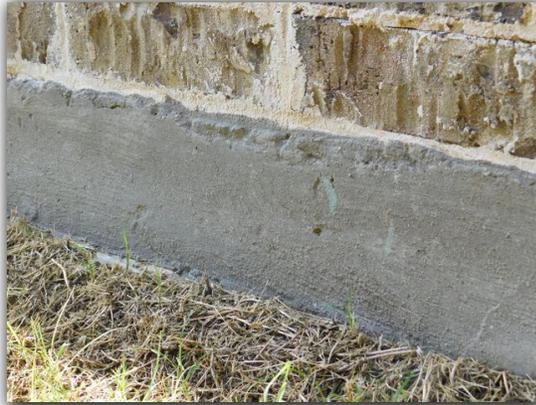
A cosmetic skim coat of mortar material has been installed over the exterior foundation perimeter beam that may conceal defects that would otherwise be observed. Foundation skim coats also create conducive conditions for wood destroying insects.

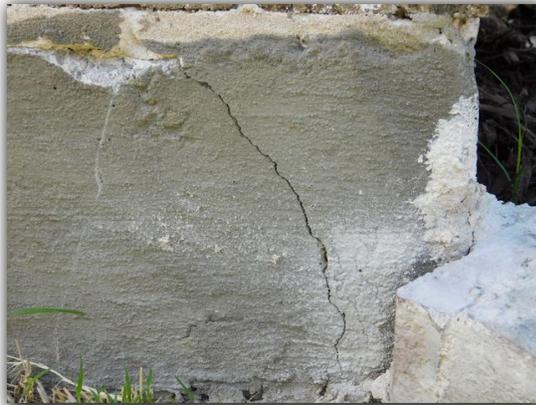
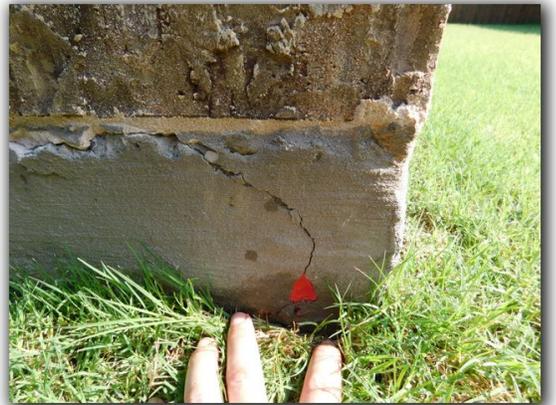
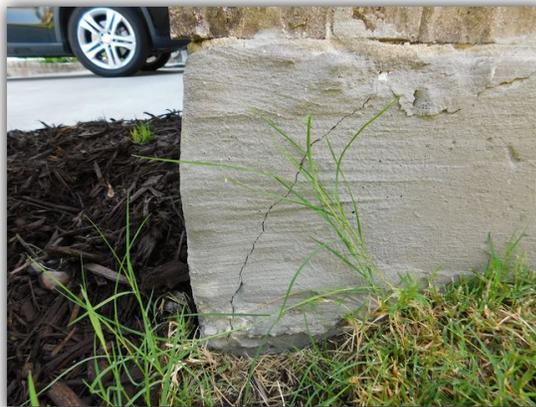
Foundation perimeter beam corners have been sheared off (corner pop). This is a common condition in slab on grade foundations and should be repaired. Repairing corner pops is recommended to prevent moisture and wood destroying insect penetration.

- Foundation perimeter beam corners have been sheared off (corner pop). This is a common condition in slab on grade foundations and should be repaired. Repairing corner pops is recommended to prevent moisture and wood destroying insect penetration.

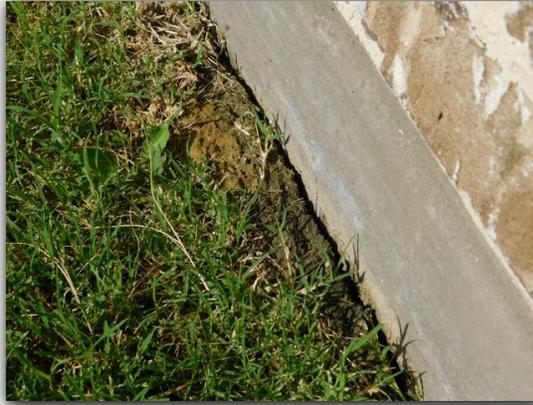
Soil pulling away from the foundation perimeter beam or other supports should be repaired.

Additional fill material and a consistent foundation-watering program are recommended.

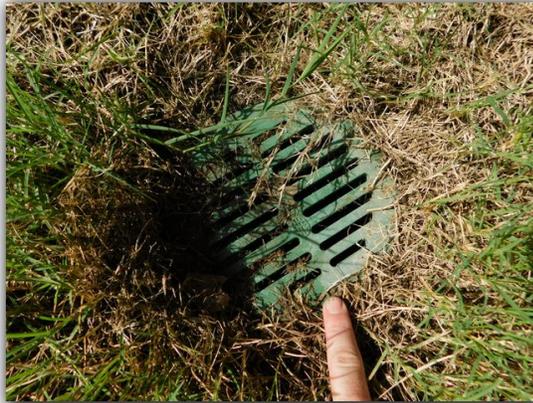
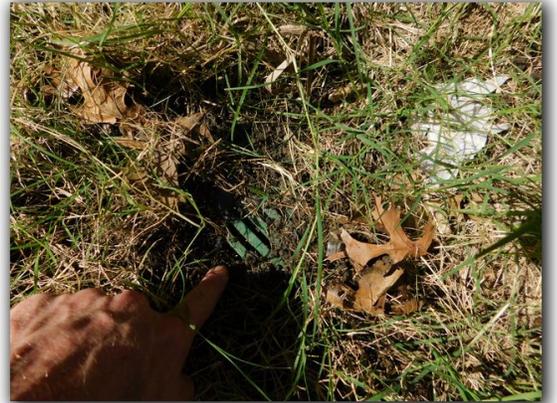
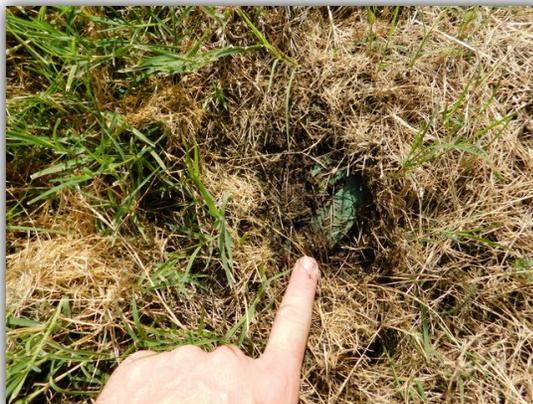
The subsurface or below grade drainage system grates, filters or drains were in need of cleaning.

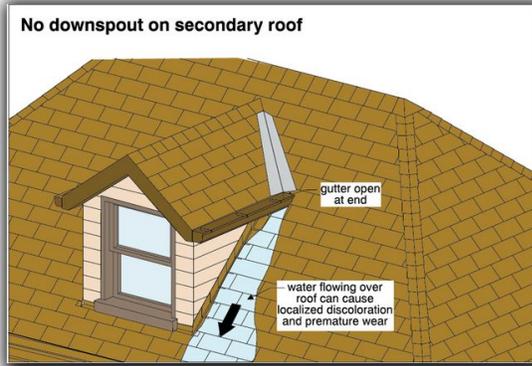
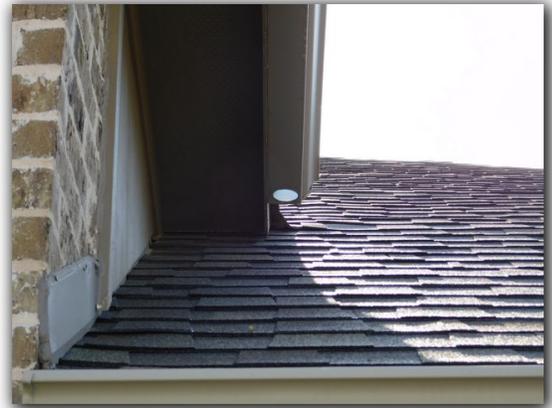
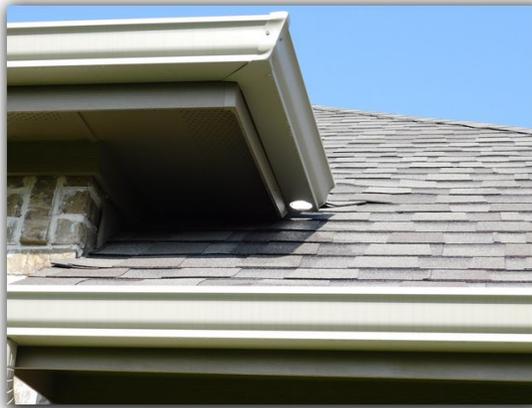
The secondary roof rain gutter lacks a downspout. Lack of a downspout at secondary roof rain

gutters may allow localized deterioration and premature wear of the roof covering materials.

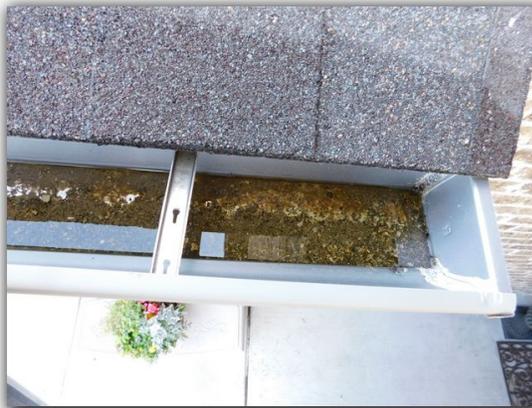
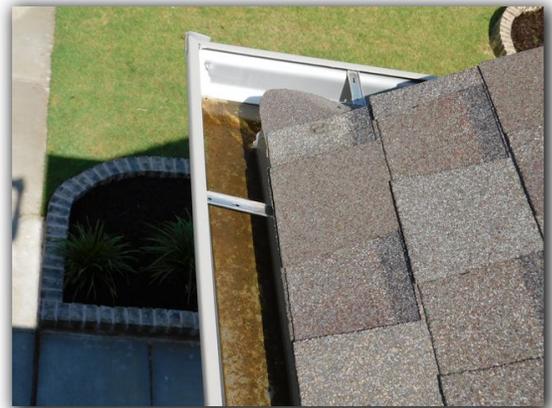
Improperly sloped rain gutters were observed. Improperly sloped rain gutters create conducive conditions for siding deterioration, soffit/eave damage, water penetration and inadequate grade drainage.

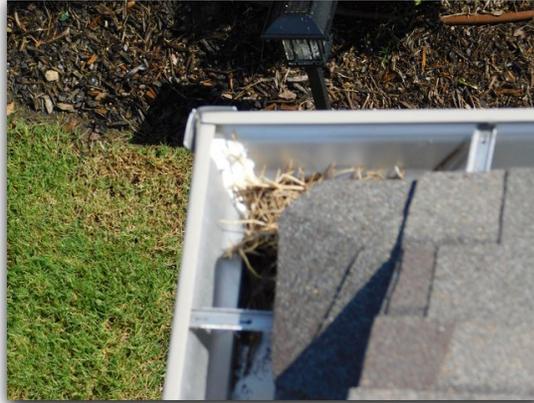
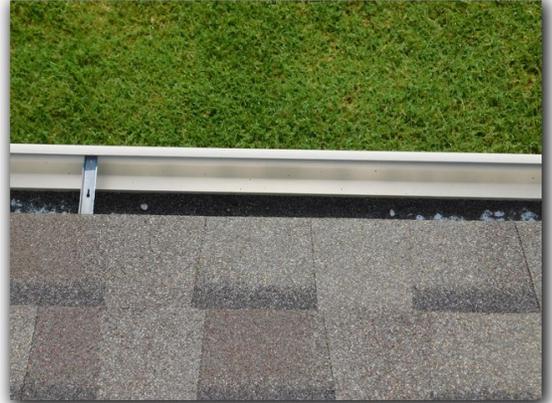
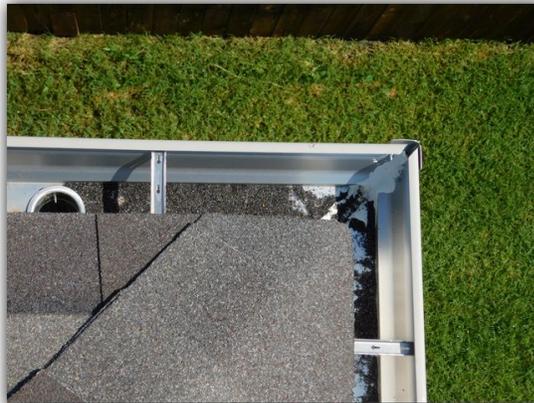
The gutters and downspouts contained leaves and other debris and should be cleaned out to allow for proper drainage.

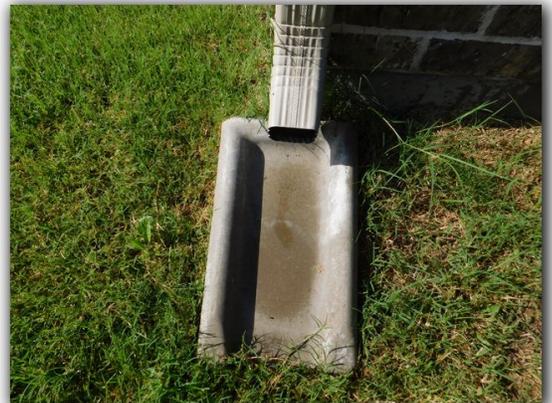
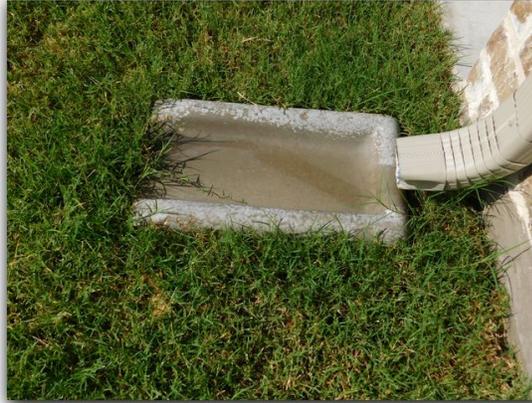
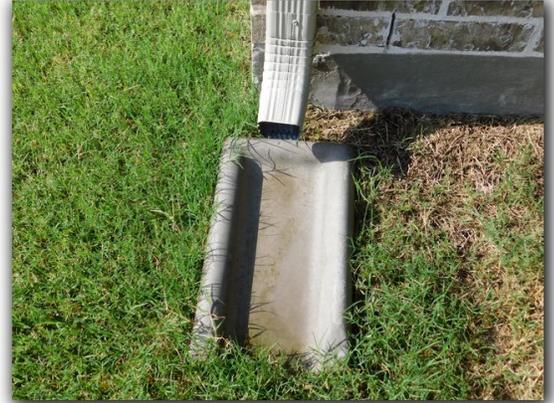
The rain gutter downspout splash blocks were installed backwards. Splash blocks that are installed backwards do not perform as intended and may contribute to erosion.

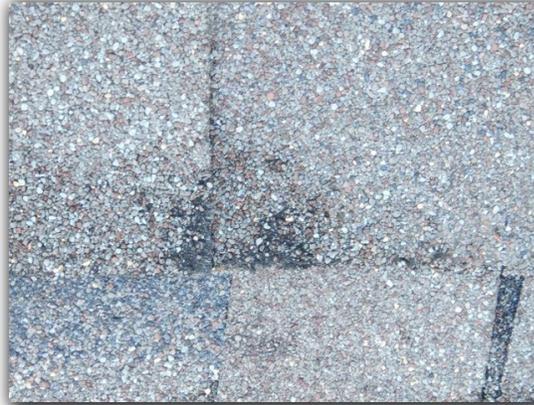
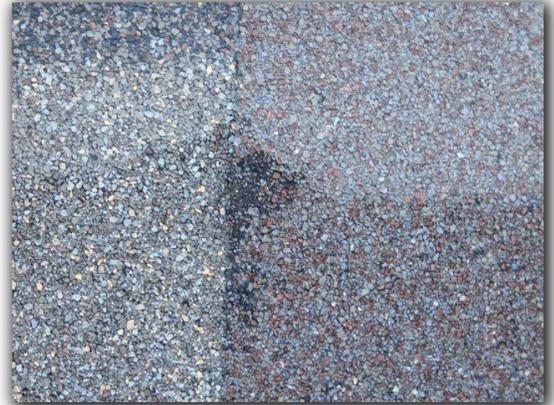
Damaged roof covering materials were observed.

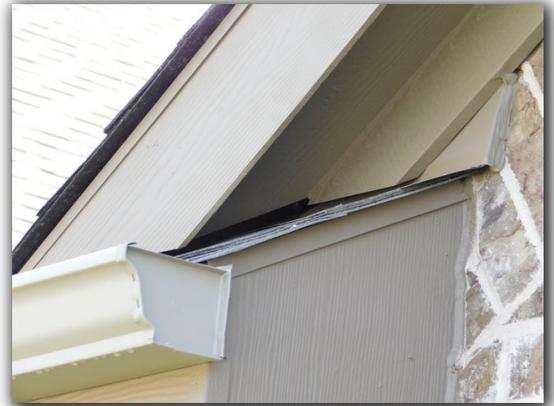
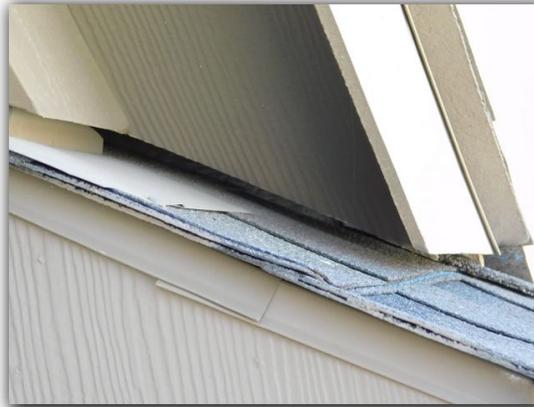
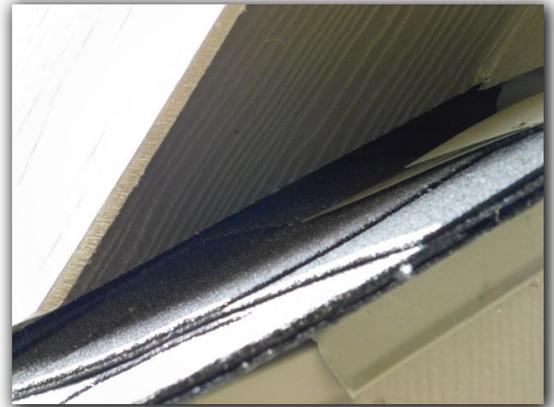
Openings in the eave returns (areas where the soffit meets an adjoining roof surface) should not be large enough to allow entry by pests according to industry standards.

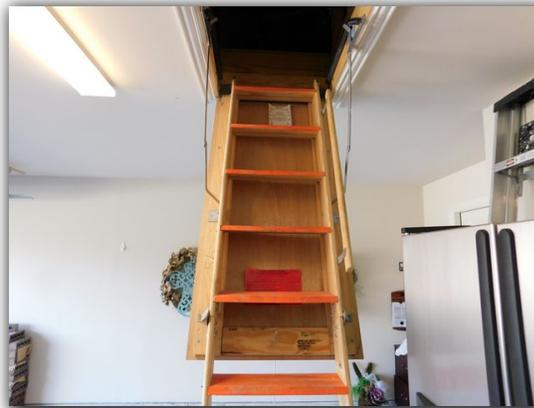
The attic access stair in the vehicle storage area (garage) was not fire rated and may allow vehicle storage area vapors to penetrate the attic and/or living area (SAFETY HAZARD).

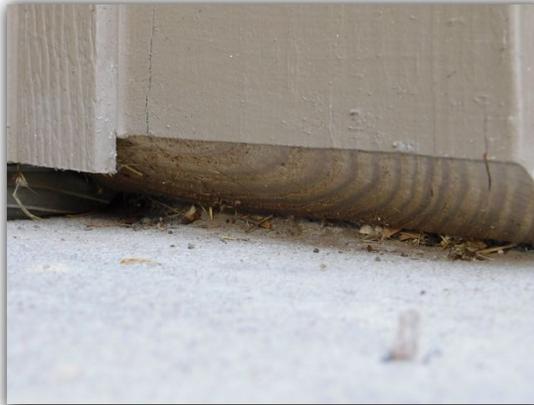
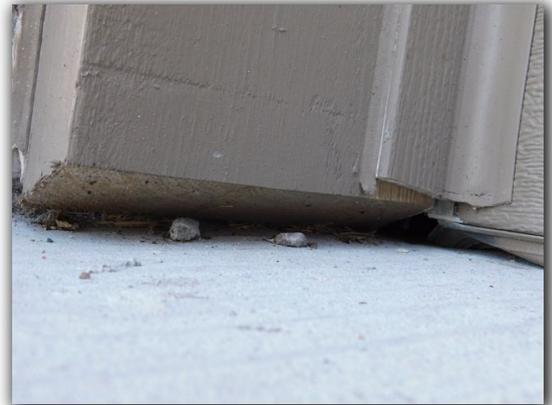
The bottom of the garage door trim should be painted or sealed to prevent wood deterioration.

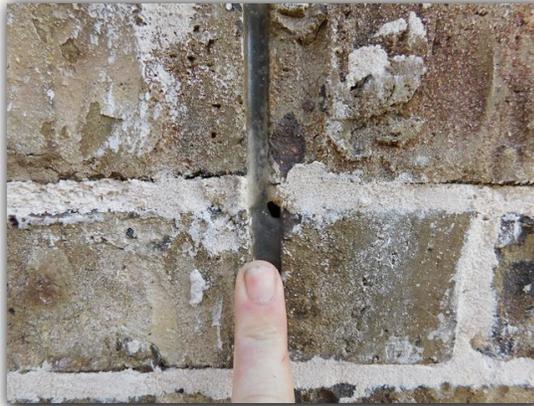
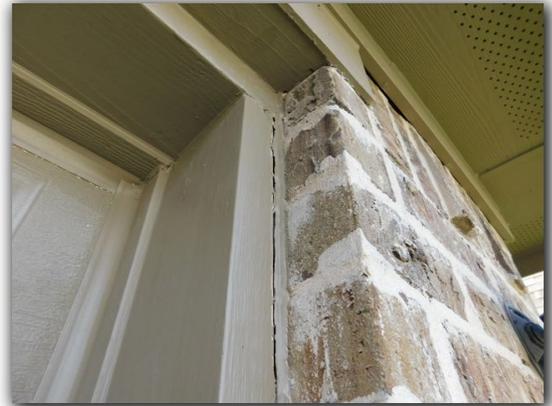
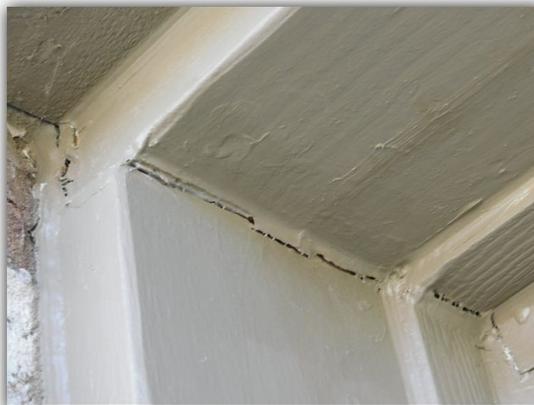
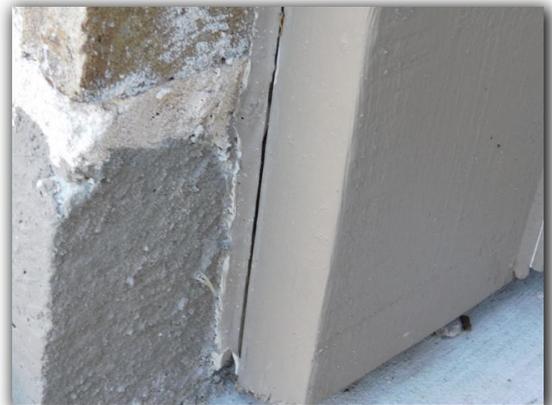
Exterior sealants were deteriorated or missing in some areas. Sealants applied in appropriate locations prevents moisture intrusion and insect penetration.

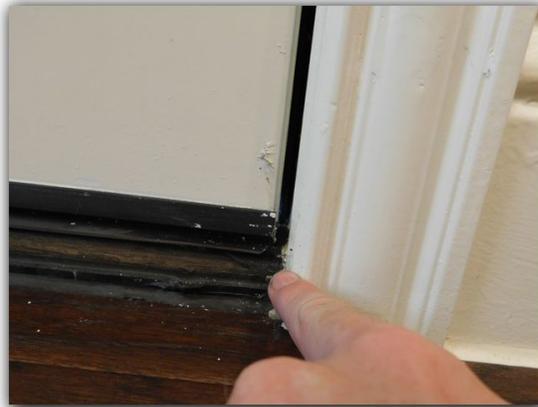
Damaged exterior door weather stripping at the back door should be replaced. Missing or damage exterior door weather stripping creates conducive conditions for moisture intrusion and conditioned air loss.

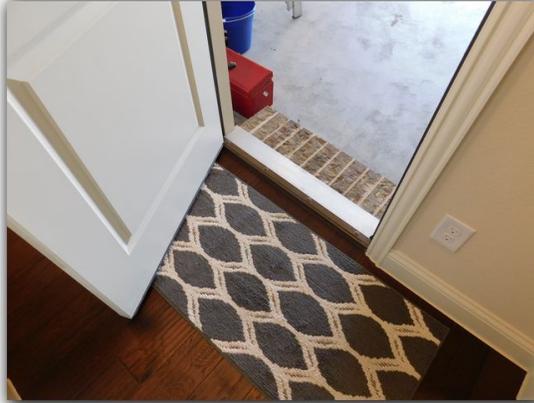
Garage entry doors should have installed self closing hinges according to today's Texas Standards of Practice. Per Texas Standards of Practice we are required to report this condition as a deficiency because it is no longer an excepted building standard.

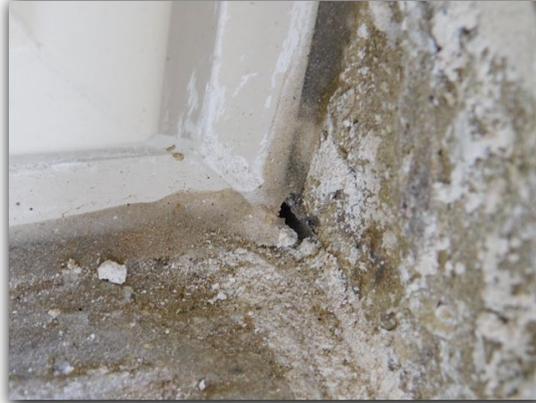
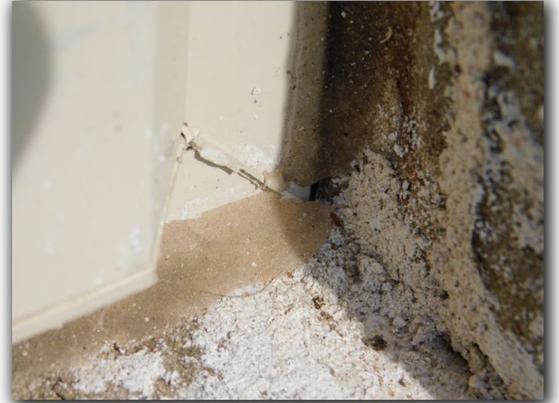
damaged or deteriorating sealant around window frames may allow moisture and insect penetration and should be repaired as needed.

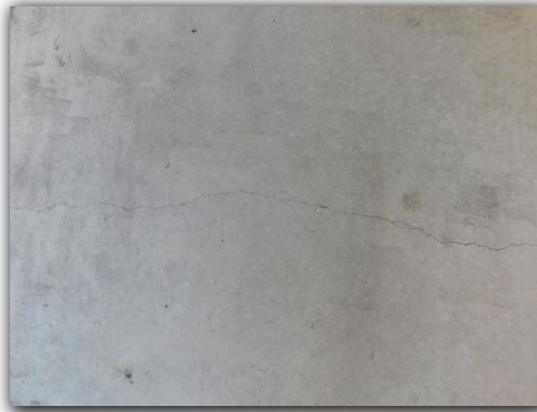
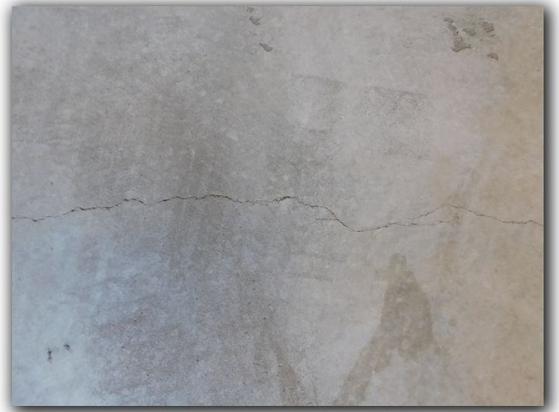
Cracks were observed in the poured concrete garage floors. Cracks and other defects in poured concrete should be repaired and monitored over time for movement, deflection and

deterioration.

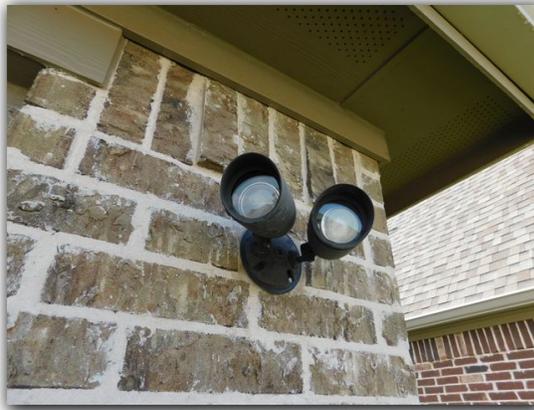
Light fixtures that are inoperative, missing bulbs or have burned out bulbs should be repaired or replaced as needed.

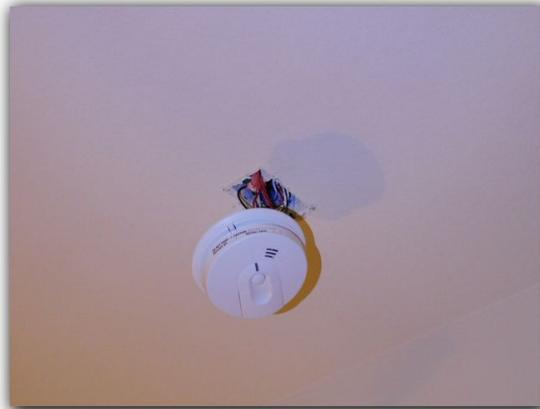
Loose smoke alarms are a SAFETY HAZARD and should be repaired.

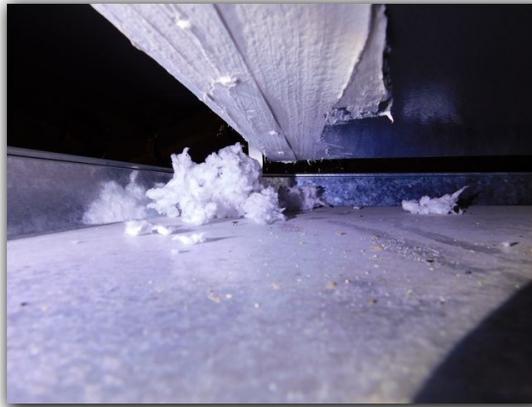
Debris was observed in the cooling equipment condensation drain pan. Debris should be removed from the cooling equipment condensation drain pan to prevent clogging of the drain and or drain plumbing. Clogged cooling equipment condensation drain pans or plumbing may result in water damage or other defects.

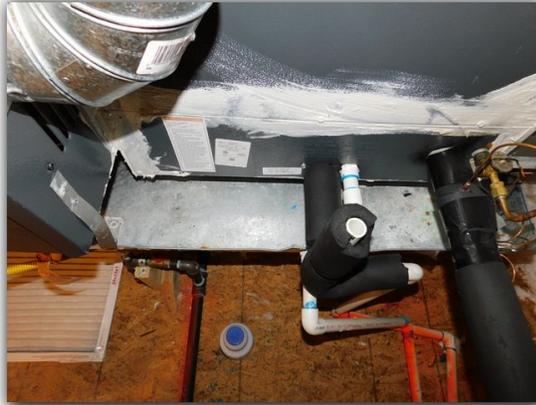
The cooling equipment condensation overflow pan or drain lines installed above ceilings were not equipped with water or moisture sensors/alarms. Cooling equipment condensation drain pans or drain line sensors and alarms should be installed at cooling equipment installed above ceilings for additional protection against water damage.

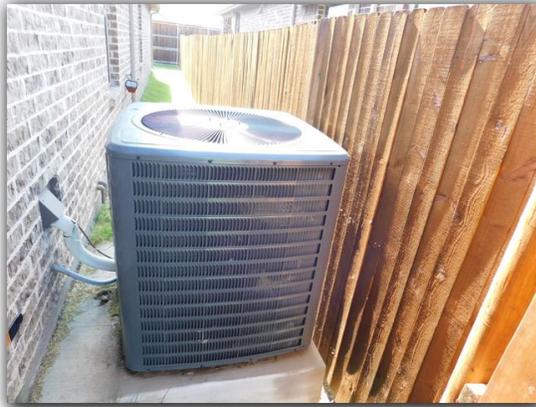
The exterior HVAC equipment was installed too close to the fence (<18"). Inadequate clearances at the exterior HVAC equipment may result in equipment damage, inadequate performance, reduced equipment life or other defects.

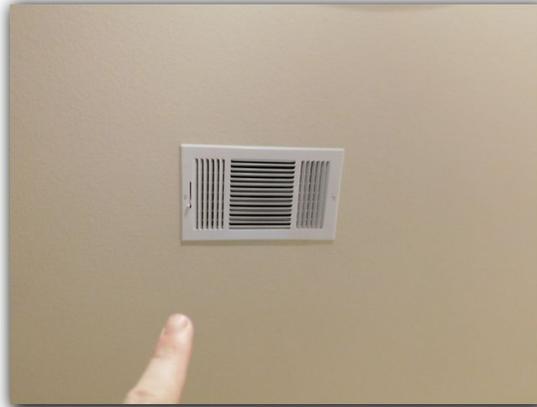
Rattling noises were heard from the Master bedroom HVAC air register vent. The cause of the noise should be determined and repaired as needed.

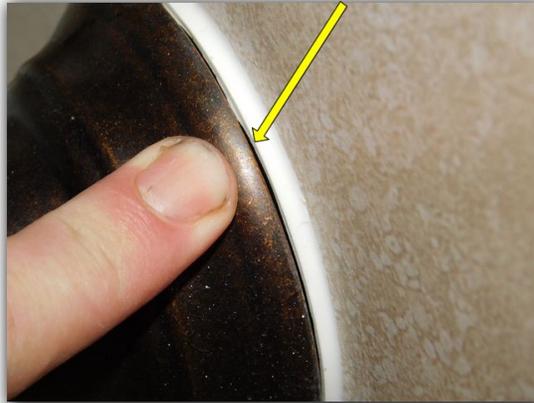
The tub/shower water supply fixtures lacked adequate sealant at the wall. Tub/shower water supply fixtures should be properly sealed at the wall to prevent water damage.

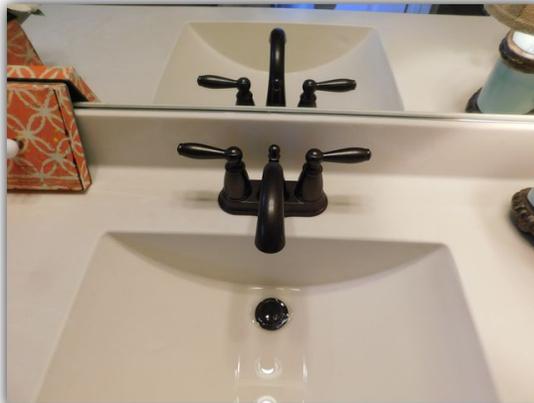
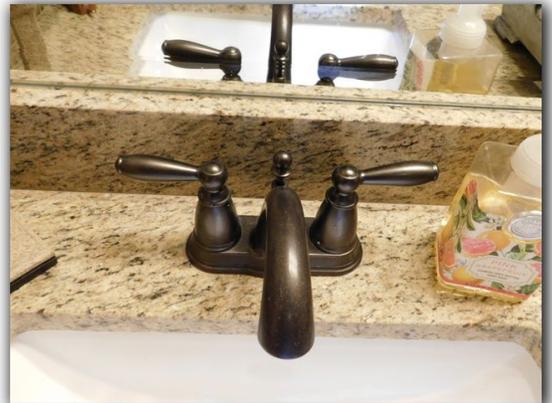
The temperature indicators are missing at the lavatory water supply fixture. Missing water temperature indicators is considered a SAFETY HAZARD.

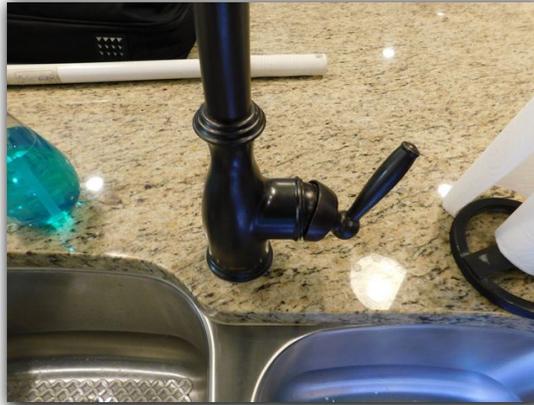
The temperature indicators are missing at the kitchen sink water supply fixture. Missing water supply temperature indicators are considered a SAFETY HAZARD.

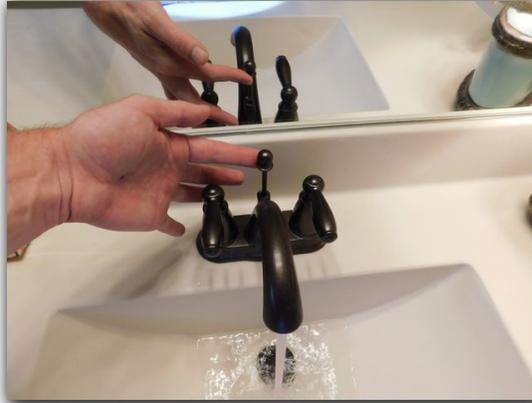
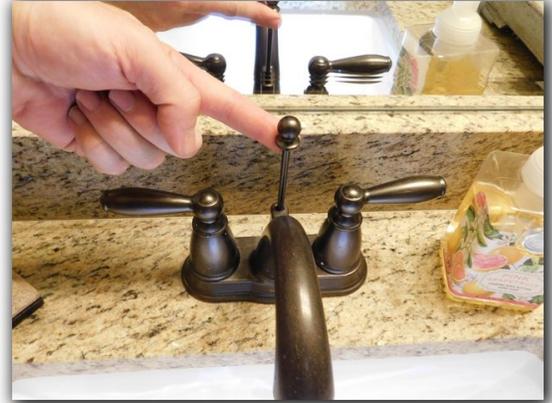
Inoperative mechanical drain stops at the sinks/tubs should be repaired.

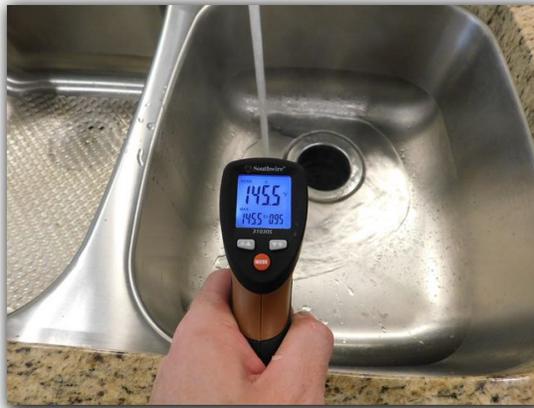
Heated Water Temperature (145.5 °F):

Heated water temperature was observed to be greater than 120 degrees Fahrenheit F and was a SAFETY HAZARD. Adequate and safe heated water temperatures are considered to be between 100 degrees and less than 120 degrees Fahrenheit. The cause of improper heated water temperature should be determined and should be corrected as needed. The water heater thermostats may be turned up too high or there may be other defects in the water heating equipment.

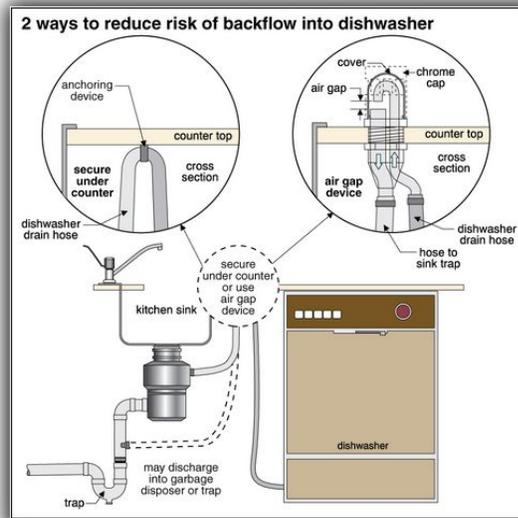
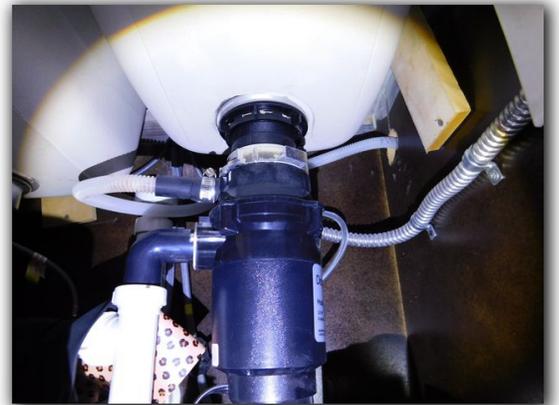
A visible anti-siphon loop or back flow prevention device was not installed at the dishwasher drain line. Some newer dishwashers may have built in anti-siphon devices that are not visible. The buyer is encouraged to consult the owner's manual or contact the manufacturer if an anti-siphon device is not visible. Lack of an anti-siphon device at a dishwasher is a SAFETY HAZARD.

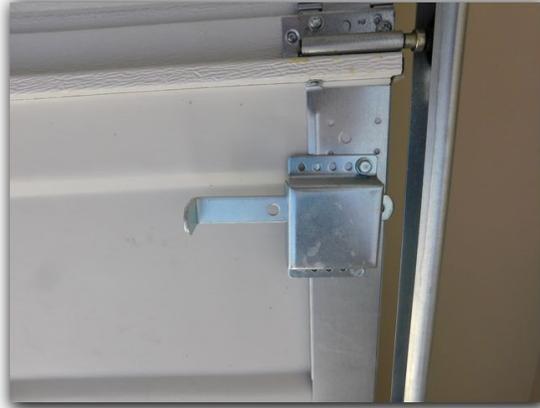
When an automatic garage door opener is installed the manual door locks should be disabled or removed to prevent damage to the garage door, garage door hardware and automatic garage door operator.
