# Fouries Home Inspection

COMPLETE HOME INSPECTION  
Prepared Exclusively For: Sample Report

1234 Somewhere, County, TX,

Inspected by Paul Fourie, Lic.#: 22325 on 04/14/2018  
Phone: (972)989-2479, Email: paul@fourieshomeinspection.com

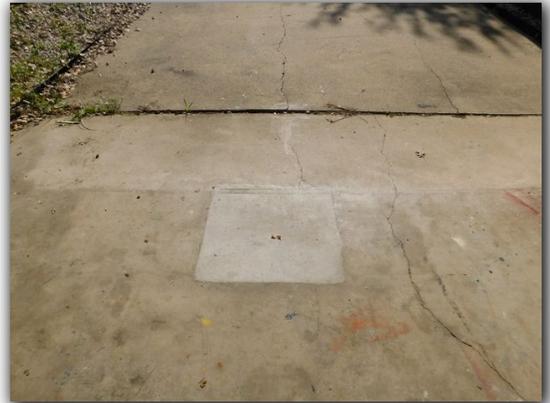
There were indications of previous foundation repairs. The inspector has no way of knowing if the foundation repairs are performing as intended. The inspector recommends that the buyer obtain as much information as possible about the foundation repairs. And, it is also recommended that the buyer obtain any and all information and documentation regarding any transferable warranty if one exists.

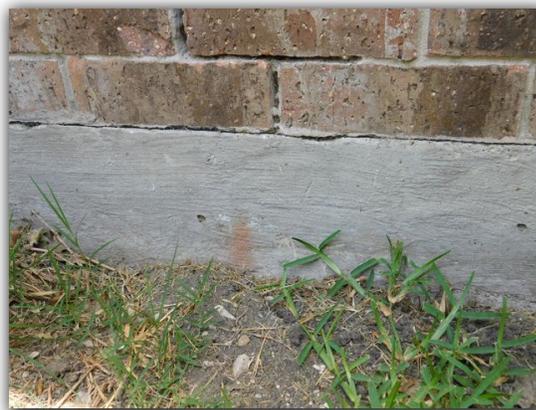
A cosmetic skim coat of mortar material has been installed over the exterior foundation perimeter beam that may conceal defects that would otherwise be observed. Foundation skim coats also create conducive conditions for wood destroying insects.

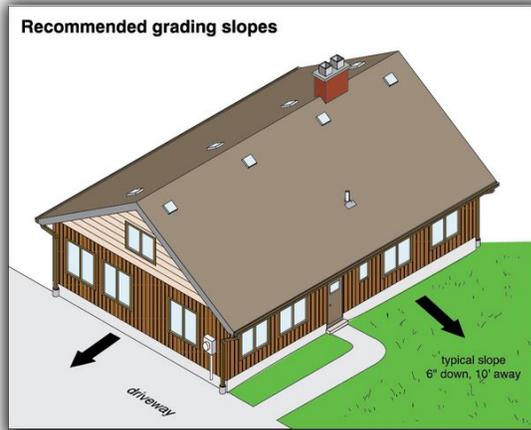
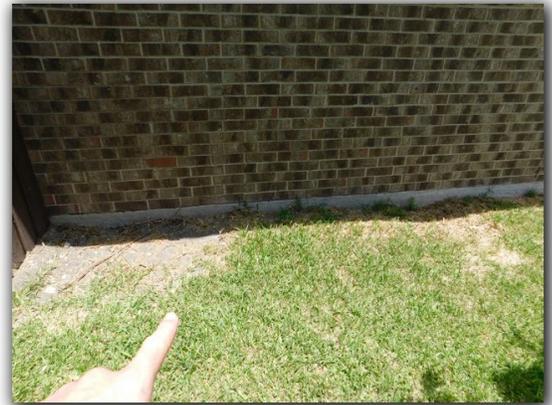
Inadequate grade slope away from the structure was observed. The recommended grade slope away from the structure is 6 inches per 10 feet. Improper grade slopes away from the structure create conducive conditions for water intrusion and inadequate foundation performance. Improper grade slope away from the structure is in need of repair.

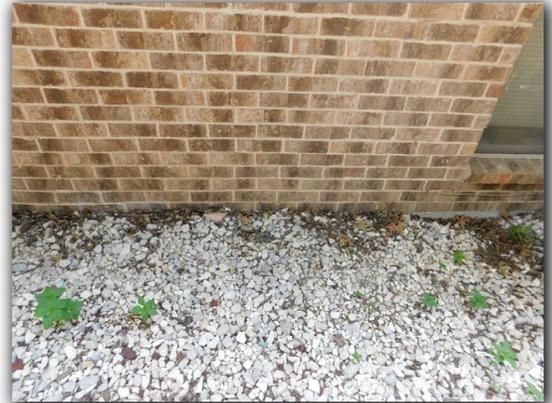
High soil levels were observed at the foundation/brick line. 4 to 6 inches of the foundation perimeter beam should be visible. High soil levels may block weep holes and prevent proper wall ventilation. High soil levels create conducive conditions for wood destroying insects and water intrusion. High soil levels prevent the inspector from observing the foundation perimeter beam. Correction of inadequate grading clearance to exterior wall and foundation surfaces is recommended.

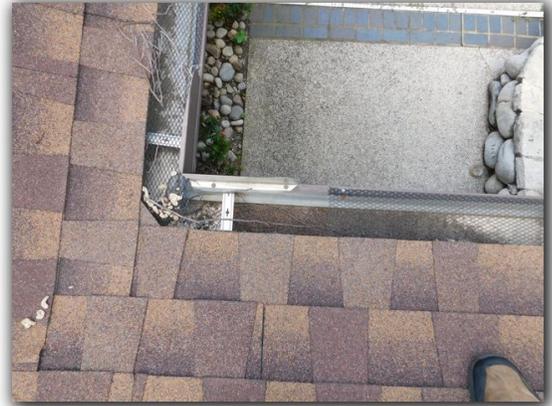
The gutters and downspouts contained leaves and other debris and should be cleaned out to allow for proper drainage.

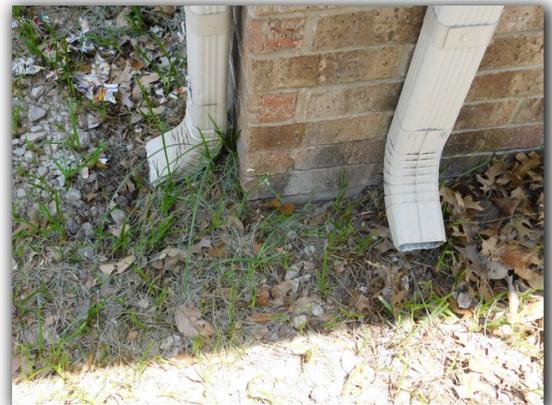
All gutter downspouts should have downspout extensions or splash blocks installed to move run off water away from the foundation and to prevent erosion. Missing splash blocks and downspout extensions should be replaced.

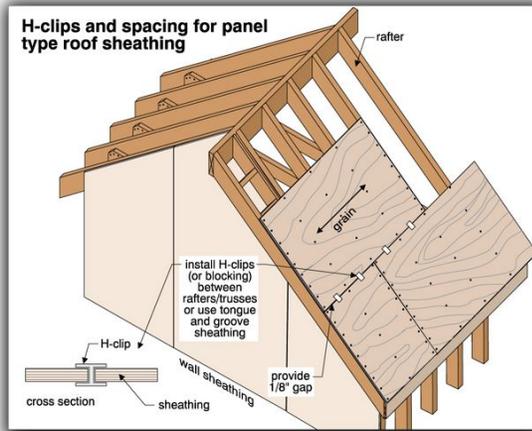
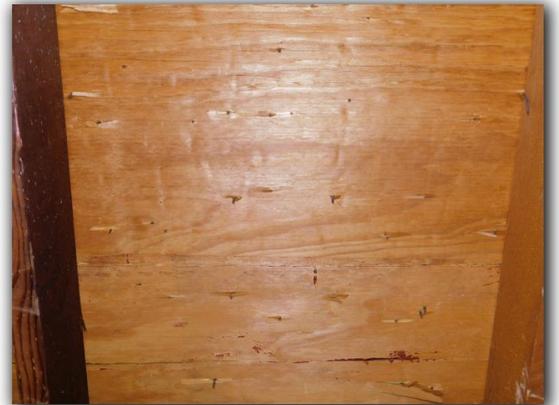
Insulation voids were observed in the attic space. Insulation voids may allow greater than normal loss of conditioned air and should be repaired.

The lack of roof decking expansion clips was observed. The lack of roof decking expansion clips may be an indication of improperly installed roof decking.

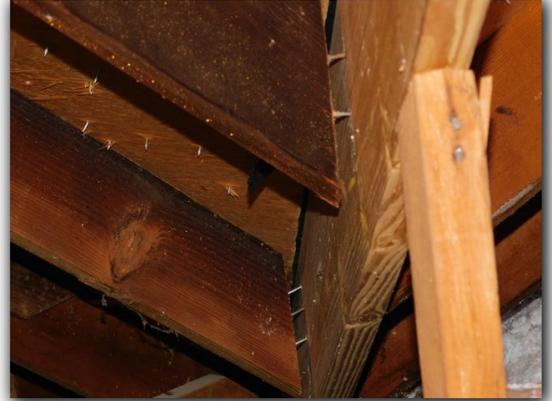
Separations between roof framing members was observed which is an indication of structural movement, settlement, inadequate workmanship or other defects. The cause of separations between roof framing members should be determined. The inspector recommends that an expert in this field be consulted for further evaluation of the structure and foundation and to provide suggestions as to what, if any, corrective actions should be taken.

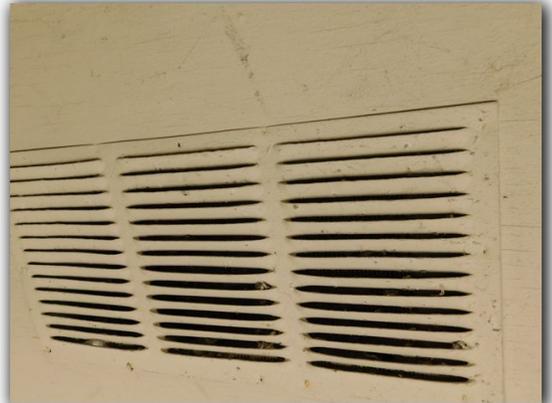
Soffit vents were observed to be dirty, blocked by insulation or debris. Clogged soffit vents are an indication of inadequate attic ventilation and should be repaired as needed.

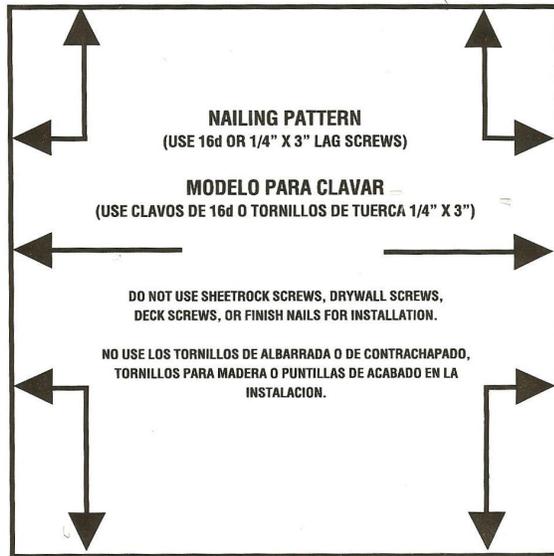
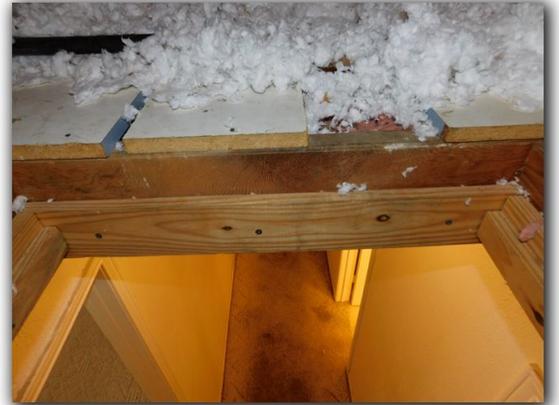
☑ The attic access ladder was installed with improper fasteners and is a SAFETY HAZARD. Attic access ladders should be installed with 16d or larger nails or bolts per manufacturer's instructions for reasons of safety.

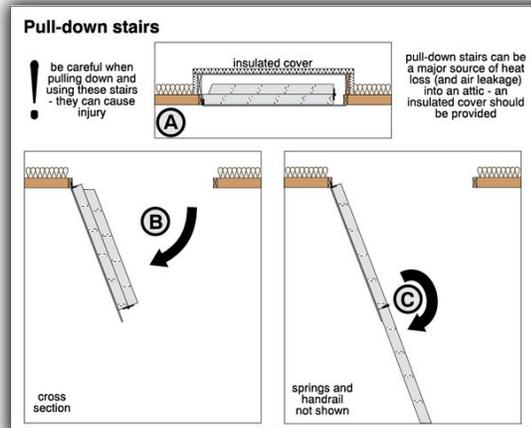
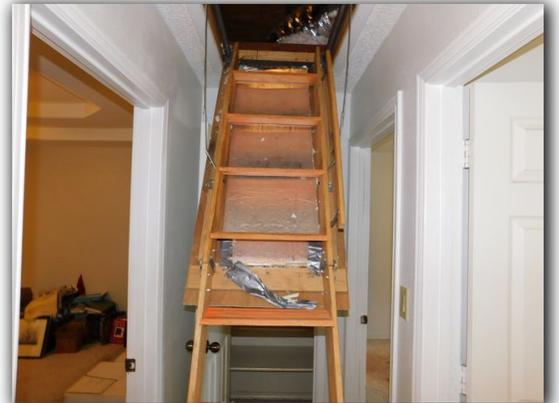
☑ Access doors from conditioned spaces to unconditioned spaces such as attics should be weather stripped and insulated to a level equivalent to the insulation on the surrounding surfaces. A wood framed or equivalent baffle or retainer should be installed when loose fill insulation is installed to assist in maintaining a consistent R-value.

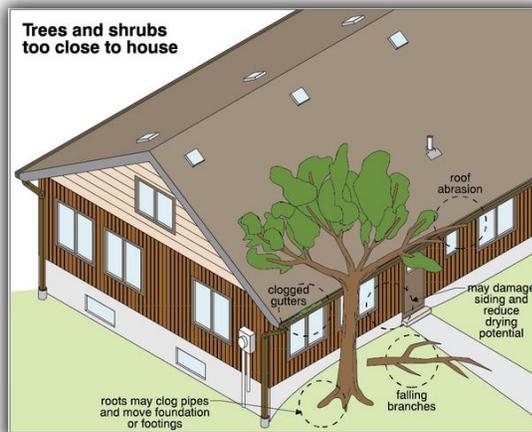
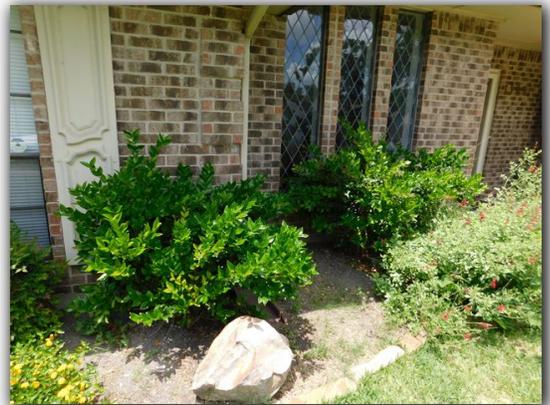
Heavy foliage growing on, over or around the exterior walls of the structure should be trimmed back at least 18-inches. Heavy foliage limits the Inspectors visual observation of the exterior surfaces. Heavy foliage at exterior walls creates conducive conditions for material damage, wood destroying insects and moisture damage. Heavy foliage may damage exterior wall cladding.

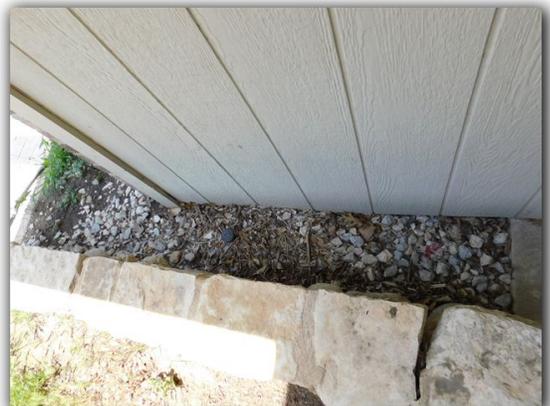
Inadequate clearance between the exterior wall cladding and grade (high soil or mulch) was observed. Inadequate clearance between the exterior wall cladding and grade should be corrected to prevent conducive conditions for wood destroying insects, water intrusion and deterioration of exterior siding materials.

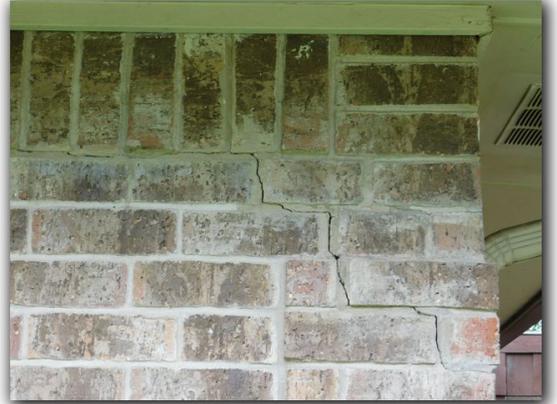
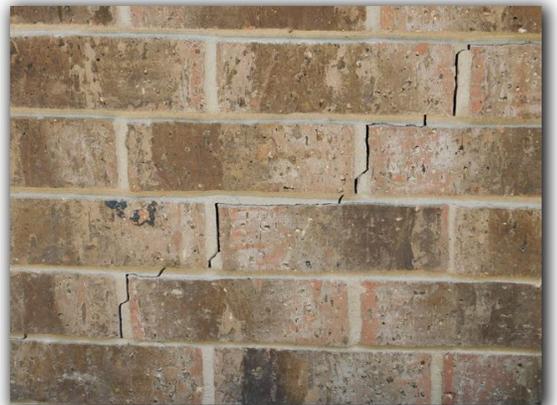
Multiple cracks in the exterior brick veneer masonry walls were observed. These cracks in the exterior brick veneer wall cladding were an indication that greater than normal movement or settlement has occurred. Further evaluation of the foundation and structure by a certified, licensed foundation and structural specialist is recommended prior to closing.

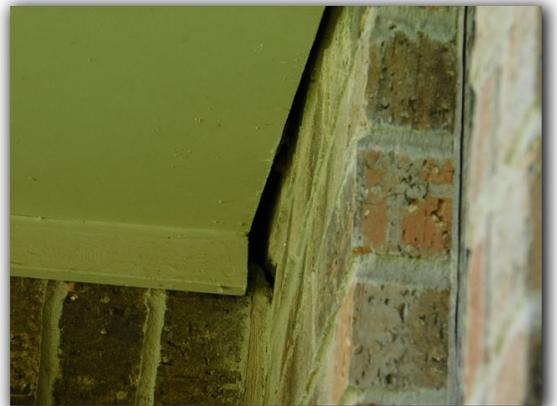
Exterior sealants (caulking) were deteriorated or missing in some areas. Sealants applied in appropriate locations prevents moisture intrusion and insect penetration.

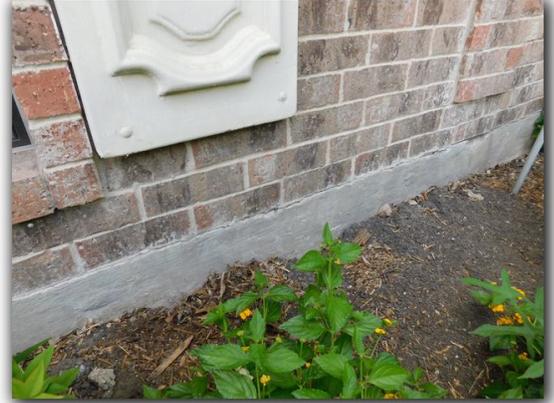
Weep holes were missing at the lower brick of the exterior walls. Weep holes should be installed and properly spaced to provide proper wall ventilation.

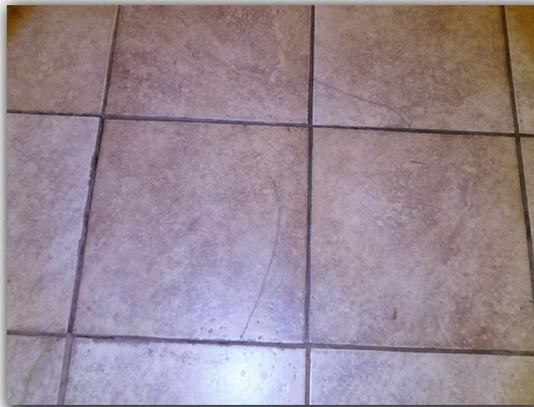
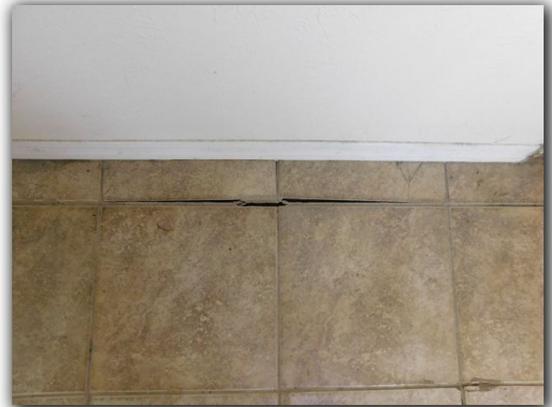
Cosmetic cracks and damaged floor tile(s) and tile grout should be repaired.

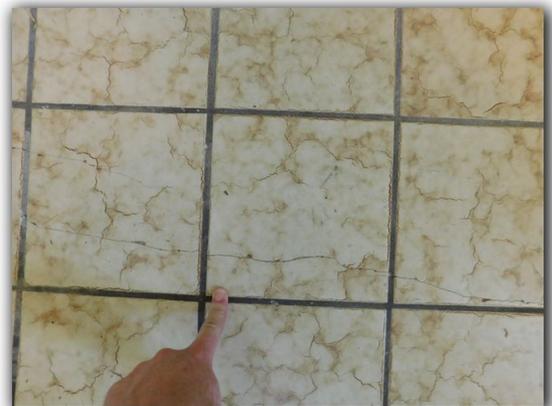
Linear cracks in floor tiles were observed. Linear cracks in floor tiles may be an indication of movement, settlement, improper installation or other defects. The cause of linear cracks in floor tiles and grout should be further evaluated and repaired as needed.

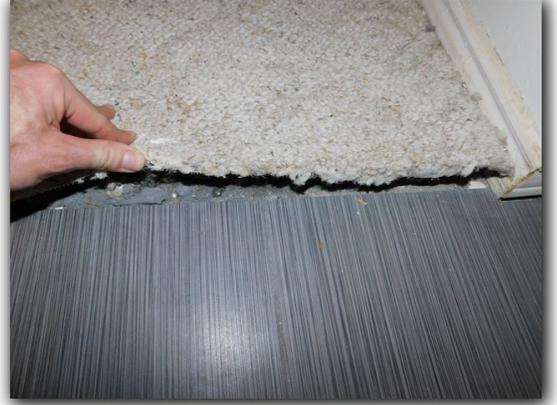
Missing floor covering transition strips should be repaired to avoid additional damage and trip hazards.

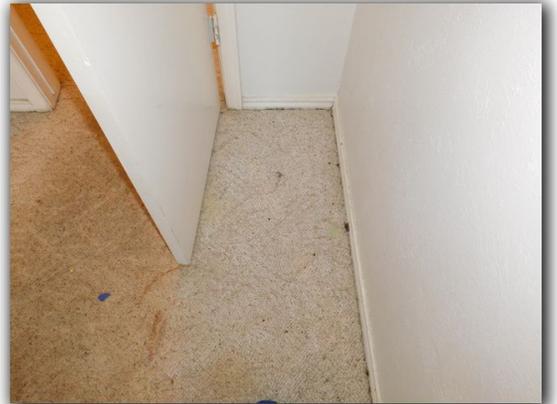
All interior doors should have door stops installed to prevent damage to adjacent interior wall coverings.

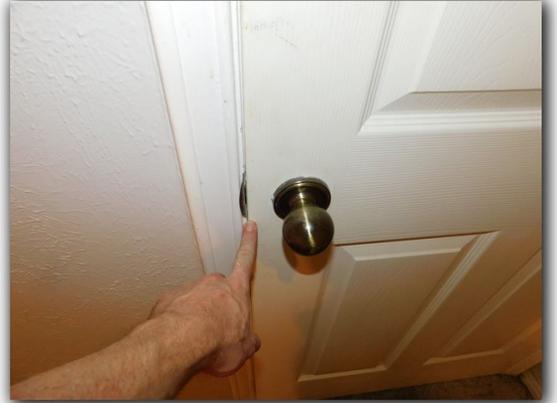
- Interior doors which do not latch as intended should be repaired.

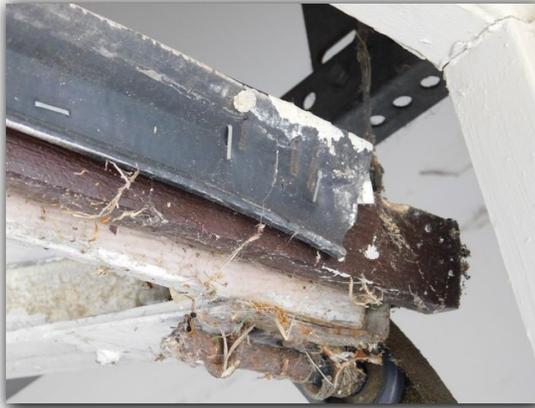
Damaged garage door weather stripping should be replaced.

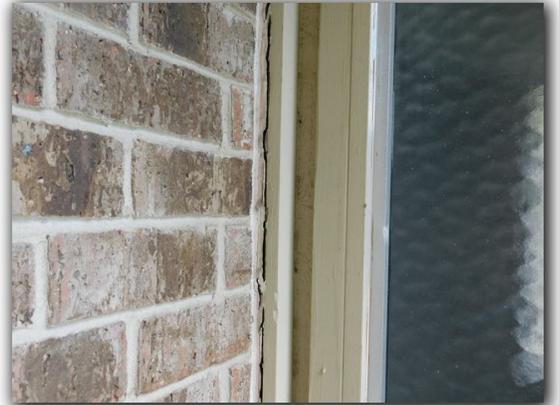
The windows need sealant between the window frames and exterior wall cladding. Lack of, damaged or deteriorating sealant around window frames may allow moisture and insect penetration and should be repaired as needed.

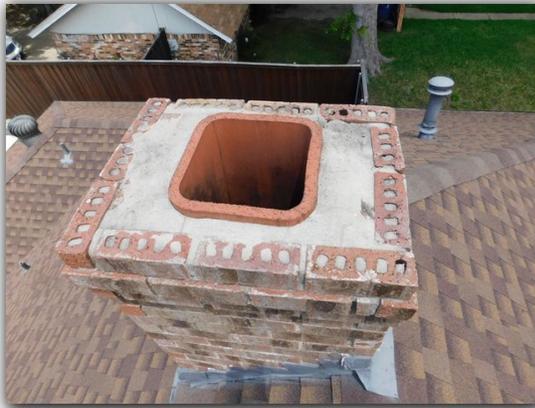
The fireplace chimney lacks a metal cap and spark arrestor. This condition should be further evaluated and corrected as necessary. Masonry chimney caps are often not visible and are known to crack which allows moisture to penetrate the structure. Masonry chimney caps are considered inadequate by current building standards and should be replaced with metal caps.

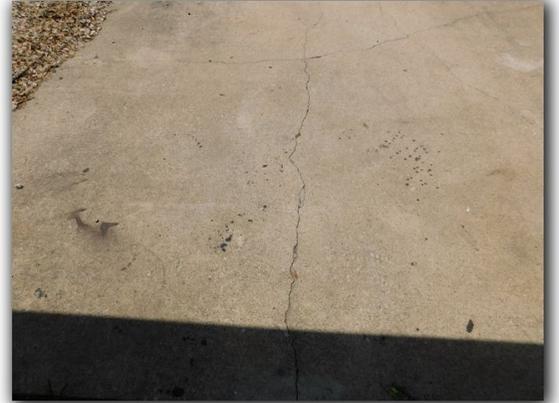
Cracks were observed in the poured concrete such as sidewalks, driveways, garage floors, porches and or patios. Cracks in poured concrete may be an indication of material defects, lack of maintenance, movement or settlement. Cracks and other defects in poured concrete should be repaired and monitored over time for movement, deflection and deterioration.

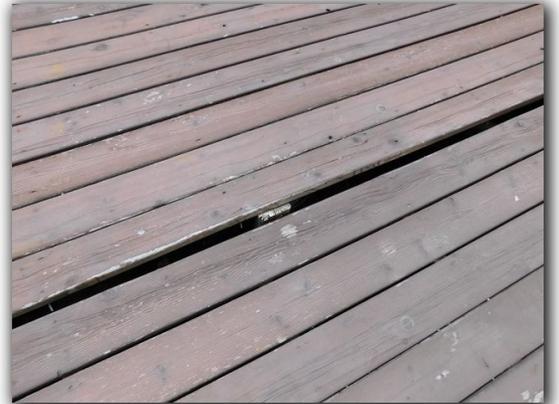
Weathered, deteriorated and damaged wood deck materials were observed and should be repaired or replaced as needed.

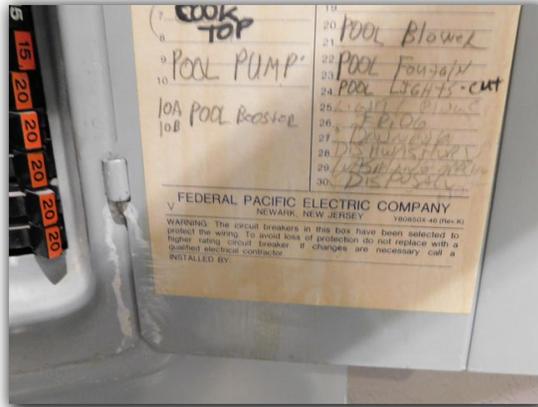
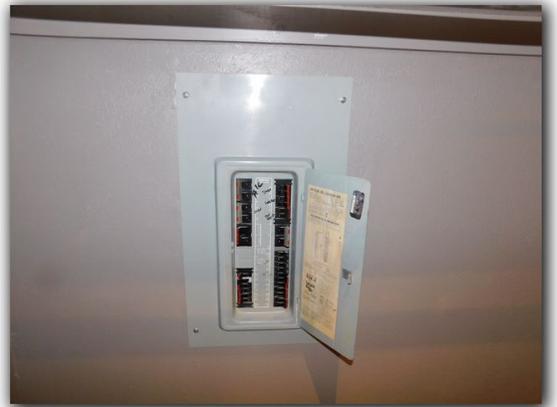
The main breaker panel was observed to be a Federal Pacific brand electric panel. Many of these panels were recalled due to electrical fire hazards and are considered a SAFETY HAZARD. The inspector recommends that all Federal Pacific brand electrical panels be evaluated, serviced, repaired and or replaced by a certified, licensed electrical specialist.

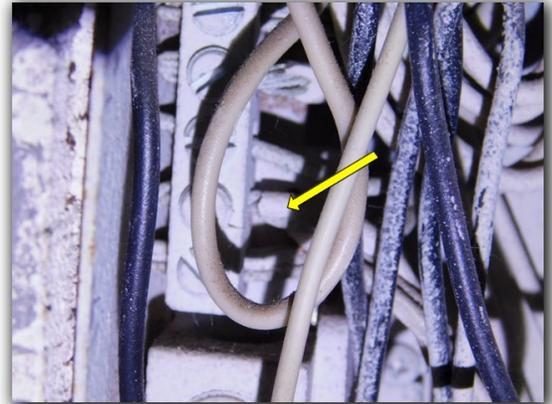
Neutral electrical conductors were observed to be “double tapped” on the neutral bus bar in the electric service panel. Each neutral electrical conductor in the electric service panel should terminate individually unless the terminals are made for more than one conductor. Double tapped neutral electrical conductors should be further evaluated and repaired as needed by a qualified electrical specialist.

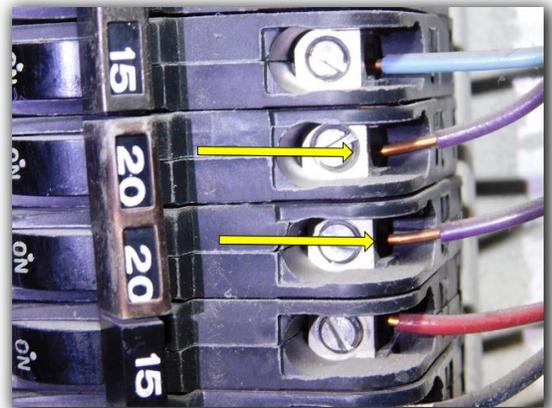
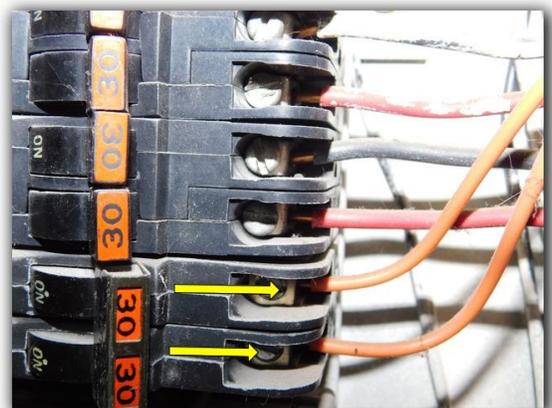
Incorrect electrical conductor sizes were observed to be connected to breakers in the electric service panel. Incorrect electrical conductor sizes are a SAFETY HAZARD and create conducive conditions for overheating and or breaker tripping. Incorrect electrical conductor sizes should be further evaluated and repaired or replaced by a qualified electrical specialist.

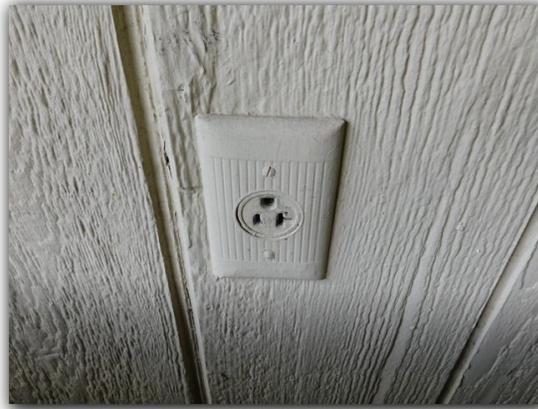
Exterior electrical receptacles in wet locations were observed to lack weather tight bubble covers. Lack of weather proof bubble covers at electrical receptacles in wet locations is a SAFETY HAZARD and should be repaired by a certified, licensed electrical specialist.

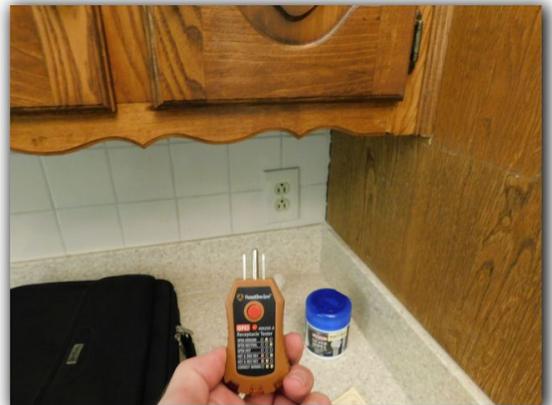
Kitchen counter top electrical receptacles were observed to lack ground fault circuit interrupter (GFCI) device protection. Under current electrical standards, all of the kitchen counter top receptacles should have GFCI protection. Lack of GFCI protection in required locations is a SAFETY HAZARD.

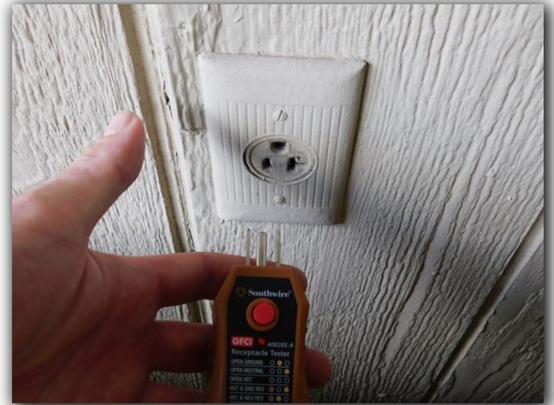
Exterior electrical receptacles were observed to lack ground fault circuit interrupter (GFCI) device protection. Under current electrical standards, all of the exterior receptacles should have GFCI protection. Lack of GFCI protection in required locations is a SAFETY HAZARD.

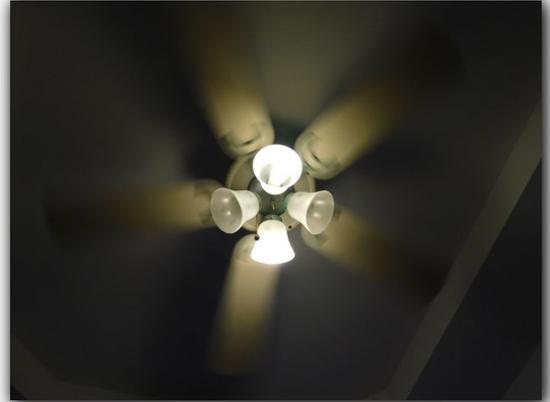
Light fixtures that are inoperative, missing bulbs or have burned out bulbs should be repaired or replaced as needed.

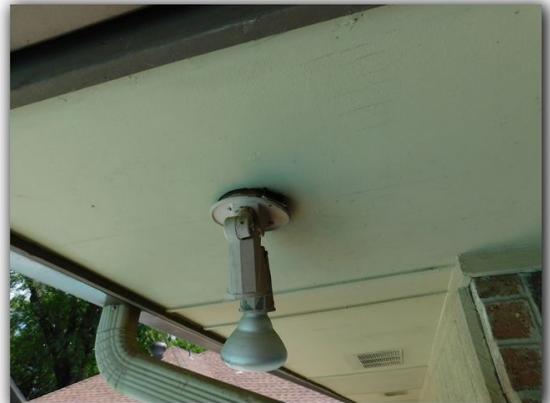
Exterior light fixtures should be sealed at the wall to prevent water intrusion for reasons of SAFETY.

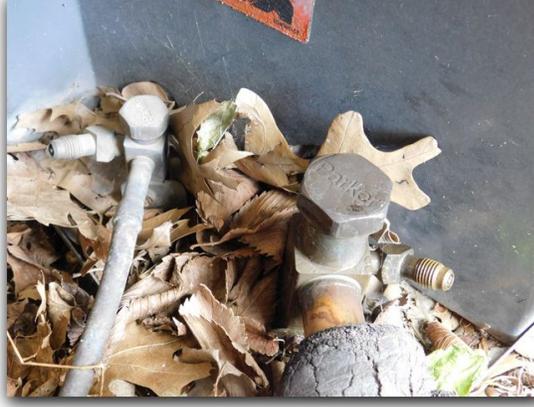
- The HVAC cooling line service valve caps were missing. The service valve caps prevent dirt, debris and damage to the service valves and should be replaced.

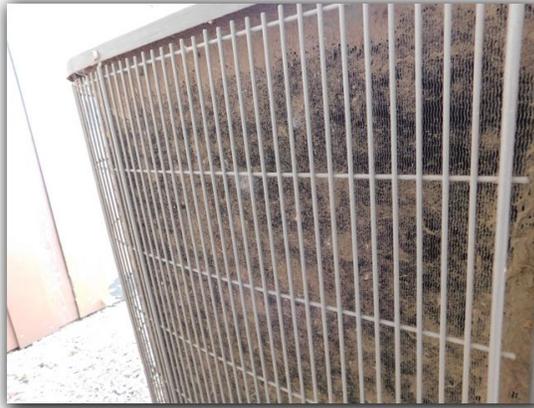
- The HVAC condenser unit coil fins were dirty and in need of service, repair or replacement. Dirty or damaged HVAC equipment coil fins may result in equipment damage, inadequate performance, reduced equipment life or other defects.

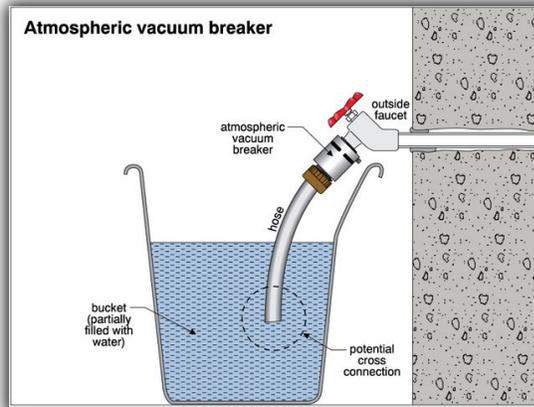
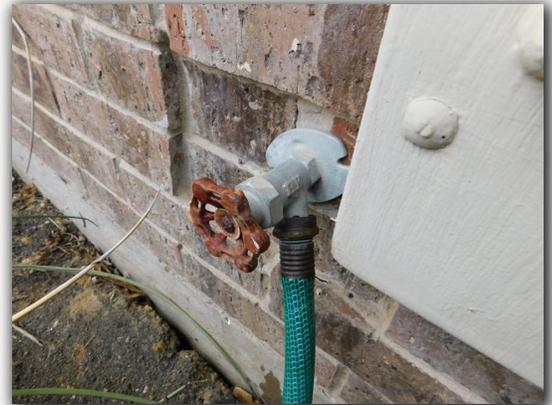
Exterior water supply faucets were missing an anti-siphon device to prevent contaminants from entering the water supply. Lack of anti-siphon devices at exterior water supply faucets is a SAFETY HAZARD. Current building standards require non-removable vacuum breakers on all hose faucets.

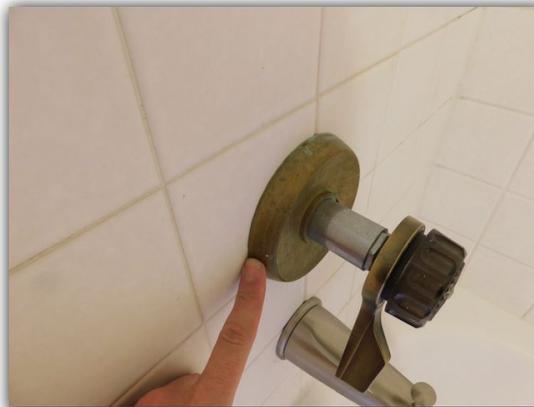
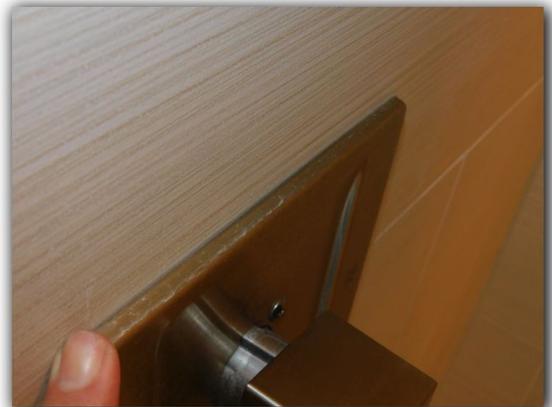
The tub/shower water supply fixtures lacked adequate sealant at the wall. Tub/shower water supply fixtures should be properly sealed at the wall to prevent water damage.

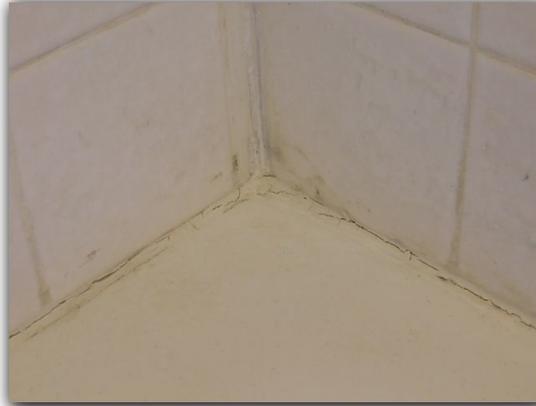
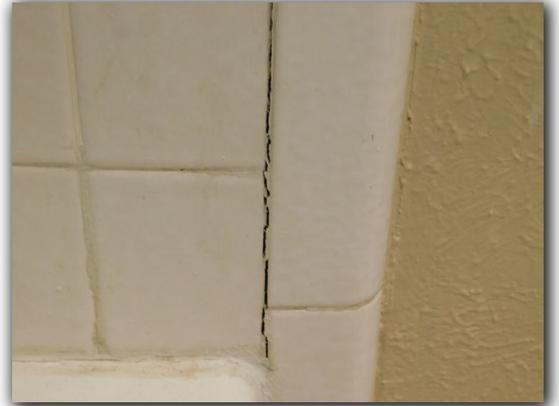
The tub/shower tile grout and sealants were observed to be in need of repair or replacement to prevent water penetration at interior walls. When tub/shower tile grout and sealants are damaged, there may be concealed water damage and or wood destroying insect damage.

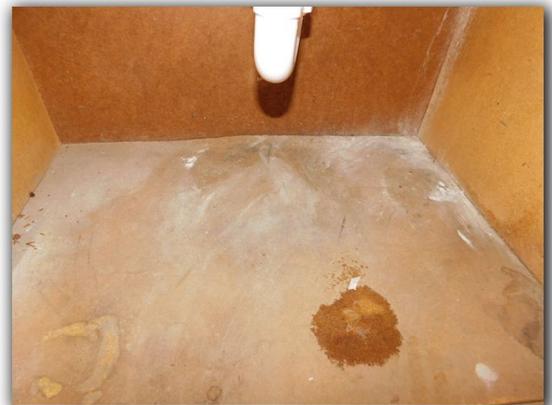
Water damage inside of sink cabinets was observed. The cause should be determined and repaired as needed.

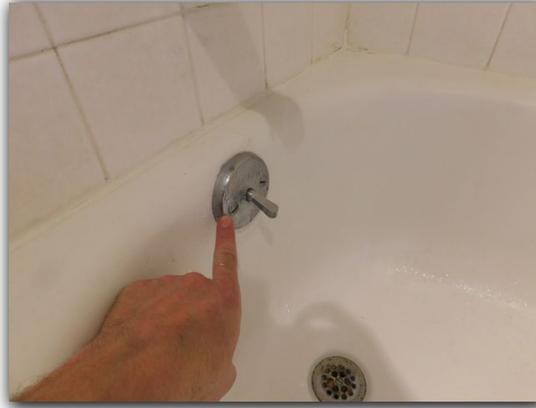
- Missing, damaged or inoperative mechanical drain stops at the sinks/tubs should be repaired.

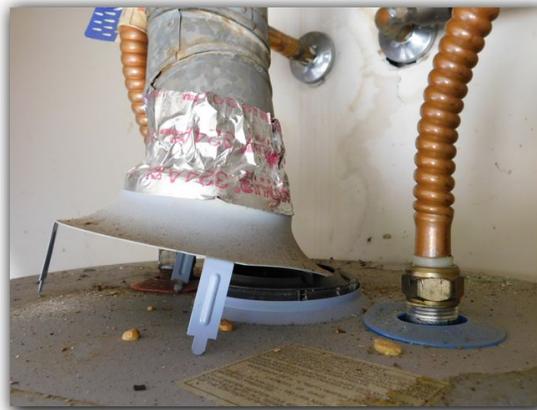
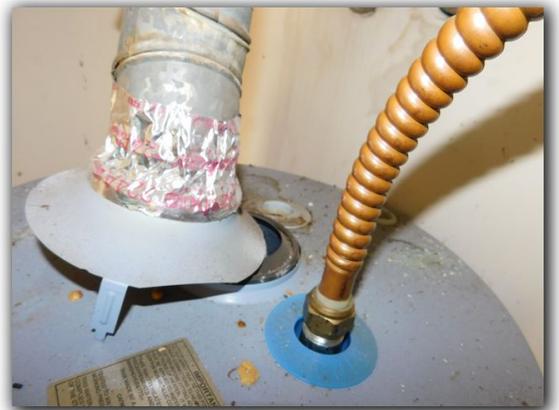
Gas flue/vent is loose, damaged, improperly installed and poorly connected at water heating equipment and was observed to be a SAFETY HAZARD. Loose, damaged, improperly installed or poorly connected gas exhaust flu should be corrected. Loose, damaged, improperly installed or poorly connected gas exhaust flues are a SAFETY HAZARD and should be repaired prior to operation of the water heating equipment.

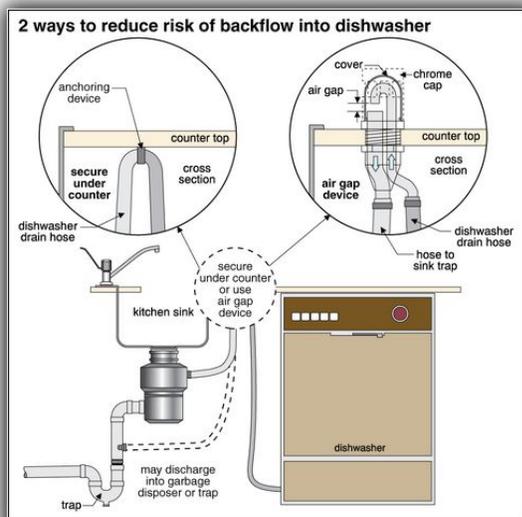
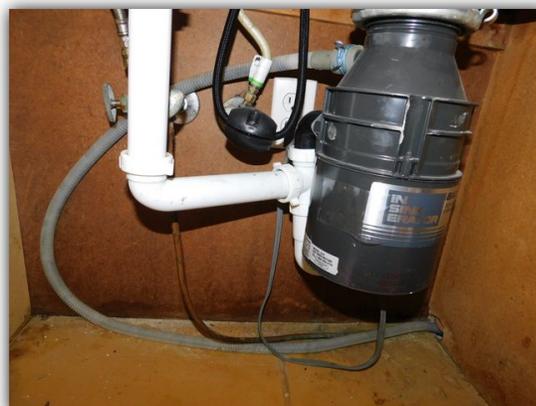
A visible anti-siphon loop or back flow prevention device was not installed at the dishwasher drain line. Some newer dishwashers may have built in anti-siphon devices that are not visible. The buyer is encouraged to consult the owner's manual or contact the manufacturer if an anti-siphon device is not visible. Lack of an anti-siphon device at a dishwasher is a SAFETY HAZARD.

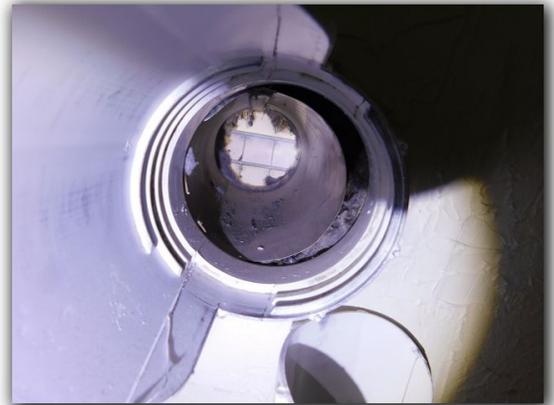
The dryer vent and duct were in need of cleaning. Flammable lint and other debris should be removed from the dryer vent and duct for reasons of SAFETY.
