Fouries Home Inspection

NEW HOME INSPECTION
Prepared Exclusively For: First Name Last Name

9999 Somewhere, Dallas, TX,

Inspected by Paul Fourie, Lic.#: 22325 on 07/18/2018
Phone: (972)989-2479, Email: paul@fourieshomeinspection.com

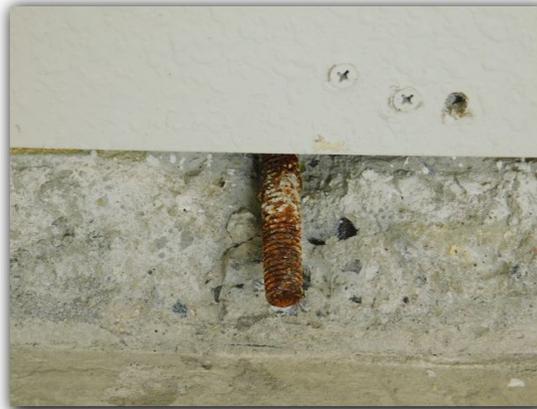
Exposed or damaged metal foundation components were observed in the garage. Exposed or damaged metal foundation components may lead to additional foundation deterioration and adverse foundation performance. This condition should be repaired as needed by a foundation specialist.

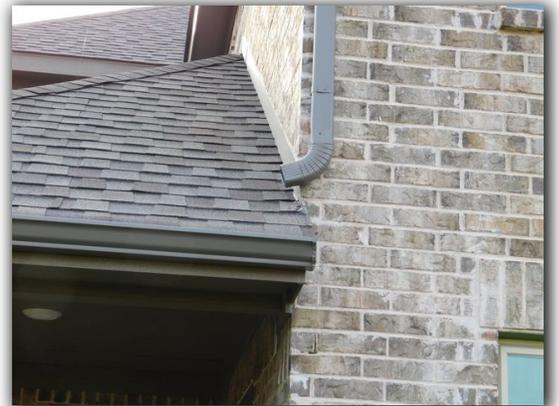
The secondary roof rain gutter lacks a downspout. Lack of a downspout at secondary roof rain gutters may allow localized deterioration and premature wear of the roof covering materials.

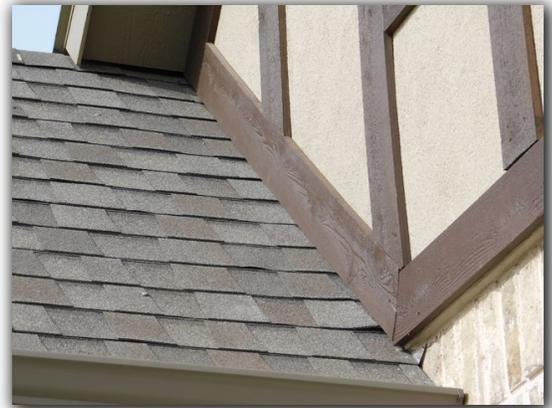
Inadequate clearance between exterior siding and roof covering materials was observed. There should be a space between the siding and roof covering. Space between the roof covering and siding provides proper ventilation and prevents water damage to the siding.

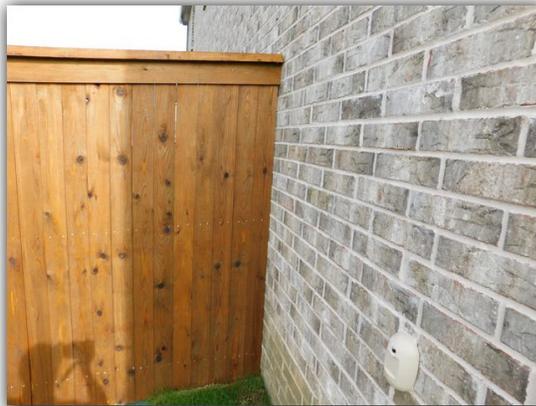
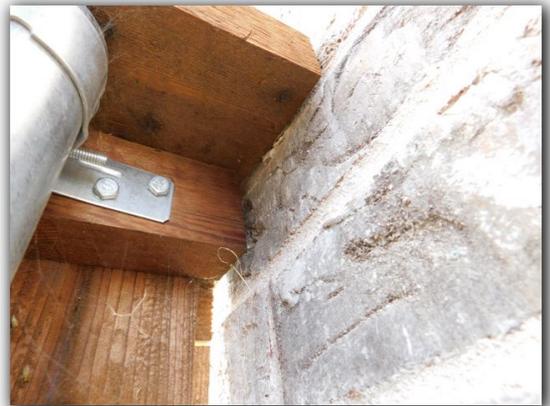
Wood fencing in contact with the structure creates conducive conditions for wood destroying insects. Wood fencing materials should be trimmed back so as not to be in contact with the exterior wall surfaces.

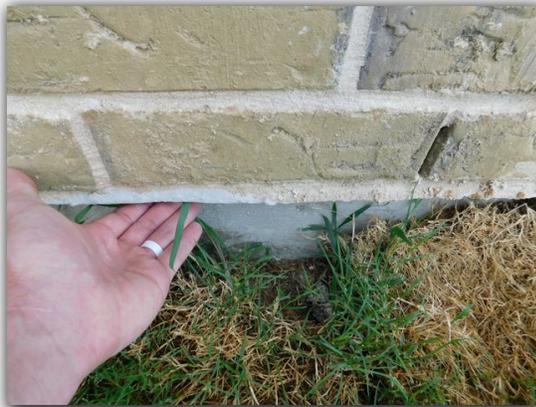
Areas of the exterior brick veneer siding overhang the foundation and appeared to be improperly installed. Brick veneer siding that does not rest on the foundation may not be properly supported.

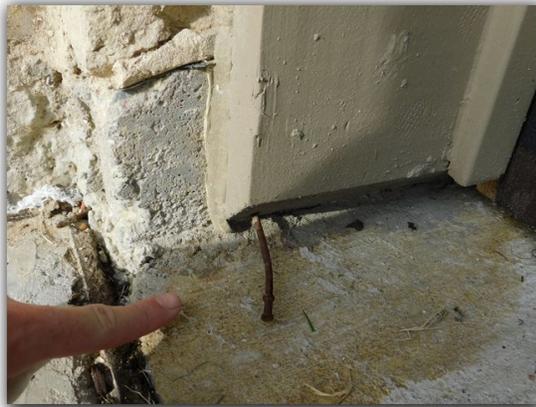
The bottom of the garage door trim has a nail left in it that should be removed.

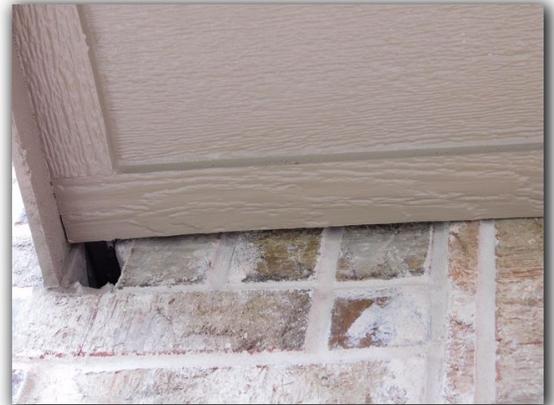
Exterior sealants (caulking) were deteriorated or missing in some areas. Sealants applied in appropriate locations prevents moisture intrusion and insect penetration.

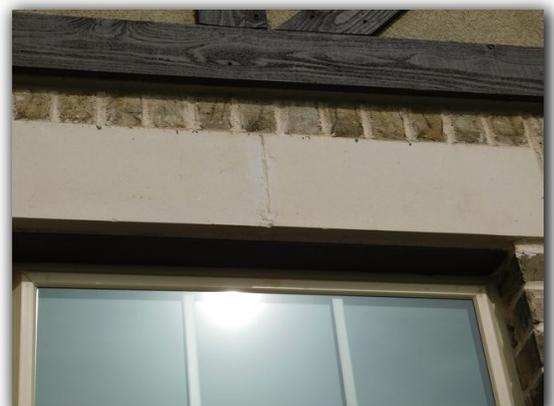
Weep holes were not open in the brick/stone masonry above the windows in required locations. This may be an "as-built" condition, however, under current building standards, weep holes should be installed in the brick/stone masonry above windows to provide proper wall ventilation.

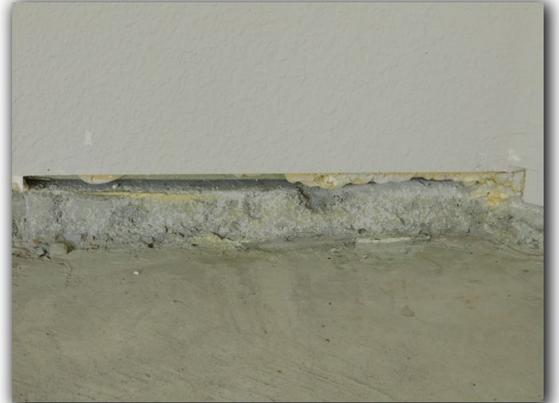
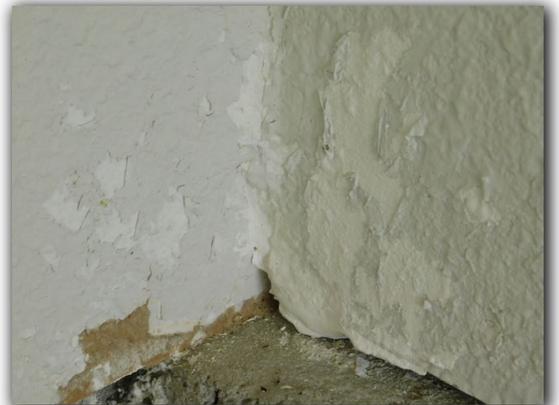
Cosmetic damages to garage interior wall coverings, drywall, texture and paint were observed to be in need of repair.

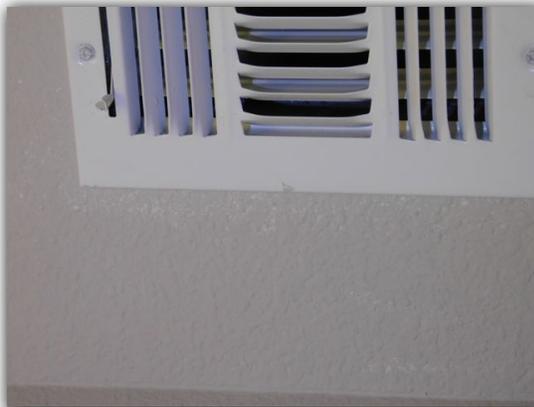
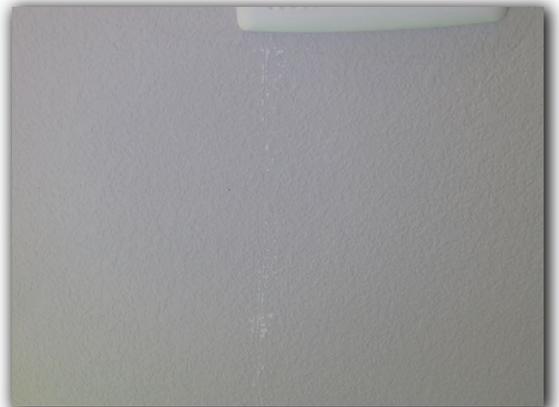
- Cosmetic damages to ceiling drywall, texture and paint should be repaired.

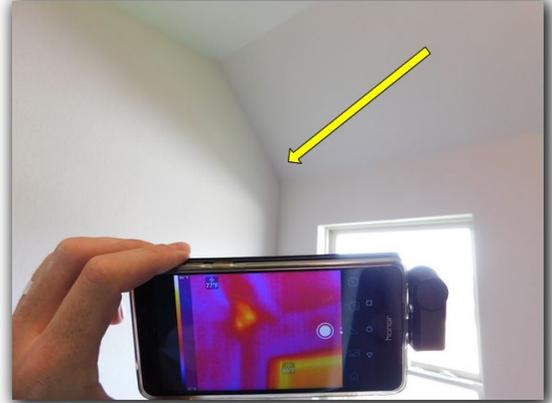
- Using a thermal imaging camera, there are areas of temperature anomalies in the ceilings

which may be indication of missing or damaged insulation. The reason for the temperature anomalies should be further evaluated and repaired as needed.

- Using a thermal imaging camera, there are areas of temperature anomalies in the ceilings which may be indication of missing or damaged insulation. The reason for the temperature anomalies should be further evaluated and repaired as needed.

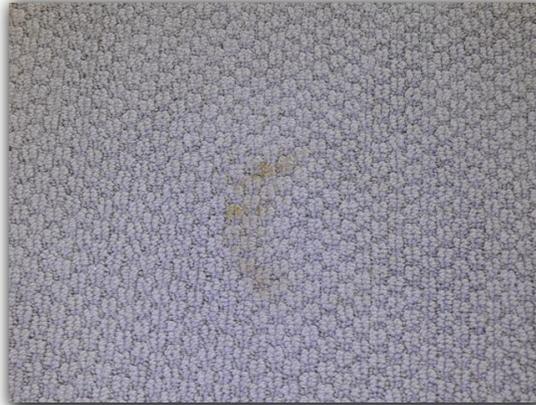
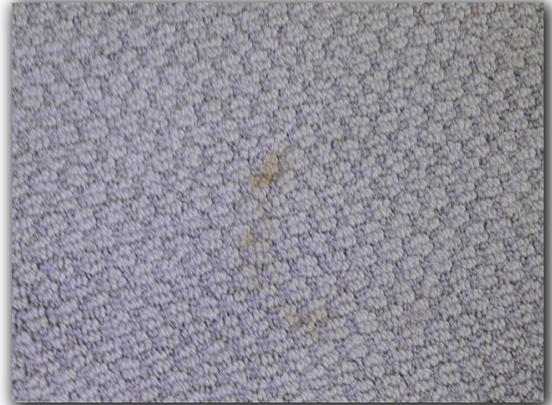
The floor covering was noticeably stained and was in need of cleaning.

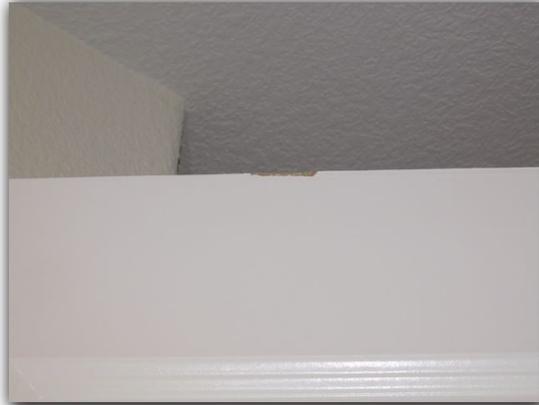
Cosmetic damage to interior doors should be repaired.

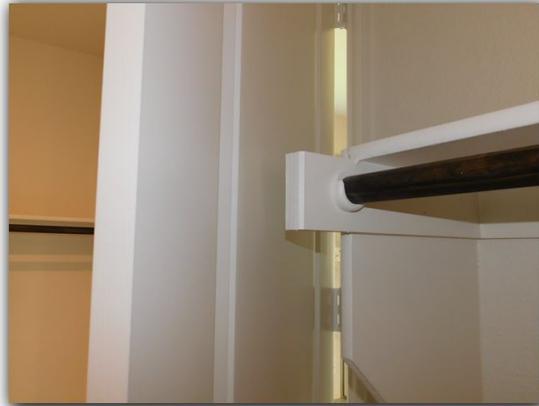
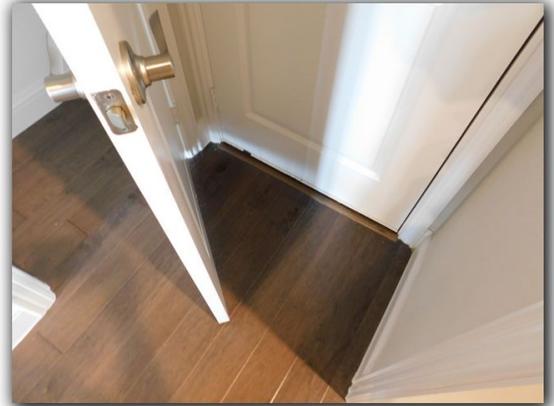
All interior doors should have door stops installed to prevent damage to adjacent interior wall coverings.

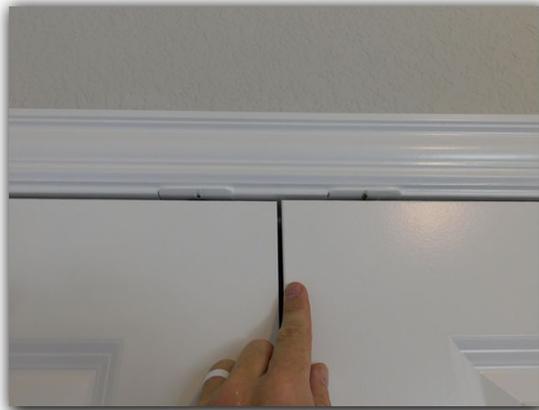
Closet doors which do not latch as intended should be repaired or replaced.

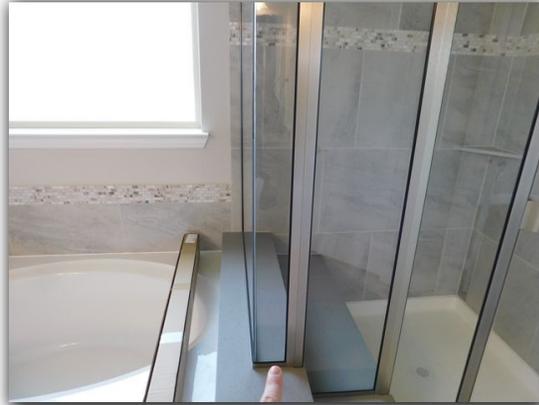
Safety glass was not installed in shower in required locations. Lack of shower safety glass in required locations is a SAFETY HAZARD.

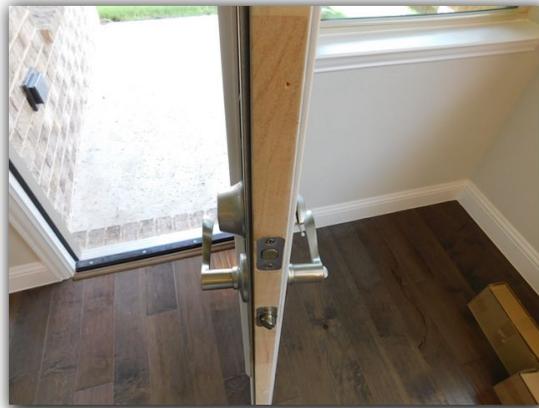
- Deficient paint at back exterior door were observed and should be repaired.

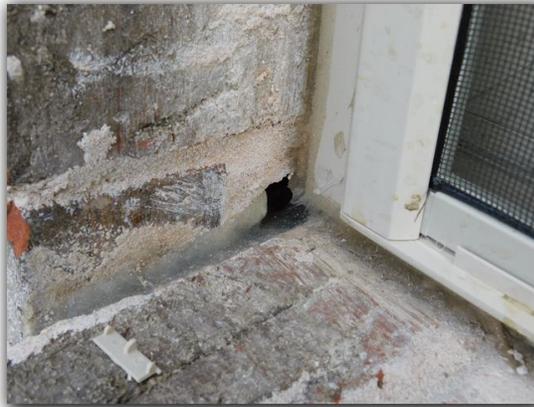
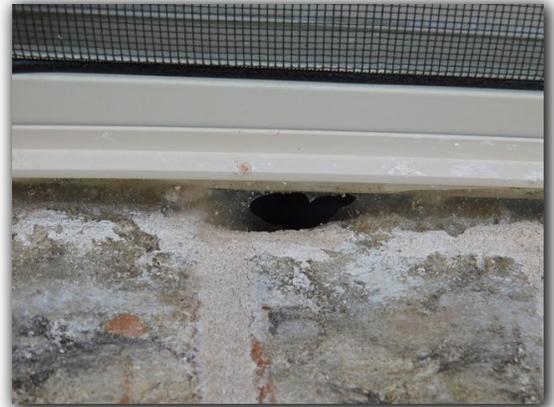
The windows need sealant between the window frames and exterior wall cladding. Lack of, damaged or deteriorating sealant around window frames may allow moisture and insect penetration and should be repaired as needed.

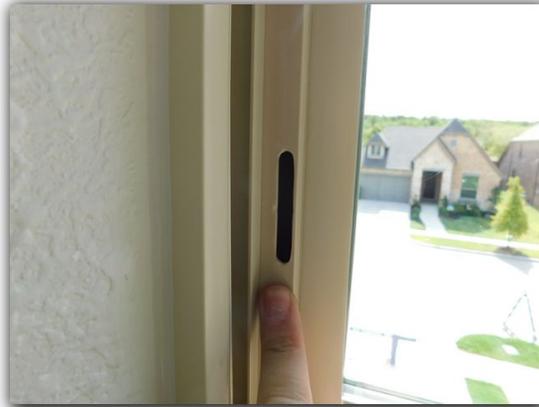
Missing window stops were observed. Missing window stops should be repaired.

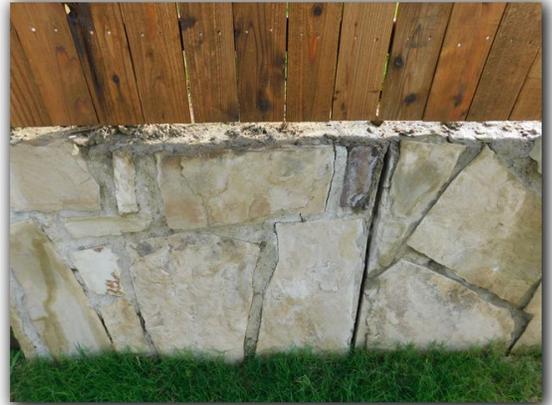
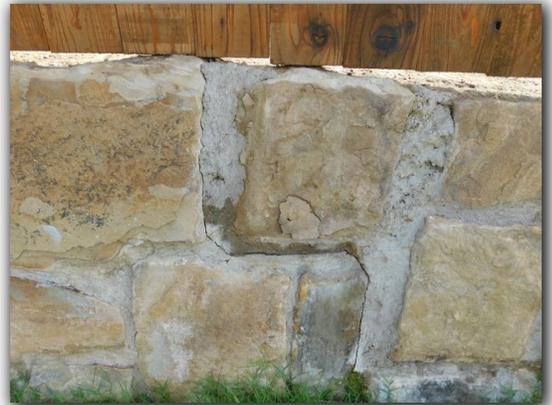
Defects such as cracks was observed at retaining walls and should be repaired to prevent erosion, soil movement or other damage.

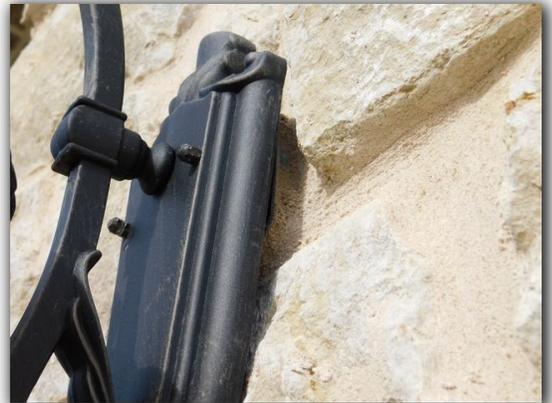
Exterior light fixtures should be sealed at the wall to prevent water intrusion for reasons of SAFETY.

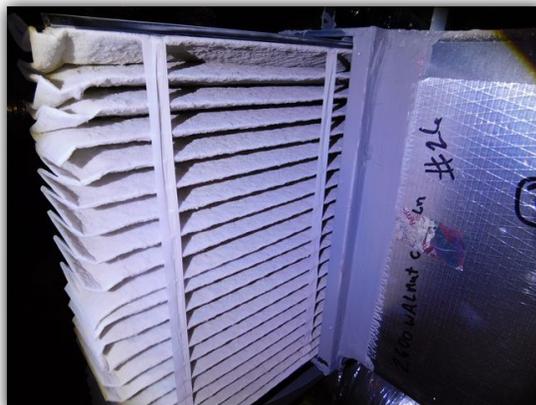
Dirty heating equipment air filters may not perform as intended and should be replaced as needed or per manufacturer instructions. Dirty heating equipment air filters may result in damage to the heating equipment.

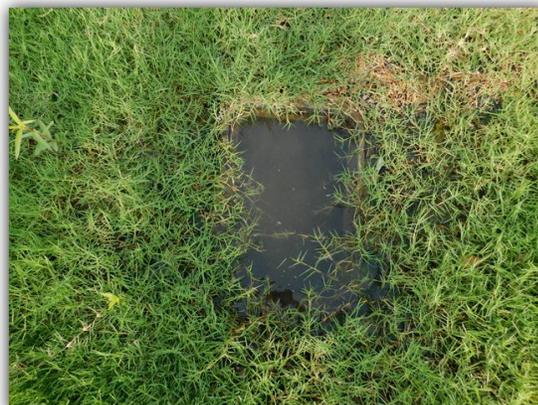
The water meter case/housing was full of water which prevented the inspector from evaluating the meter and or determining if there are any water leaks. The inspector recommends that the meter and plumbing system be further evaluated by the local authority and or a certified, licensed plumbing specialist.

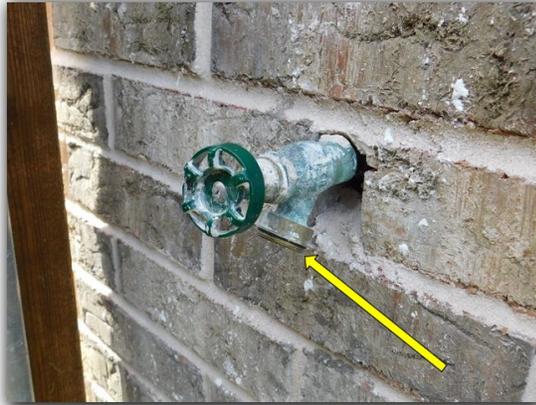
Damaged exterior water supply hose bibs were observed and should be repaired or replaced as needed.

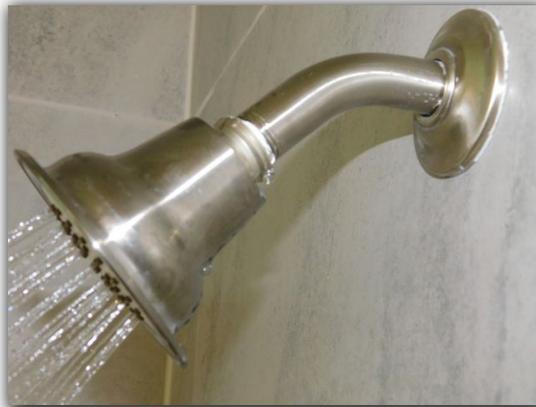
- Leaking showerhead fixtures should be repaired or replaced.

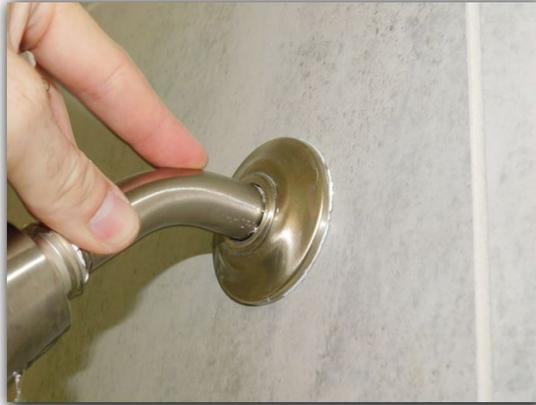
- The shower water supply plumbing was observed to be loose in the wall.

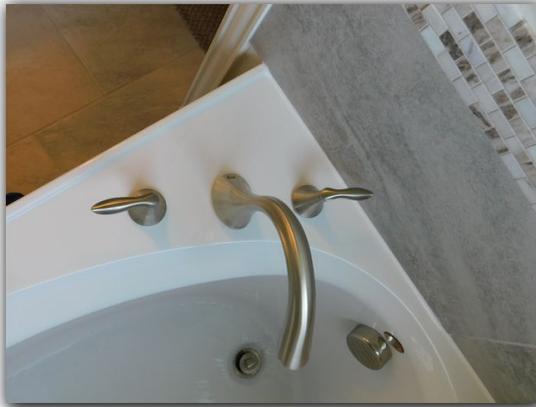
The temperature indicators were missing at the tub/shower water supply fixture. Missing temperature indicators are considered a SAFETY HAZARD. Tub/shower water supply fixture that are missing temperature indicators should be repaired or replaced.

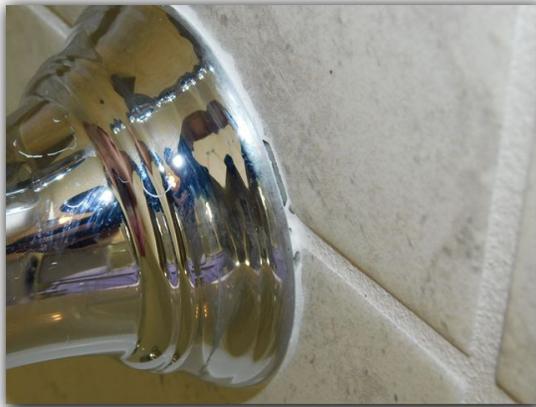
The tub/shower water supply fixtures lacked adequate sealant at the wall. Tub/shower water supply fixtures should be properly sealed at the wall to prevent water damage.

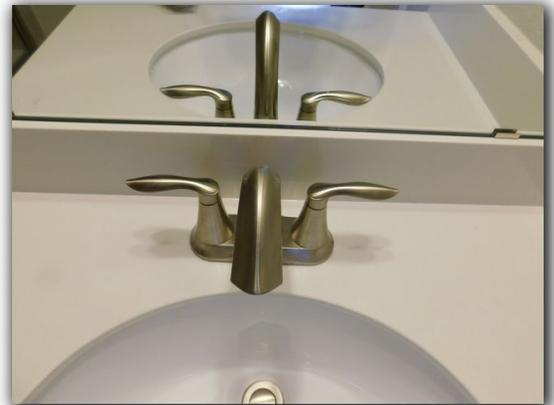
The temperature indicators are missing at the lavatory water supply fixture. Missing water temperature indicators is considered a SAFETY HAZARD.

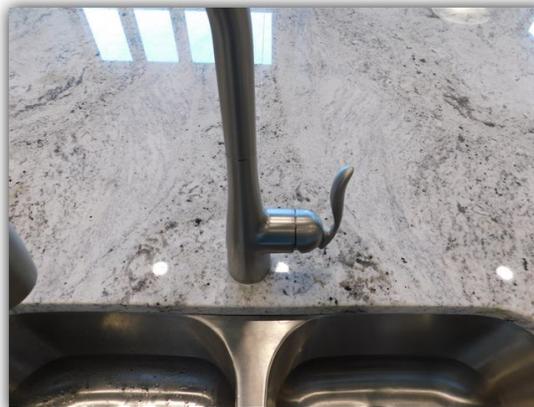
The temperature indicators are missing at the kitchen sink water supply fixture. Missing water supply temperature indicators are considered a SAFETY HAZARD.

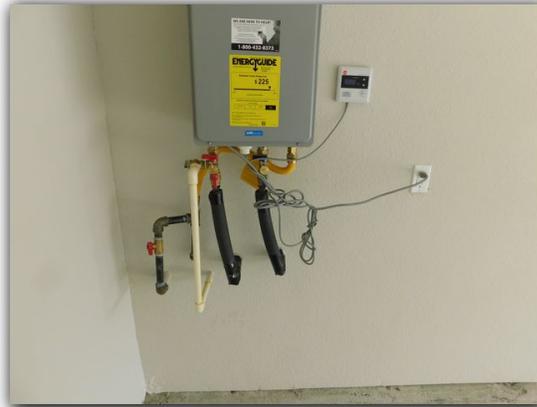
The water heating equipment was installed without an overflow pan. Current building standards state that all water heaters should be equipped with an overflow pan with a drain that drains to the exterior of the structure if leaks would cause damage.

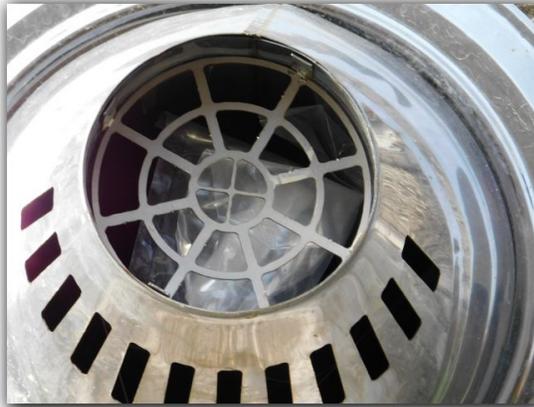
The gas-fired water heating equipment gas exhaust vent flu had debris in it. Debris in the gas exhaust flu was observed to be a SAFETY HAZARD and should be repaired prior to operation of the water heating equipment.

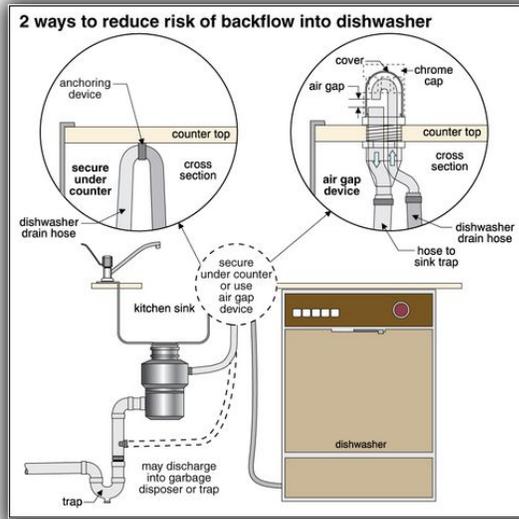
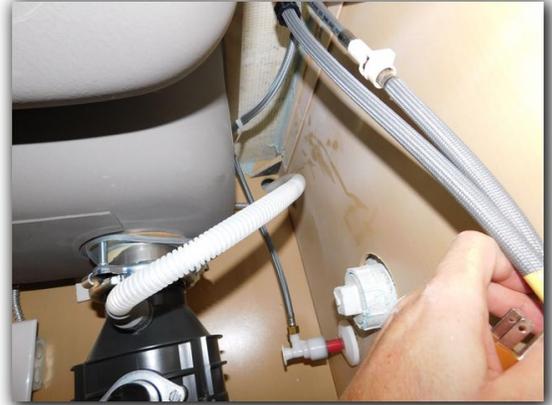
A visible anti-siphon loop or back flow prevention device was not installed at the dishwasher drain line. Some newer dishwashers may have built in anti-siphon devices that are not visible. The buyer is encouraged to consult the owner's manual or contact the manufacturer if an anti-siphon device is not visible. Lack of an anti-siphon device at a dishwasher is a SAFETY HAZARD.

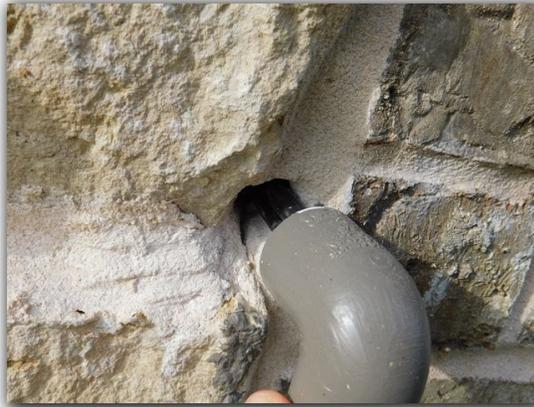
The landscape irrigation system electrical conduit needs to be sealed at the wall.

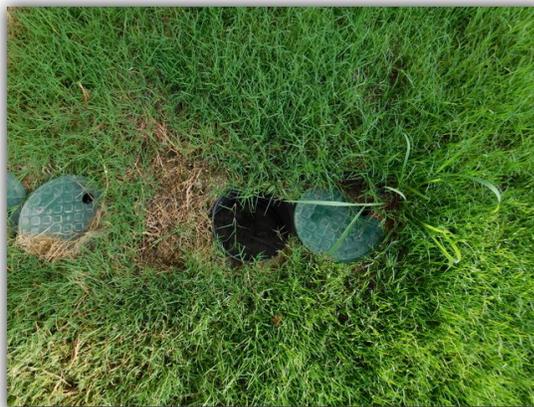
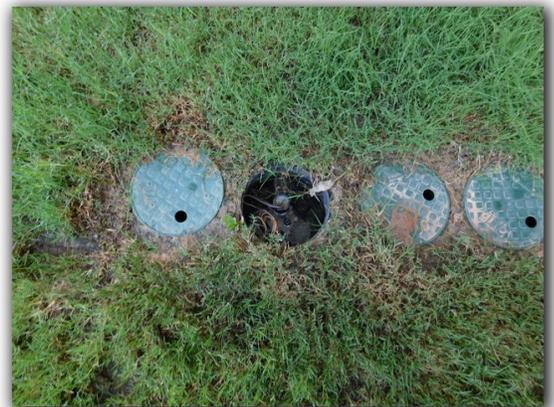
The landscape irrigation system had missing control covers that should be replaced.

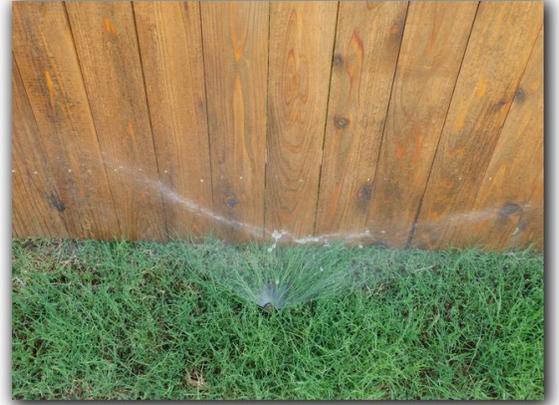
The landscape irrigation system sprinkler heads were observed to spray the structure or in unwanted directions and require repair, replacement or adjustment.
