# Fouries Home Inspection

COMPLETE HOME INSPECTION  
Prepared Exclusively For: First Name Last Name

Built in 1897  
(122 year old home), , TX,

Inspected by Paul Fourie, Lic.#: 22325 on 01/01/2019  
Phone: (972)989-2479, Email: paul@fourieshomeinspection.com

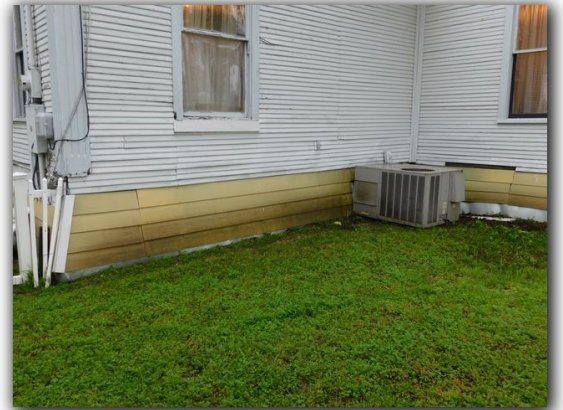
The crawl space was flooded in numerous areas.

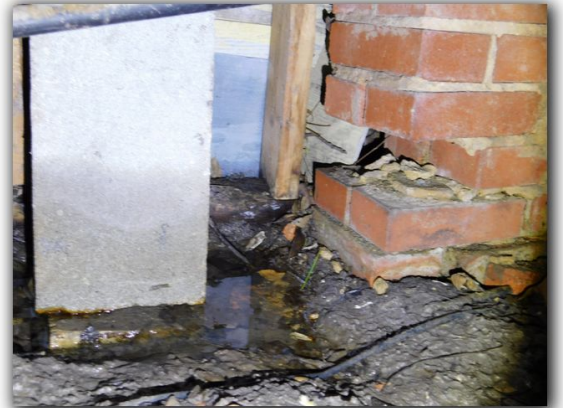
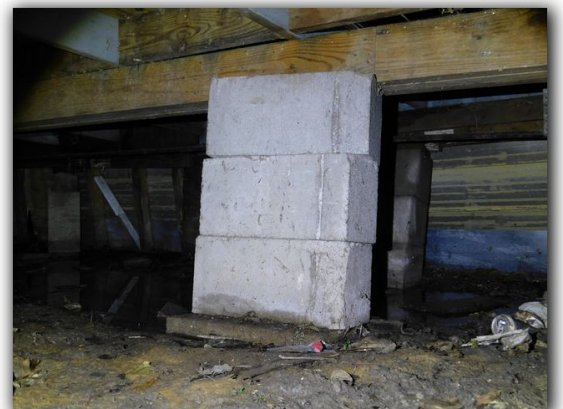
No subfloor insulation was installed in the crawl space between the floor joists. Subfloor insulation prevents moisture intrusion and energy loss through the living space flooring.

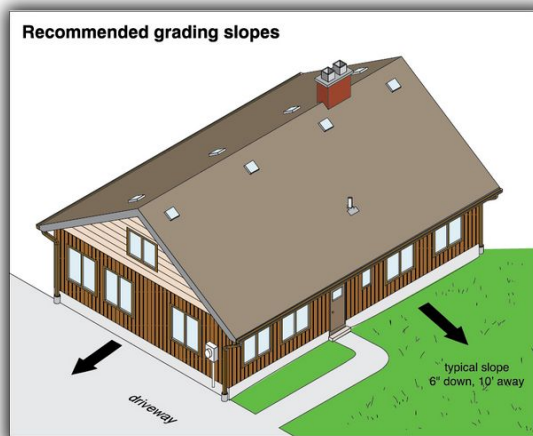
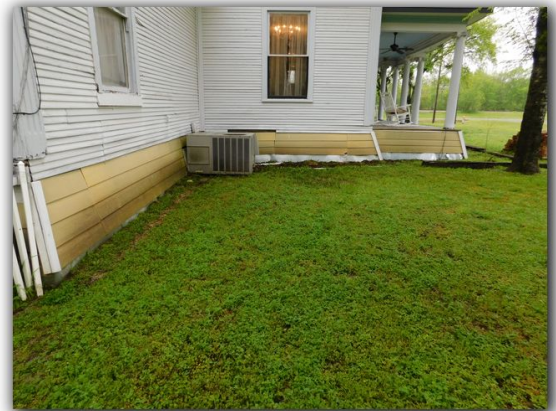
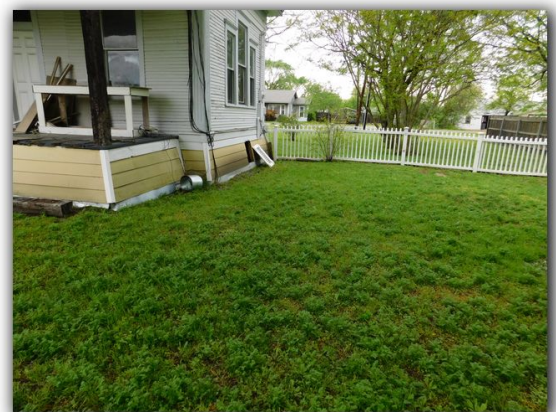
Inadequate grade slope away from the structure was observed. The recommended grade slope away from the structure is 6 inches per 10 feet. Improper grade slopes away from the structure create conducive conditions for water intrusion and inadequate foundation performance. Improper grade slope away from the structure is in need of repair.

Ponding next to the foundation was observed. Any area where the ground or grade does not slope away from the structure is to be considered an area of improper drainage. Corrective measures may be needed if the water stands within 10-feet of the foundation perimeter beam for more than 24-hours. Grading improvements are needed to direct run off water away from the structure. Recommended slope away from the foundation is 6 inches per 10 feet.

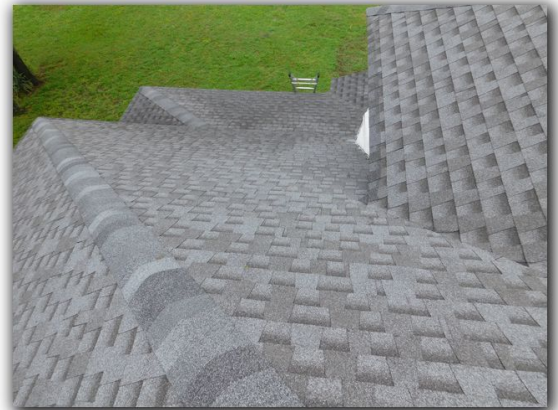
Inadequate clearance between exterior siding and roof covering materials was observed. There should be a space between the siding and roof covering. Space between the roof covering and siding provides proper ventilation and prevents water damage to the siding.

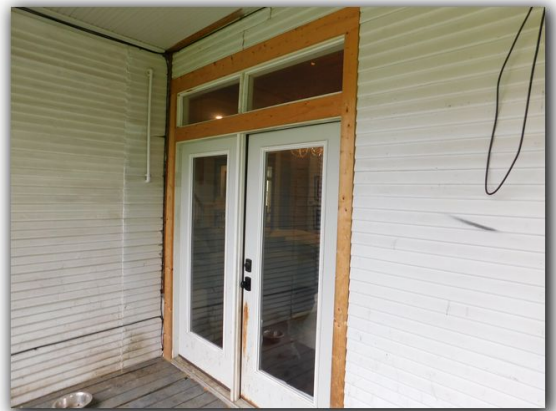
The exterior wood veneer siding was observed to have some deterioration and/or damage. Damaged and deteriorated exterior wooden siding should be repaired to prevent wall damage, moisture penetration and wood destroying insects.

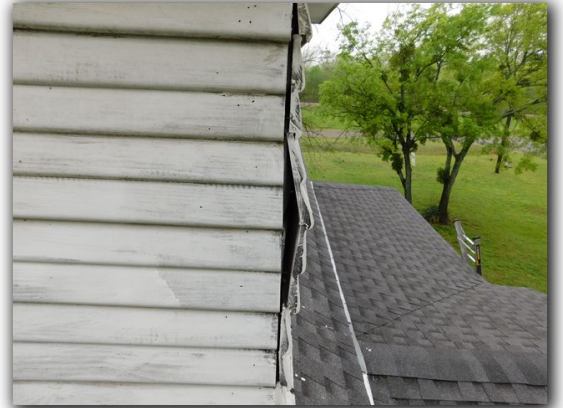
The exterior wood trim was observed to have some deterioration and/or damage. Damaged and deteriorated exterior wood trim should be repaired to prevent wall damage, moisture penetration and wood destroying insects.

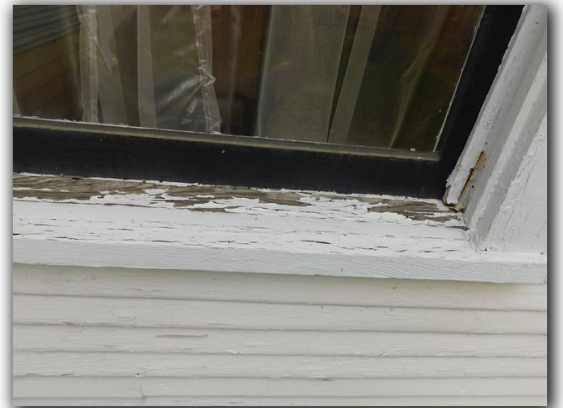
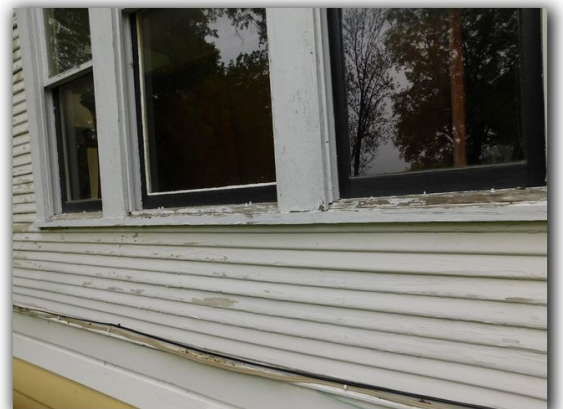
The exterior wood window casing and trim materials were observed to have some deterioration and/or damage. Damaged and deteriorated exterior wood window casing and trim should be repaired to prevent wall damage, moisture penetration and wood destroying insects.

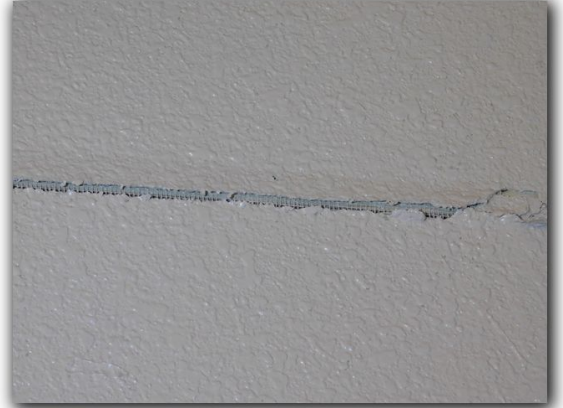
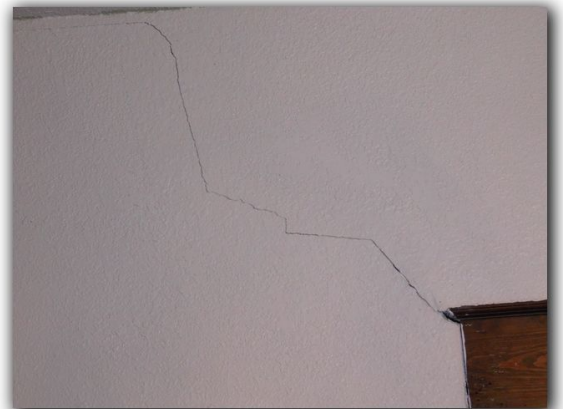
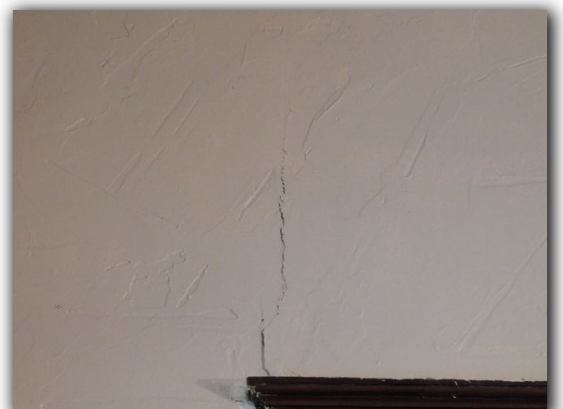
Multiple interior wall cracks were observed and were an indication of structural settling,

movement or other defects. The cause of any interior drywall, texture and paint wall cracks should be determined and repaired as needed and monitored over time for additional movement. Further evaluation of the foundation and structure by a certified, licensed foundation and structural specialist is recommended.

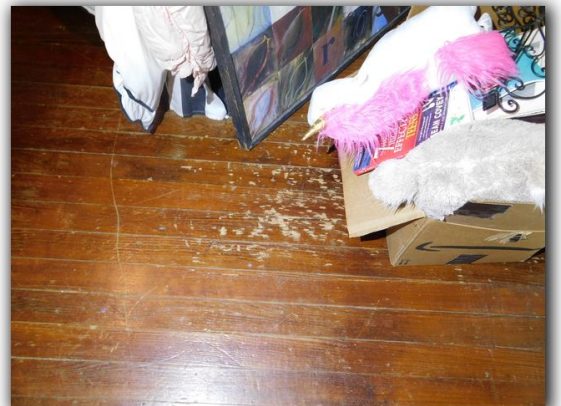
The floor covering was noticeably worn or damaged and was in need of cleaning, repair or replacement.

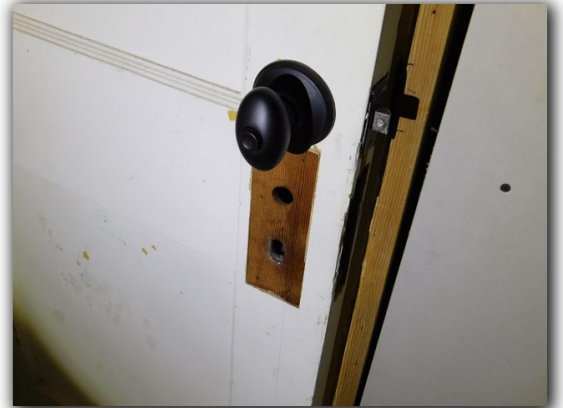
Deficient hardware was observed at interior doors and should be repaired or replaced.

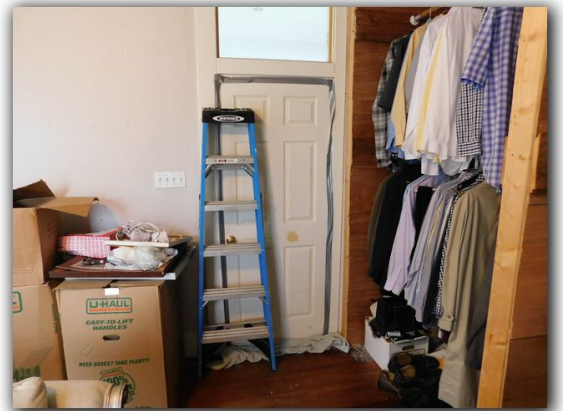
Damaged or missing exterior door weather stripping should be replaced. Missing or damage exterior door weather stripping creates conducive conditions for moisture intrusion and conditioned air loss.

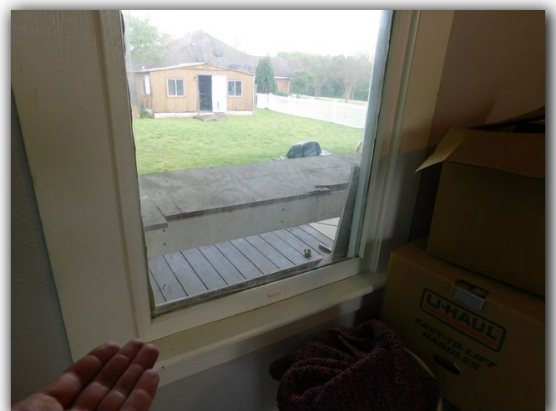
One or more of the bedroom windows have been painted shut. At least one window in each bedroom should open fully, with free access to the outdoors. Lack of an operable window in each bedroom is a FIRE SAFETY HAZARD and should be repaired prior to being occupied.

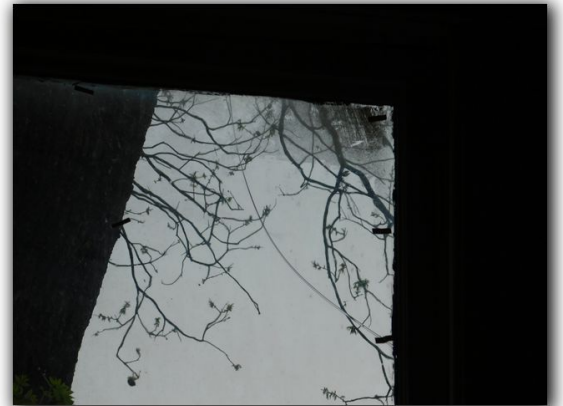
Cracked and/or broken window glass was observed. Cracked or broken window glass may allow discoloration of the window glass, allow moisture intrusion, contribute to the loss of conditioned air. Cracked or broken window glass may be a SAFETY HAZARD and should be replaced as needed.

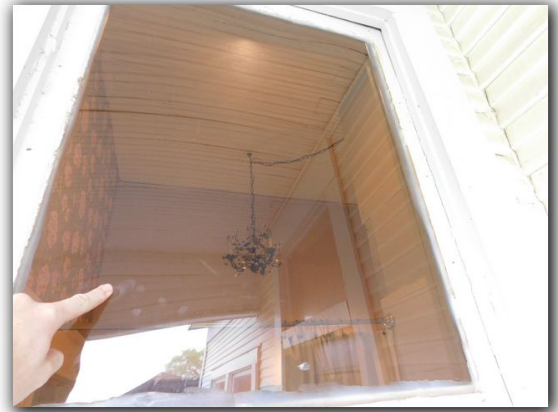
Windows were observed to be acrylic. Acrylic window screens should be replaced.

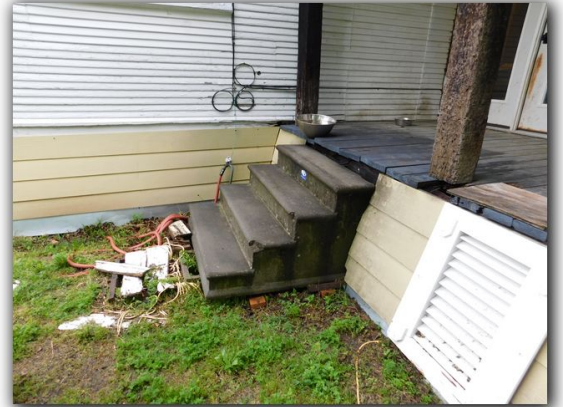
No handrail was installed for stairs or steps with 4 or more risers. For improved safety, a handrail should be installed at all stairs and steps with 4 or more risers. Lack of properly installed stairway handrails is a SAFETY HAZARD.

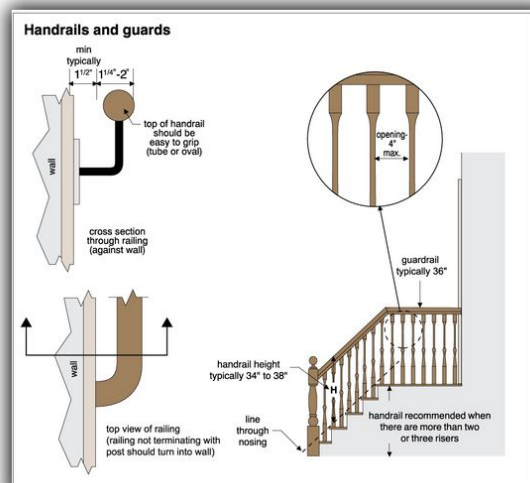
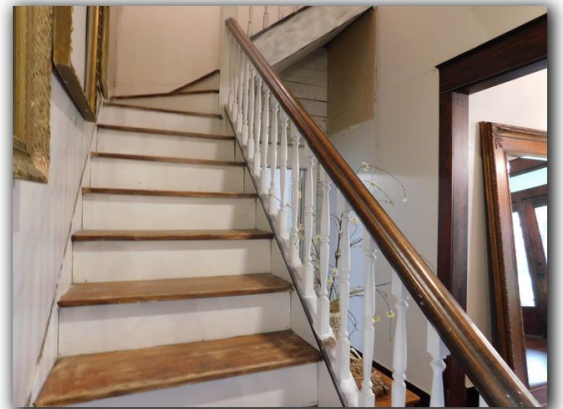
The stairway handrail height was observed to be inadequate and was a SAFETY HAZARD. Under current building standards, the stairway handrail height should be 34"-36" and should be corrected prior to closing.

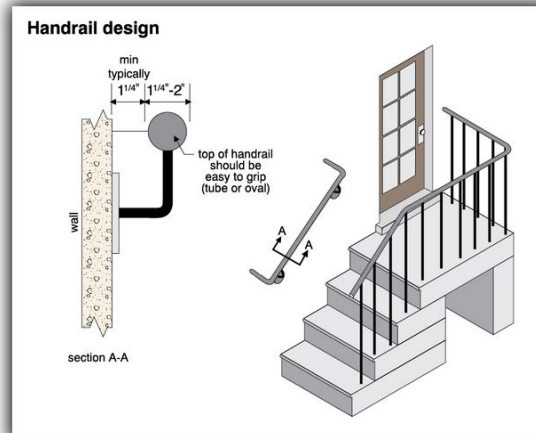
☑ The stairway handrail grip was observed to be inadequate. Stairway handrails should be graspable. Current building standards state that the stairway handrail grip should not be larger than 2". Stairway handrails that are not graspable are a SAFETY HAZARD.

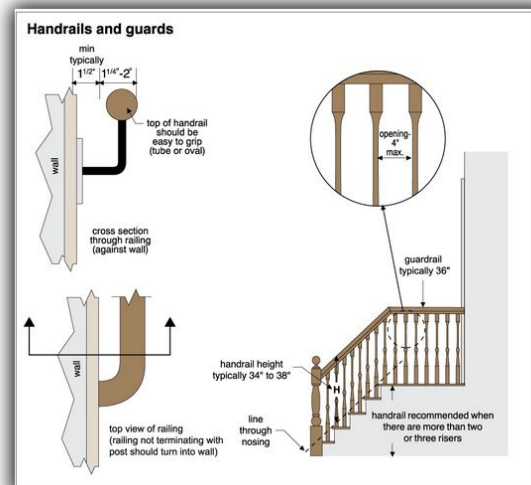
☑ The stairway guard balusters and/or spindles were installed to far apart and were observed to be a SAFETY HAZARD. Under current building standards, stairway guard balusters or spindles should not allow passage of any object greater than 4". This condition should be repaired prior to closing for reasons of safety.

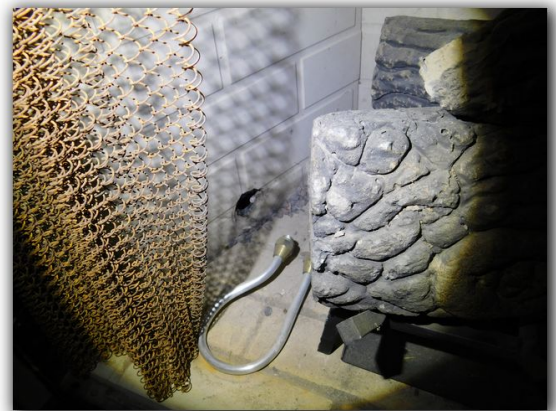
Gas fireplace equipment that is not vented to the exterior of the structure is a SAFETY HAZARD. Improperly vented gas heating equipment may allow carbon monoxide or other vapors to accumulate in the living area.

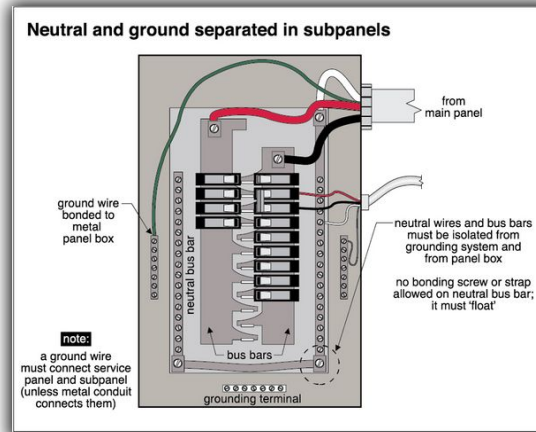
☑ Neutral electrical conductors were observed to be “double tapped” on the neutral bus bar in the electric service panel. Each neutral electrical conductor in the electric service panel should terminate individually unless the terminals are made for more than one conductor. Double tapped neutral electrical conductors should be further evaluated and repaired as needed by a qualified electrical specialist.

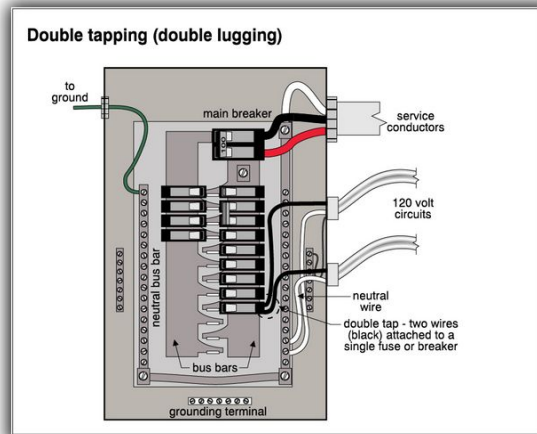
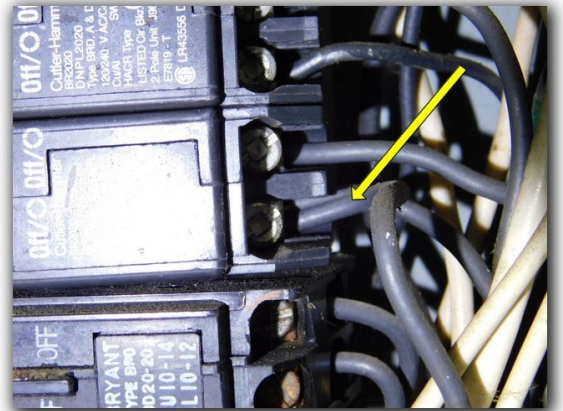
☑ Double tapped breakers / fuses were observed to be a SAFETY HAZARD in the electric service panel. Each breaker should provide electric service to only one circuit. The inspector recommends that the electric service panel be further evaluated and repaired or replaced as needed by a certified, licensed electrician.

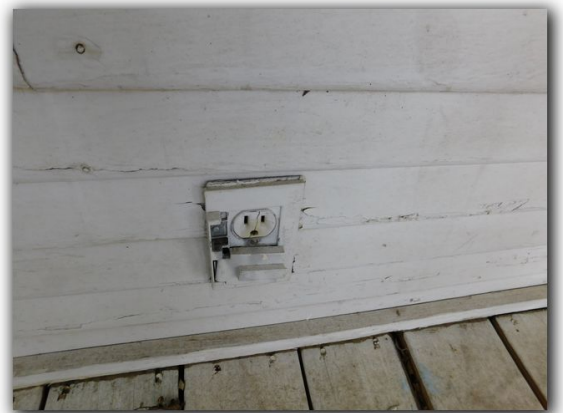
Exterior electrical receptacles in wet locations were observed to lack weather tight bubble covers. Lack of weather proof bubble covers at electrical receptacles in wet locations is a SAFETY HAZARD and should be repaired by a certified, licensed electrical specialist.

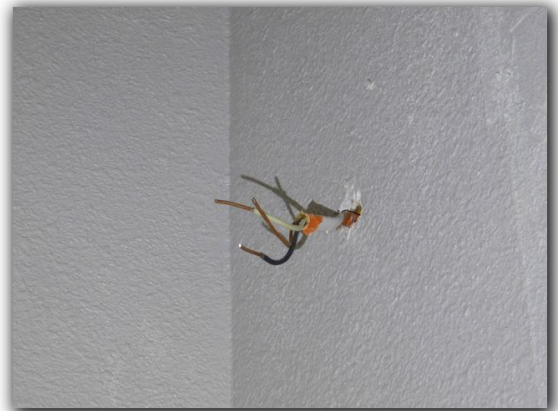
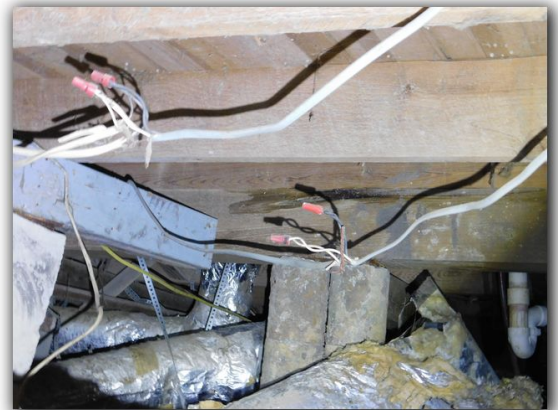
Improperly terminated electrical conductors were observed. All electrical conductor connections should be installed in sealed junction boxes for reasons of safety. Improperly terminated electrical conductors should be repaired by a certified, licensed electrical specialist.

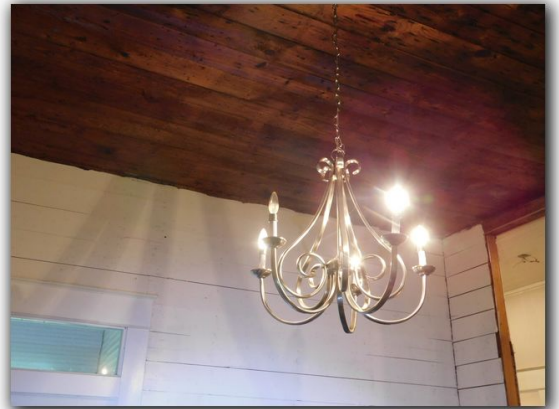
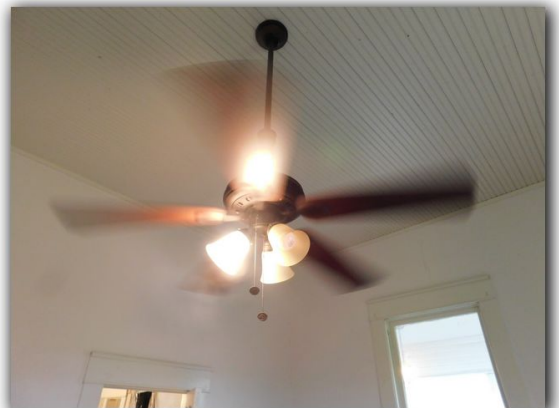
Light fixtures that are inoperative, missing bulbs or have burned out bulbs should be repaired or replaced as needed.
