Fouries Home Inspection

NEW HOME INSPECTION
Prepared Exclusively For: Buyer Name

Any Street, Irving, TX, 75063

PROPERTY INSPECTION REPORT

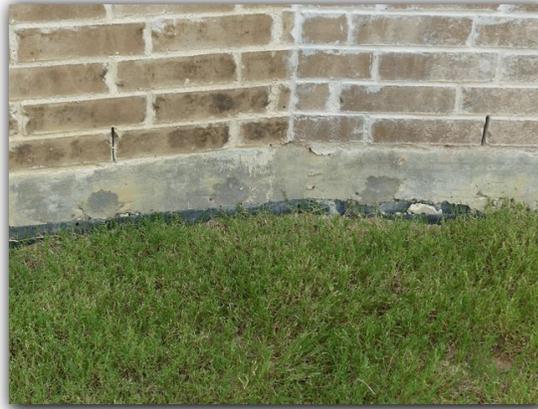
Cracks and damage were observed in the cosmetic skim coat covering the foundation slab. Cracks in the cosmetic skim coat should be repaired. Moisture penetration may allow further deterioration of the cosmetic skim coat.

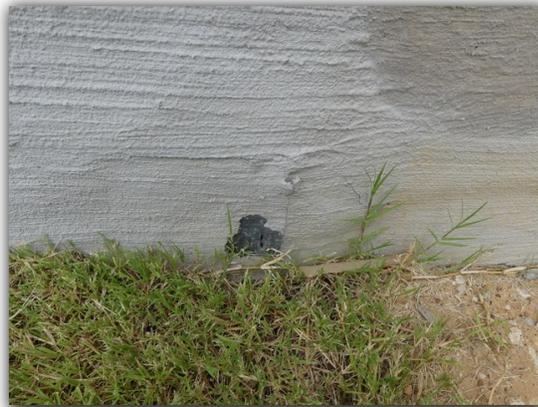
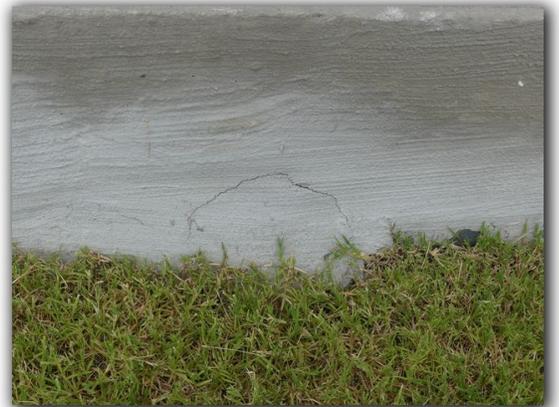
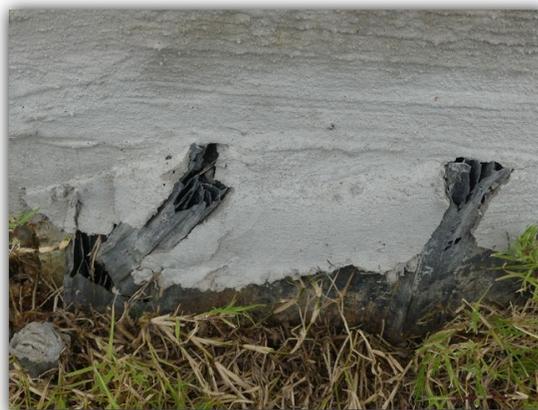
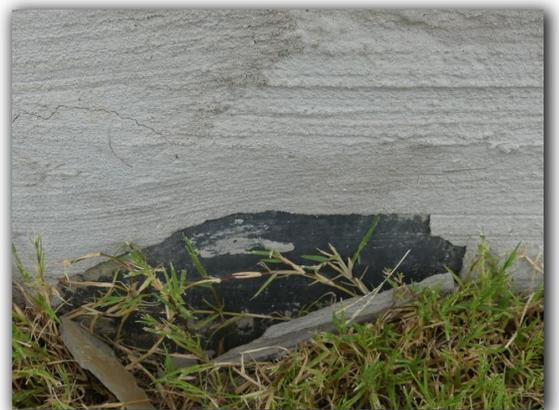
Foundation slab corners have been sheared off (corner pop). This is a common condition in slab on grade foundations and should be repaired. Repairing corner pops is recommended to prevent moisture and wood destroying insect penetration.

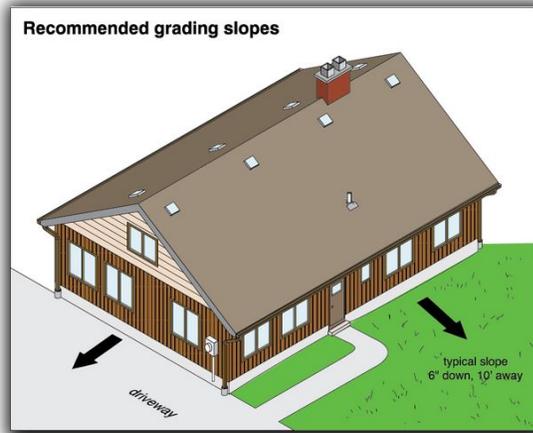
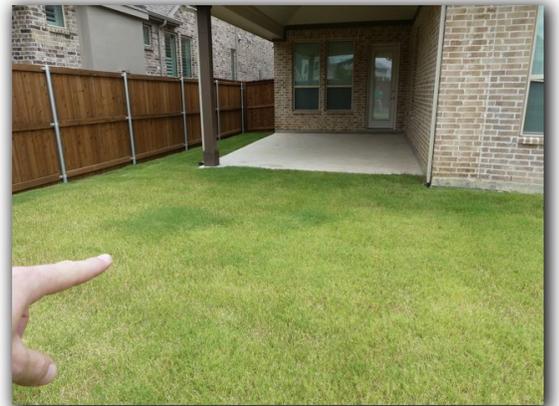
Inadequate grade slope away from the structure was observed. The recommended grade slope away from the structure is 6 inches per 10 feet. Improper grade slopes away from the structure create conducive conditions for water intrusion and inadequate foundation performance. Improper grade slope away from the structure is in need of repair.

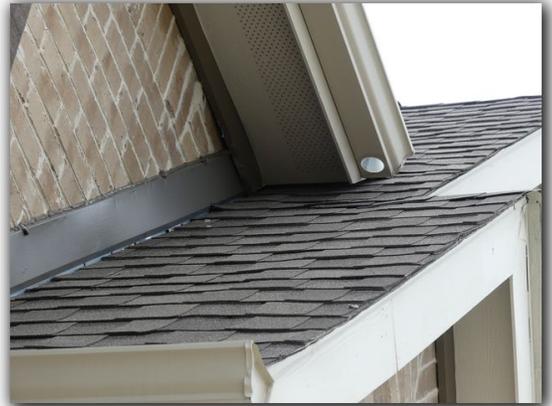
The secondary roof rain gutter lacks a downspout. Lack of a downspout at secondary roof rain gutters may allow localized deterioration and premature wear of the roof covering materials.

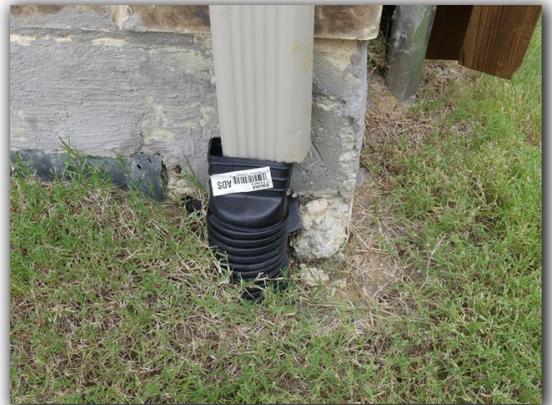
Damaged or improperly installed rain gutters and downspouts should be repaired. Damaged or leaking rain gutters and downspouts create conducive conditions for siding deterioration, soffit/eave damage, roof covering damage, water penetration and inadequate grade drainage.

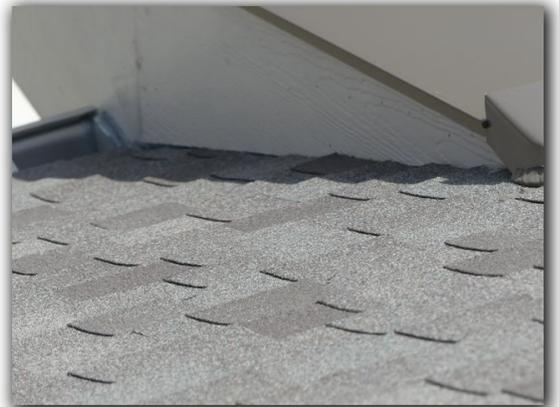
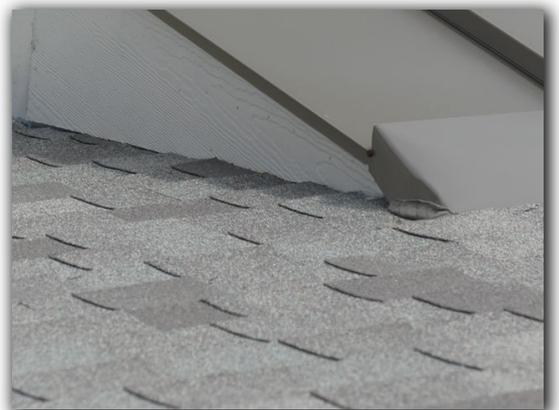
Inadequate clearance between exterior siding and roof covering materials was observed. There should be a space between the siding and roof covering. Space between the roof covering and siding provides proper ventilation and prevents water damage to the siding.

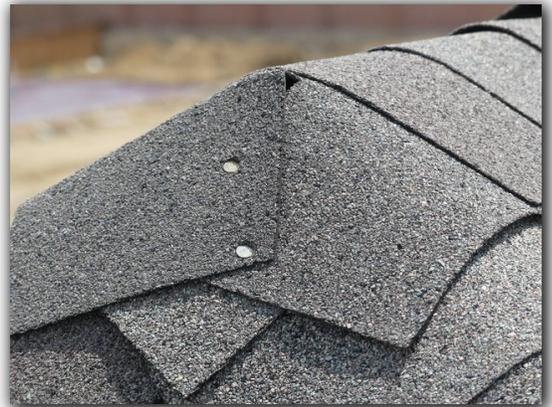
Roof covering drip edge and flashings were observed to be missing, damaged or improperly installed and were in need of repair or replacement. Missing, damaged or improperly installed flashings may allow water penetration.

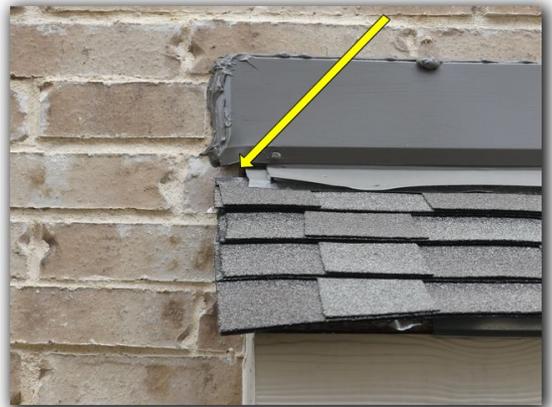
Current construction standards require a kick out flashing at the roof coverings and wall intersections. Kick out flashings prevent water leaks, damage and discoloration to walls.

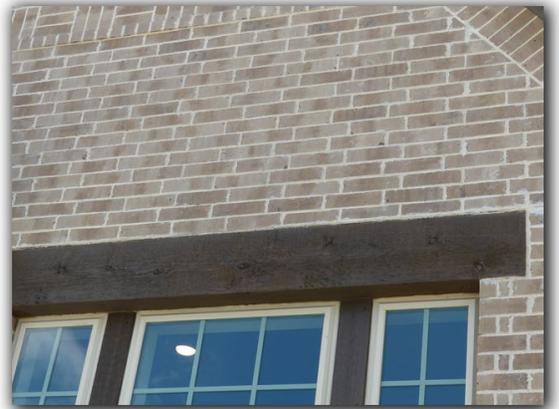
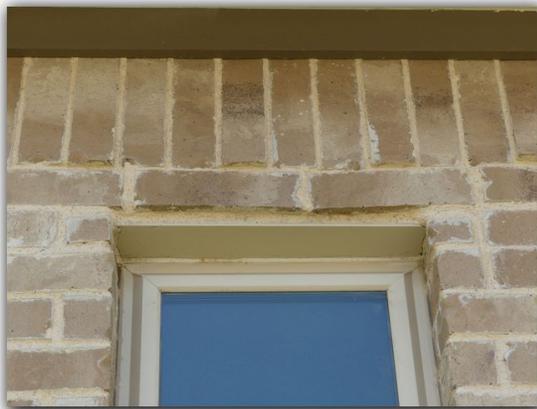
Weep holes were not installed in the brick/stone masonry above the windows in required locations. Under current building standards, weep holes should be installed in the brick/stone masonry above windows to provide proper wall ventilation.

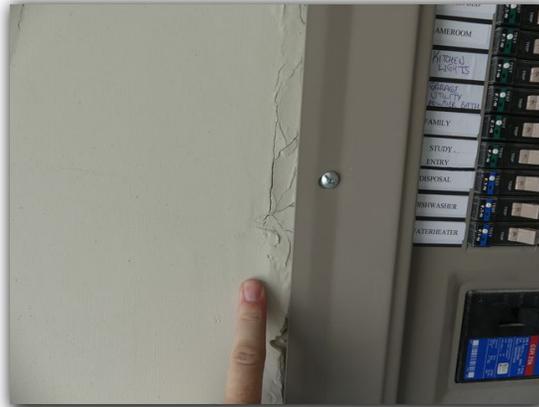
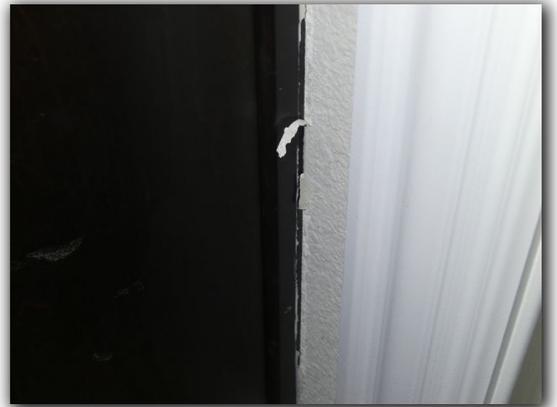
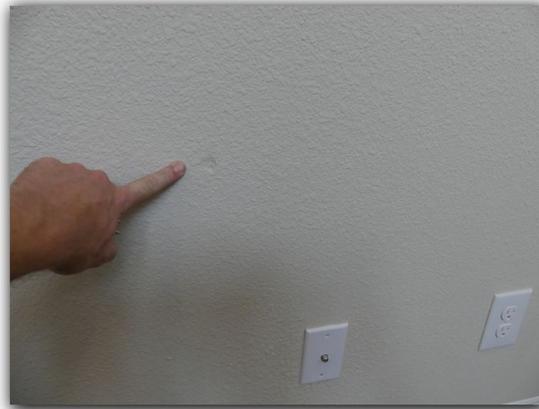
Cosmetic damages to interior wall coverings, drywall, texture and paint were observed to be in need of repair.

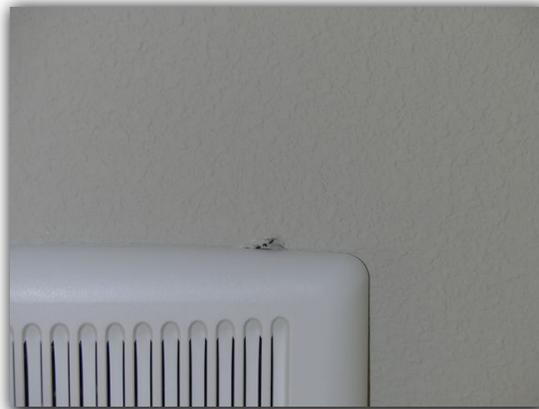
- Cosmetic damages to ceiling drywall, texture and paint should be repaired.

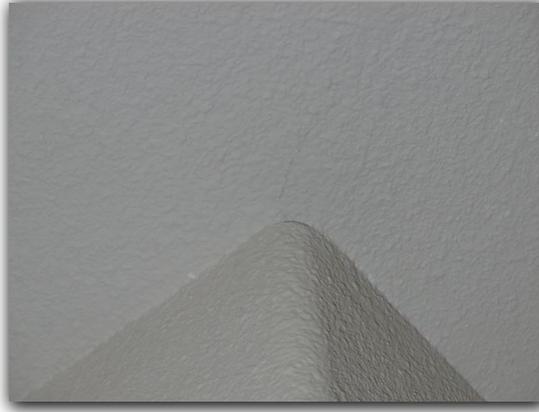
- At least one interior ceiling crack was observed which is an indication of structural settling,

movement or other defects. Ceiling drywall, texture and paint cracks should be repaired and monitored over time for additional movement. If concerns about the foundation performance exist, the inspector recommends further evaluation by a certified, licensed foundation specialist.

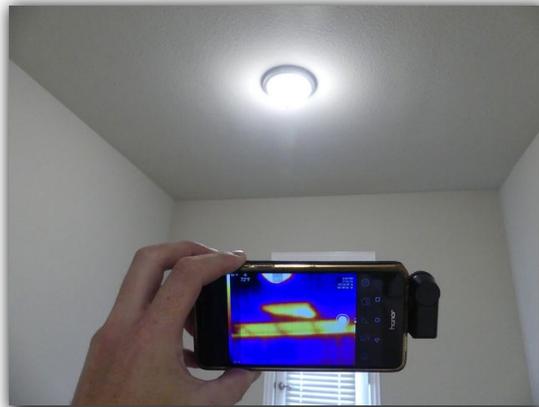
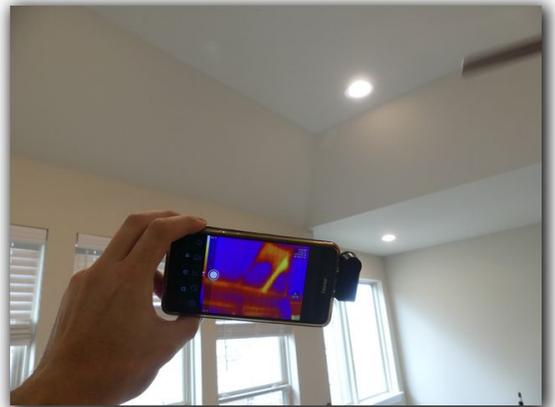
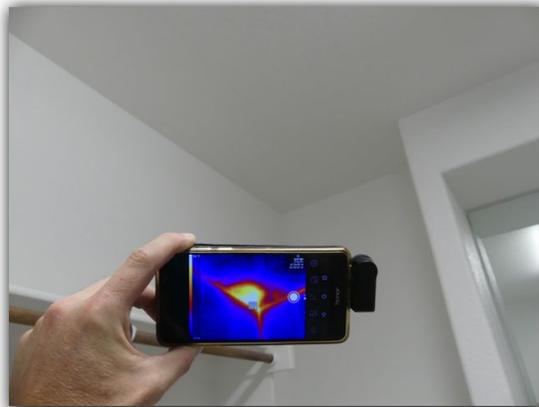
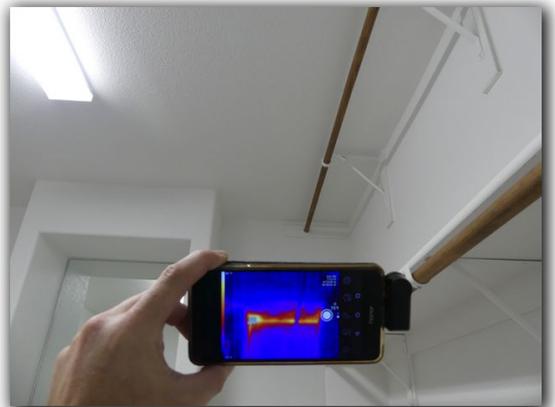
Using a thermal imaging camera, there are areas of temperature anomalies in the ceilings which may be indication of missing or damaged insulation. The reason for the temperature anomalies should be further evaluated and repaired as needed.

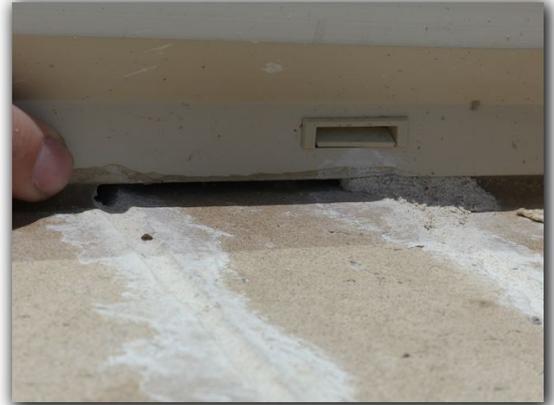
The windows need sealant between the window frames and interior wall cladding. Lack of, damaged or deteriorating sealant around window frames should be repaired as needed.

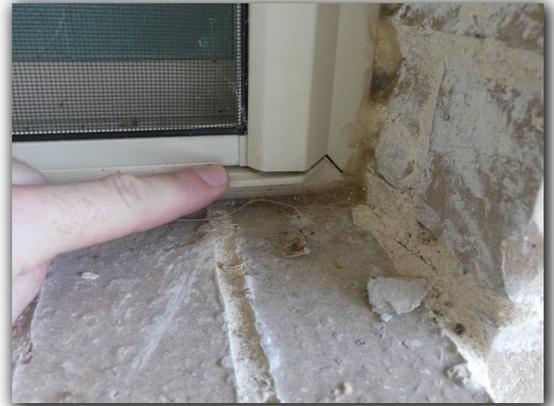
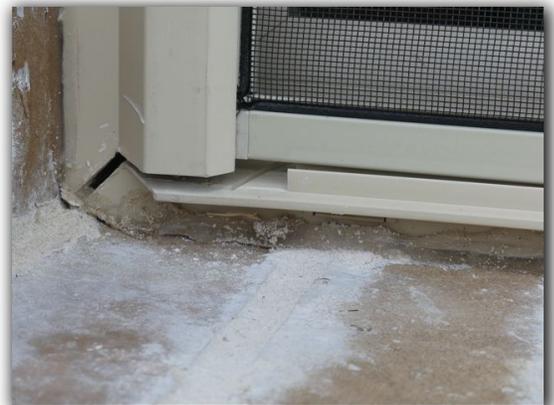
The window frames were observed to be damaged. Damaged windows may allow moisture penetration, conditioned air loss and insect penetration and should be repaired.

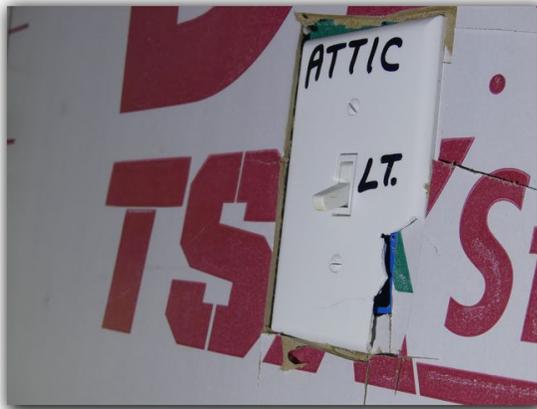
Electrical receptacles, switches and or covers were observed to be loose, damaged, missing or missing screws and were in need of repair. Damaged or missing electrical receptacles or switches should be repaired by a certified, licensed electrical specialist.

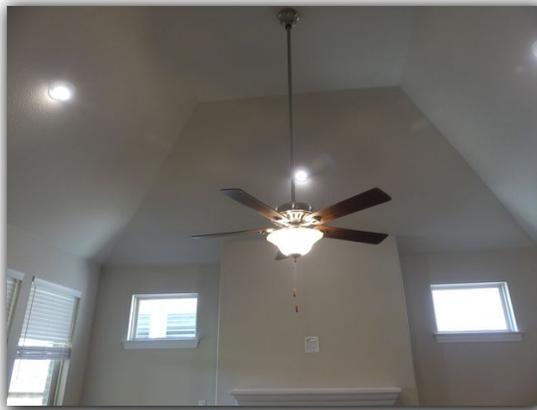
Inoperative ceiling fans were observed to be in need of repair or replacement.

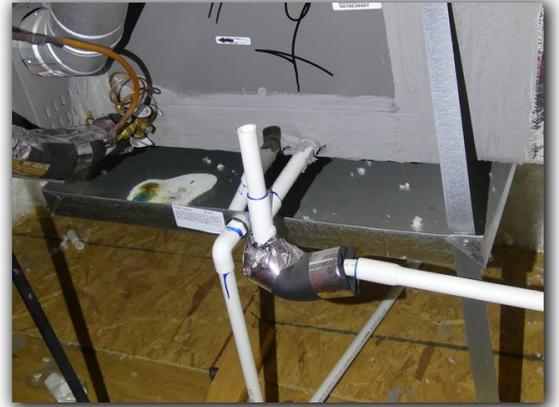
The cooling equipment condensation overflow pan or drain lines installed above ceilings were not equipped with water or moisture sensors/alarms. Cooling equipment condensation drain pans or drain line sensors and alarms should be installed at cooling equipment installed above ceilings for additional protection against water damage.

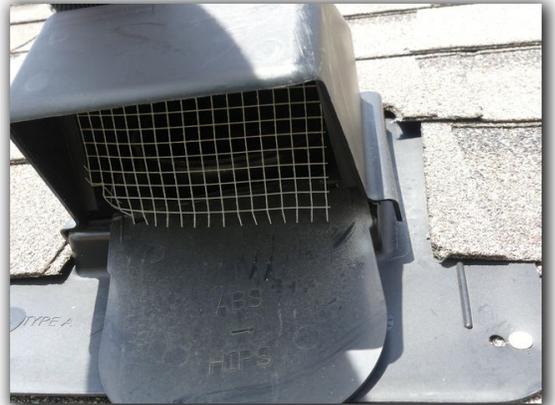
- Damaged mechanical exhaust vent covers should be replaced.

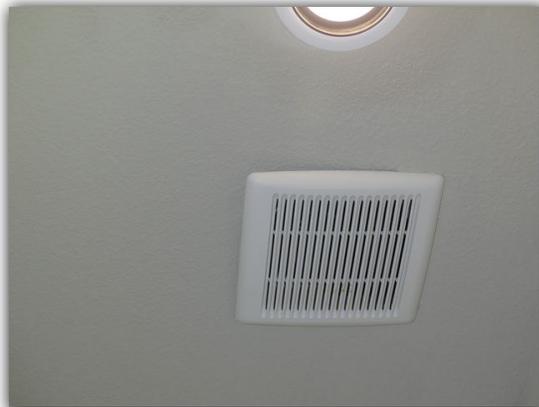
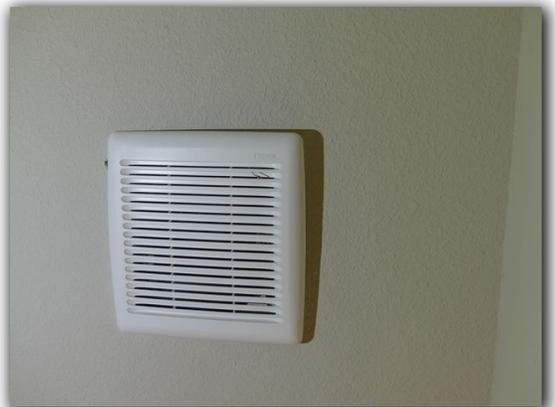
- Loose mechanical exhaust vents covers at the ceiling should be repaired.
