# Fouries Home Inspection

1 YEAR WARRANTY HOME INSPECTION  
Prepared Exclusively For: Buyer Name

Any Street, Prosper, TX, 75078

## PROPERTY INSPECTION REPORT

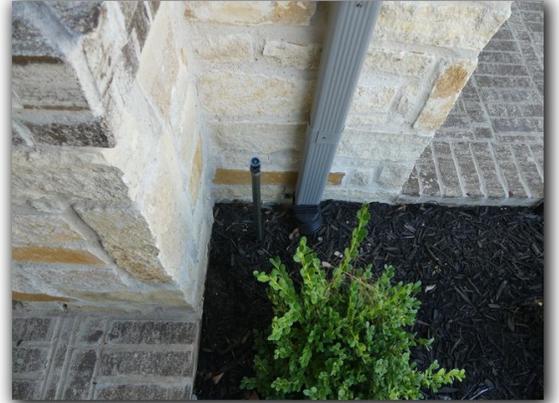
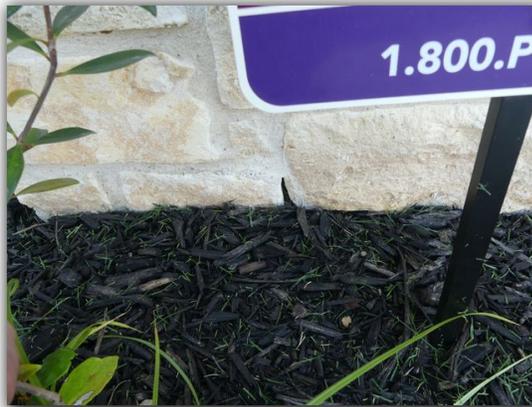
High soil levels were observed at the foundation/brick line. 4 to 6 inches of the foundation perimeter beam should be visible. High soil levels may block weep holes and prevent proper wall ventilation. High soil levels create conducive conditions for wood destroying insects and water intrusion. High soil levels prevent the inspector from observing the foundation perimeter beam.

Correction of inadequate grading clearance to exterior wall and foundation surfaces is recommended.

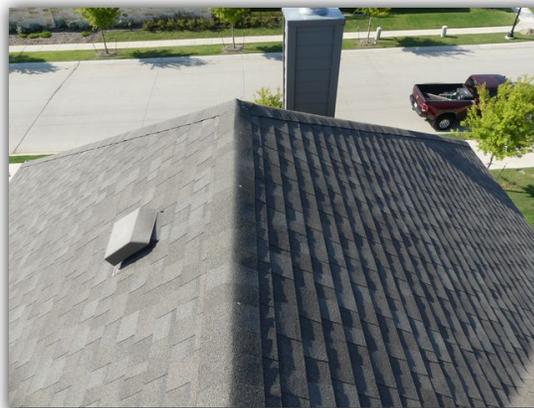
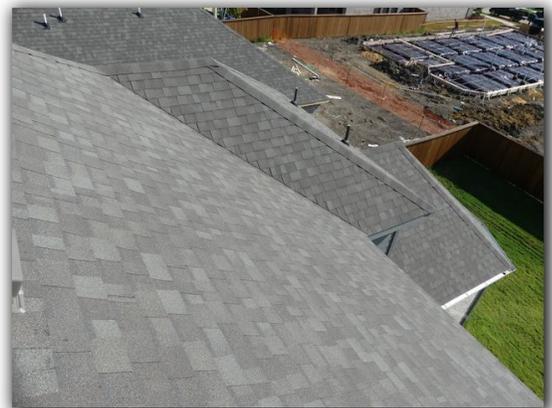
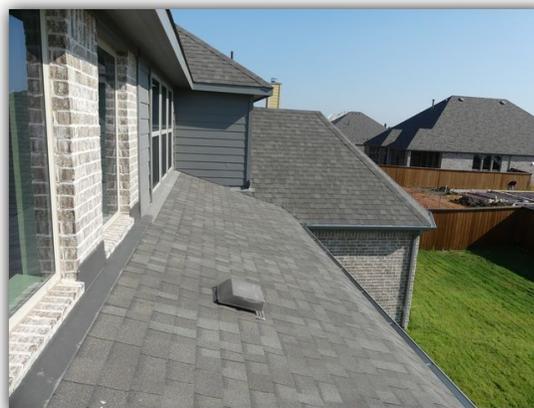
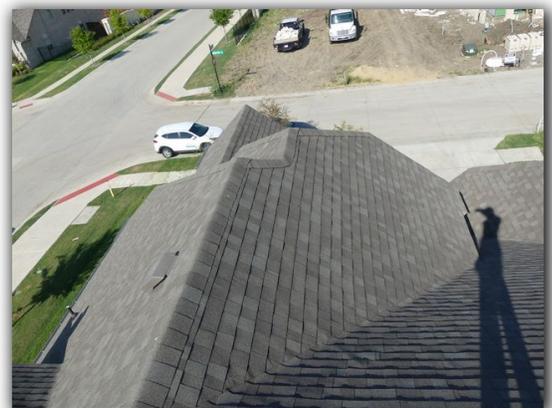
There were indications of impact damage on the roof covering. Impact damaged roof covering shingles may allow further deterioration of the roof covering, deterioration of the roof structure,

water penetration or other damage.

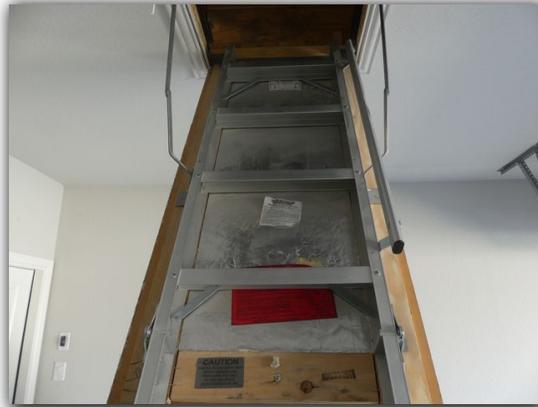
The attic access stair in the vehicle storage area (garage) was not fire rated (SAFETY HAZARD).

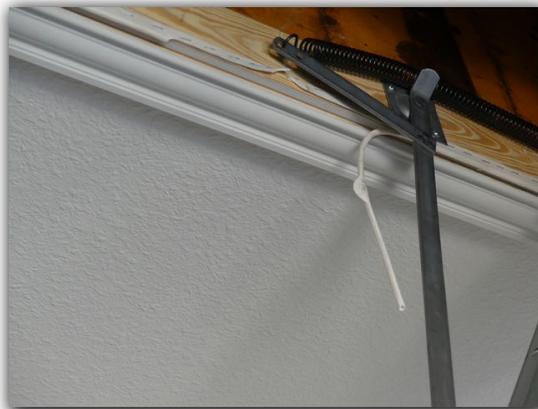
The attic access stair in the vehicle storage area (garage) weatherstripping was missing or damaged and was not fire rated and may allow vehicle storage area vapors to penetrate the attic and/or living area (SAFETY HAZARD).

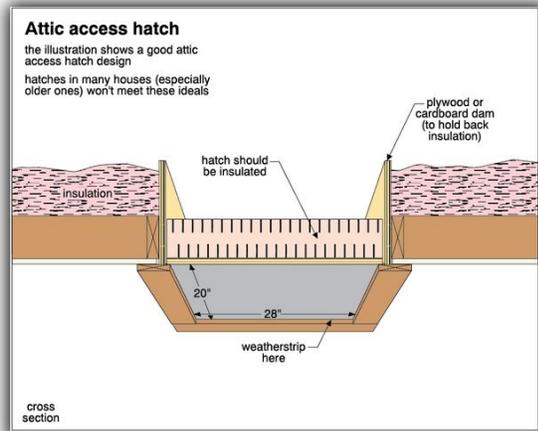
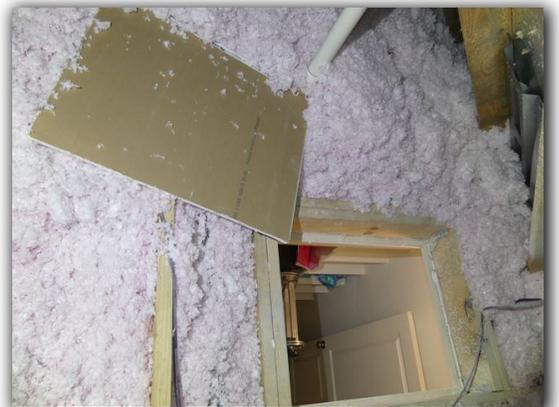
Access doors from conditioned spaces to unconditioned spaces such as attics should be weather stripped and insulated to a level equivalent to the insulation on the surrounding surfaces. A wood framed or equivalent baffle or retainer should be installed when loose fill insulation is installed to assist in maintaining a consistent R-value.

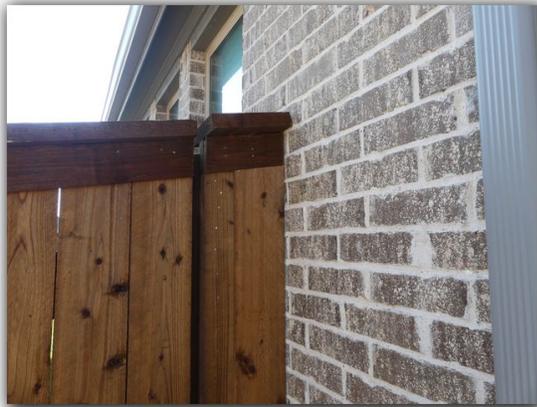
Wood fencing in contact with the structure creates conducive conditions for wood destroying insects. Wood fencing materials should be trimmed back so as not to be in contact with the exterior wall surfaces.

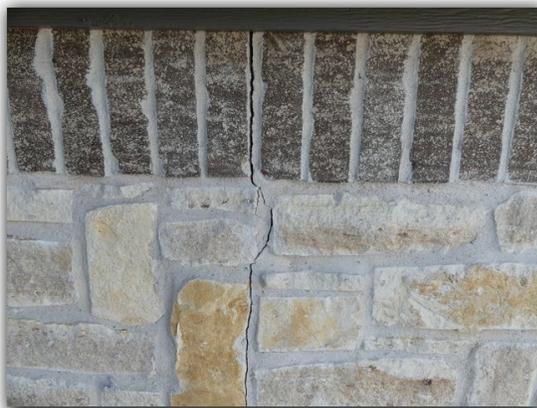
One or more cracks were observed at the exterior brick/stone veneer masonry walls. Cracks in exterior brick/stone veneer wall cladding are indications that some movement or settlement has occurred. The inspector recommends that cracks in exterior walls be repaired and closely monitored. If concerns about the current or future foundation performance exist, the inspector recommends further evaluation by a certified, licensed foundation specialist.

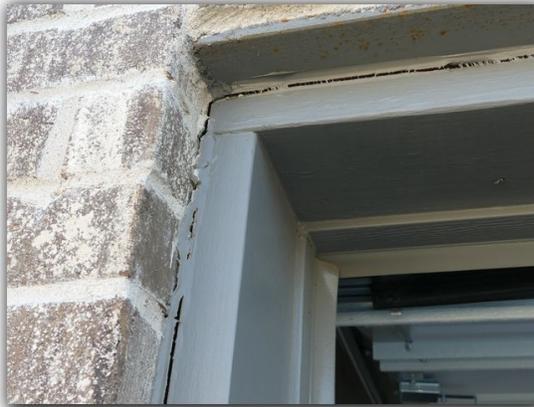
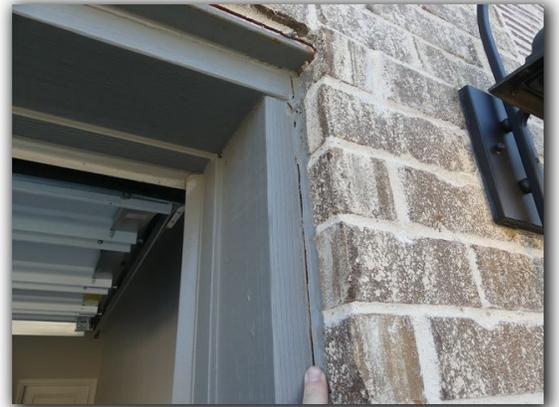
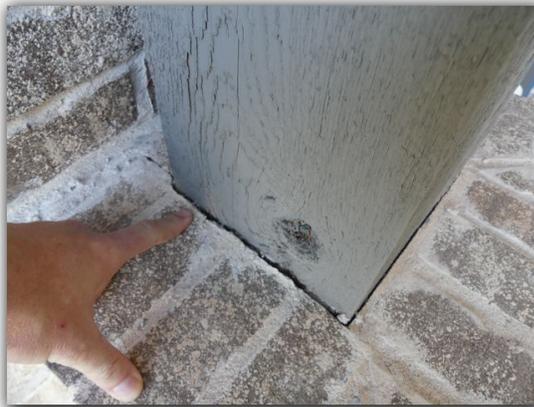
Exterior sealants (caulking) were deteriorated or missing in some areas. Sealants applied in appropriate locations prevents moisture intrusion and insect penetration.

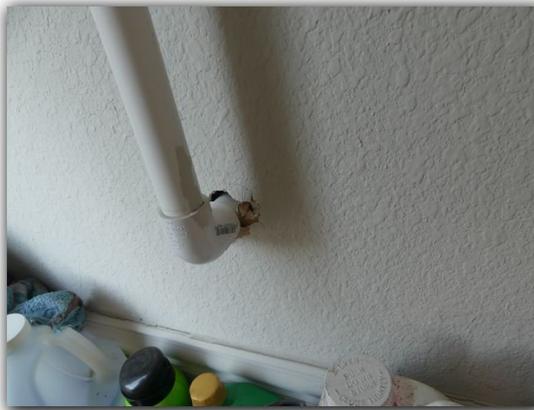
Cosmetic damages to interior wall coverings, drywall, texture and paint were observed to be in need of repair.

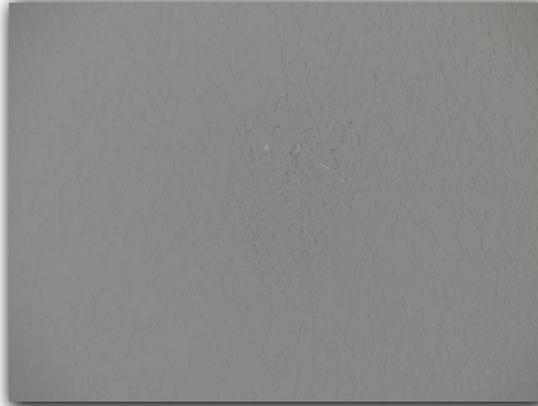
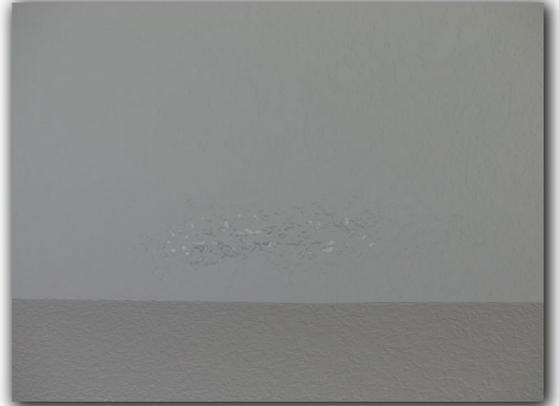
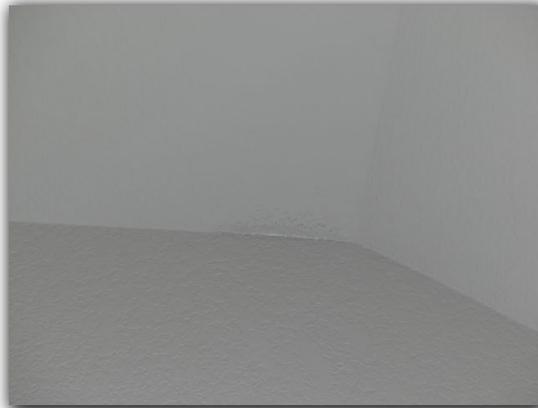
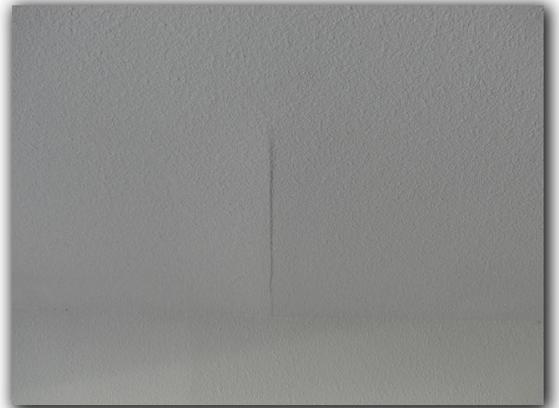
Cosmetic damages to ceiling drywall, texture and paint should be repaired.

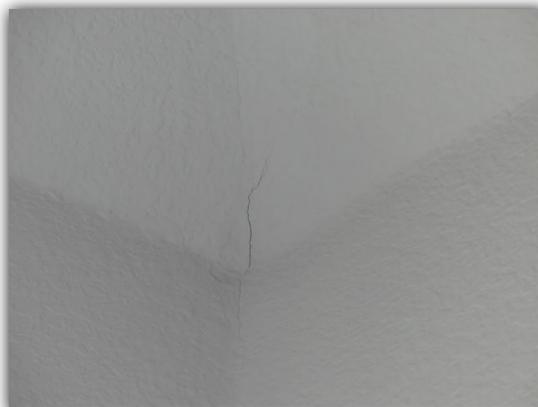
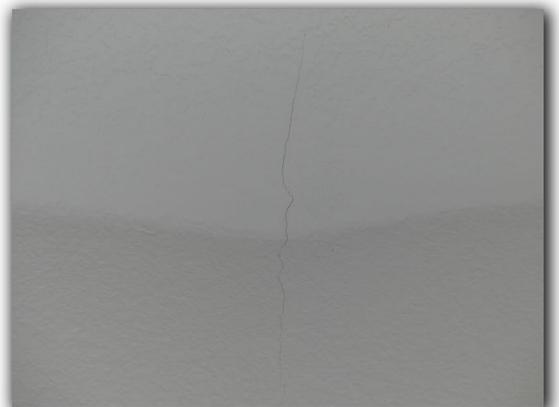
Cracks in ceilings were an indication of movement, settlement or other defects (See Ceilings).

Several interior ceiling cracks were observed which is an indication of structural settling, movement or other defects. Ceiling drywall, texture and paint cracks should be repaired and monitored over time for additional movement.

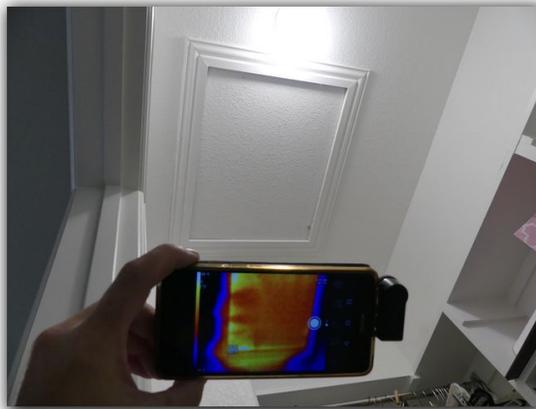
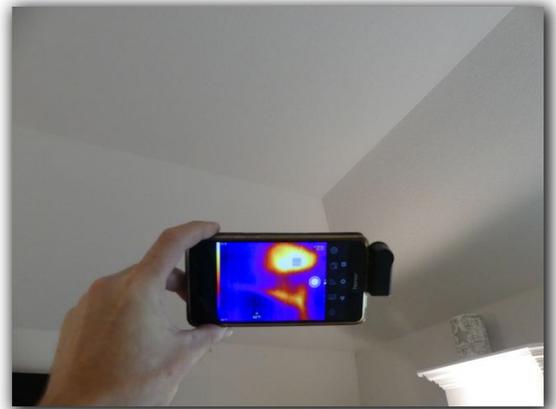
Using a thermal imaging camera, there are areas of temperature anomalies in the ceilings which may be indication of missing or damaged insulation. The reason for the temperature anomalies should be further evaluated and repaired as needed.

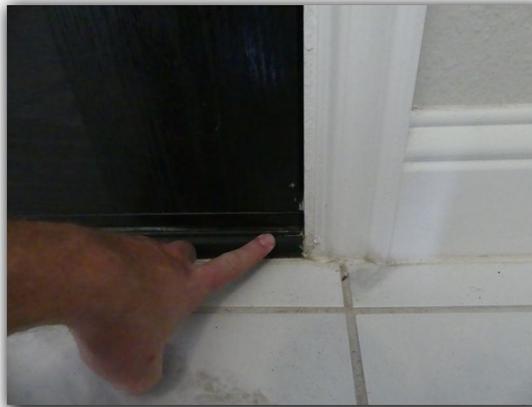
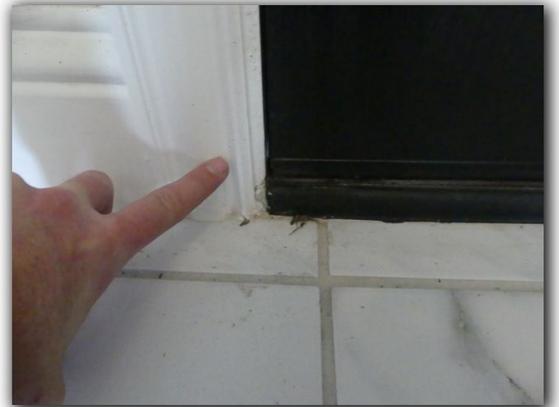
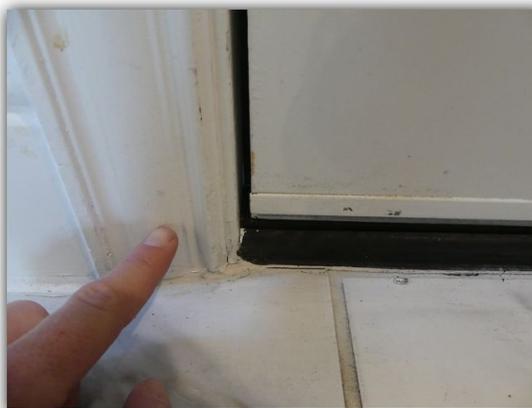
Damaged or missing exterior door weather stripping should be replaced. Missing or damage exterior door weather stripping creates conducive conditions for moisture intrusion and conditioned air loss.

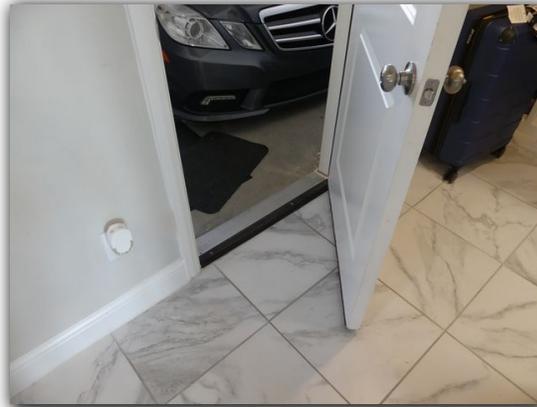
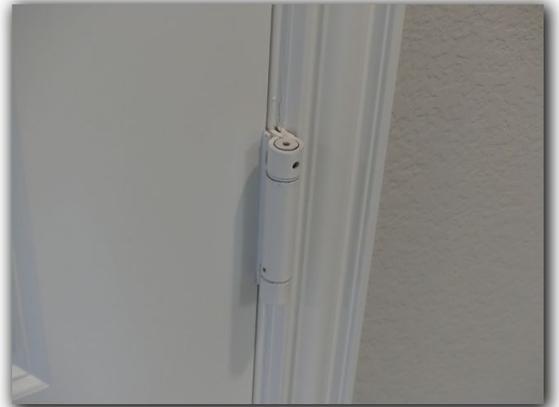
Garage entry doors should have installed operational self closing hinges according to today's Texas Standards of Practice. Per Texas Standards of Practice we are required to report this condition as a deficiency because it is no longer an excepted building standard.

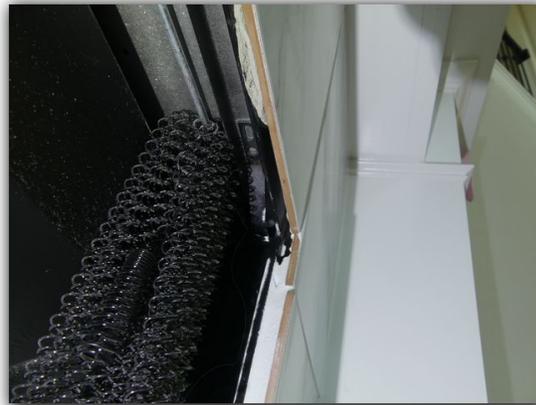
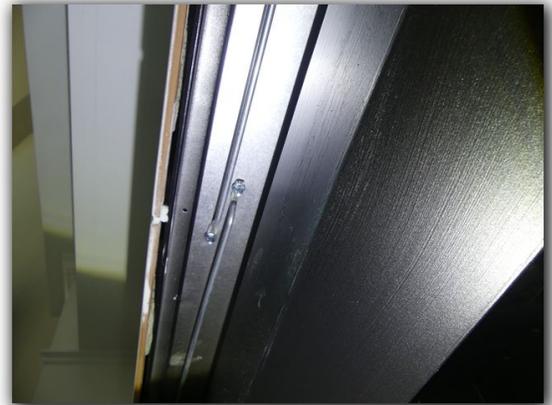
The fireplace firebox was not sealed at the hearth or lintel and was a SAFETY HAZARD. Inadequate fireplace seals may allow heat to transfer to flammable materials and is a SAFETY HAZARD that should be repaired by a qualified fireplace specialist.

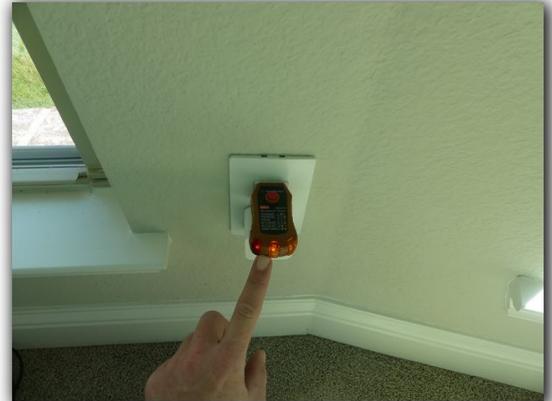
Reversed polarity connections (i.e. it is wired backwards) were observed at electrical receptacles. Reversed polarity at electrical receptacles is a SAFETY HAZARD and may cause damage to modern electric appliances. The cause of reversed polarity at electrical receptacles should be determined and repaired or replaced as needed by a certified, licensed electrical specialist.

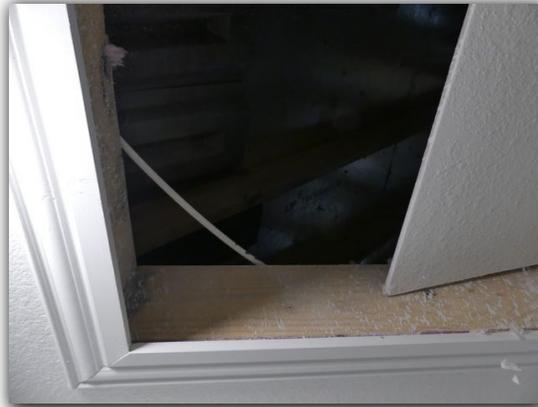
Electrical conductors or other unsecured wires were routed across the attic access and are a SAFETY HAZARD. Electrical conductors or other unsecured wires crossing the attic access should be repaired by a certified, licensed electrical specialist.

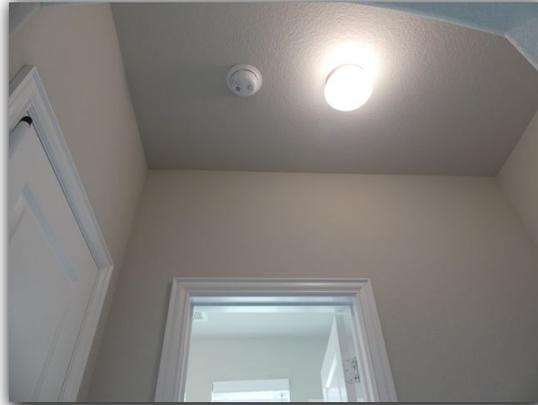
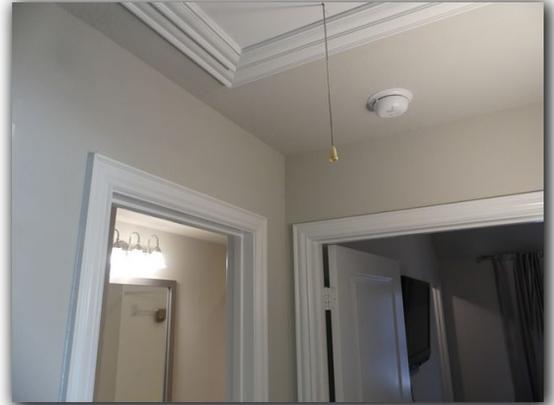
There was a smoke alarm installed within 3' of a bathroom door. Under current building standards, smoke alarms should be more than 3' from a bathroom door opening.

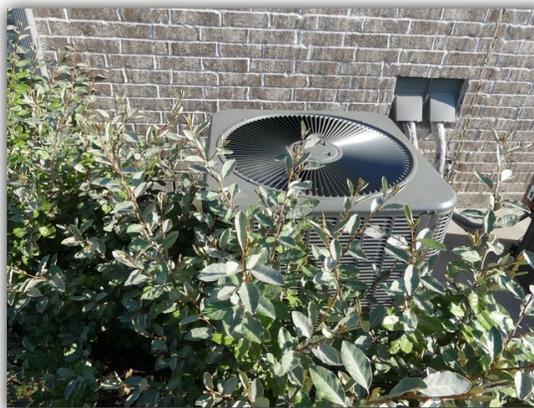
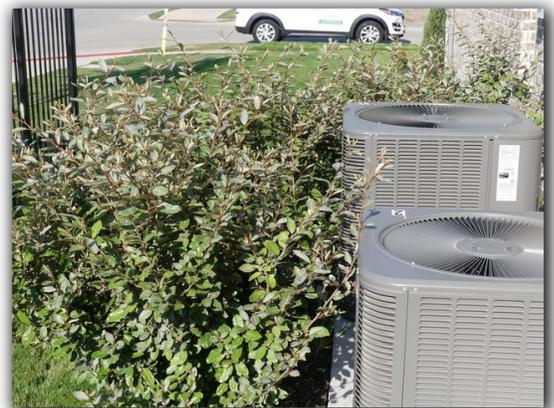
The heavy foliage at and around the outside condenser/coils should be trimmed back a minimum of 18-inches for proper air circulation. Lack of adequate air flow at the exterior HVAC equipment may result in equipment damage, inadequate performance, reduced equipment life or other defects.

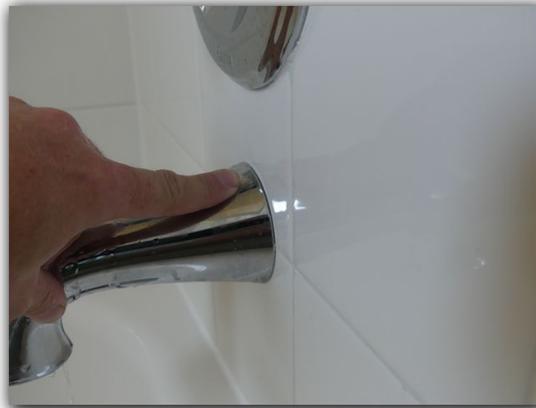
- The tub/shower water supply fixtures lacked adequate sealant at the wall. Tub/shower water supply fixtures should be properly sealed at the wall to prevent water damage.

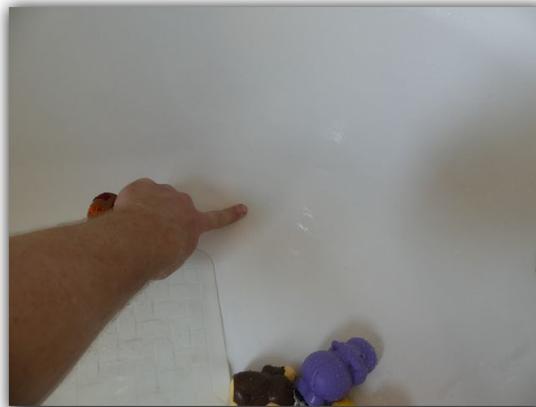
- Surface damage to one or more bathtubs was observed.

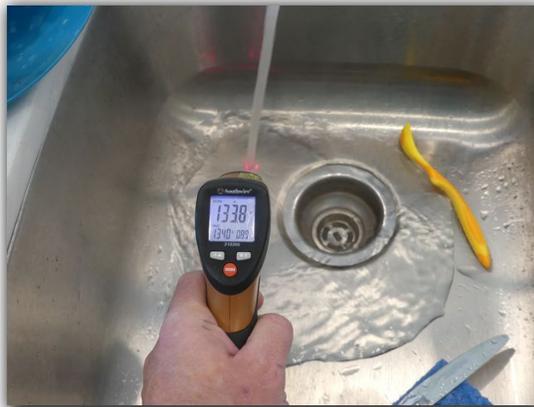
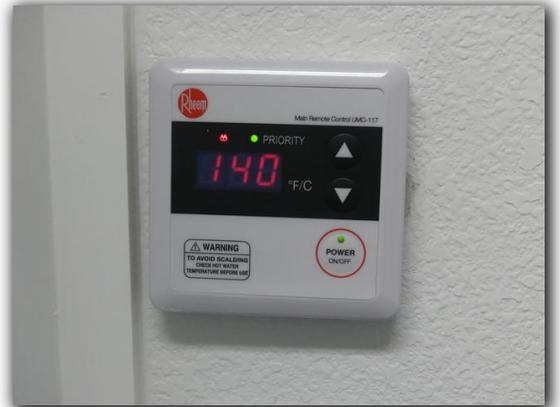
Heated Water Temperature ( 133.8 °F ):

Heated water temperature was observed to be greater than 120 degrees Fahrenheit F and was a SAFETY HAZARD. Adequate and safe heated water temperatures are considered to be between 100 degrees and less than 120 degrees Fahrenheit. The cause of improper heated water temperature should be determined and should be corrected as needed. The water heater thermostats may be turned up too high or there may be other defects in the water heating equipment.

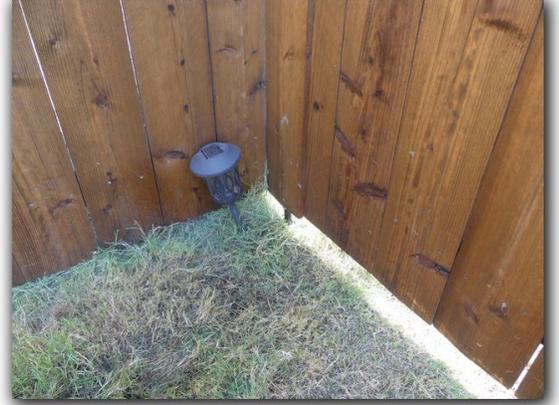
- The landscape irrigation system had misplaced heads that should be replaced.
