Fouries Home Inspection

COMPLETE HOME INSPECTION
Prepared Exclusively For: Buyer Name

Any Street, Grand Prairie, TX, 75052

Inspected by Paul Fourie, Lic.#: 22325 on 08/26/2019
Phone: (972)989-2479, Email: paul@fourieshomeinspection.com

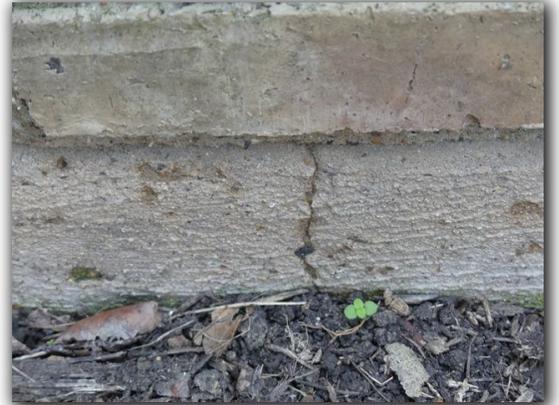
Foundation slab corners have been sheared off (corner pop). This is a common condition in slab on grade foundations and should be repaired. Repairing corner pops is recommended to prevent moisture and wood destroying insect penetration.

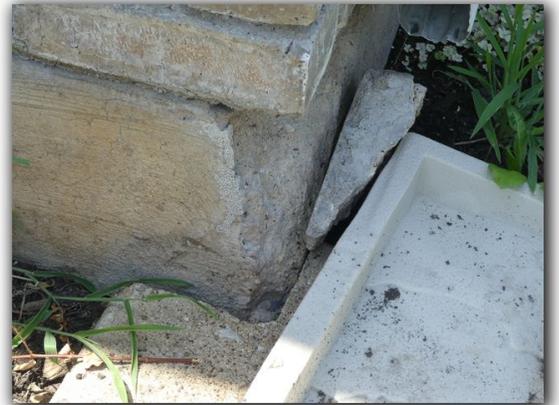
Tree(s) in close proximity to the foundation were observed. The buyer should consider removal of the tree(s) or the installation of a root barrier to reduce the possibility of damage to the foundation from tree roots and moisture removal.

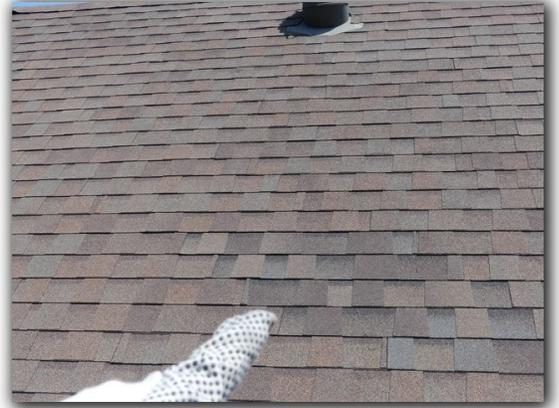
Composition shingle tab granules were observed to be thinning on the roof covering. You are encouraged to have your insurance company and a certified, licensed roofing contractor physically inspect the roof, prior to closing, to fully evaluate the insurability and condition of the roofing material.

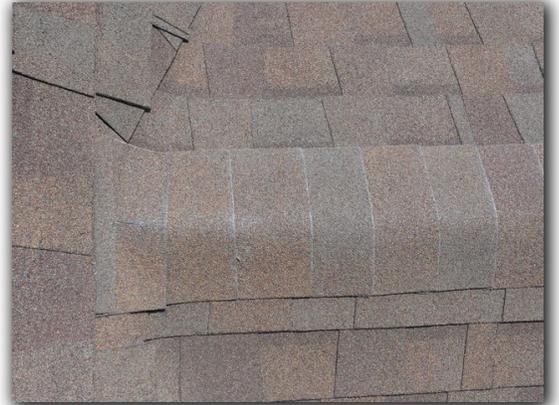
Broken and damaged roof covering materials were observed.

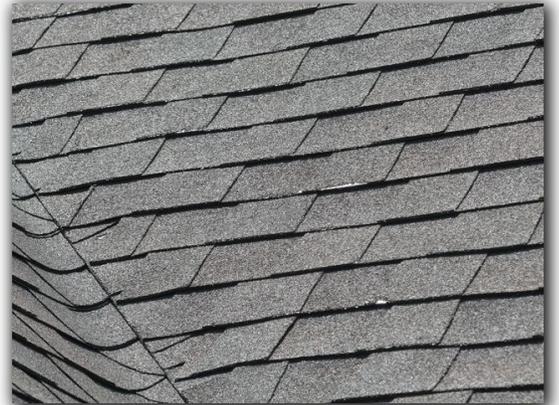
There were indications of impact damage on the roof covering. Impact damaged roof covering shingles may allow further deterioration of the roof covering, deterioration of the roof structure, water penetration or other damage.

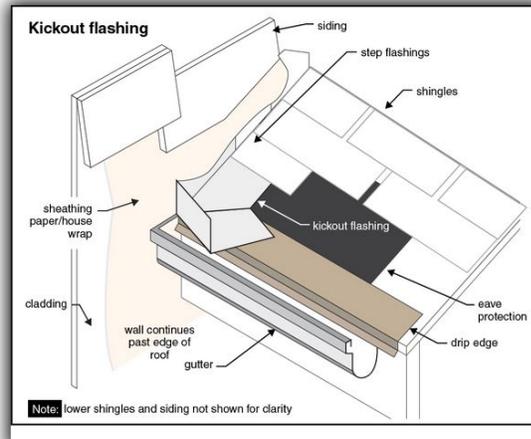
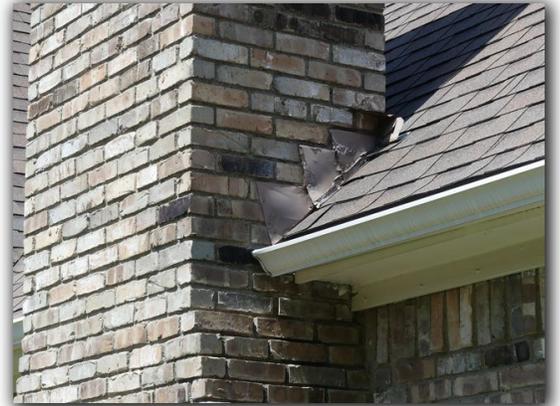
Current construction standards require a kick out flashing at the roof coverings and wall intersections. Kick out flashings prevent water leaks, damage and discoloration to walls.

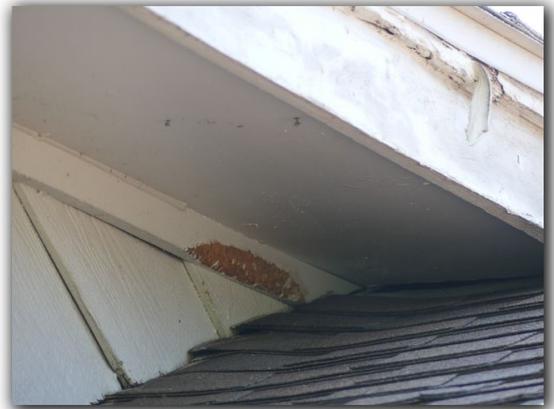
Fascia, soffit, eaves and or trim materials were observed to be damaged. Damaged fascia, soffits, eaves and trim materials should be repaired as needed to prevent further damage, wildlife penetration and moisture penetration.

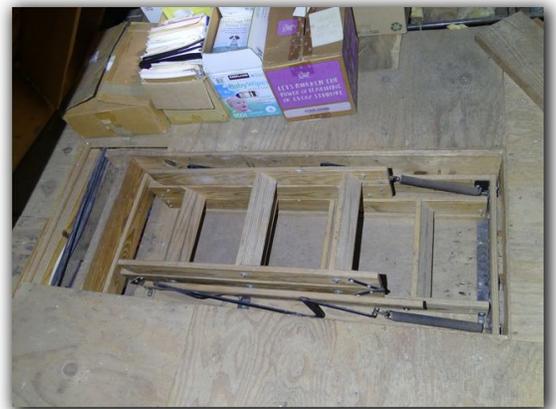
Access doors from conditioned spaces to unconditioned spaces such as attics should be weather stripped and insulated to a level equivalent to the insulation on the surrounding surfaces. A wood framed or equivalent baffle or retainer should be installed when loose fill insulation is installed to assist in maintaining a consistent R-value.

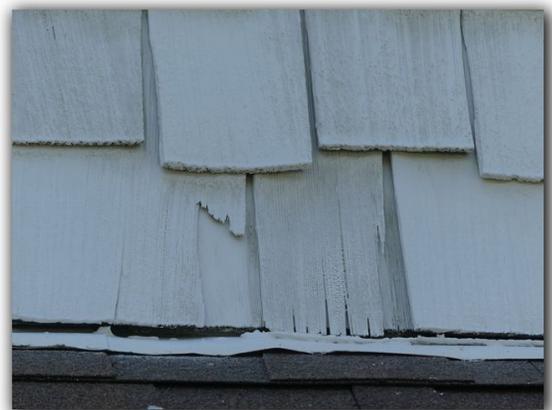
The exterior wood siding was observed to have some deterioration and/or damage. Damaged and deteriorated exterior wooden siding should be repaired to prevent wall damage, moisture penetration and wood destroying insects.

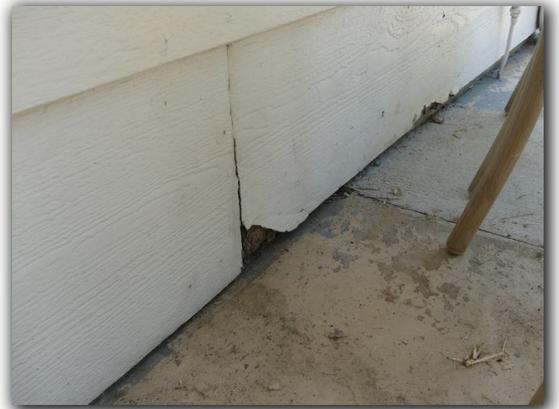
Water damage and/or wood rot was observed at the exterior siding and/or trim. Damaged and deteriorated exterior wooden siding should be repaired to prevent wall damage, moisture penetration and wood destroying insects.

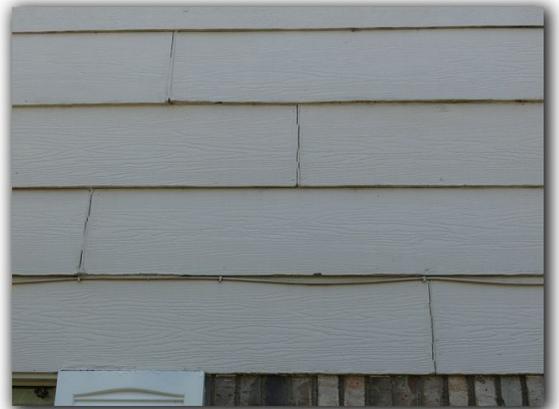
Exterior sealants (caulking) were deteriorated or missing in some areas. Sealants applied in appropriate locations prevents moisture intrusion and insect penetration.

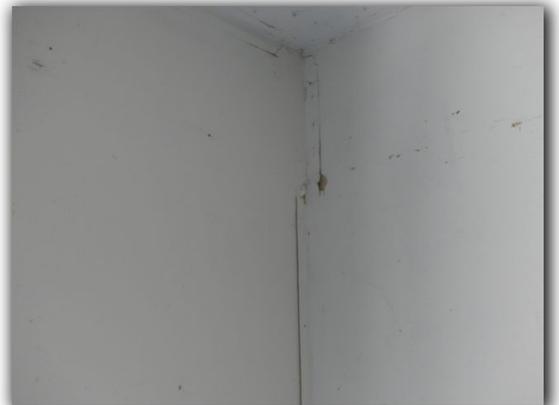
At least one interior wall crack was observed and may be an indication of structural settling, movement or other defects. The cause of any interior drywall, texture and paint wall cracks should be determined and repaired as needed and monitored over time for additional movement. If concerns about the foundation performance exist, the inspector recommends further evaluation by a certified, licensed foundation specialist.

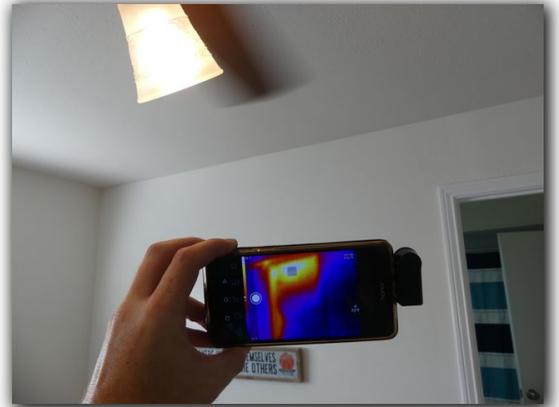
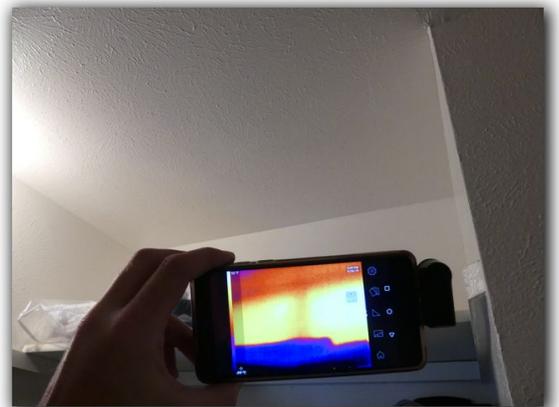
Using a thermal imaging camera, there are areas of temperature anomalies in the walls which may be indication of missing or damaged insulation. The reason for the temperature anomalies should be further evaluated and repaired as needed.

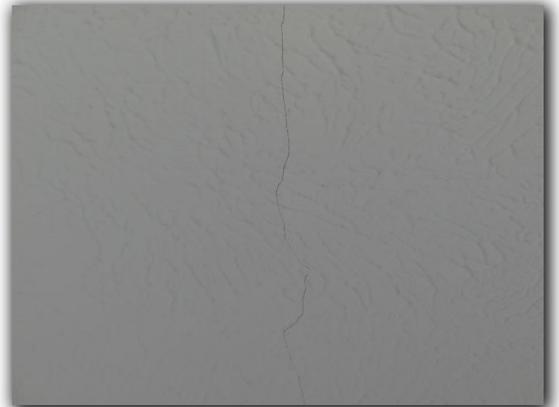
Several interior ceiling cracks were observed which is an indication of structural settling, movement or other defects. Ceiling drywall, texture and paint cracks should be repaired and monitored over time for additional movement. Further evaluation of the foundation and structure by a certified, licensed foundation and structural specialist may be needed.

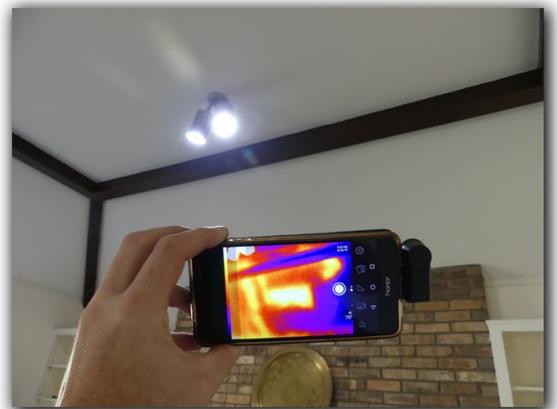
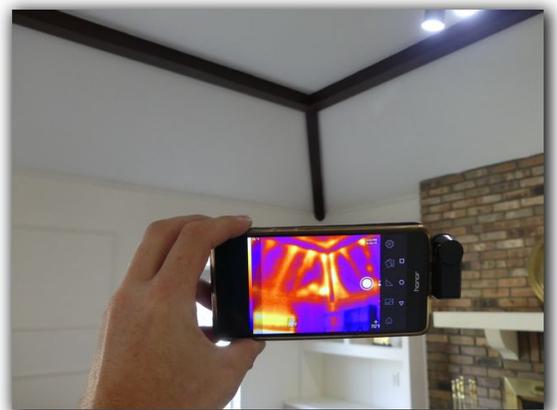
Using a thermal imaging camera, there are areas of temperature anomalies in the ceilings which may be indication of missing or damaged insulation. The reason for the temperature anomalies should be further evaluated and repaired as needed.

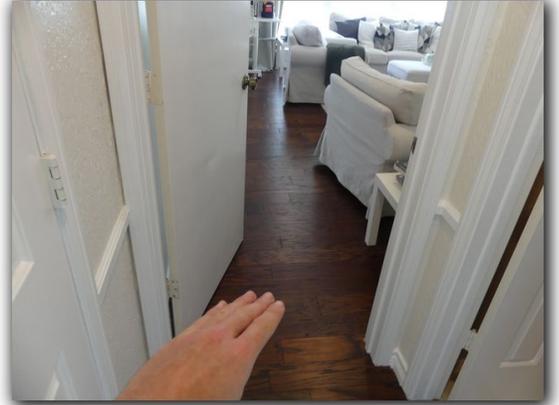
Areas of the interior floors did not appear to be level and were an indication of movement, settlement or other defects. The cause of un-level floors should be further evaluated by a structural specialist and repaired as needed.

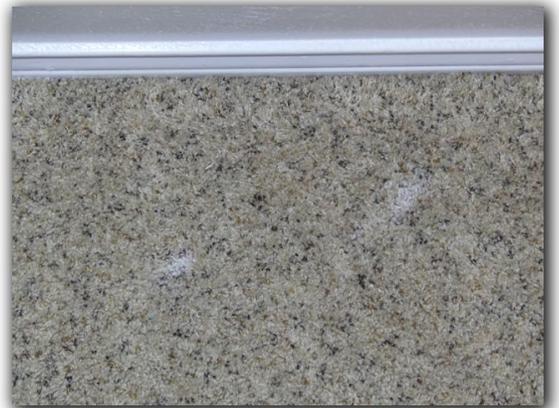
The floor covering was noticeably stained or damaged and was in need of cleaning, repair or replacement.

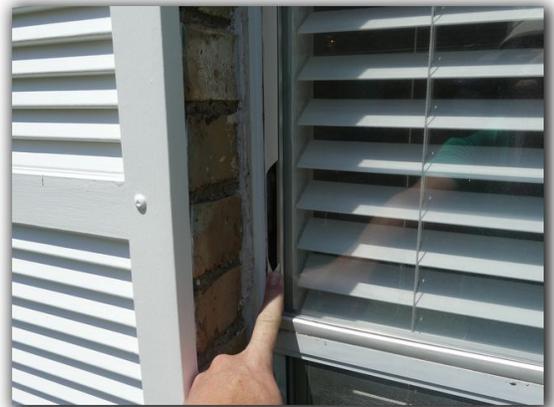
The window weather-stripping was observed to be damaged. Damaged or missing weather stripping around windows may allow moisture penetration, conditioned air loss and insect penetration and should be repaired.

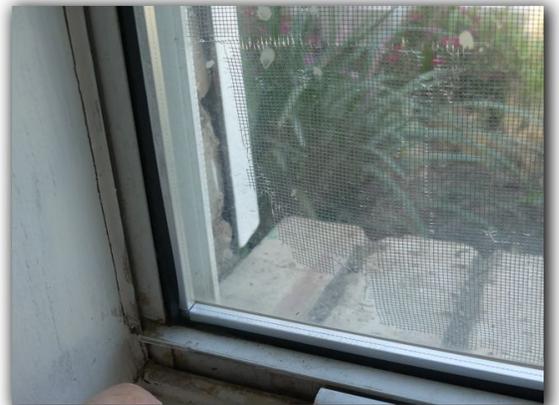
Damaged window screens were observed. Window screens help protect window glass from minor impact damage and prevent insect penetration at the windows. Damaged window screens should be repaired or replaced.

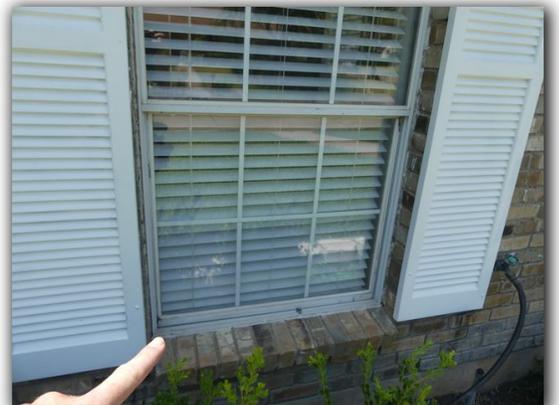
Windows were observed to be missing window screens. Window screens help protect window glass from minor impact damage and prevent insect penetration at the windows. Missing window screens should be replaced.

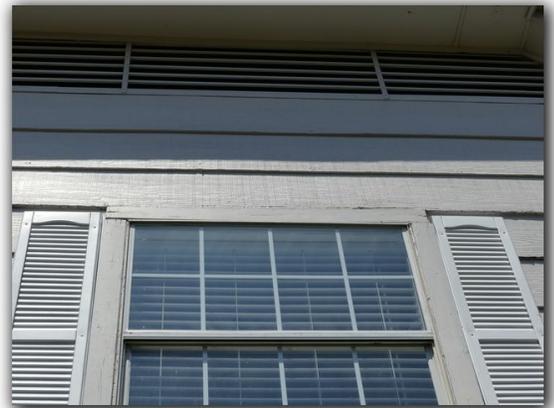
Windows were observed to be missing cap flashing. Missing window flashing should be repaired or replaced as needed.

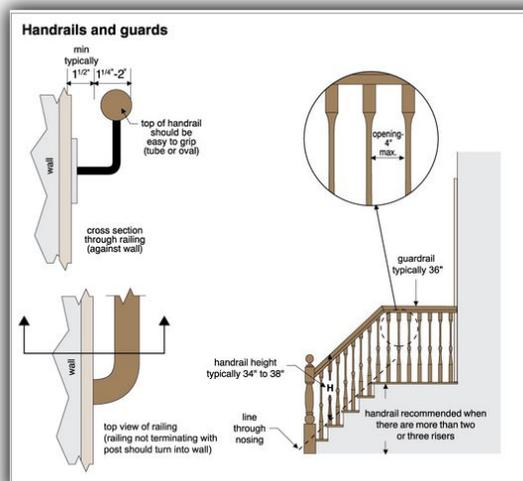
The stairway handrail height was observed to be inadequate and was a SAFETY HAZARD. Under current building standards, the stairway handrail height should be 34"-36" and should be corrected prior to closing.

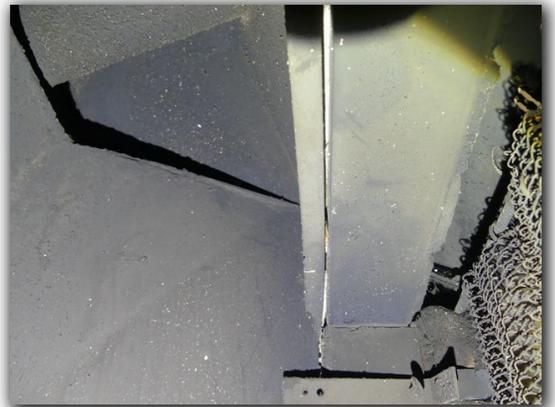
The fireplace firebox brick/mortar was not sealed at the hearth or lintel and was a SAFETY HAZARD. Inadequate fireplace seals may allow heat to transfer to flammable materials and is a SAFETY HAZARD that should be repaired by a qualified fireplace specialist.

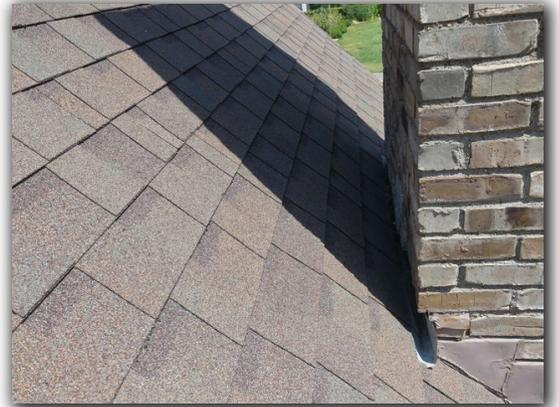
There is no cricket or saddle in place behind the roof level chimney structure. Under current building standards, there should be a cricket or saddle installed behind the ridge side of any chimney greater than 30-inches wide. You are encouraged to have your Insurance Company and/or certified, licensed roofing contractor to physically inspect the roof, prior to closing, to fully evaluate the insurability and condition of the roofing material.

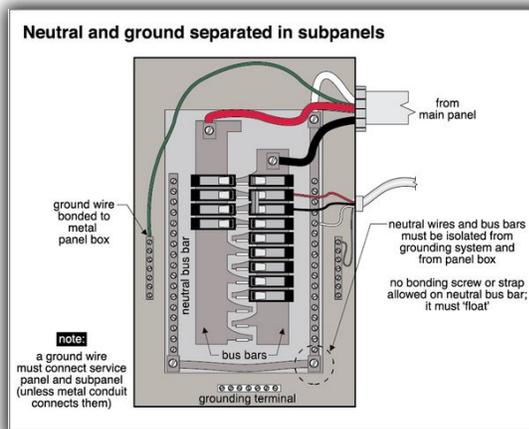
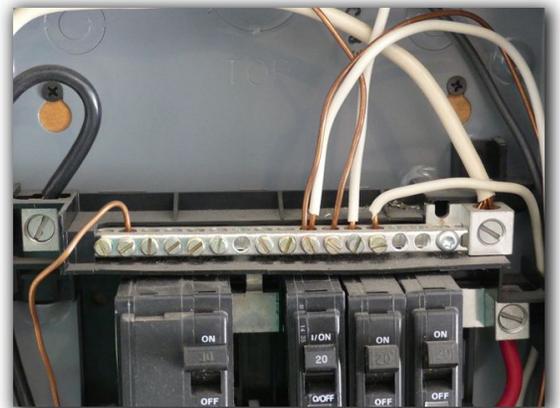
☑ Sub-Panel grounds and neutrals were installed on the same bus bar. The ground wires and the neutral wires were not properly separated in the sub-panel electrical cabinet. The neutral wires should be on their own isolated bus bar and the ground wires should be connected to the sub-panel cabinet. Although the sub-panel may be functional, it does not meet current National Electrical Code standards and should be further evaluated and repaired or replaced by a certified, licensed electrical specialist.

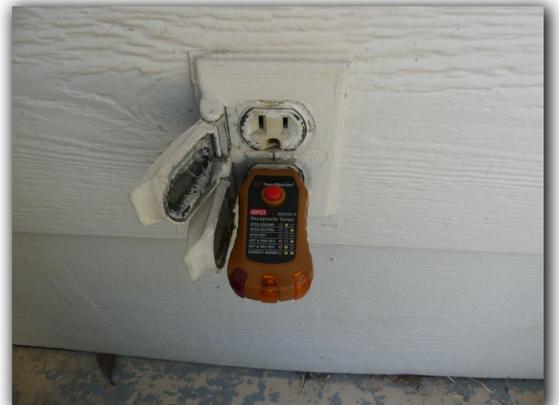
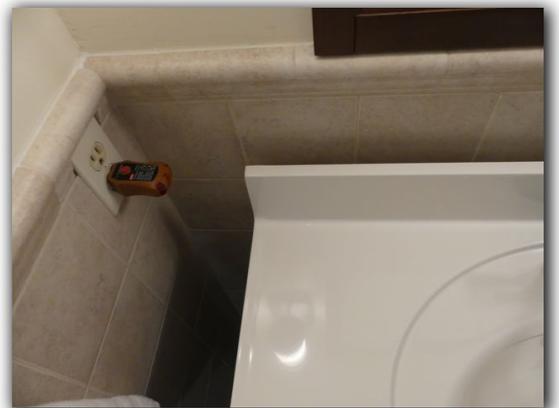
Inoperative electrical receptacles were observed. The cause of inoperative electrical receptacles should be further evaluated and repaired or replaced as needed by a certified, licensed electrical specialist.

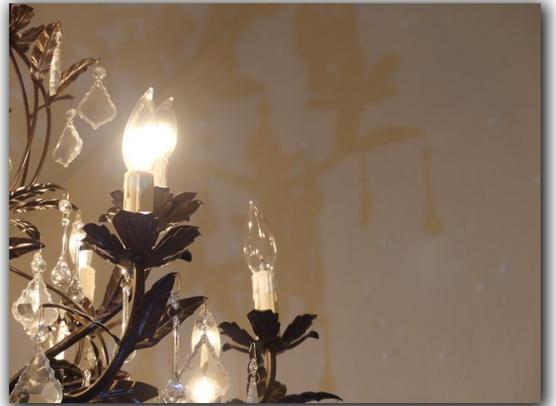
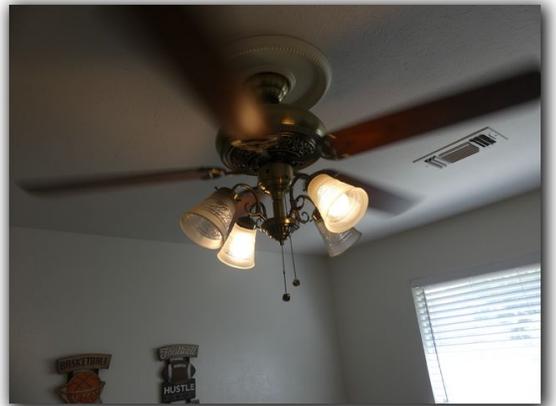
Light fixtures that are inoperative, missing bulbs or have burned out bulbs should be repaired or replaced as needed.

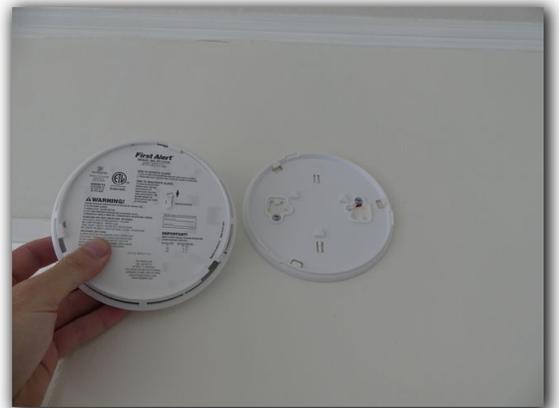
The smoke alarms were not electrically interconnected. Under current building standards, if one smoke alarm sounds, all other smoke alarms should be activated.
