# Fouries Home Inspection

Condo Inspection  
Prepared Exclusively For: Buyer Name

Any Street, Fort Worth, TX, 76107

## PROPERTY INSPECTION REPORT

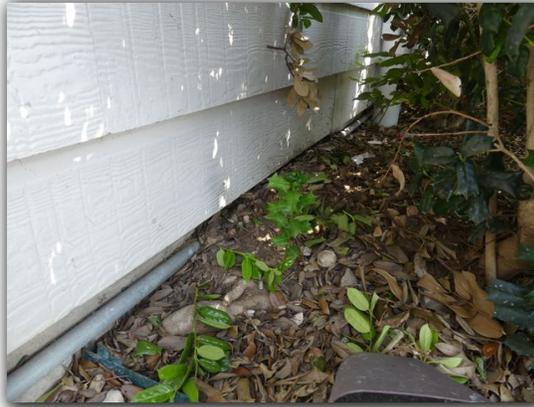
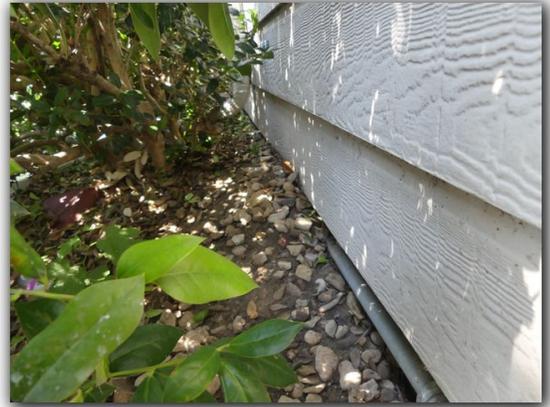
High soil levels were observed at the foundation/brick line. 4 to 6 inches of the foundation perimeter beam should be visible. High soil levels may block weep holes and prevent proper wall ventilation. High soil levels create conducive conditions for wood destroying insects and water intrusion. High soil levels prevent the inspector from observing the foundation perimeter beam. Correction of inadequate grading clearance to exterior wall and foundation surfaces is recommended.

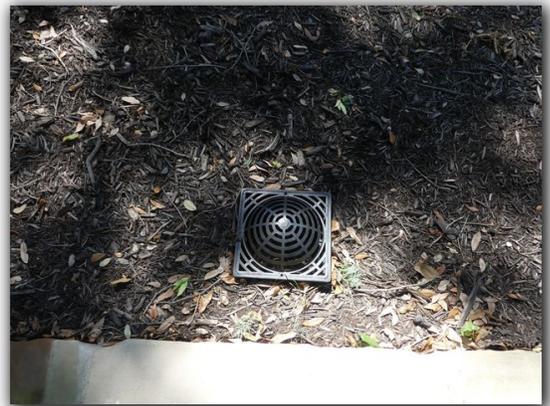
There is a subsurface or below grade drainage system installed. The inspector has no way of knowing if below grade drainage systems are performing as intended. The inspector recommends that the below grade drainage system be monitored for performance.

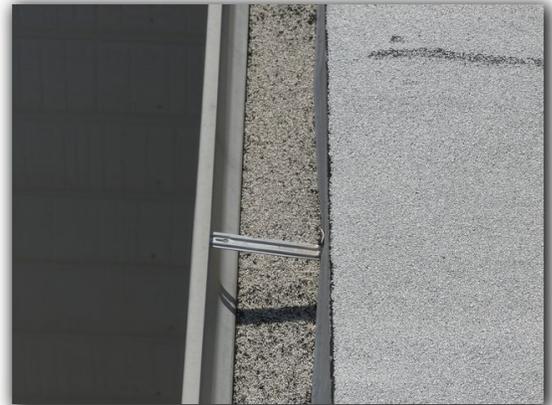
The gutters and downspouts contained leaves and other debris and should be cleaned out to allow for proper drainage.

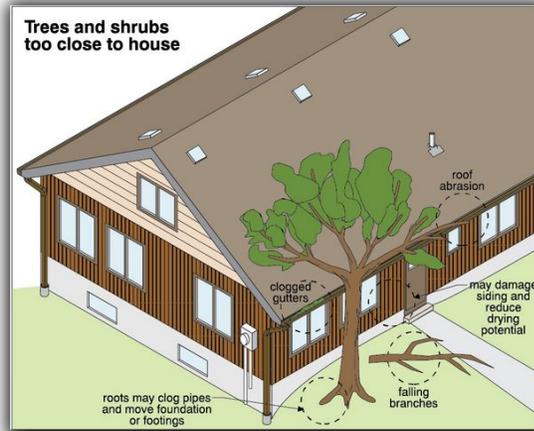
Heavy foliage growing on, over or around the exterior walls of the structure should be trimmed back at least 18-inches. Heavy foliage limits the Inspectors visual observation of the exterior surfaces. Heavy foliage at exterior walls creates conducive conditions for material damage, wood destroying insects and moisture damage. Heavy foliage may damage exterior wall cladding.

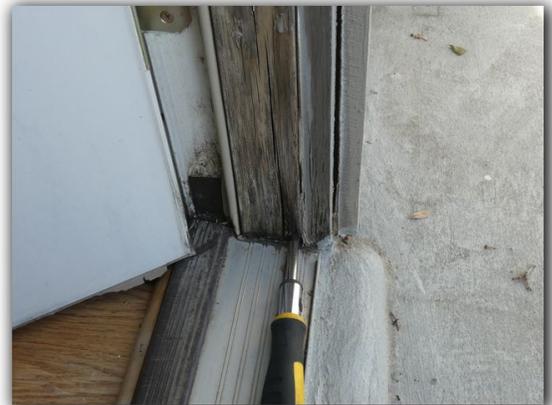
The exterior wood trim was observed to have some deterioration and/or damage. Damaged and deteriorated exterior wood trim should be repaired to prevent wall damage, moisture penetration and wood destroying insects.

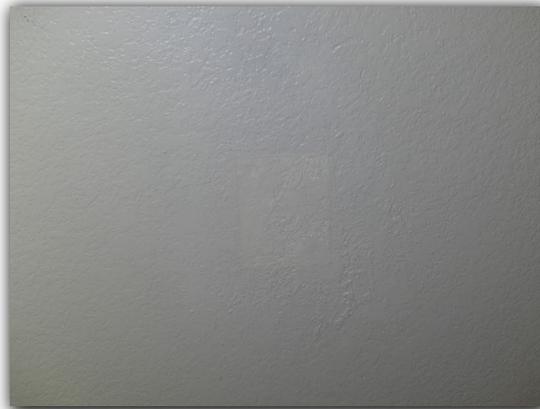
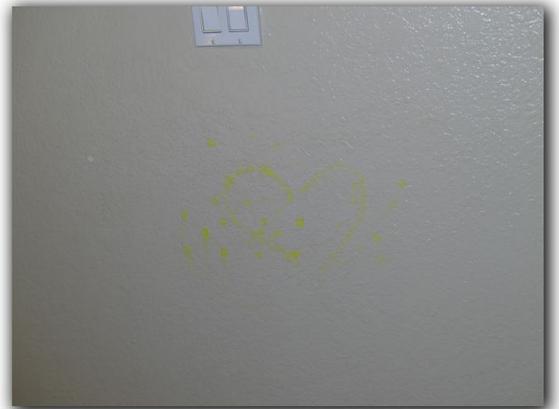
Cosmetic damages to interior wall coverings, drywall, texture and paint were observed to be in need of repair.

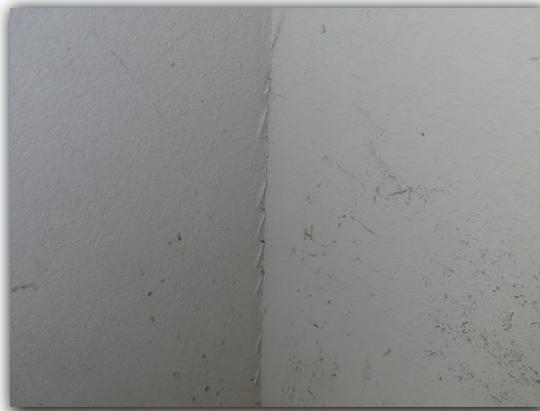
Interior drywall corner tape was observed to be pulling and twisting where walls and or ceilings intersect. This condition is related to adverse foundation or structural performance and should be further evaluated by a foundation or structural specialist and repaired as necessary.

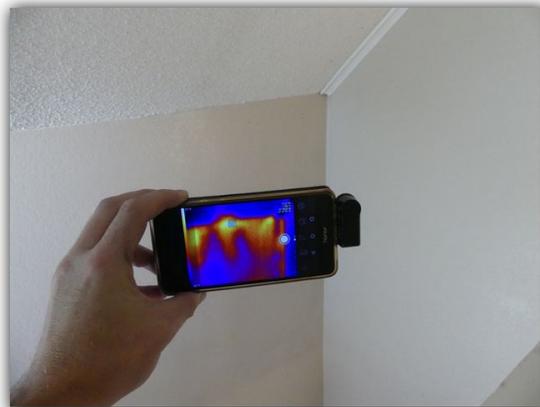
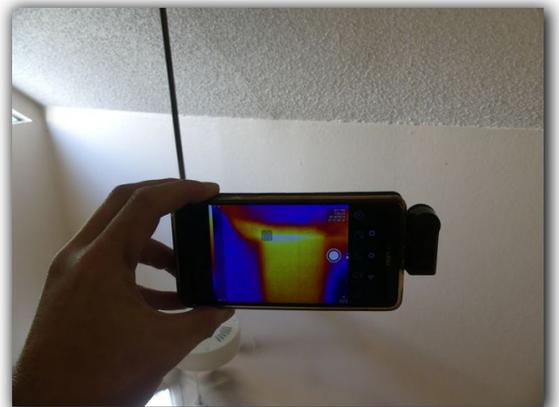
Using a thermal imaging camera, there are areas of temperature anomalies in the walls which may be indication of missing or damaged insulation. The reason for the temperature anomalies should be further evaluated and repaired as needed.

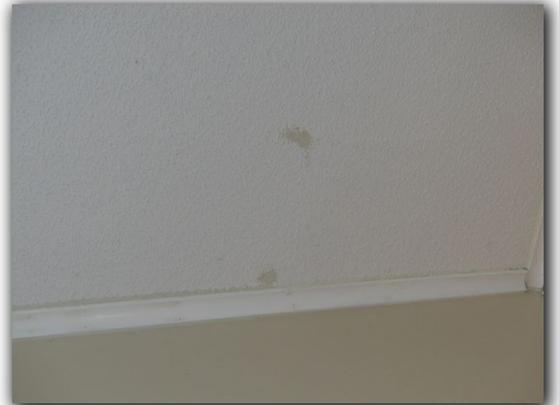
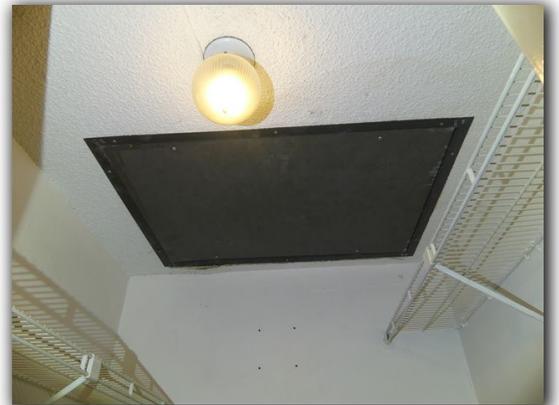
Cosmetic damages to ceiling drywall, texture and paint should be repaired.

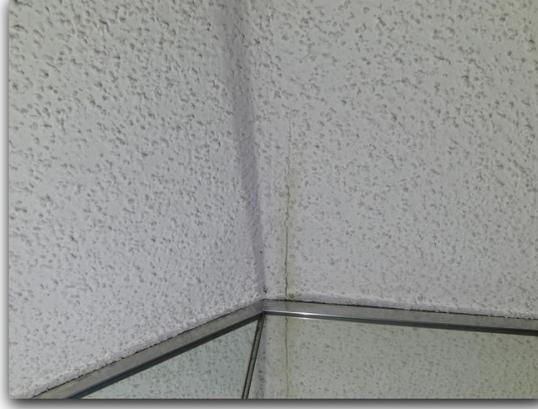
At least one interior ceiling crack was observed which is an indication of structural settling,

movement or other defects. Ceiling drywall, texture and paint cracks should be repaired and monitored over time for additional movement. If concerns about the foundation performance exist, the inspector recommends further evaluation by a certified, licensed foundation specialist.

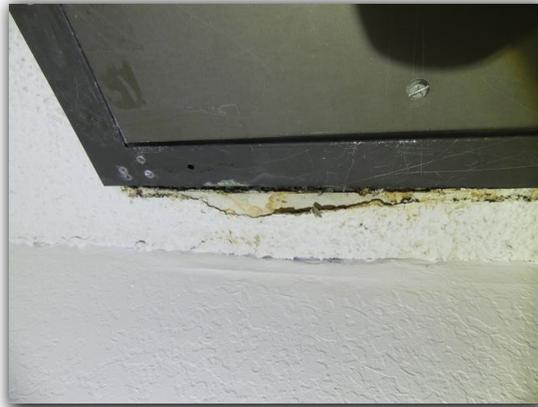
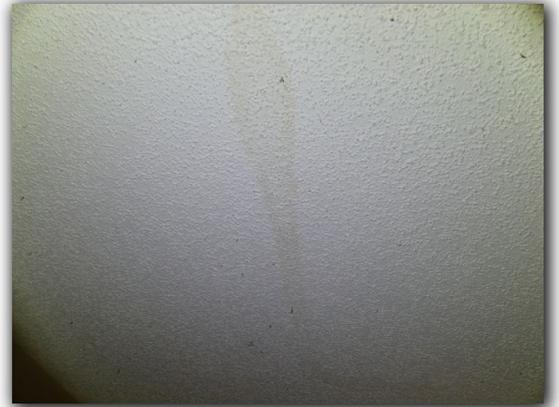
Water stains or water damage was observed at the ceiling drywall, texture and paint. The cause of the water staining or water damage should be determined and repaired as needed.

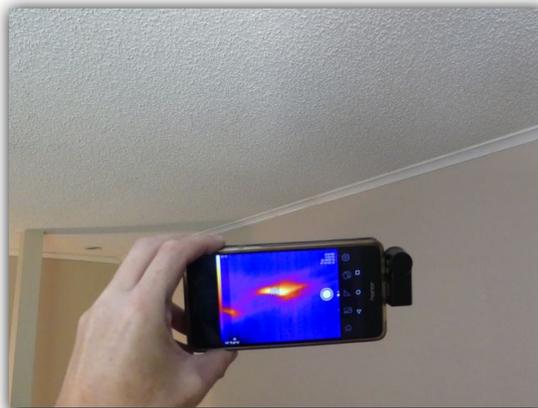
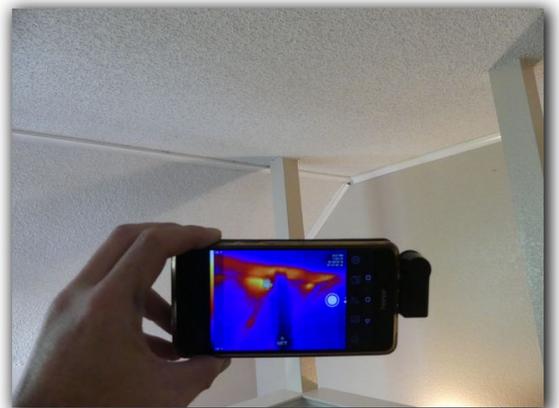
Using a thermal imaging camera, there are areas of temperature anomalies in the ceilings which may be indication of missing or damaged insulation. The reason for the temperature anomalies should be further evaluated and repaired as needed.

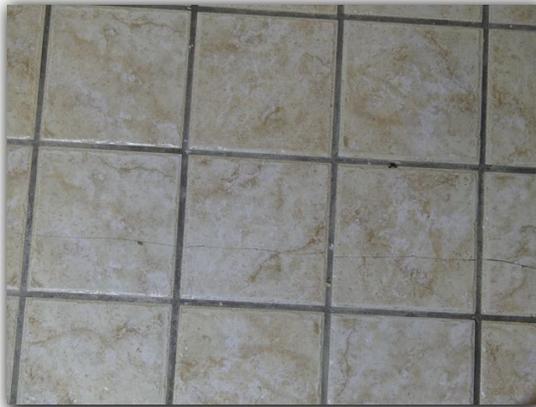
Linear cracks in floor tiles or grout were observed. Linear cracks in floor tiles and grout may be an indication of movement, settlement, improper installation or other defects. The cause of linear cracks in floor tiles and grout should be further evaluated and repaired as needed.

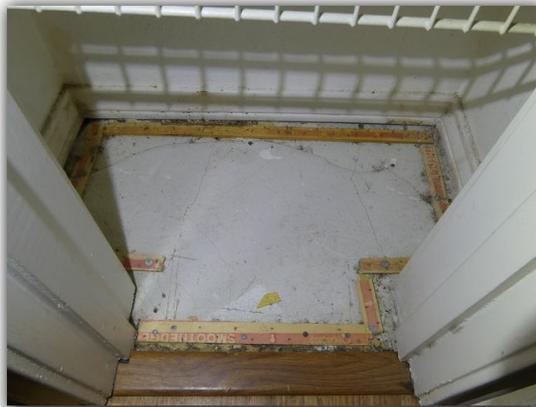
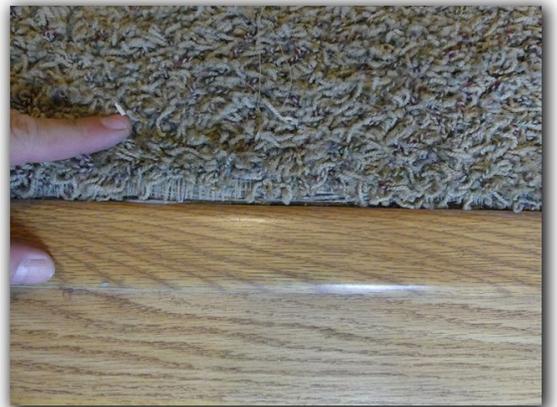
The floor covering was noticeably worn or damaged and was in need of cleaning, repair or replacement.

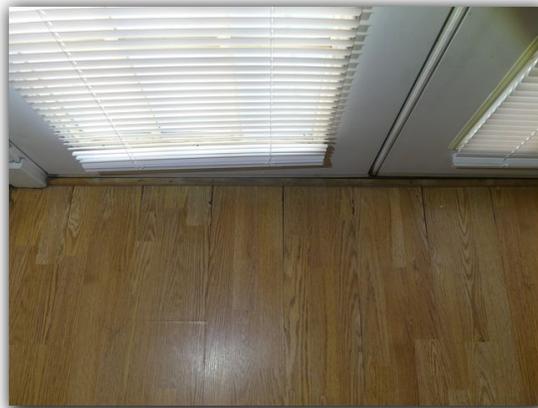
The wood floor covering was observed to be water damaged. The cause of water damaged wood flooring should be determined and repaired as needed.

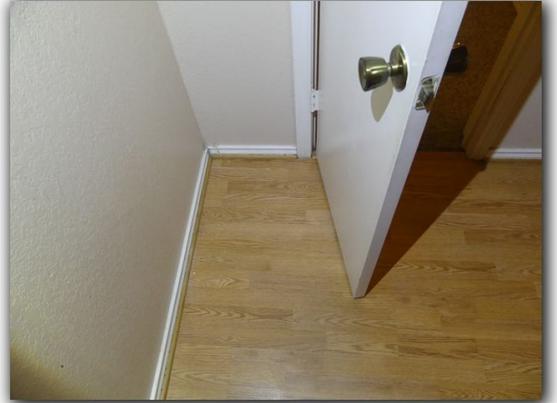
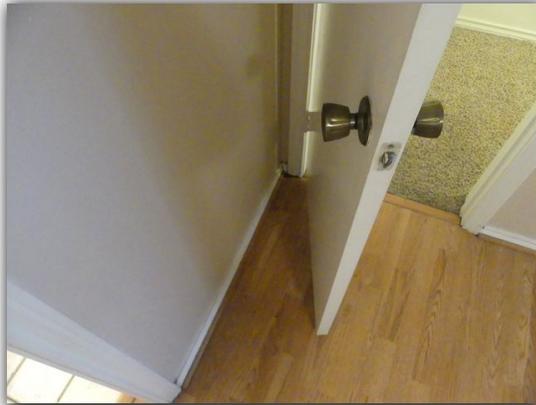
All interior doors should have door stops installed to prevent damage to adjacent interior wall coverings.

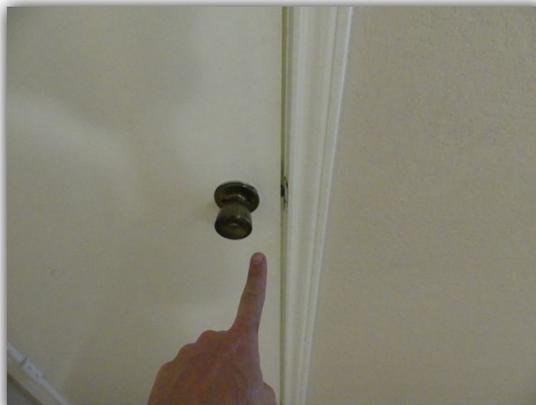
Interior doors which do not latch as intended should be repaired.

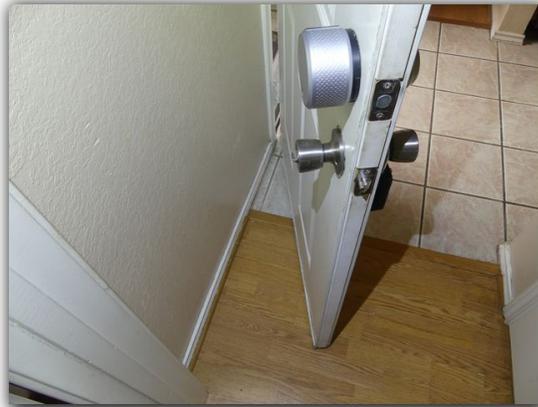
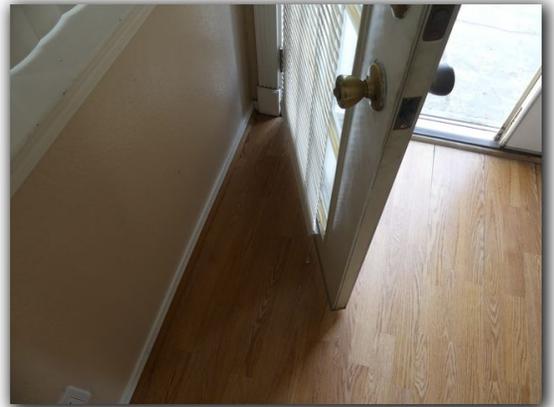
All exterior doors should have door stops installed to prevent damage to adjacent interior wall coverings.

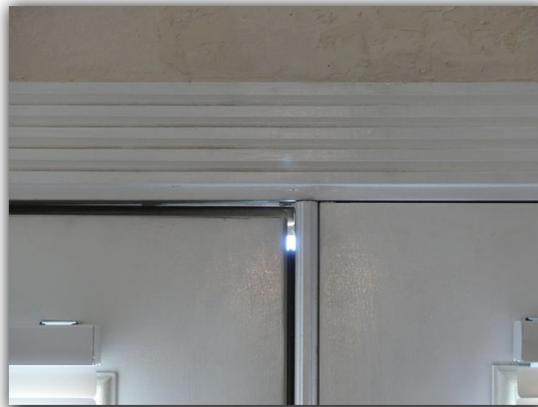
Damaged or missing exterior door weather stripping should be replaced. Missing or damage exterior door weather stripping creates conducive conditions for moisture intrusion and conditioned air loss.

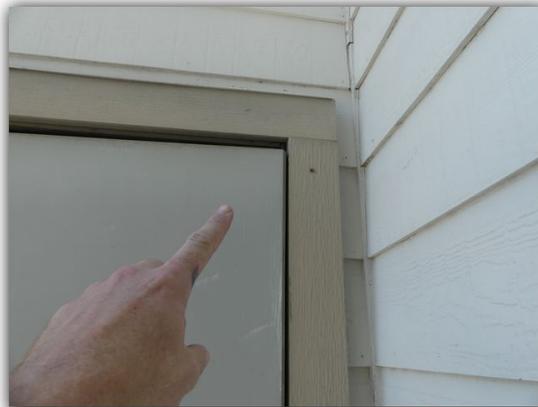
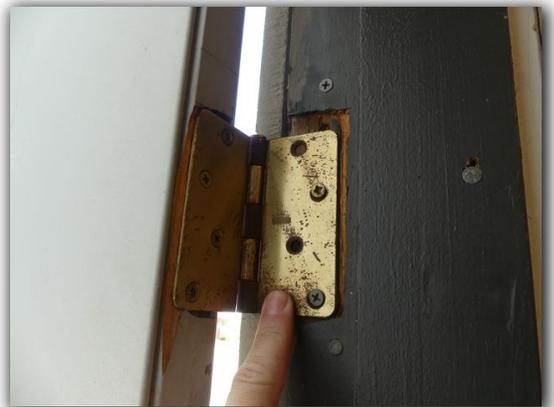
Exterior doors that rub, stick or hit door frames were observed. Exterior doors that stick, rub, hit the door frame or do not perform as intended are indications of movement, settlement or other defects. The cause of exterior doors that rub, stick or hit door frames should be determined and repaired as needed.

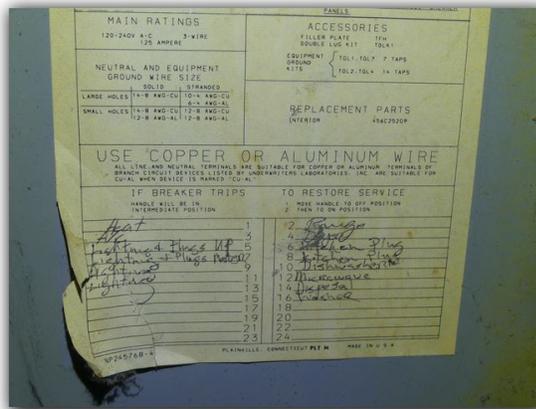
The electric service panel breaker use was not labeled. Each electric service panel breaker should be adequately labeled as to what appliance or circuit it serves.

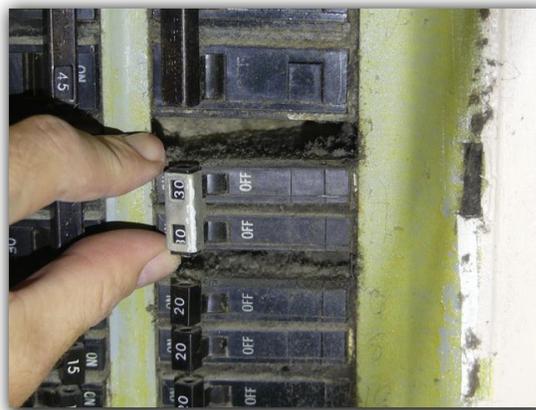
Blank spaces (missing breakers) in the electrical service panel were observed to be missing filler covers. Missing or unused breaker slots should be covered with electrical fillers to prevent the unwanted entry of pests, moisture or other items. Lack of a cover filler at missing or unused breaker slots is considered a SAFETY HAZARD and should be repaired as needed by a qualified electrical specialist.

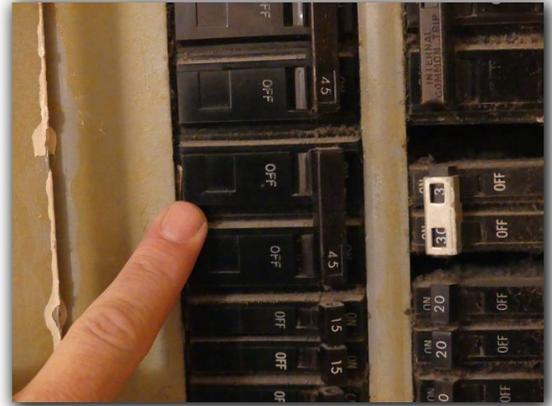
Mismatched breaker sizes between the exterior HVAC equipment (Max./Min. Amperage), electric disconnect and/or the electric service panel breaker were observed. Mismatched breaker sizes between HVAC equipment and the electric service panel should be further evaluated and repaired or replaced by a qualified electrical or HVAC specialist.

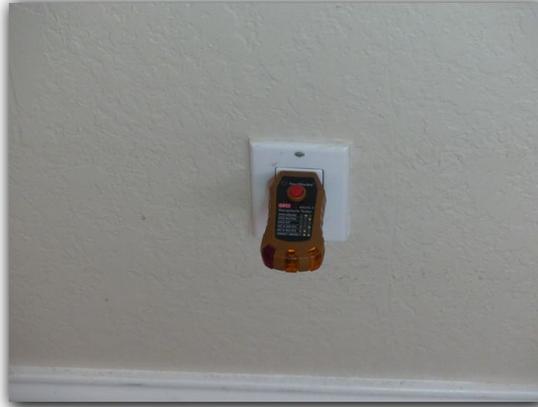
Inoperative electrical receptacles were observed in the loft area. The cause of inoperative

electrical receptacles should be further evaluated and repaired or replaced as needed by a certified, licensed electrical specialist.

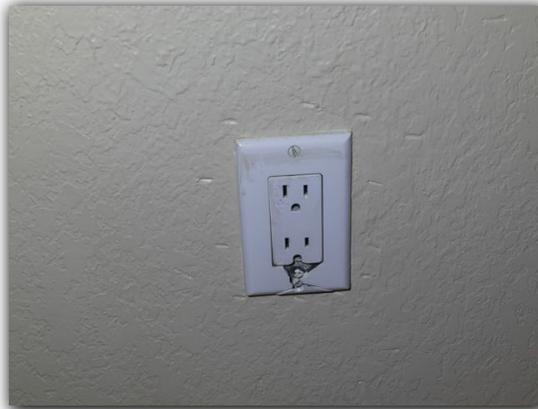
Electrical receptacles, switches and or covers were observed to be loose, damaged, missing or missing screws and were in need of repair. Damaged or missing electrical receptacles or switches should be repaired by a certified, licensed electrical specialist.

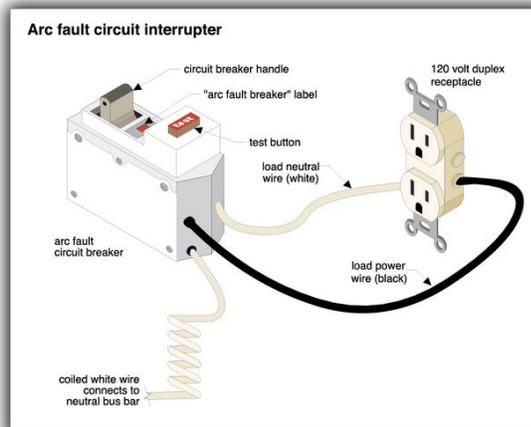
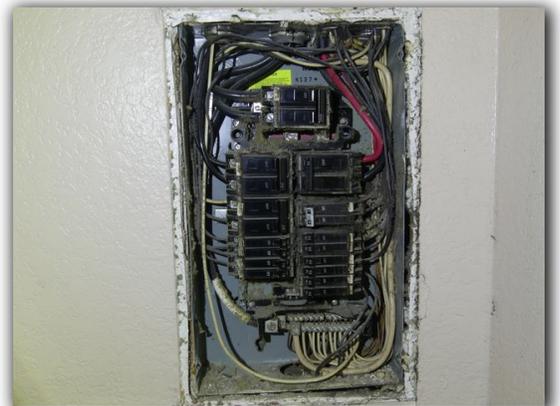
Dual function breakers that provide both AFCI and GFCI protection are now available and became a National Electric Code (NEC) building standard in 2014. Under current electrical standards, AFCI protection is now required in family rooms, dining rooms, living rooms, parlors, libraries, dens, bedrooms, sun rooms, recreation rooms, closets, hallways, kitchens and laundry rooms. Lack of AFCI protection in required locations is a SAFETY HAZARD.

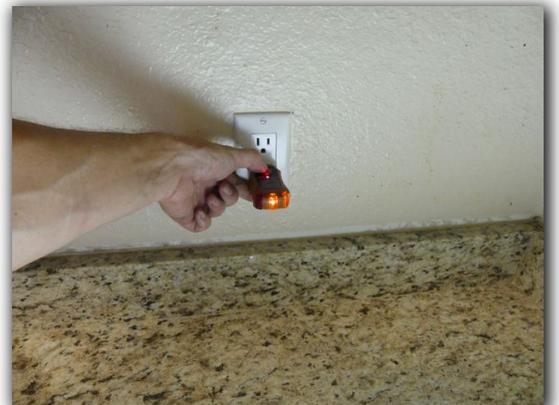
☑ Kitchen counter top electrical receptacles were observed to lack ground fault circuit interrupter (GFCI) device protection. Under current electrical standards, all of the kitchen counter top receptacles should have GFCI protection. Lack of GFCI protection in required locations is a SAFETY HAZARD.

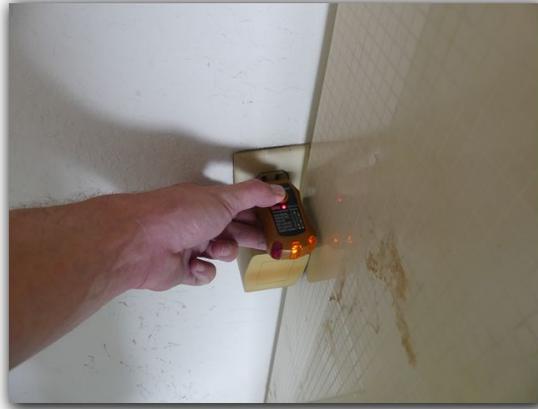
Outbuilding electrical receptacles were observed to lack ground fault circuit interrupter (GFCI) device protection. Lack of GFCI protection in required locations is a SAFETY HAZARD.

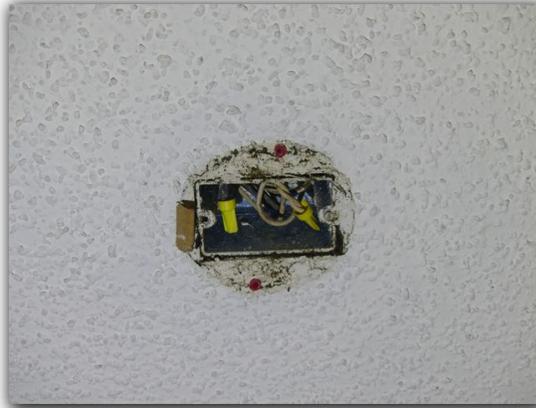
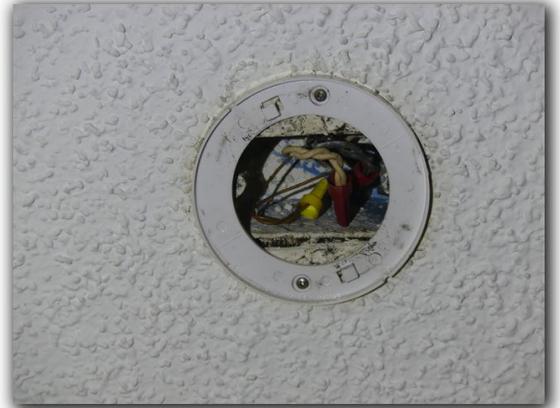
Loose, missing, missing batteries or damaged smoke alarms are a SAFETY HAZARD.

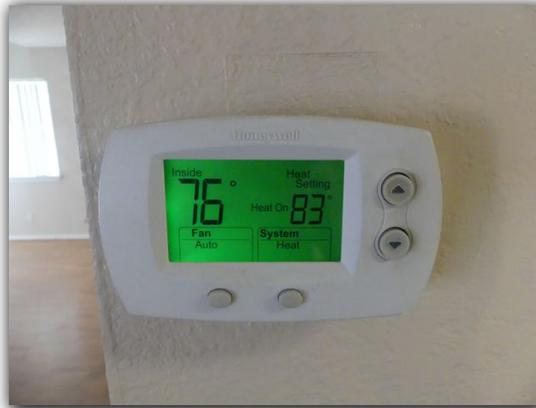
Under current building standards, the primary cooling equipment thermostat should be programmable for improved energy efficiency.

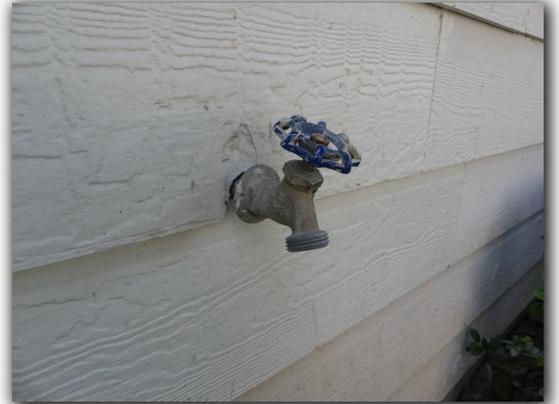
entering the water supply. Lack of anti-siphon devices at exterior water supply faucets is a SAFETY HAZARD. Current building standards require non-removable vacuum breakers on all hose faucets.

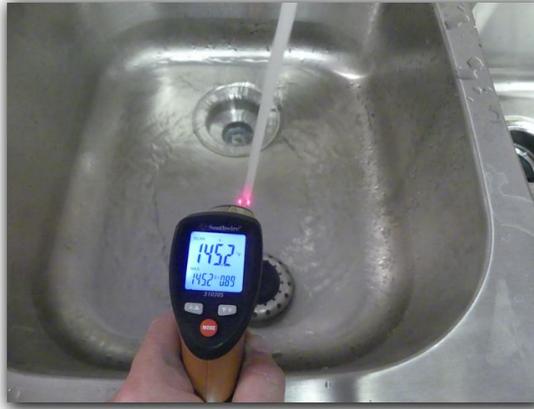
**Heated Water Temperature ( 145.2 °F ):**

Heated water temperature was observed to be greater than 120 degrees Fahrenheit F and was a SAFETY HAZARD. Adequate and safe heated water temperatures are considered to be between 100 degrees and less than 120 degrees Fahrenheit. The cause of improper heated water temperature should be determined and should be corrected as needed. The water heater thermostats may be turned up too high or there may be other defects in the water heating equipment.

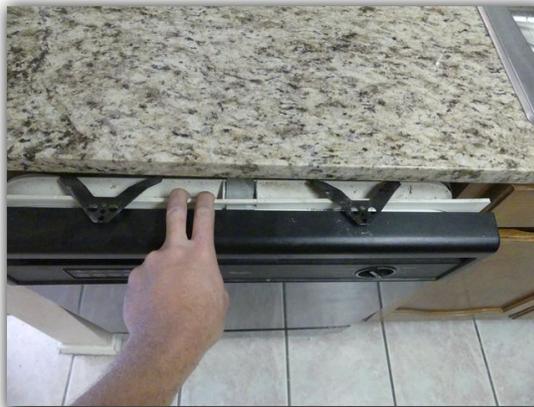
The dishwasher was not properly secured to the cabinets or counter top. Improperly secured dishwashers create conducive conditions for other defects, water leaks and other damage and should be properly secured prior to use.
