Fouries Home Inspection

COMPLETE HOME INSPECTION
Prepared Exclusively For: Buyer Name

Any Street, Mesquite, TX, 75150

By: Paul Fourie, Lic #22325 07/22/2019
(Name and License Number of Inspector) (Date)

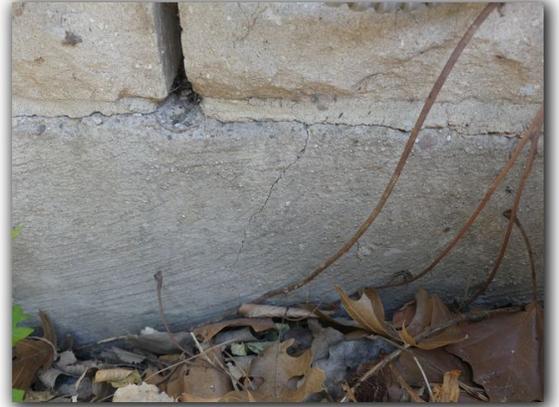
Exposed or damaged metal foundation reinforcement components were observed. Exposed or damaged metal foundation reinforcement components may lead to additional foundation deterioration and adverse foundation performance. This condition should be repaired as needed by a foundation specialist.

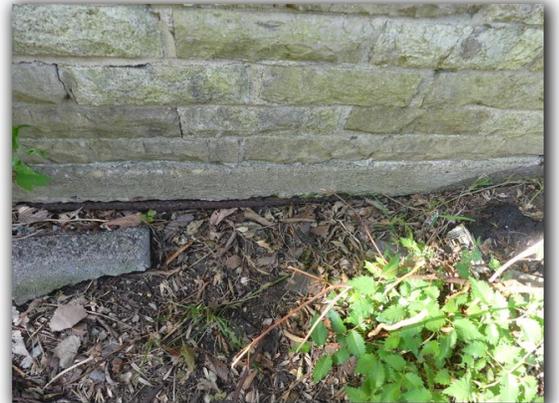
Foundation slab corners have been sheared off (corner pop). This is a common condition in slab on grade foundations and should be repaired. Repairing corner pops is recommended to prevent moisture and wood destroying insect penetration.

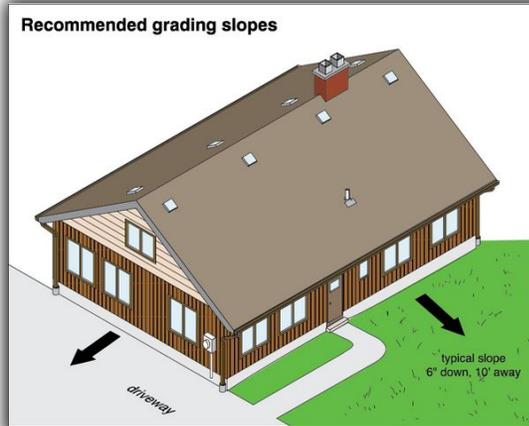
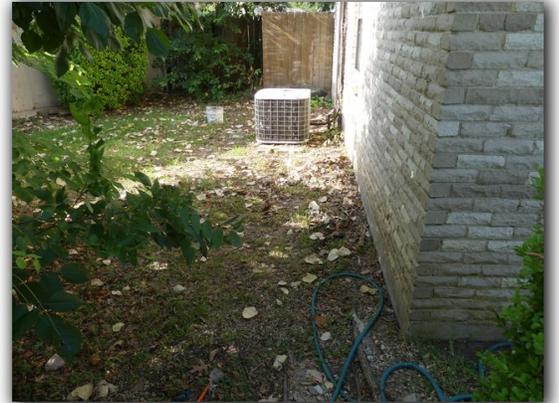
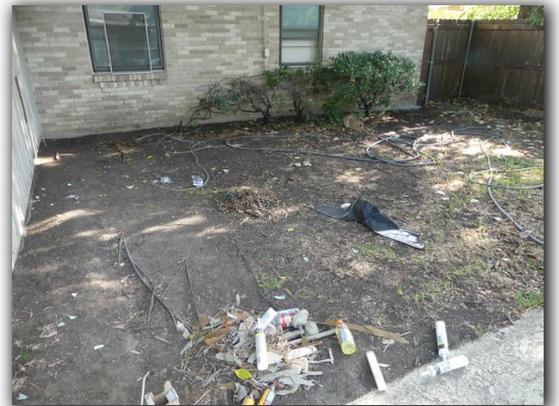
High soil levels were observed at the foundation/brick line. 4 to 6 inches of the foundation perimeter beam should be visible. High soil levels may block weep holes and prevent proper wall ventilation. High soil levels create conducive conditions for wood destroying insects and water intrusion. High soil levels prevent the inspector from observing the foundation perimeter beam. Correction of inadequate grading clearance to exterior wall and foundation surfaces is recommended.

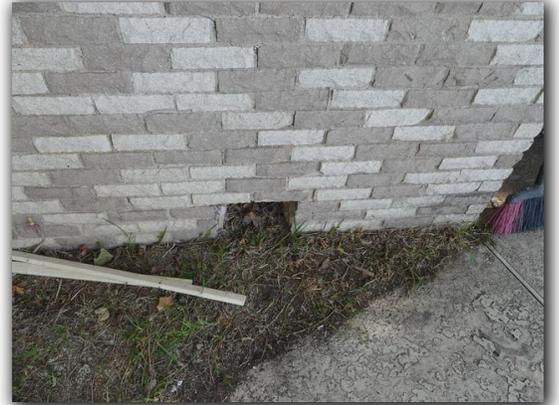
Grading and drainage could be improved with the installation of rain gutters. Properly installed rain gutters can prevent erosion and water ponding and help direct water away from the foundation.

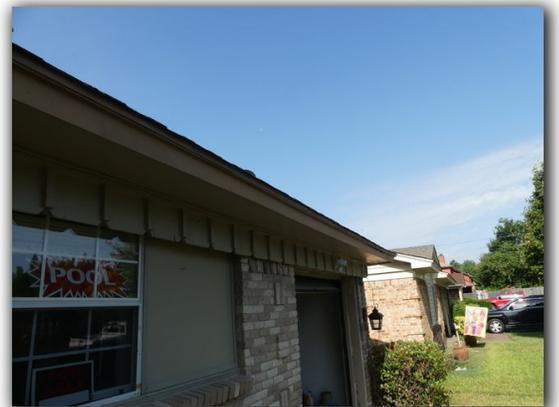
Damaged or leaking rain gutters and downspouts should be repaired. Damaged or leaking rain gutters and downspouts create conducive conditions for siding deterioration, soffit/eave damage, roof covering damage, water penetration and inadequate grade drainage.

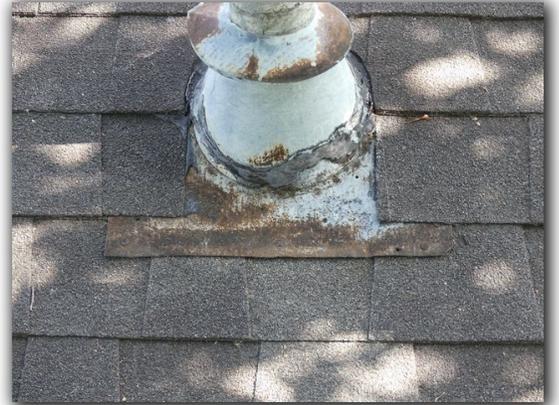
Roof covering flashings were observed to be lifting, damaged or improperly installed and were in need of repair or replacement. Lifting, damaged or improperly installed flashings may allow water penetration.

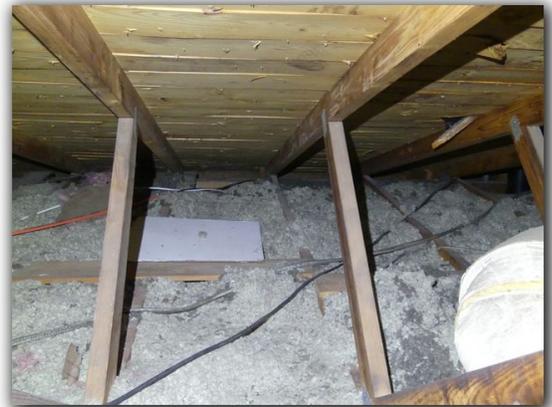
Water stains were observed on the roof sheathing (decking). The cause of the water stains should be determined. You are strongly encouraged to have your insurance company and a certified, licensed roofing contractor to physically inspect the roof covering materials, prior to closing, to fully evaluate the insurability and condition of the roofing material.

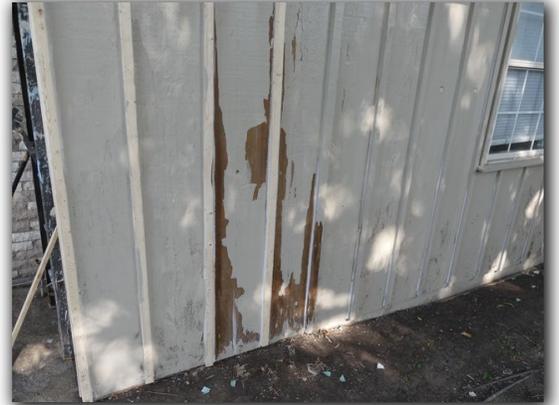
Peeling, damaged or deteriorating paint, stain and/or sealant was observed at the exterior trim. Peeling, damaged and deteriorating paint or sealant should be repaired to prevent moisture penetration and deterioration of materials.

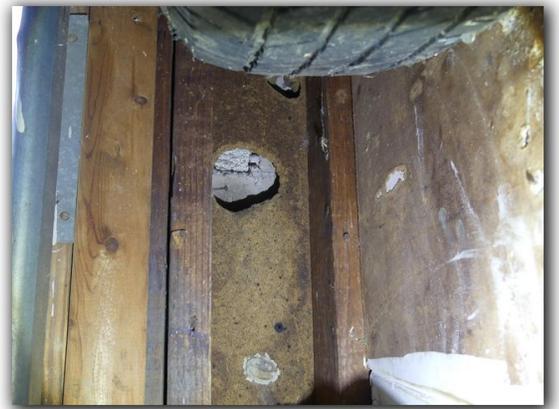
Indications of **wood destroying insect damage or activity** was observed. There may be more damage than what was visible at the time if the inspection. Further evaluation is recommended.

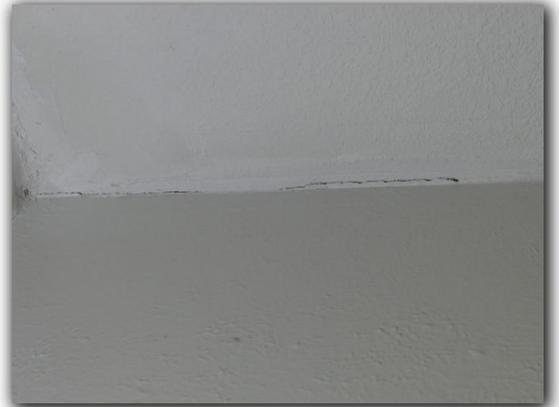
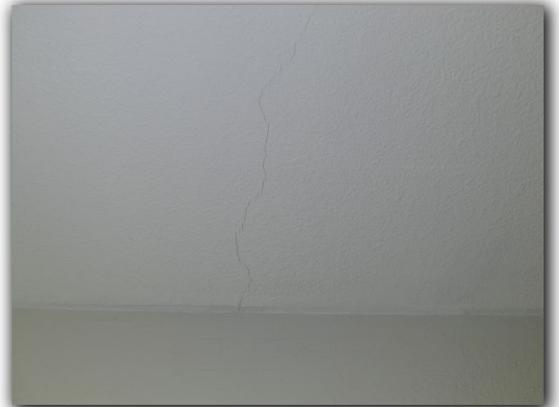
The ceiling drywall corner tape was observed to be pulling and twisting where walls and ceilings intersect. This condition is related to adverse foundation or structural performance and should be further evaluated by a certified, licensed foundation or structural specialist and repaired as needed.

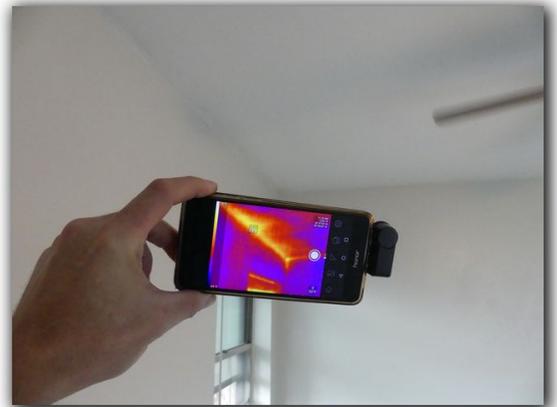
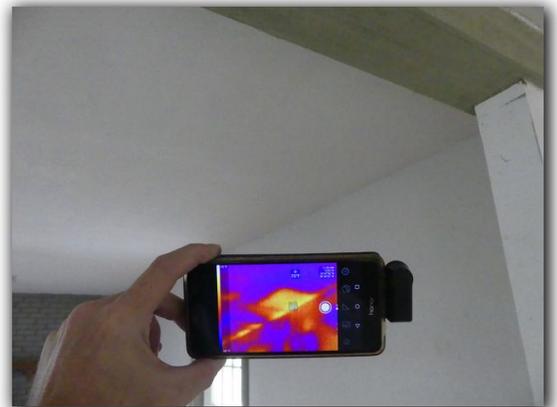
Using a thermal imaging camera, there are areas of temperature anomalies in the ceilings which may be indication of missing or damaged insulation. The reason for the temperature anomalies should be further evaluated and repaired as needed.

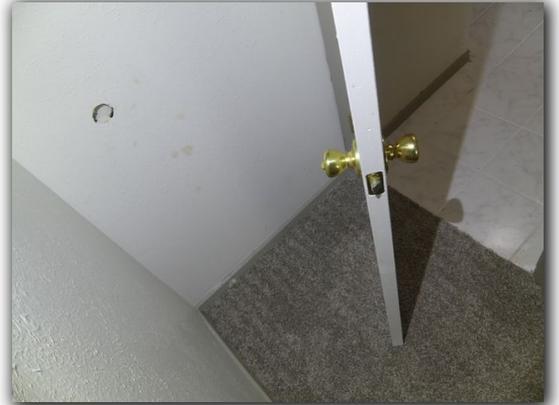
Interior doors which are in contact with the floor covering should be repaired. Door which are in contact with floor covering may damage the flooring.

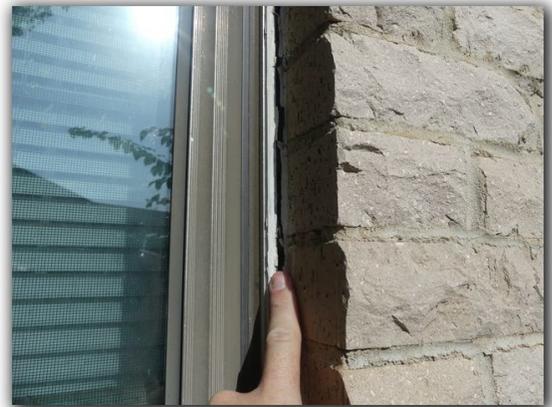
The window weather-stripping was observed to be damaged. Damaged or missing weather stripping around windows may allow moisture penetration, conditioned air loss and insect penetration and should be repaired.

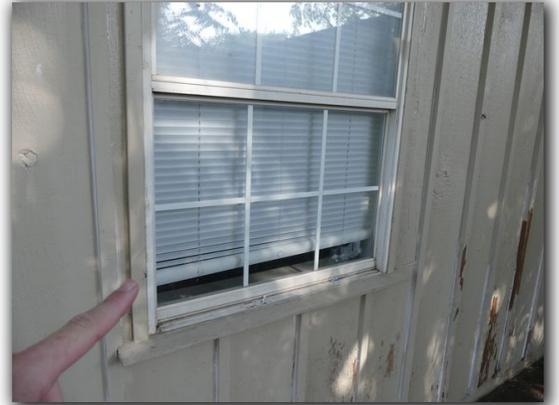
The window above the tub/shower did not appear to have a safety glass etching or label. Glass less than 5' above the tub/shower should be tempered safety glass. Lack of safety glass in required locations is a SAFETY HAZARD and should be replaced.

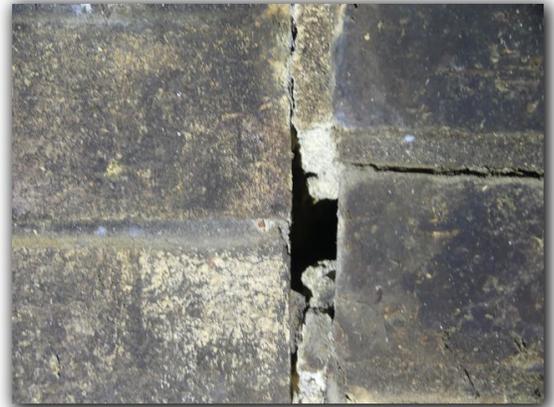
The fireplace firebox brick/mortar was not sealed at the hearth or lintel and was a SAFETY HAZARD. Inadequate fireplace seals may allow heat to transfer to flammable materials and is a SAFETY HAZARD that should be repaired by a qualified fireplace specialist.

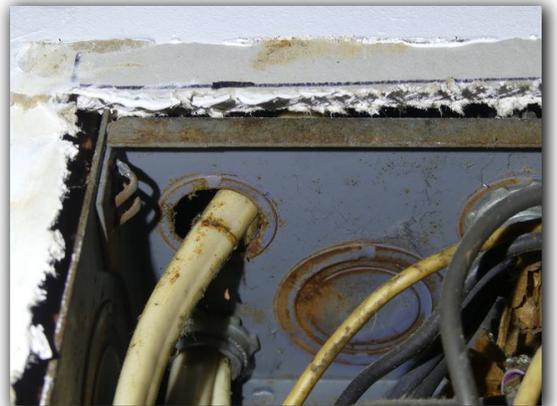
The electric service panel electrical conductors have not been properly secured or protected from the sharp edges and/or the dead front cover of the cabinet. Electrical conductors that are in contact with the service panel dead front cover and/or not protected from sharp edges are a SAFETY HAZARD and should be repaired by a qualified electrical specialist.

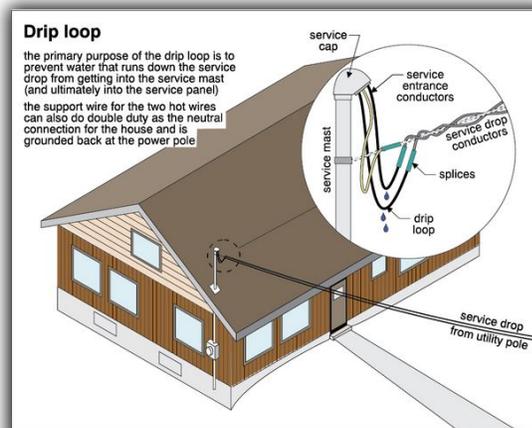
☑ The overhead service drop electrical conductors had inadequate clearance from tree branches.

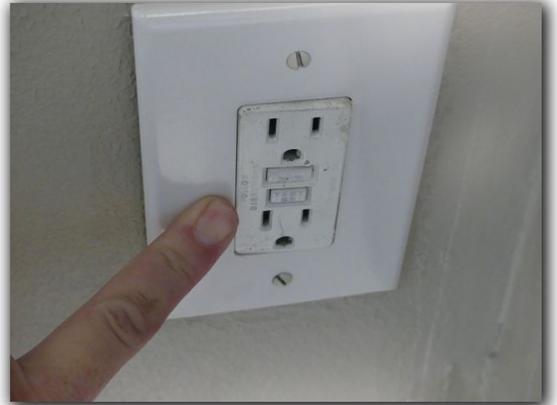
Electrical receptacles, switches and or covers were observed to be loose, damaged, missing or missing screws and were in need of repair. Damaged or missing electrical receptacles or switches should be repaired by a certified, licensed electrical specialist.

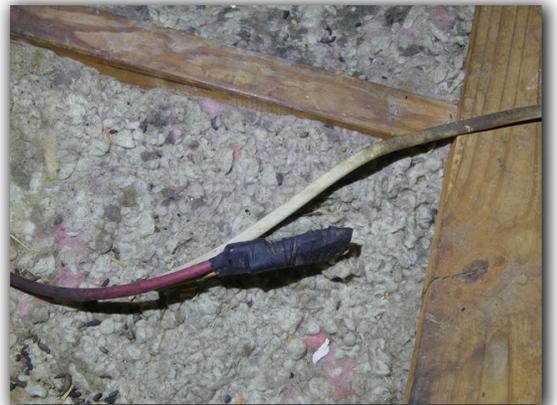
Improperly terminated electrical conductors were observed. All electrical conductor connections should be installed in sealed junction boxes for reasons of safety. Improperly terminated electrical conductors should be repaired by a certified, licensed electrical specialist.
