June 17, 2014

Property Inspection Report

**772 Fairlane Avenue
Los Angeles, CA 90049**

Prepared for: New Homebuyer

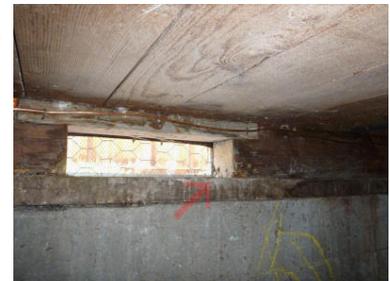
BEAMS & JOISTS: The visible portions of the underfloor beams and joists appear to be generally serviceable. **A small area of wood damage noted at the rim joist - see photo.** For further commentary and recommendations refer to a current structural pest control report.

very small area of damage at rim joist

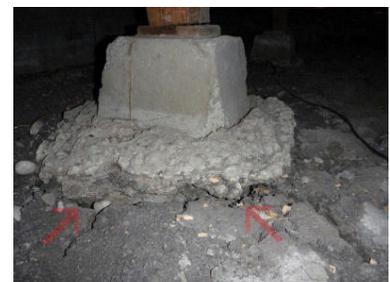
COLUMNS/SUPPORTS: The existing columns/supports appear serviceable, although the expansive nature of the soil has led to shrinkage away from a few piers - see photo. Consider the property upgrade of improvement by adding self-leveling fill around a few piers as needed. **One post/pier was not provided with a cement pad at grade - see photo.** Consider improvement by adding a pad at this location.

consider filling cracks in soil at pads

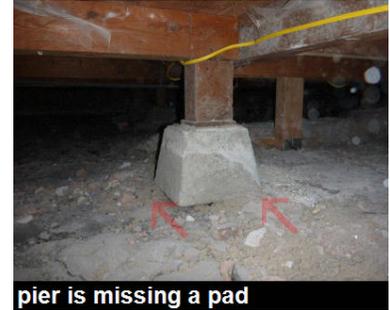
pier is missing a pad

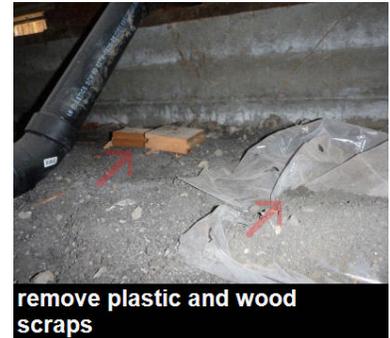
Symptoms of water entry exist - damp soil. (The precise source and cause of the moisture was not determined, but it may be related to seasonal soil conditions.) *Plastic sheeting is present in some places on the soil of the underfloor area. However, the plastic tends to aggravate wet conditions because it does not control the water during wet cycles and it keeps the soil from drying out during dryer times.* We suggest removal of the plastic sheeting.

The underfloor ventilation is adequate in the accessible areas. *Remove cellulose debris (wood, etc.) from the underfloor area so as not to attract termites or other pests.*

remove plastic and wood scraps

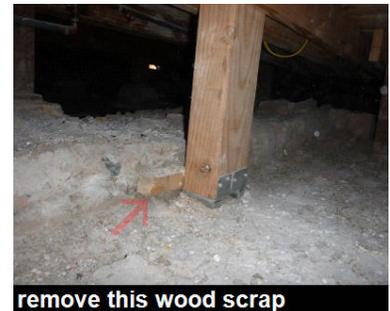
remove this wood scrap

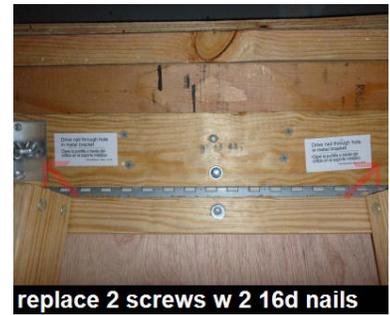
Attic is full size. The inspector entered all accessible areas of the attic. The attic access panel is located in a hallway and in the garage. **The pull-down access ladder is missing key fasteners.** Add a 16d nail in each top bracket per manufacturer's recommendation (see photo). Screws are not acceptable as they do not have the shear strength of nails. *Although not required, we recommend protective covers or cages be installed on light bulb/s to prevent injury as a property upgrade.*

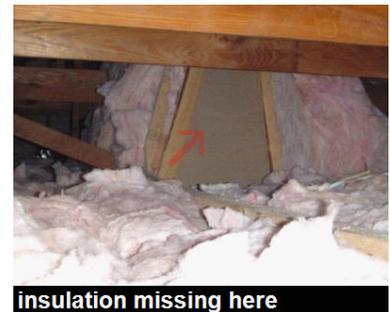
Fiberglass batting Cellulose-loose fill. *Insulation coverage is not complete (gaps seen). A 1% loss of coverage will mean roughly a 5% loss in efficiency. Coverage should be improved to restore full functioning of the insulation layer. Remember to keep any insulation clear of vents and all exhaust flues (and any non-IC-rated recessed lighting). Consider fully insulating all skylight chase/s or sun tube/s for more efficient heating and cooling of the interior of the home.*

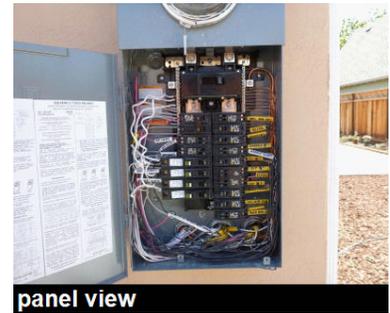
The electrical service panel / meter is located at the exterior of the building.

Grounding system is present, Circuit and wire sizing correct so far as visible. **The panel enclosure does not appear to be properly bonded.** The neutral and ground bars appear to be connected at a "floating" bus bar. This is easily corrected by adding a bonding jumper strap.

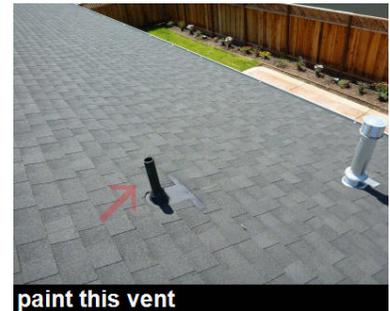
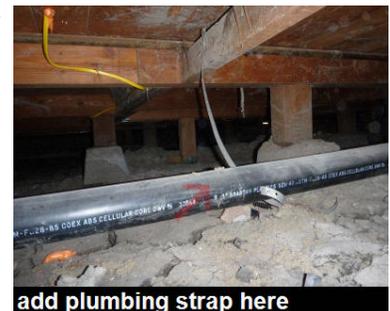
CONDITION: *The waste piping could have additional support hangers of an approved type - see photo.* Current building standards dictate that ABS waste piping should be supported with approved hardware every 4' horizontally and at every change of direction.
