March 18, 2014

Property Inspection Report

**12520 Nancarrow Way
Pacific Palisades, CA 90272**

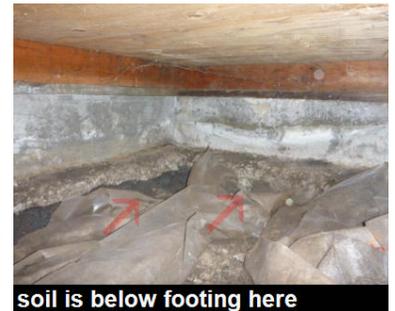
Poured concrete. The perimeter foundation is believed to be performing well for the age of the building. Anchor bolts are fasteners that connect the wood framing to the foundation. They are a basic precaution to help prevent a home from moving off it's foundation during an earthquake. Anchor bolts were found to be in place in the visible and accessible areas although the inspector did not perform a bolt by bolt search. **A section of concrete perimeter footing is undermined / lacks adequate support near the front entry** (perhaps for excavation of the sewer line) - see photo. No distress is noted, but consider improving support (by backfilling) here.

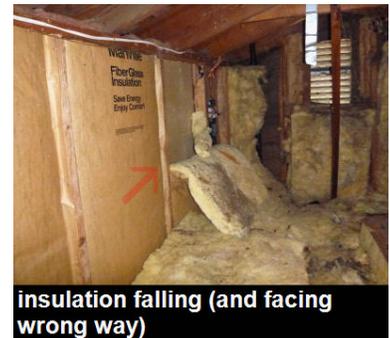
insulation falling (and facing wrong way)

Fiberglass batting Fiberglass-loose fill. *Insulation coverage is not complete (gaps seen). Coverage should be improved* to restore full functioning of the insulation layer. Remember to keep any insulation clear of vents and all exhaust flues (and any non-IC-rated recessed lighting). *Batting insulation is installed backwards (with the vapor barrier facing away from the conditioned space).* For decreased maintenance (to prevent condensation inside the insulation) you should turn the insulation to face the other way.

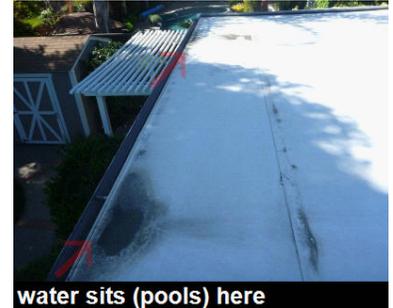
Every low-slope roof should slope at least 1/4" per foot to a drain. **There is evidence of water "ponding"**. We recommend improvement to allow the water to drain completely.

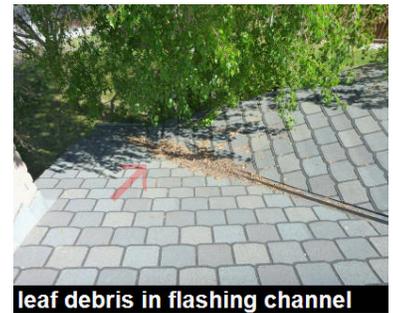
Metal. *Exposed fasteners are seen at the flashing detail.* For decreased maintenance these fasteners should be covered with approved sealant. *Debris has built up in the flashing channels.* This material should be removed as part of periodic maintenance and to better view its condition.

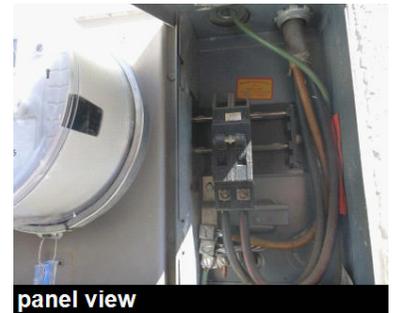
panel view

The size of the incoming electrical service is sufficient for a typical single family's needs. This service is equipped with a "Zinsco" brand electrical panel. **While often these panels are dependable, they are aging and some configurations are notable for poor connections of the breakers at the busbar as well as undependable tripping of the breakers and as such call for review (and possible replacement) by a qualified electrician.** When the electricity use patterns change more demand can be placed on a given circuit which may highlight a problematic circuit breaker.

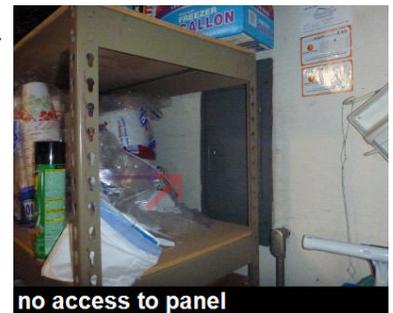
The electrical equipment panel is located in the garage. **Circuit/s are without the benefit of complete and clear labeling.** This is problematic for a person attempting to safely work on a circuit. Each circuit should be accurately identified. **Panel working space should ideally be 36" deep extending to the floor.** For increased safety and to facilitate inspection of this panel we recommend keeping this area clear. In other words nothing should be installed or stored in this area under the panel to allow safe access and escape from the immediate panel area. **Inspector was unable to open the panel and inspect the interior because**

no access to panel

of blocked access. We recommend evaluation of the panel interior & correction of any issues by a qualified electrician. This service is equipped with a "Zinsco" brand electrical panel. **While often these panels are dependable, they are aging and some configurations are notable for poor connections of the breakers at the busbar as well as undependable tripping of the breakers and as such call for review (and possible replacement) by a qualified electrician.** When the electricity use patterns change more demand can be placed on a given circuit which may highlight a problematic circuit breaker.

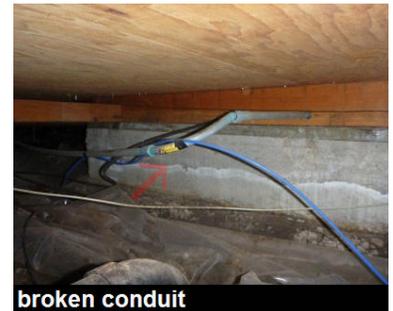
The visible 120v portions are copper non-metallic sheathed cable. (Opening of the garage panel may reveal aluminum wiring as well, simply because of the year built.) **Extension cord/s used as semi-permanent wiring in the garage, which is not an approved method of providing permanent power.** We recommend consultation with a qualified electrician to evaluate how improvements (such as hard-wiring additional receptacle/s) can be accomplished to prevent this practice. **For increased safety we recommend exposed wiring be properly attached and protected - repair is needed at a broken conduit in the underfloor area** to reduce the potential for stretching and abrasion.

broken conduit

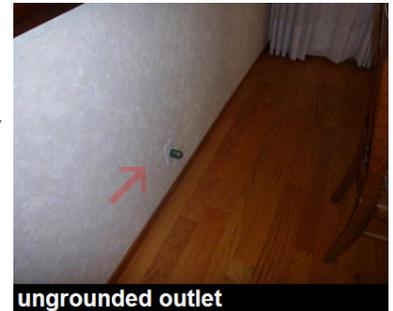
A Ground Fault Circuit Interrupter (GFCI) is a safety protection device incorporated into an electrical receptacle. Although the home very likely met the electrical requirements at the time of construction, **GFCI outlets were not observed / labeled in all recommended locations. If an electrical circuit is controlled by a GFCI outlet or breaker, but individual outlets don't have reset buttons we expect to see a sticker on those receptacles to show that GFCI protection is present.** (Often the stickers are just missing.) GFCI outlets are inexpensive and typically installed at all exterior, garage, basement, bathroom and kitchen counter locations (unless the outlet is dedicated to serve a specific appliance). **We do not determine if GFCI circuit breakers are controlling appropriate circuits.** (Refrigerators should be on a dedicated, non-GFCI circuit). GFCI outlets were not tripped/reset as part of this inspection nor were the redundant reset locations established because often GFCI outlets are controlling an entire circuit and it can be a significant inconvenience if they fail to re-set. They should be tested by the occupants periodically. **For increased safety all receptacles in wet locations could have a (bubble-type) listed enclosure that is weatherproof even when a cord is plugged in to it. At least one grounded type outlet tested as having no ground connection - see photo.** We recommend review /

ungrounded outlet

correction as needed by a qualified electrician.

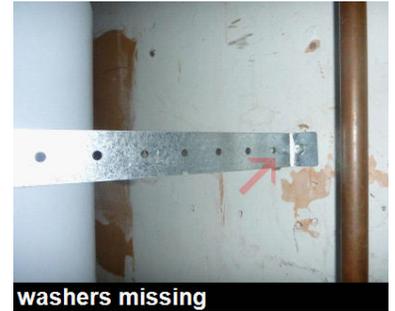
washers missing

A water shutoff valve is installed, but not tested. Temperature-pressure relief (TPR) valve noted. **The water heater needs improvement to seismic strapping to meet California safety standards.** As part of the transfer of real property in California all tank storage water heaters must have seismic strapping correctly installed. Unfortunately, water heater strapping is a widely misunderstood subject. The standards that most municipalities use for water heater strapping is issued by the State Architect's Office can be found at http://www.seismic.ca.gov/HOG/waterheaterbracing_08-11-04.pdf. We recommend immediate installation of proper restraints in accordance with current industry standards and local jurisdictional requirements. **There are no washers to protect the strapping from tearing at the lag screws.** Seek corrections as needed by a qualified tradesperson.

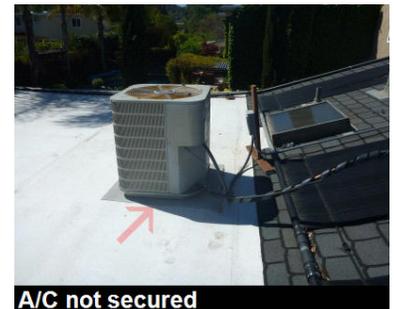
We suggest installing seismic tie-downs at the condenser unit pad (outside) to prevent damage to the equipment and wiring.

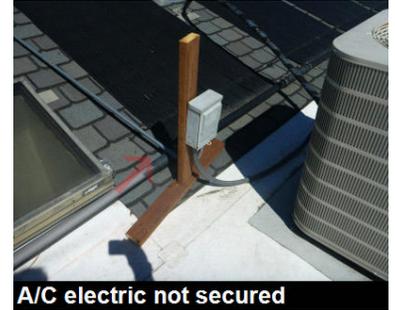
POWER SOURCE: 240 volt. Electrical disconnect present, but the wiring / box is mounted to an unsecured / wobbly post. **Correction should be considered.**

A/C electric not secured

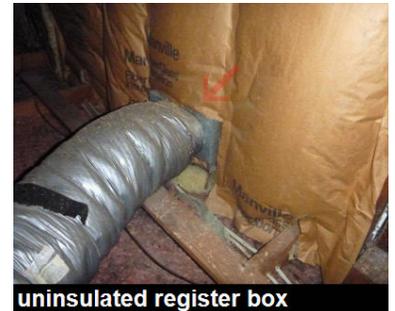
TYPE & CONDITION: The visible portion consists of flexible metal (insulated) ducts. Insulated sheet metal ductwork. *This is older ductwork and as such it is likely due for cleaning of the duct interior as an investment in indoor air quality.* **Outer wrapping of ductwork is missing in places.** This adversely affects the efficiency of the system. All ductwork / register boxes (including return air ducts) in unheated spaces should be insulated to prevent heat loss, but also to protect against condensation.

uninsulated register box

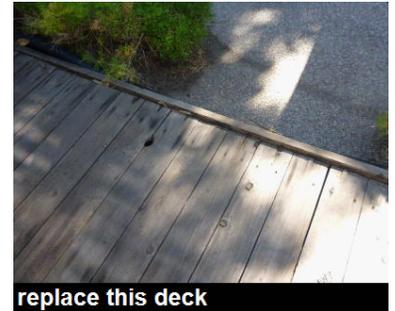
CONDITION: *The deck surface has an opening/hole which presents a tripping hazard (especially with certain shoes). This is a safety issue. Deterioration noted to the deck surface. Viewing was restricted under the deck structure and so a full assessment of this area was not possible. The structure of the deck is compromised. Replacement should be budgeted for.*
