September 15, 2014

Property Inspection Report

**170 Sturla Court
Santa Monica, CA 90403**

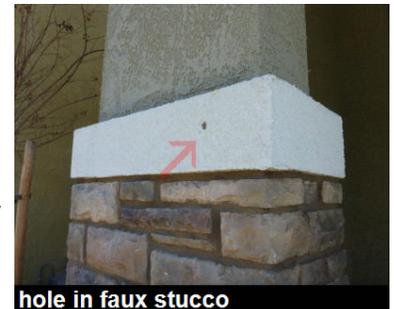
A faux stucco (we do not determine if it is EIFS) is utilized as trim. Special attention should be given to flashing details and sealing of all joints and cracks or openings. Complete evaluation of this type of material, if desired, is done by certified specialists who perform full moisture intrusion tests to determine the quality of installation and concealed conditions. **Damaged trim is noted at the front of the house** - see photo.

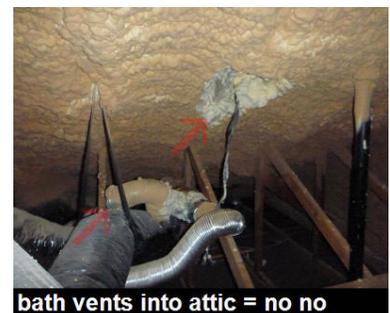
The attic and roof support structures appear to be performing well. Ventilation is not provided. This is a foam-encapsulated attic, which we are not familiar with in regards to ventilation requirements. Inquiry with the builder and municipal code officials is suggested. ***Bathroom ventilation fan/s terminate in the attic space.*** This will produce warm, moist air which is undesirable in the attic. We suggest making certain that all fans vent to the exterior.

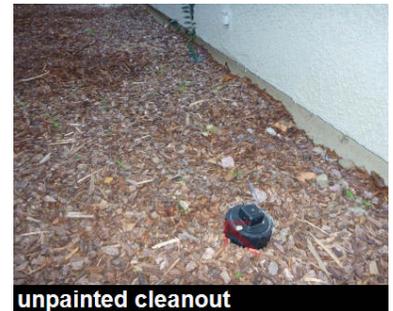
MATERIAL: The portion viewed was ABS, *Unpainted exterior ABS roof plumbing cleanout seen.* We recommend painting all exterior ABS pipes to reduce premature degradation of the vent piping from sunlight.

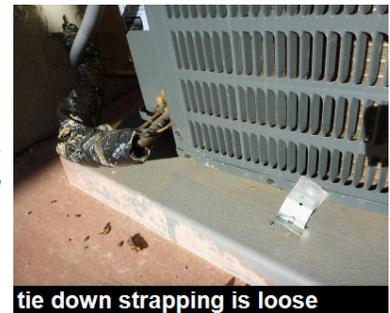
TYPE: Central. Central cooling is accomplished by electrically-powered refrigerant compression, with the cooling (evaporator) coil mounted adjacent to the gas-fired furnace and the condenser at the exterior of the structure. *We suggest installing seismic tie-downs at the condenser unit pad (outside) to prevent damage to the equipment and wiring.*

tie down strapping is loose

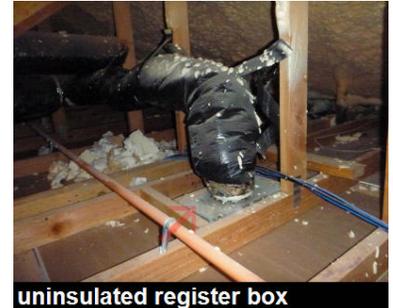
The visible portion consists of flexible metal (insulated) ducts. **Outer wrapping of ductwork is missing in places.** This adversely affects the efficiency of the system. All ductwork / register boxes (including return air ducts) in unheated spaces should be insulated to prevent heat loss, but also to protect against condensation. **Ductwork is disconnected in the attic.** This allows conditioned air to escape resulting in an inefficient operation and allows dust/dirt into the house air. We recommend having a qualified HVAC contractor make review / correction as needed.

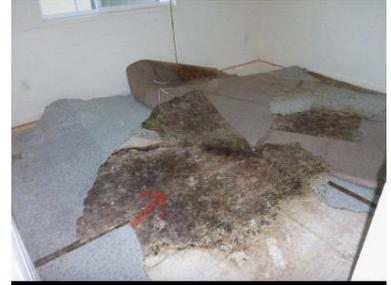
Floor covering is vinyl and carpet and *with damage noted* and tile. **The flooring is extensively damaged (with mold of an unidentified type) underneath the carpet at three bedrooms.** We suggest safe (professional) removal of material to accurately determine the cause and extent of any damage behind finished surfaces, including walls and ceilings. **It should be assumed that dangerous mold is present in the floors, walls and ceilings until proven otherwise!** Professional verification / treatment of all mold is strongly advised.

extensive mold / floor damage

The flooring is extensively damaged (with mold of an unidentified type) underneath the carpet at the three upstairs bedrooms. We suggest safe removal of material to accurately determine the cause and extent of any damage behind finished surfaces. **Professional verification / treatment of all mold is strongly advised.**

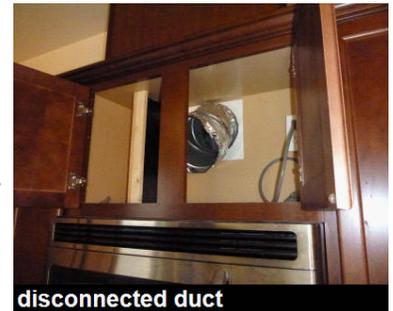
External. Fan was operational one or more speed settings at the time of the inspection. **Exhaust vent is not aligned/connected and air is being expelled into the attic/cabinet.** We recommend correction prior to use. **Exhaust fan screen is dirty.** In addition to underperforming and causing strain on the motor it would be dangerous if it ever caught fire. For increased safety we recommend cleaning this screen prior to use and on a regular schedule. A grease fire is not stopped with water, but instead with the use of a listed, approved fire extinguisher. **The fan is mounted rather low over the range burners (less than 24").** Consider modification to follow current building standards for increased safety.

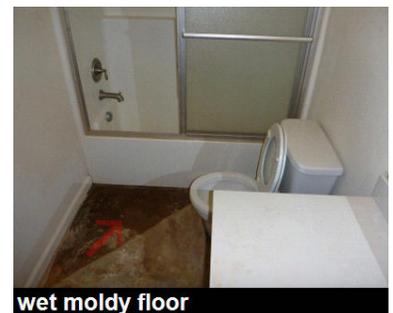
BATH FLOOR/WALLS: **Damage is noted to the vinyl covering - replacement is needed. Mold of an unidentified type was seen along with water damage to the subfloor.** We always advise professional treatment of mold and ensuring that the ventilation is adequate. Consider destructive testing to determine the status and extent of any issue behind finished surfaces. A qualified tradesperson should make review/correction as needed. For further commentary, refer to a current structural pest control report.

Damage is noted to the vinyl floor covering - replacement is needed. Mold of an unidentified type was seen along with water damage to the subfloor. We always advise professional treatment of mold. Consider destructive testing to determine the status and extent of any issue behind finished surfaces.
