YOUR INSPECTION REPORT

[REDACTED]
Vancouver, BC V6J 3S2

RE: Report No. 1054
[REDACTED]

GENERAL DESCRIPTION OF PROPERTY

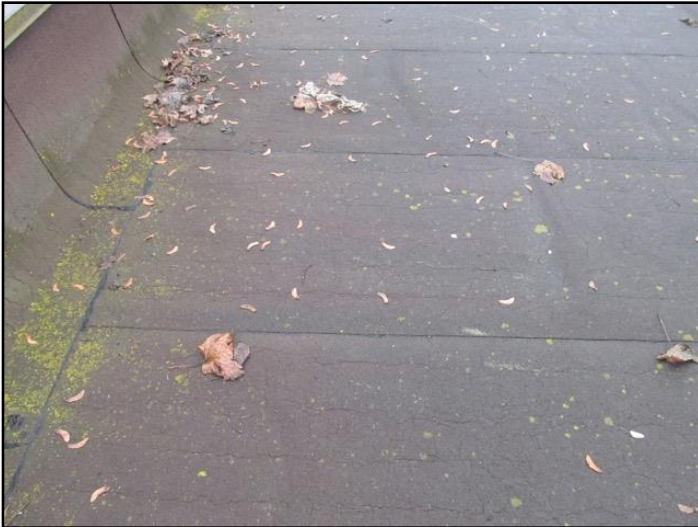
1. General

The roofing material installed is a torch-on/roll roofing that appears to be in unsatisfactory condition with visible patches, cracks, blisters and typical deterioration.

The roof has one drain without screens and it requires regular maintenance/cleaning. I recommend cleaning all debris from the roof and around drainage system. Installing drainage screen to protect debris and other dirt entering in the drainage system is recommended. The roof surfaces have minimal signs of standing water.

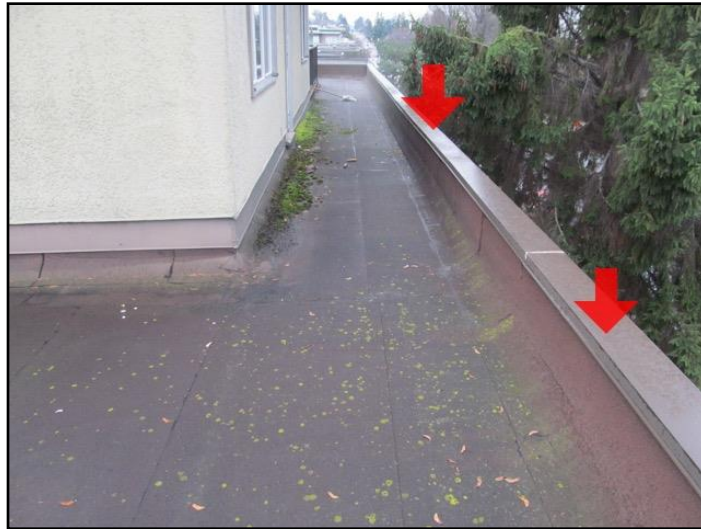
4. Metal

The building has a metal flashing along exterior walls. The flashing is in fairly satisfactory condition overall with visible patched and caulked areas to be reviewed.

Probability of leakage: • High

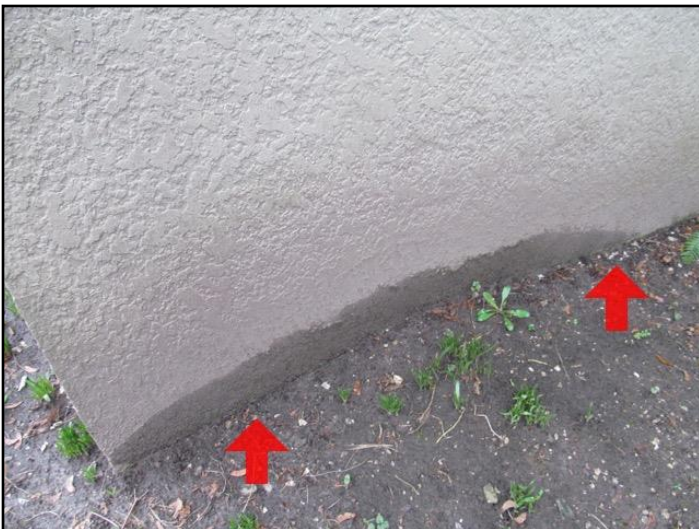
11. Too close to grade

The stucco siding is in contact with the ground and requires a clearance of 6" to 8" from the bottom of the siding to the top of the ground to ensure no moisture damage.

Implication(s): Chance of water damage to structure, finishes and contents | Material deterioration

Task: Improving stucco clearance is recommended.

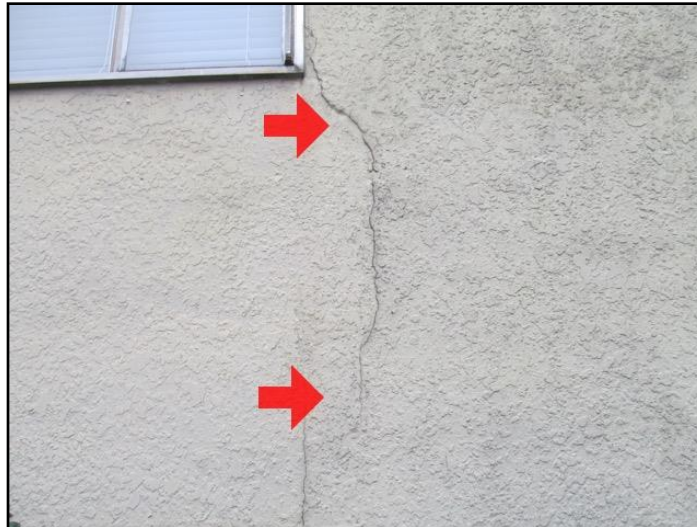
13. *Minor cracks*

The face sealed stucco siding is in fairly satisfactory condition with various minor cracks and damage to be repaired.

Task: Repairing stucco is recommended and prevent water penetration inside the wall

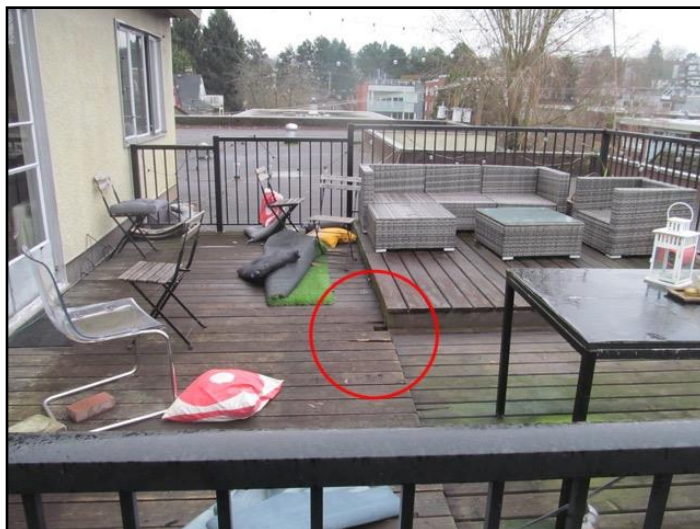
15. Damage

6. Condition: • [Damage](#)

Task: The wood on the deck is damaged and needs to be repaired. Also the deck cleaning is recommended.

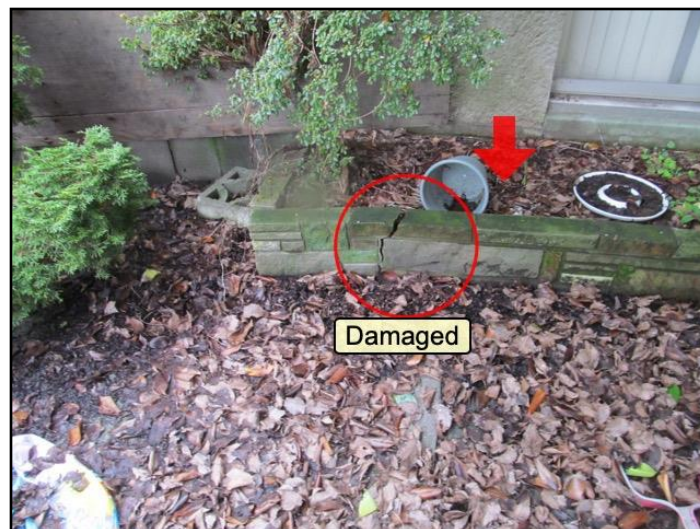
20. Planters and gardens against walls

9. Condition: • [Planters and gardens against walls](#)

Implication(s): Chance of water entering building | Chance of damage to structure | Chance of structural movement

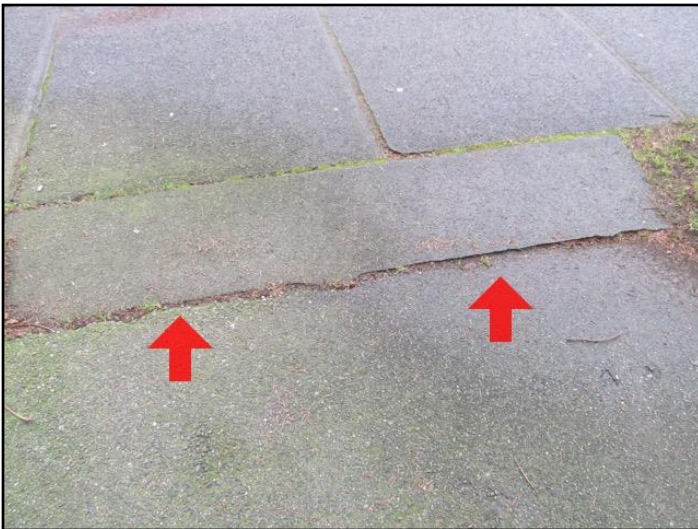
22. Possible trip hazards

11. Condition: • The property has poured in place concrete sidewalks leading the entrance doors of the building and they are in unsatisfactory condition with some visible cracks that need repair to prevent further water and ice damage making them worse over the years, and minor trip hazards that will need to be levelled off.

Task: I recommend repairing cracked concrete walkway to ensure safety/trip fall

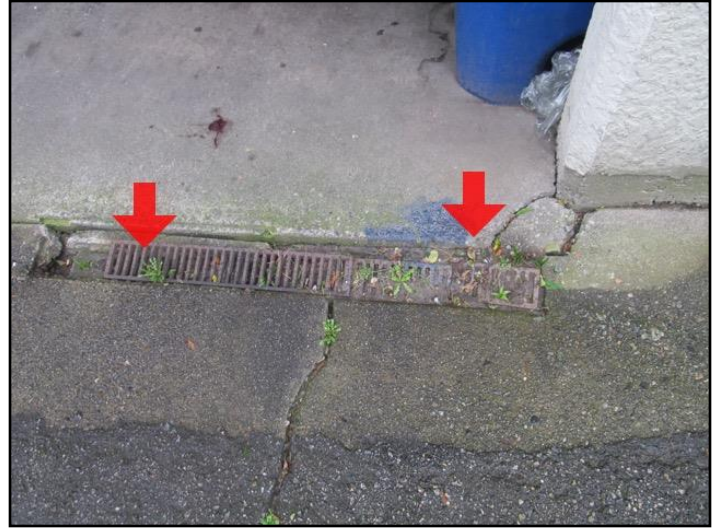
25. Drainage system

12. Condition: • Observed that drainage at the back of the building is damaged and plugged wit debris and dirt. It is recommended contacting a licensed drainage company for investigation and evaluation of the drainage system.

Task: I recommend cleaning and repairing drainage system.

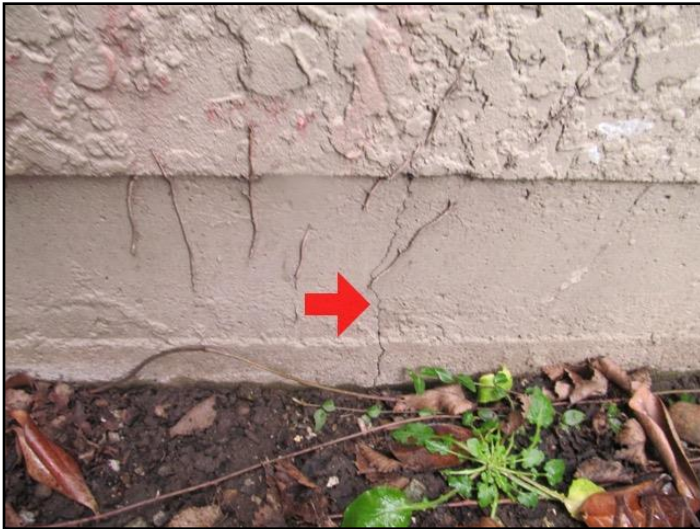
28. Typical minor cracks

13. Condition: • Typical minor cracks

Observed common typical minor cracks on the foundation wall. This type of cracks are not serious and I only recommended repairing this cracks to prevent water penetration inside the building.

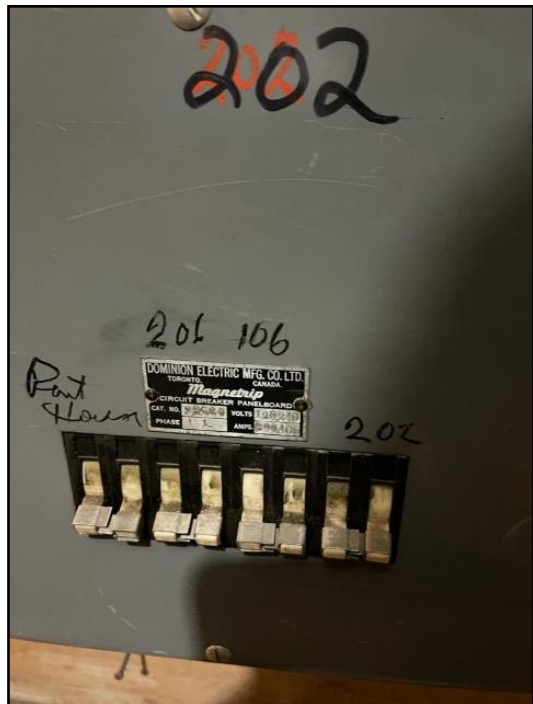
30.

General: • Observed that cover on the high voltage systems where opened at the time of the inspection. It is required that this cover is closed as it is dangerous of potential contact with these high voltage systems. The buildings main electrical service is fed overhead and enters the building in the electrical room (West side). The building has a 500-amp main switch providing power to the various units 60-amp and in unit #107 100-amp switch panels. This service equipment is original and remains in fairly satisfactory and operational condition. I suggest replacing the equipment in the near future to avoid unexpected equipment failure as well recommend contacting insurance provider for more information about this old equipment.

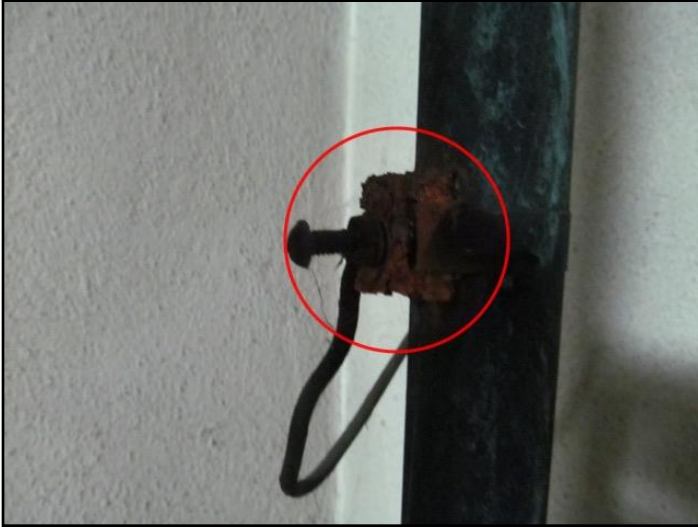
43. Rusted clamps

System grounding material and type: • Grounding for the electrical system is located in the boiler room (bonded to the water line). All clamps are metal and they are in unsatisfactory condition.

Task: I recommend contacting qualified trade person for replacing all clamps.

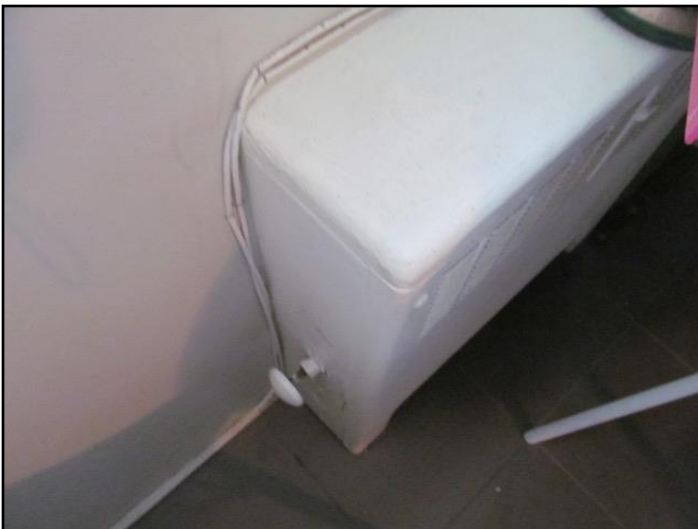
52. Baseboards

The building has radiant hot water baseboard heaters that are in unsatisfactory condition to fairly satisfactory condition, some signs of previous leakage were noted on the day of the inspection along with damaged shut off valve handle and loose metal covers. No current leaks were seen on the day of the inspection.

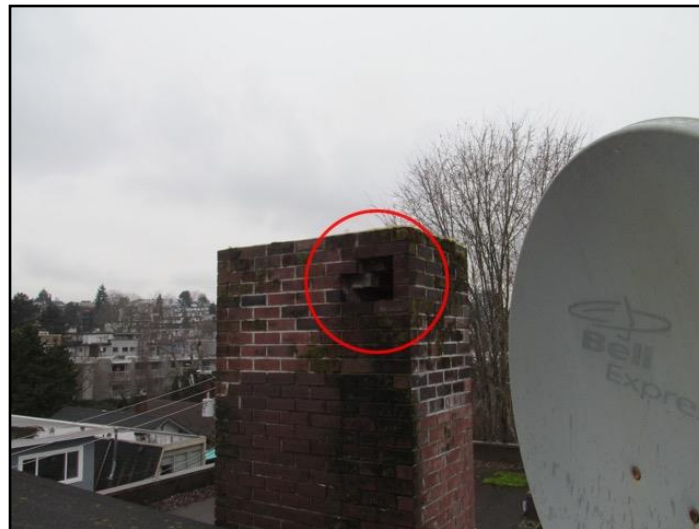
54. Loose, missing or deteriorated masonry

16. Condition: • [Loose, missing or deteriorated masonry](#)

Observed damaged chimney that needs to be repaired.

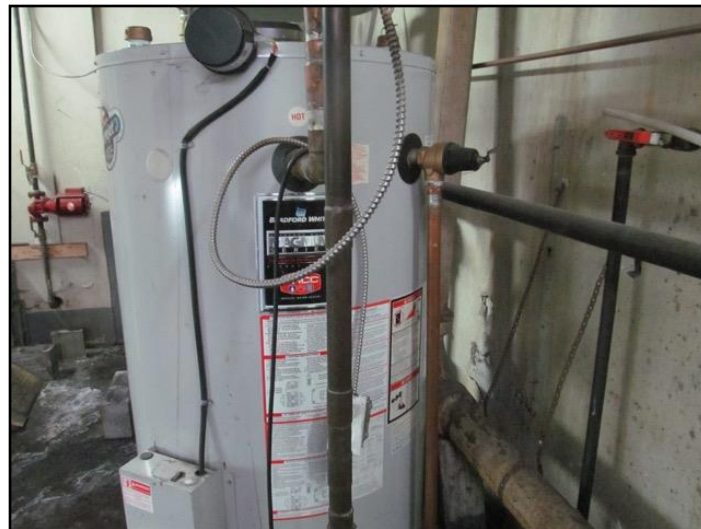
67.

General: • The building has one model "Bradford White" hot water holding storage tank located in the boiler room. The tank has a capacity of 100 US gallons, and manufactured in September 2009. The tank is near the end of life expectancy. The expected service life for this type of tank is between 8 and 10 years.

Observed missing seismic straps. There is a floor drain in the boiler room nearby the tank.

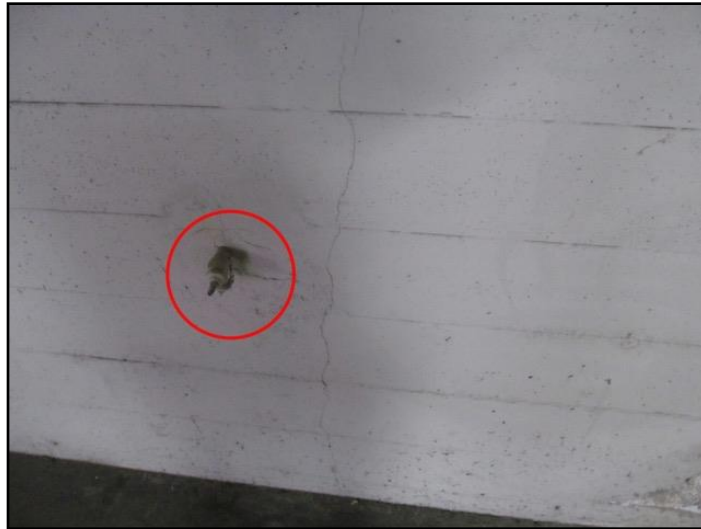
76.

Exterior hose bibb (outdoor faucet): • The hose bibb is in unsatisfactory condition and also there is no back- flow prevention and bib is not frost protected.
