December 10, 2021

Taryn Arbeiter
President
Friends of Chosewood Park
FriendsofChosewoodPark@gmail.com

**SUBJECT: Findings for the Bank Erosion Hazard Index and Near Bank Stress Analysis
Chosewood Park
Atlanta, Fulton County, Georgia**

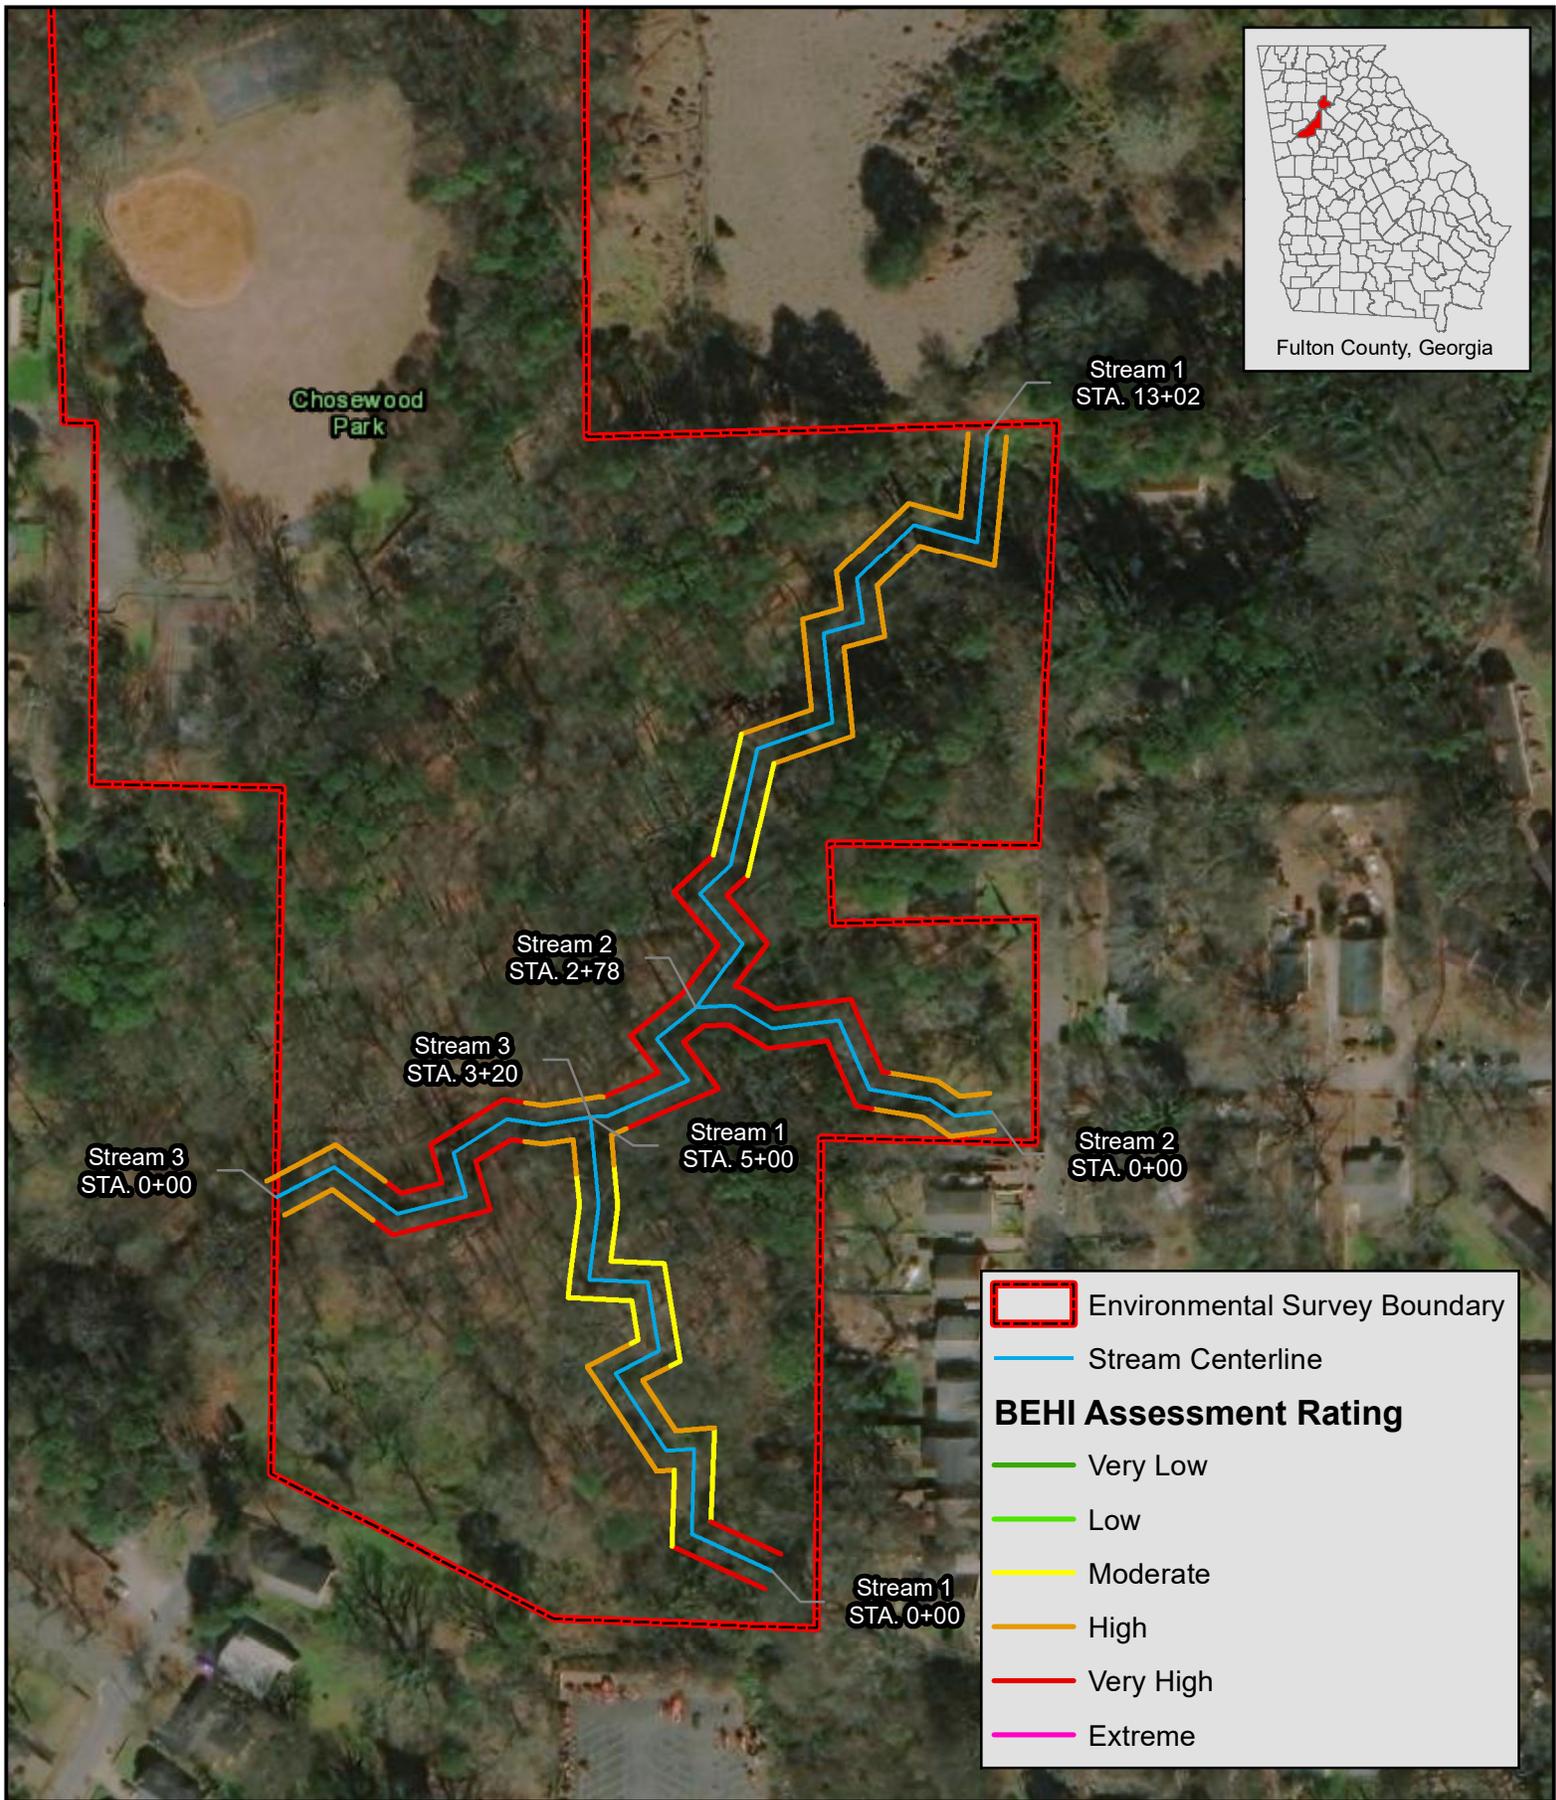
Figure 3
Bank Erosion Hazard Index Map

As noted in the attached figures (see Figures 3 & 4; **Attachment A**) the BEHI evaluation for Streams 1-3 identified primarily moderate, high, and very high-risk ratings along the surveyed stream reaches. The greatest contributing factors to the moderate to very high-risk ratings were low root density, high streambank angle, low surface protection, and streambank height as compared to the bankfull (i.e., typical portion of channel accessed by flow) height. Stream reaches within tight meander bends and at locations of converging flows exhibited increased BEHI ratings. Additionally, stream reaches characterized with low radius meander bends are subject to greater forces during storm events and typically result in greater channel bank instability and erosive soil loss. The streambank substrate is primarily clay loam with some sand intermixed which is beneficial for the system and helps the streambank soil to bind to itself and vegetation. Only slight amounts of sediment deposition were observed in the channel itself, indicating there is likely little upstream sediment contribution and the system is transporting a majority of the sediment loss from the streambanks downstream to other surface waters. Overall, the streambanks along all three streams exhibited near vertical slopes and were highly entrenched. **Figure 1** (below) provides a graphical depiction of streambank characteristics associated with the BEHI evaluation.

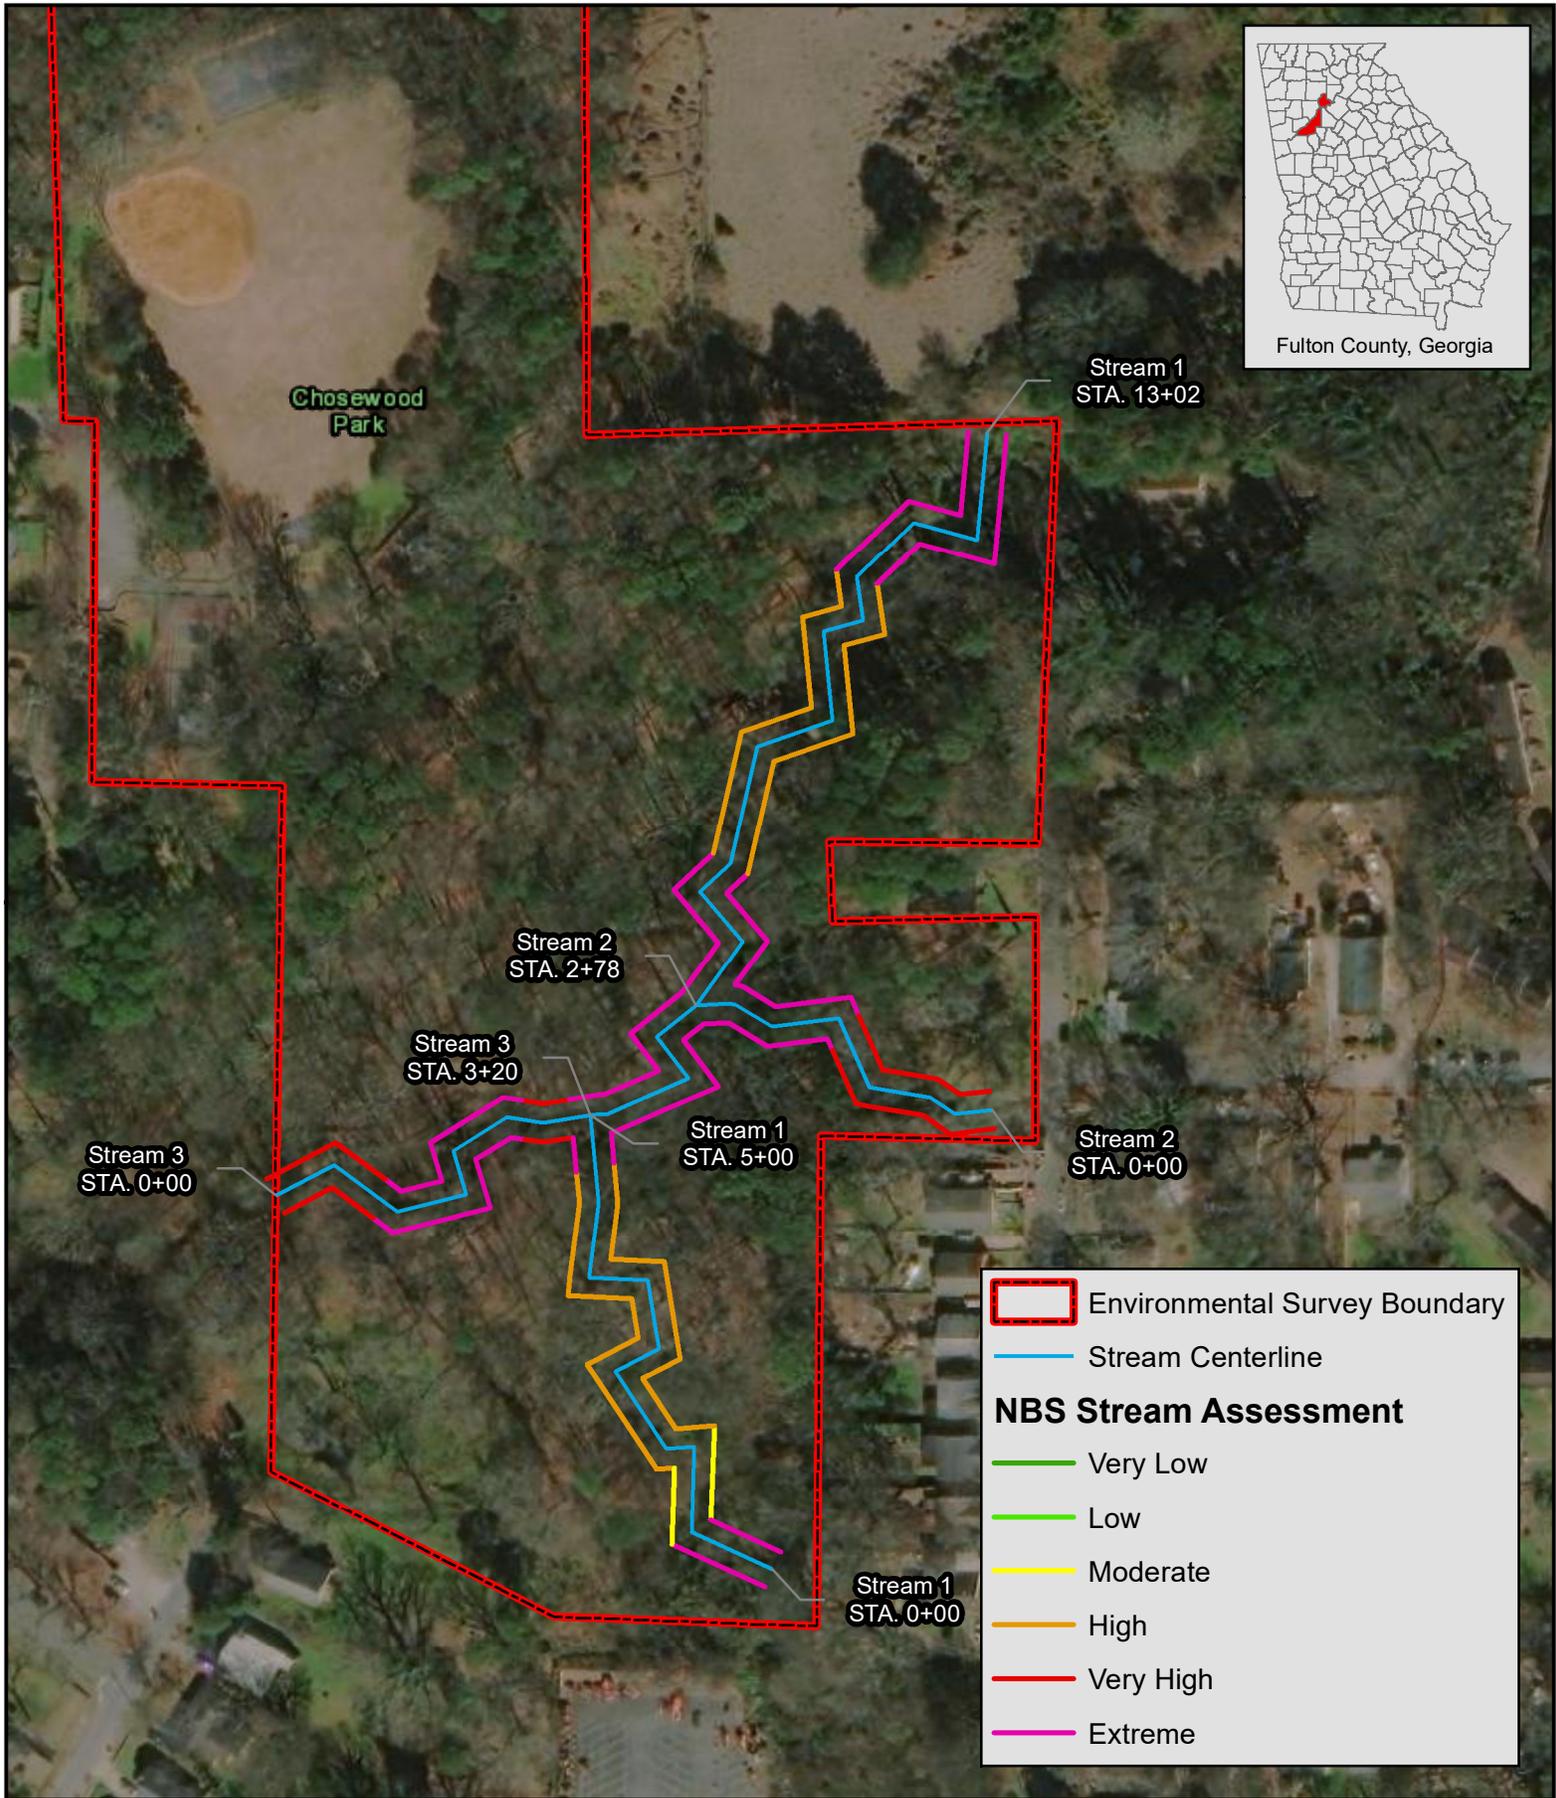
Figure 4
Near Bank Stress Map

The NBS evaluation for Streams 1-3 identified primarily high, very high, and extreme risk ratings. The stream reaches associated with moderate to high NBS risk ratings were associated with areas that were more attached to a floodplain shelf with relief from flood flows during storm events. Many areas were identified as very high or extreme risk as these reaches were highly entrenched with tight meander bends and consisted of head cuts and steep slopes. Typically, stream reaches which are highly entrenched and consist of erosional gullies and converging flows in confined systems are of very high to extreme risk as it relates to the NBS evaluation. Much of the evaluated stream system, due to erosional streambank losses and downcutting in stream channel elevation, have resulted in confined conditions. **Figure 2** (below) provides a graphical depiction of various geomorphic channel cross-sections and their associated NBS risk rating. Refer to **Attachment B** for photos of the various streams associated with this evaluation.

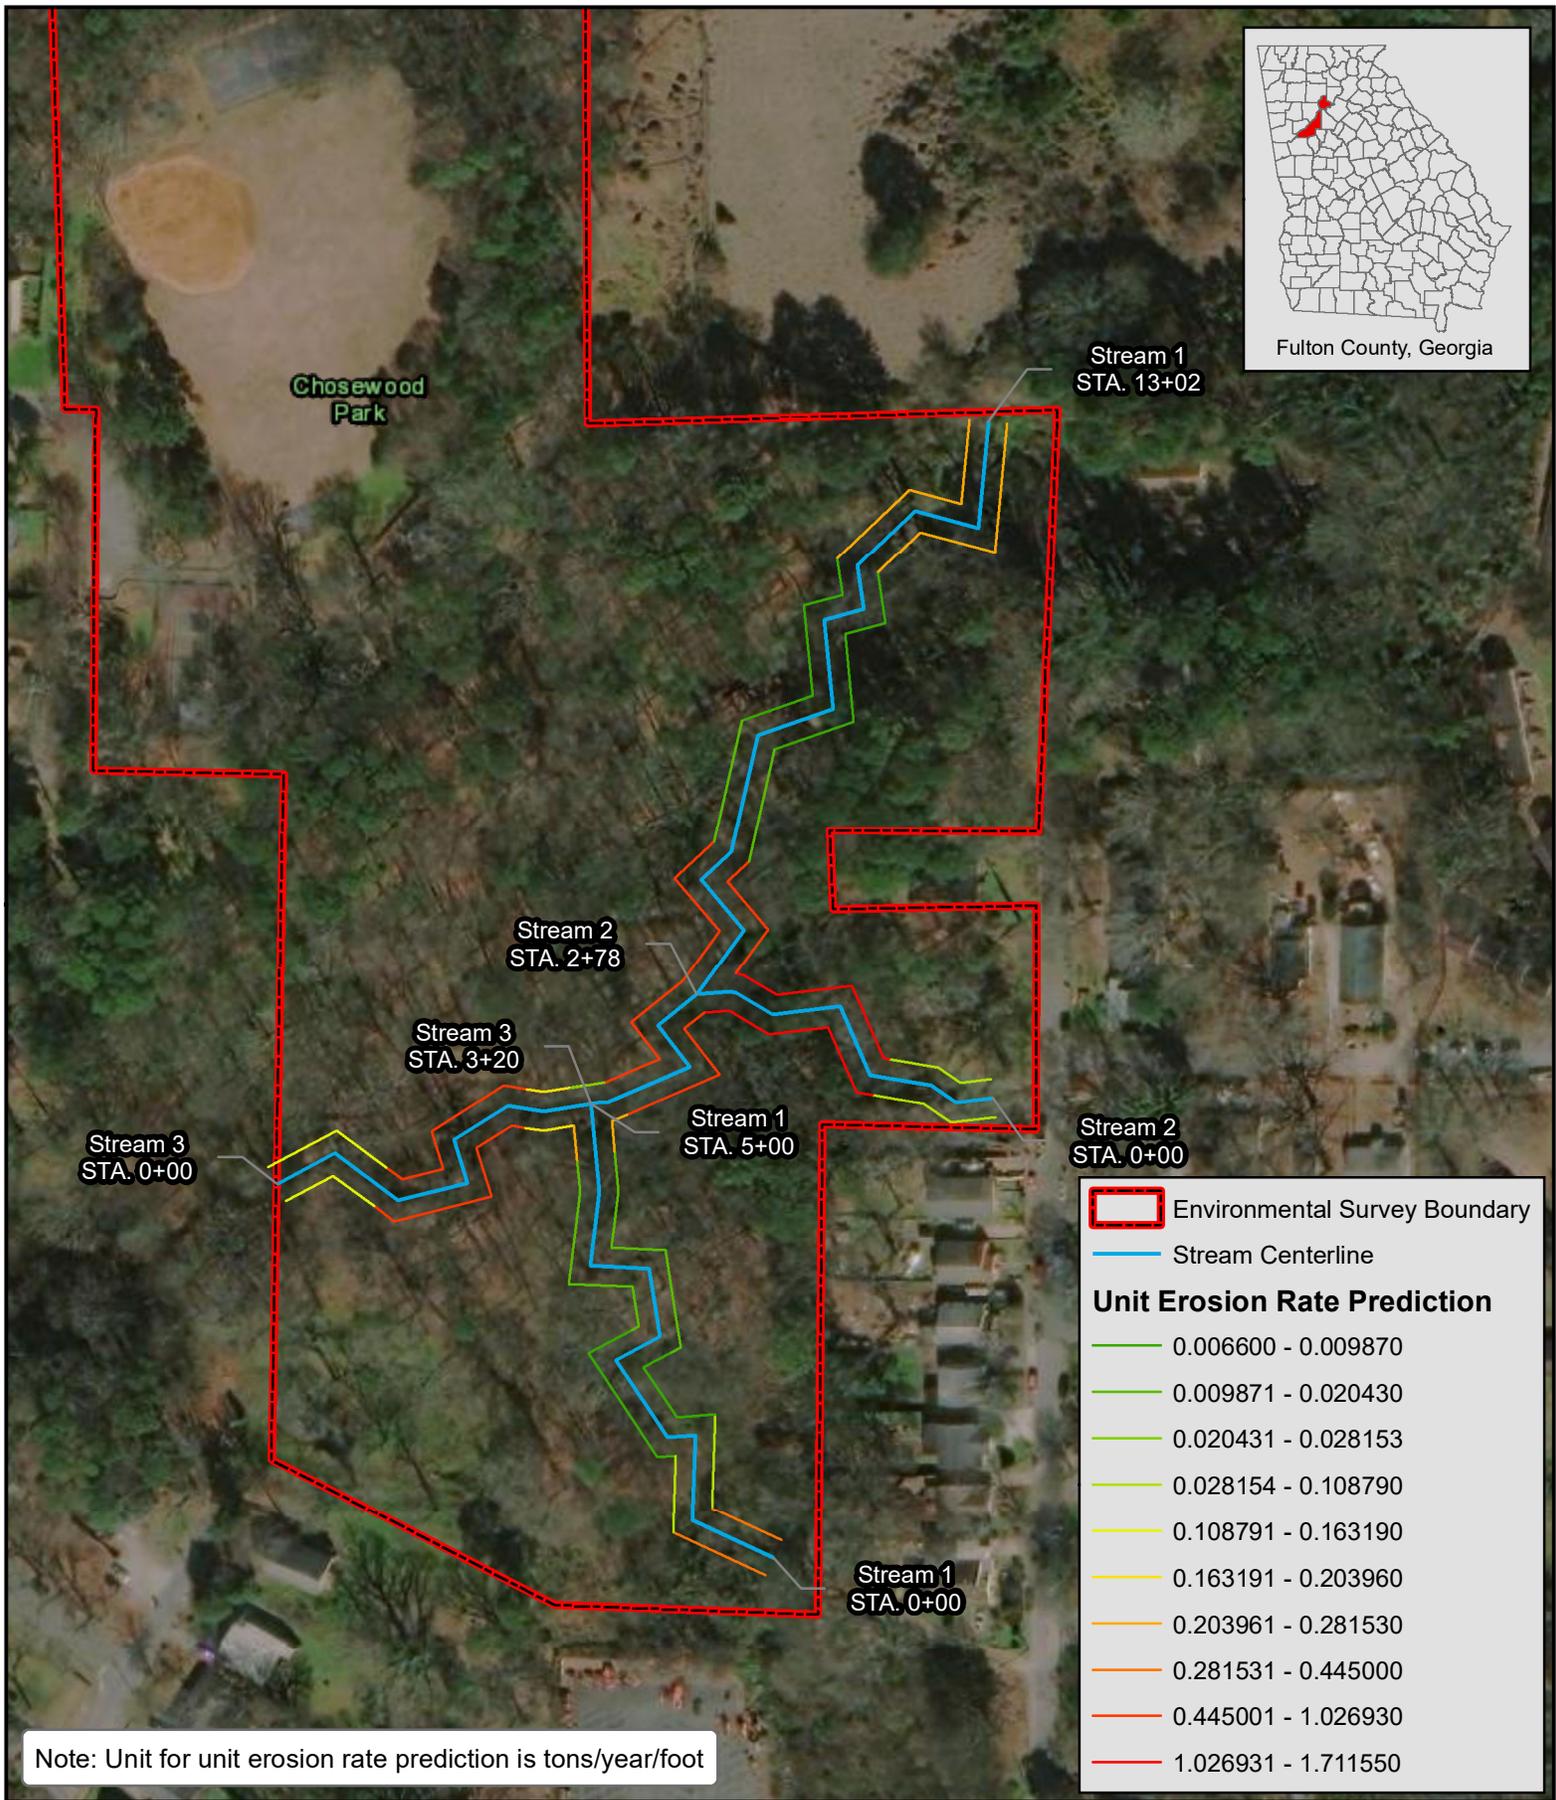
Figure 5
Erosion Prediction Map

Together NBS and BEHI analyses provide a predictive model for potential streambank erosion. Moreover, the unit rate of erosion (tons/year/foot) provides an estimate for erosive losses at any given point along Streams 1-3. Based on the observations and computations associated with the NBS and BEHI analyses, the predicted sediment loss of Stream 1 is approximately 711 tons of streambank material per year with an average unit erosion rate of 0.55 tons of streambank material per year per linear foot. Stream 2 is predicted to contribute 602 tons of material per year with a unit erosion rate of 2.17 tons of material per year per linear foot. Stream 3 is predicted to contribute 402 tons of material per year with a unit erosion rate of 1.26 tons of material per year per linear foot. These values provide a rough estimate of the potential downstream sediment migration. As the system transports sediment downstream, and approaches Entrenchment Creek and its floodplain, sediment is likely to deposit in the larger system and potentially result in downstream degradation. As flow and sediment from Streams 1-3 move downstream and enter into Entrenchment Creek, energy dissipates over its floodplain, and sediment will fall out of suspension. A summary of the observed BEHI and NBS observations and erosion predictions are provided as attachments (see Figure 5; **Attachment A & C**).

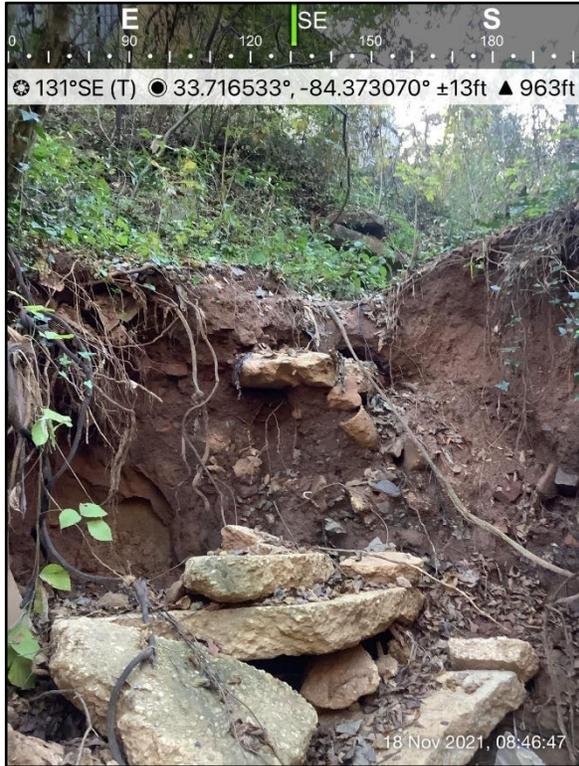
Photograph 1: Erosional drainage feature adjacent to abandoned culvert structure looking upstream along Stream 1

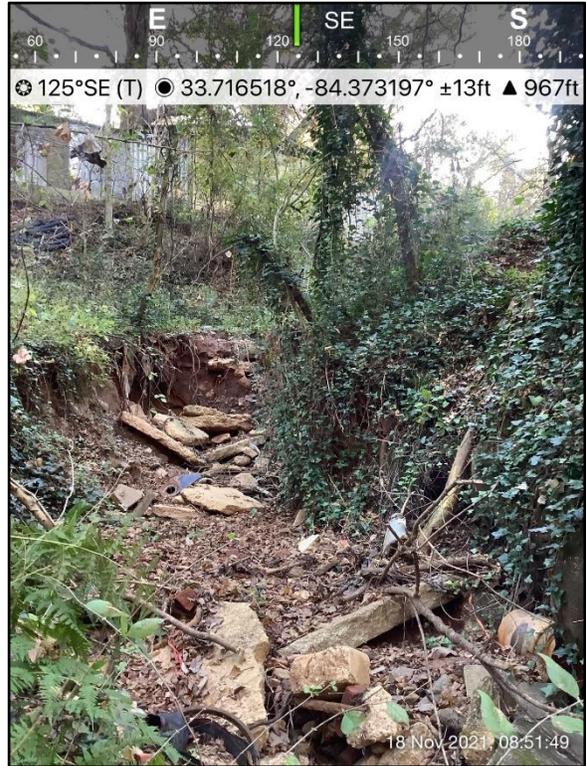
Photograph 2: Erosional drainage feature adjacent to abandoned culvert structure looking upstream along Stream 1

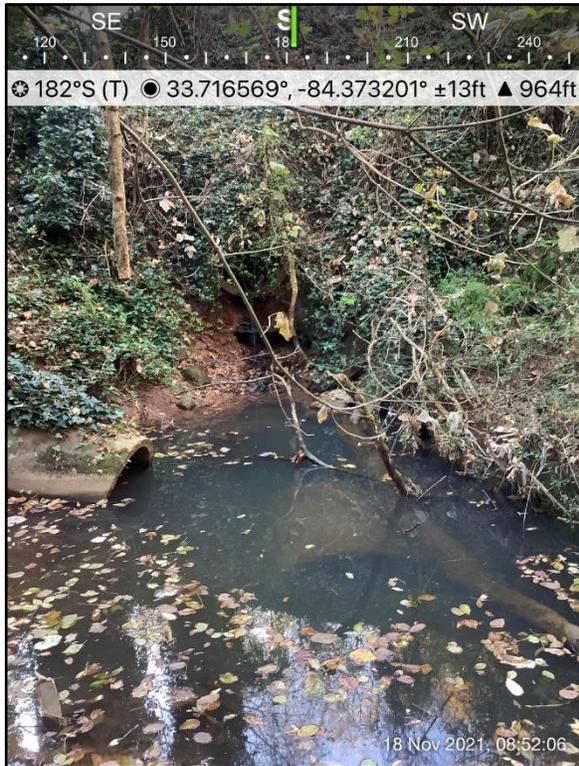
Photograph 3: Primary culvert structure draining to Stream 1 looking upstream at erosional plunge pool and relic culvert structure in the foreground

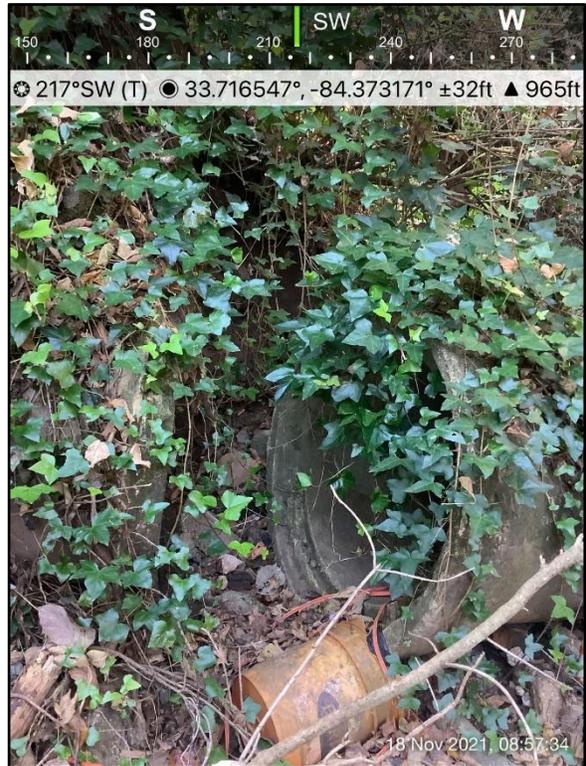
Photograph 4: Non-functional culvert structure for drainage shown in photographs 1-3

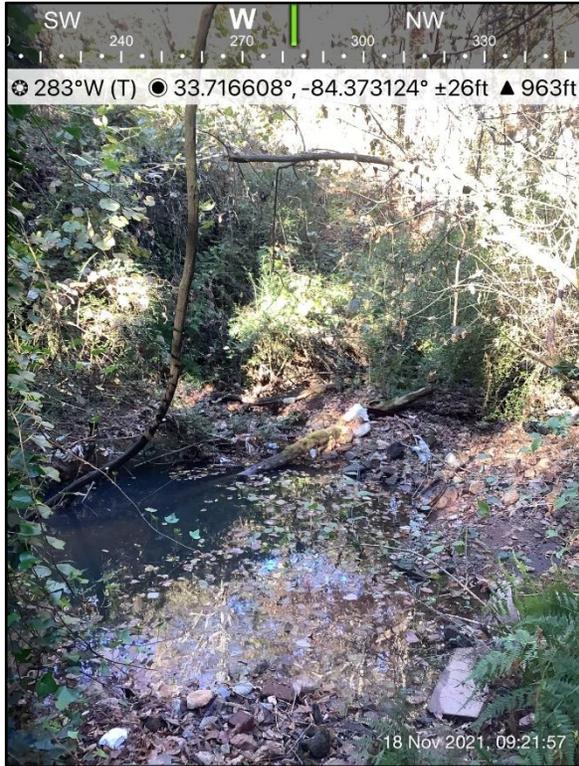
Photograph 5: Plunge pool feature from outlet of primary culvert drainage structure along Stream 1 looking downstream

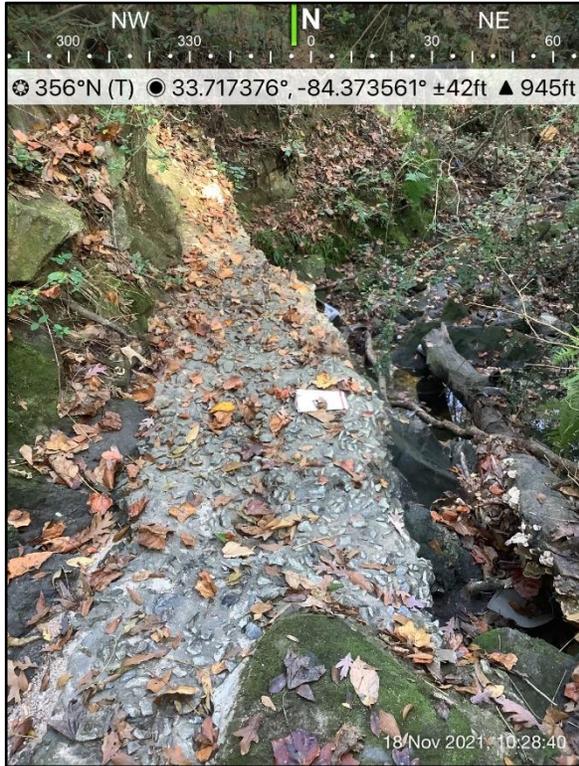
Photograph 13: Concrete pipe protection over sanitary sewer line at large headcut along Stream 1 at approx. Sta. 4+70

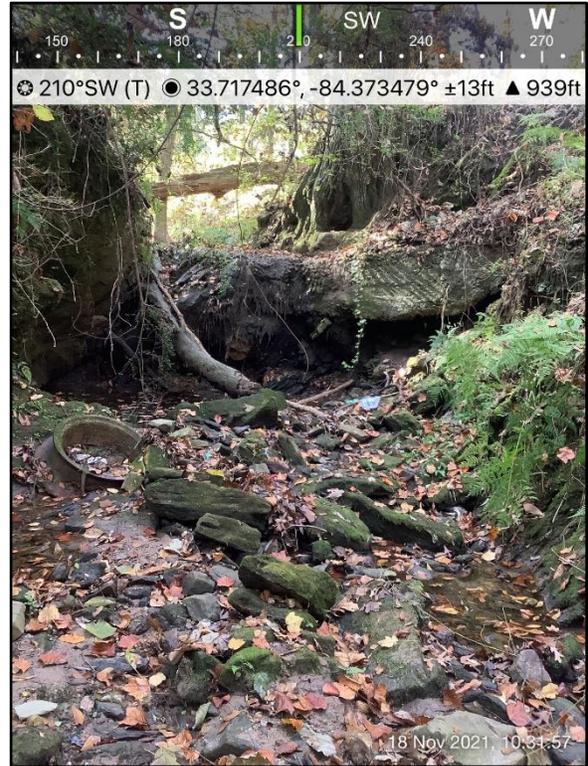
Photograph 14: Large headcut along Stream 1 near confluence with Stream 3 and sanitary sewer crossing at approx. Sta. 5+00

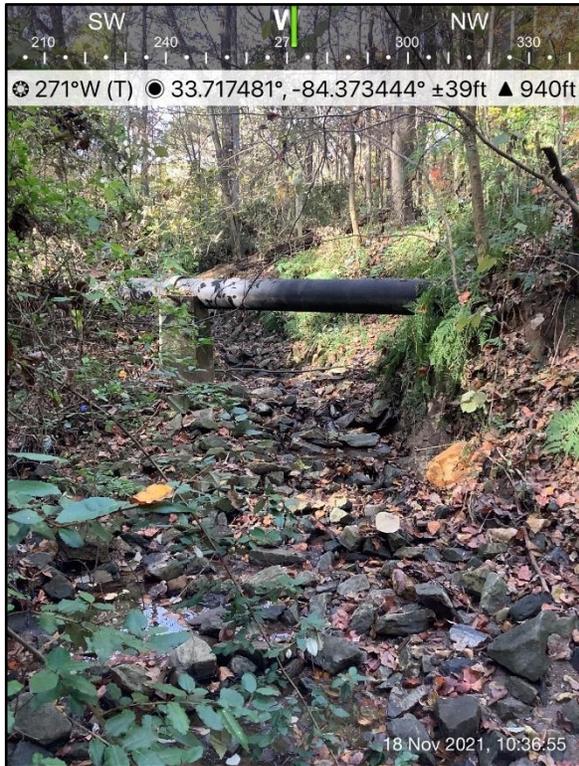
Photograph 15: Sanitary sewer crossing near confluence of Stream 1 and Stream 3 at approx. Sta. 5+00

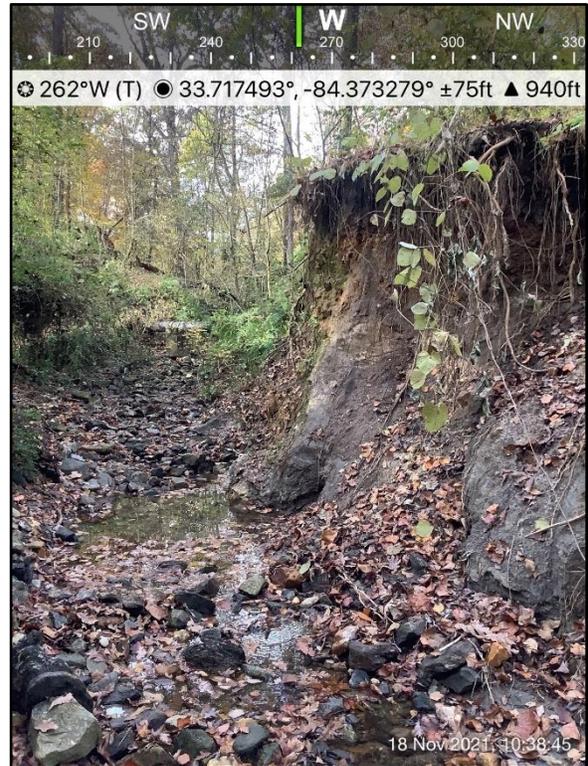
Photograph 16: Stream 1 looking upstream at actively eroding stream bank at approx. Sta. 5+60

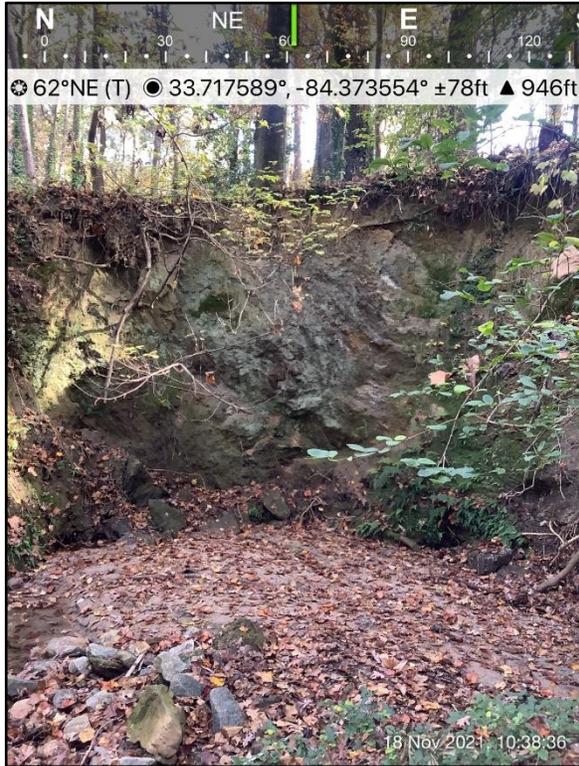
Photograph 17: Stream 1 looking downstream at erosional stream bank at approx. Sta. 5+70

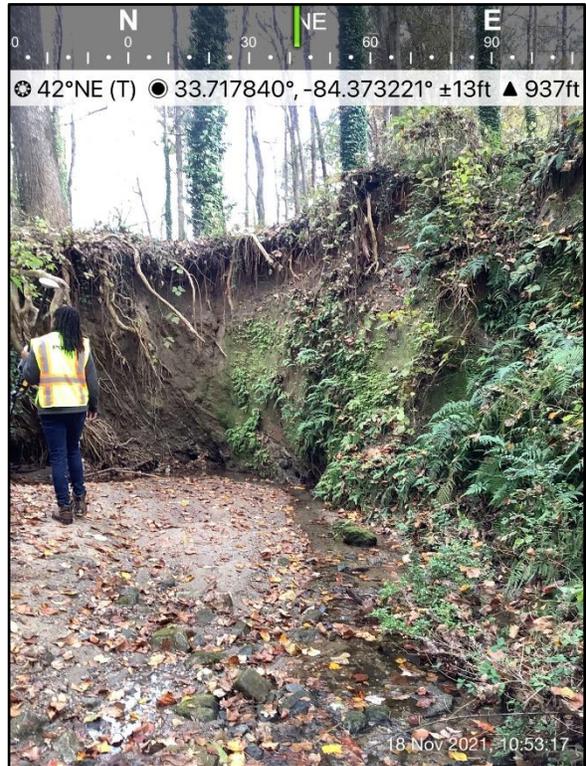
Photograph 20: Stream 1 looking downstream at undercut bank with active erosion at approx. Sta. 7+00

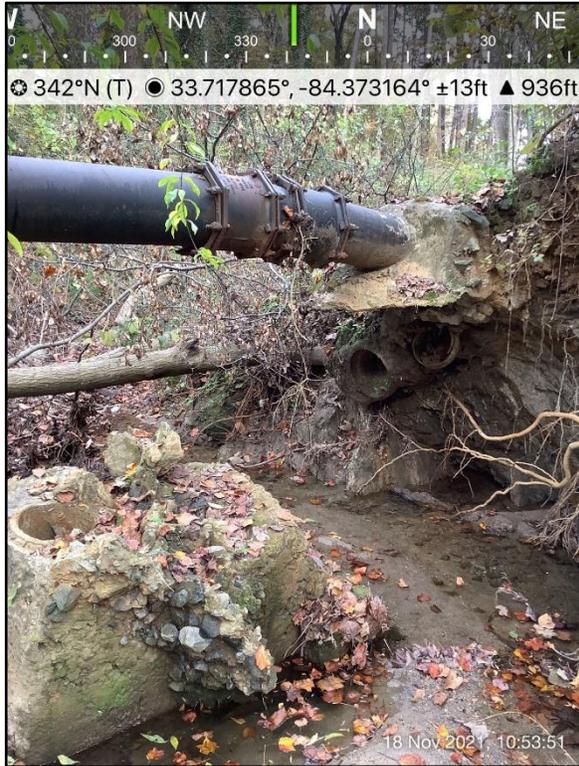
Photograph 21: Stream 1 looking downstream at sanitary sewer crossing at approx. Sta. 7+40

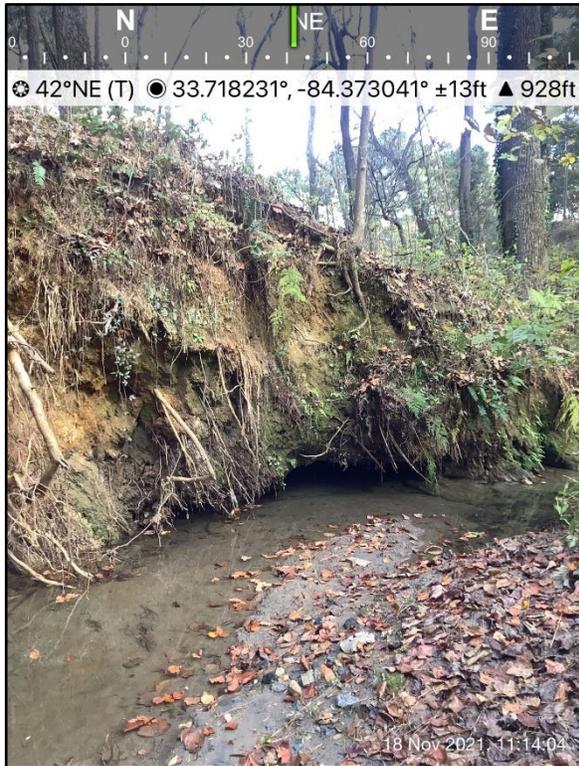
Photograph 23: Stream 1 looking downstream at actively eroding left bank at approx. Sta. 9+00

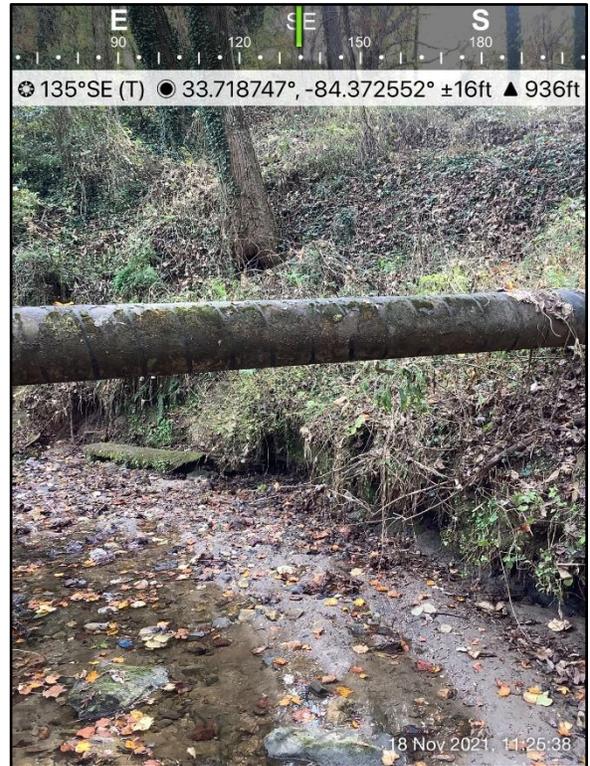
Photograph 28: Stream 1 looking upstream at sanitary sewer crossing

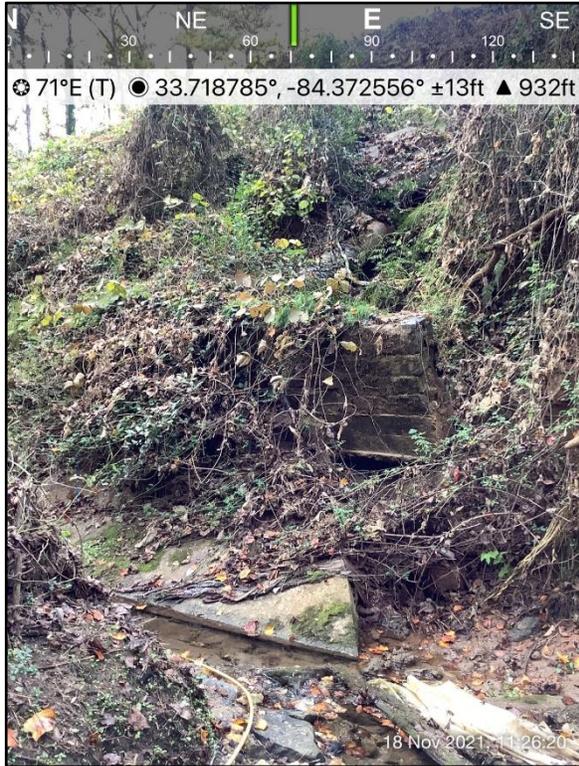
Photograph 29: Stream 1 looking downstream at failing headwall and culvert outlet in right bank at approx. Sta. 12+40

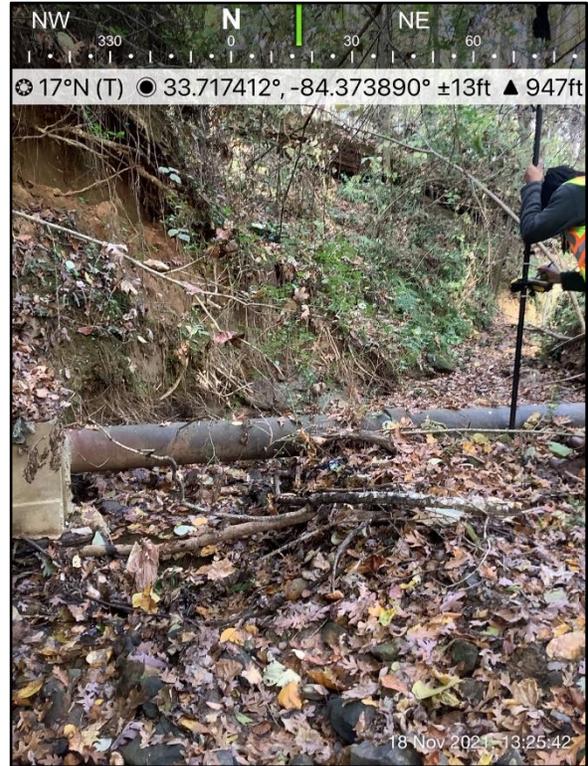
Photograph 46: Stream 3 looking downstream at sanitary sewer crossing near Sta. 2+20

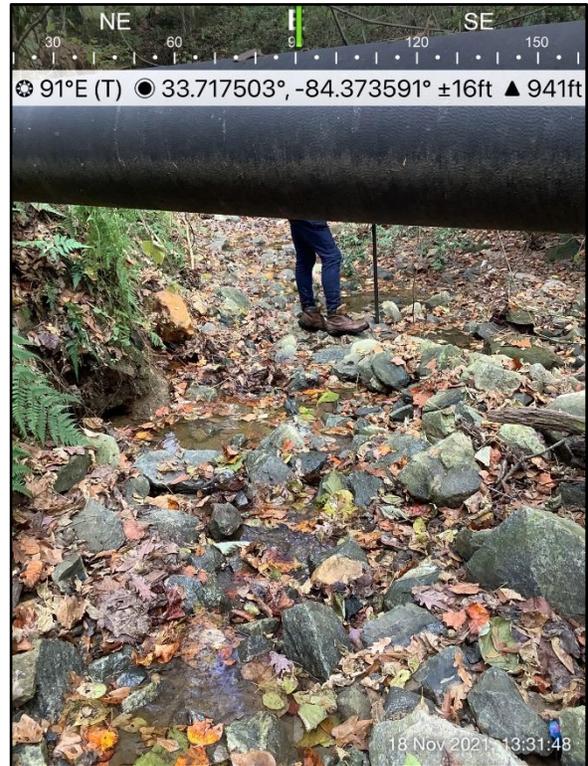
Photograph 48: Stream 3 looking downstream at sanitary sewer crossing near confluence with Stream 1 (approx. Sta. 3+10)
