RIGHT AT HOME

Property Inspection Report

Property address: **3500 Shields**

Inspection date: **Wednesday, February 14, 2018**

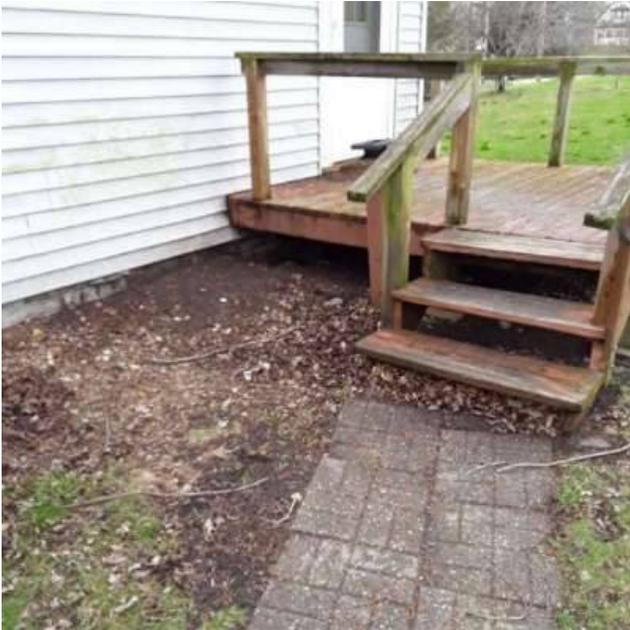
Photo 4-1

Soil was in contact with or close to wooden stairs at one or more locations. This is a conducive condition for wood-destroying organisms. Soil should be graded and/or removed so no wood-soil contact is present, if possible. Otherwise, installing products such as borate-based Impel rods may help to prevent infestation and damage. For more information, visit: <http://www.reporthost.com/?IMPEL>

Area of concern is rear deck stairs and front West side stairs.

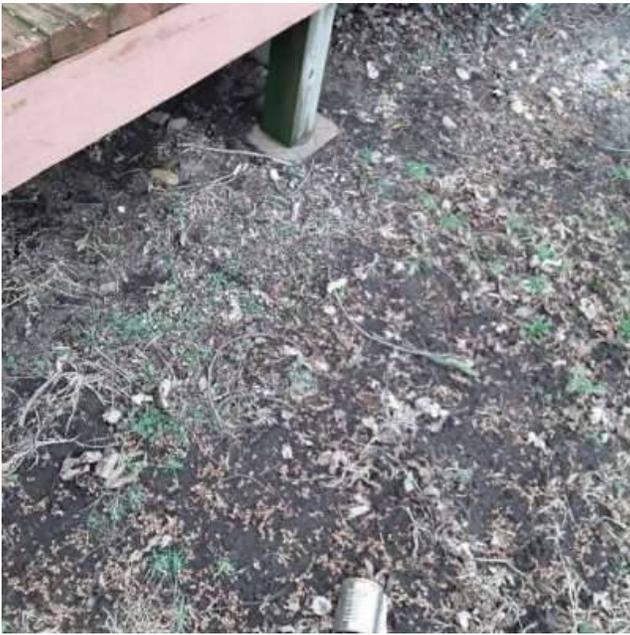
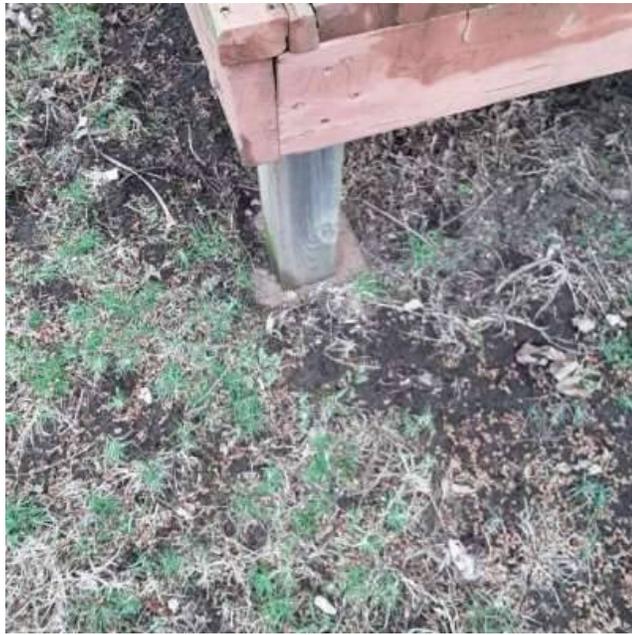
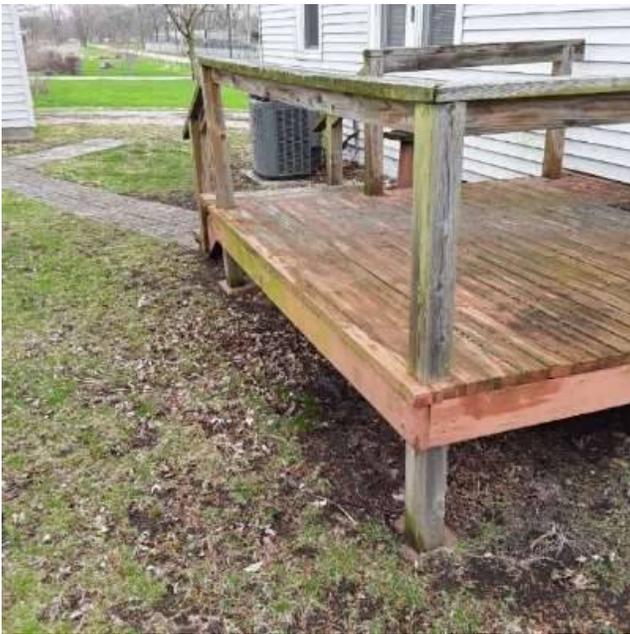
One or more pier blocks supporting the deck or porch were resting on soft soil. The deck may settle as a result, or the structure may become damaged. Concrete pier blocks should be installed on undisturbed soil or poured concrete footings. If on soil, then no soil immediately around the base of the pier block should be excavated or eroded away. Recommend that a qualified person repair per standard building practices.

Porch/deck of concern is the rear. The support posts are resting upon patio pavers.

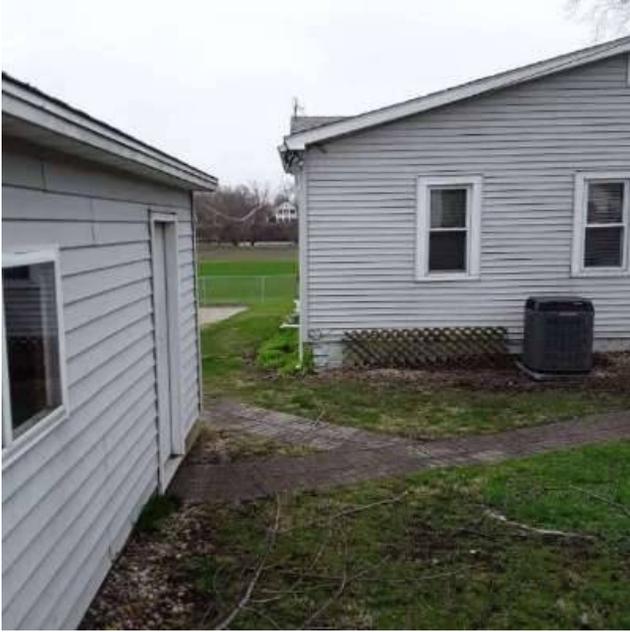
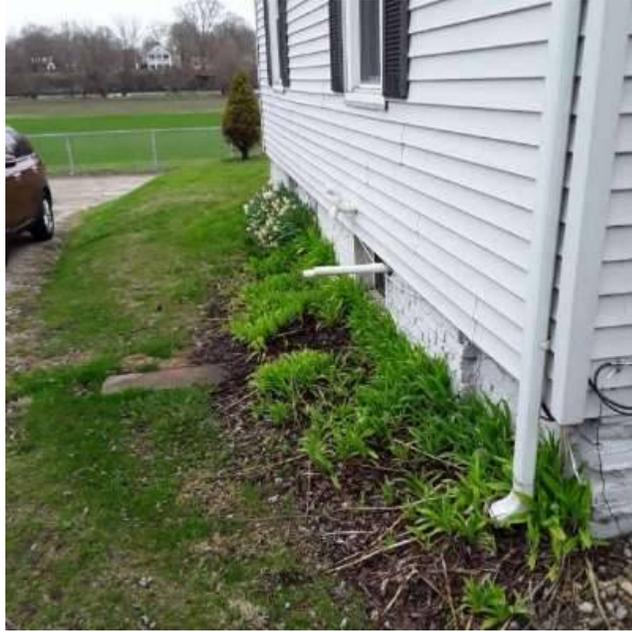
The soil or grading sloped down towards building perimeters in one or more areas. This can result in water accumulating around building foundations or underneath buildings. At a minimum, monitor these areas, and areas under the structure in the future for accumulated water. If water does accumulate, recommend grading soil so it slopes down and away from buildings with a slope of at least 1 inch per horizontal foot for at least 6 feet out from buildings.

Area of concern is rear yard. It does appear, however, that water may divert to east side of house..

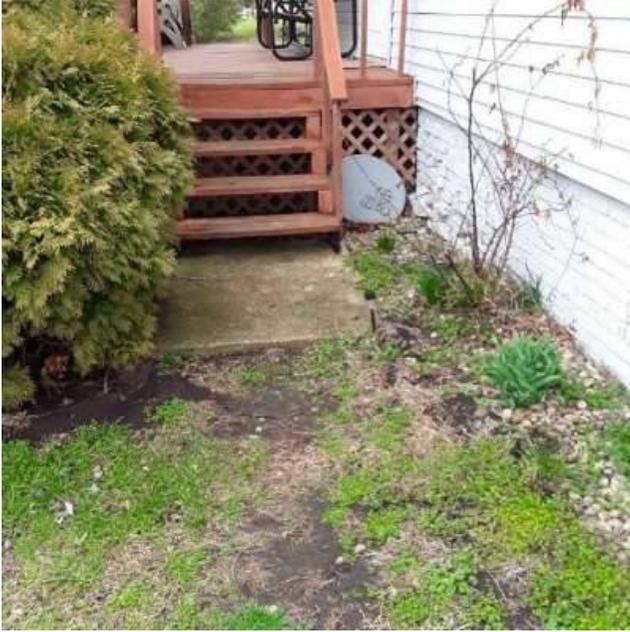
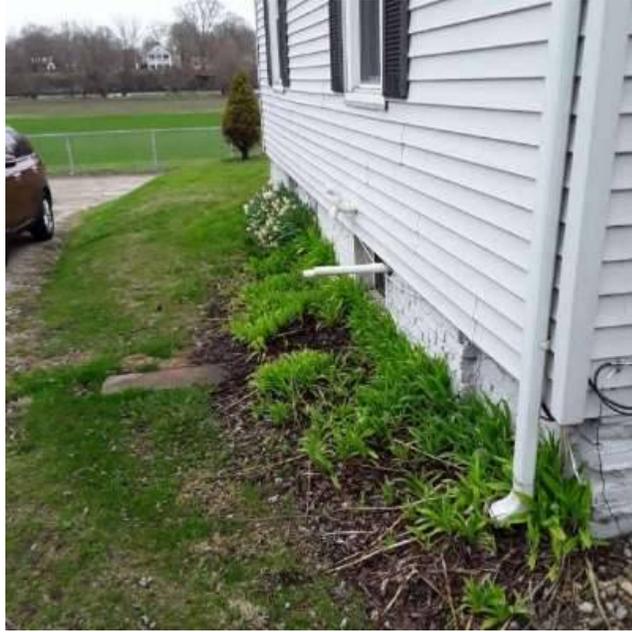
Vegetation such as trees, shrubs and/or vines was in contact with or close to the building exterior. Vegetation can serve as a pathway for wood-destroying insects and can retain moisture against the exterior after it rains. This is a conducive condition for wood-destroying organisms. Recommend pruning, moving or removing vegetation as necessary to maintain at least 6 inches of space between it and the building exterior. A 1-foot clearance is better.

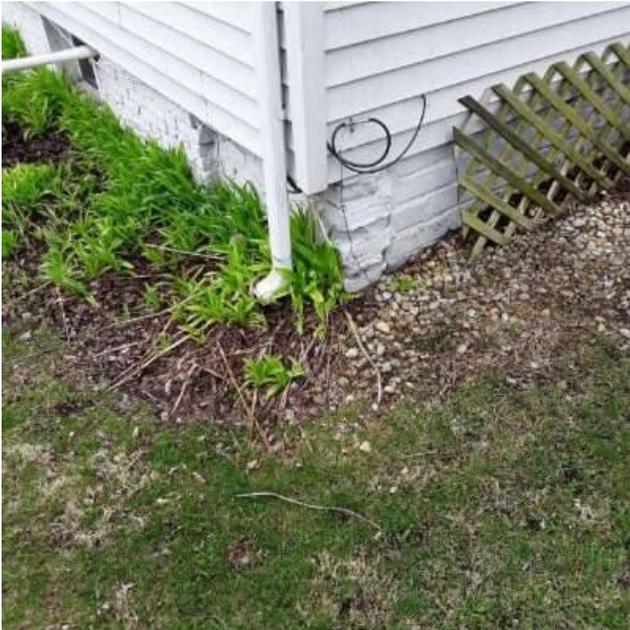
Photo 11-1

11) **i** Some above-grade foundation walls were obscured by vegetation. The inspector was unable to evaluate these areas. They are excluded from this inspection.

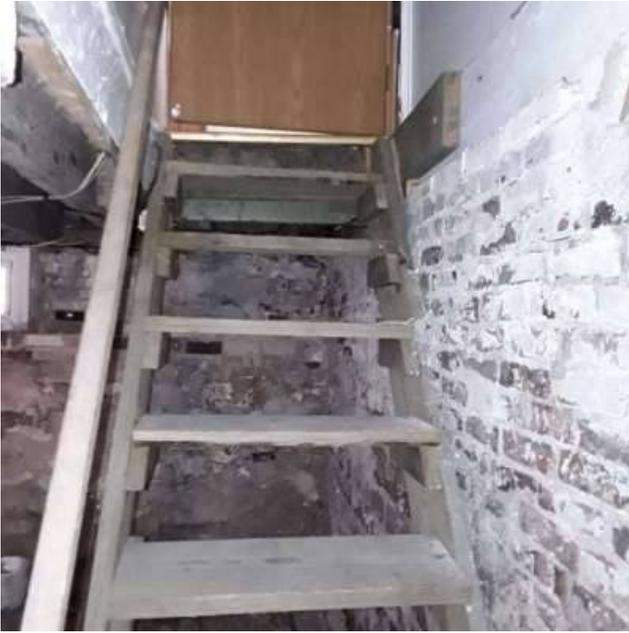
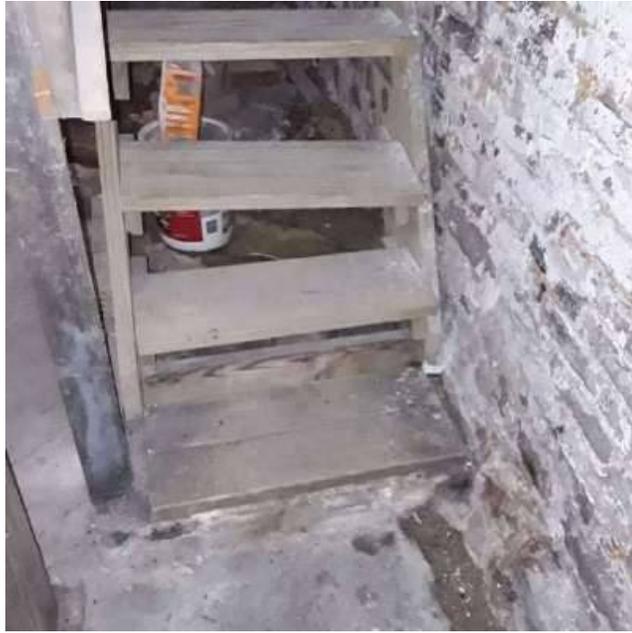
Risers for stairs at one or more locations were higher than 7 3/4 inches and posed a fall or trip hazard. Risers should be 7 3/4 inches or shorter. At a minimum, be aware of this hazard, especially when guests who are not familiar with the stairs are present. Recommend that a qualified contractor repair per standard building practices.

Some treads were pitched forward, some were loose and rocked when walked upon.

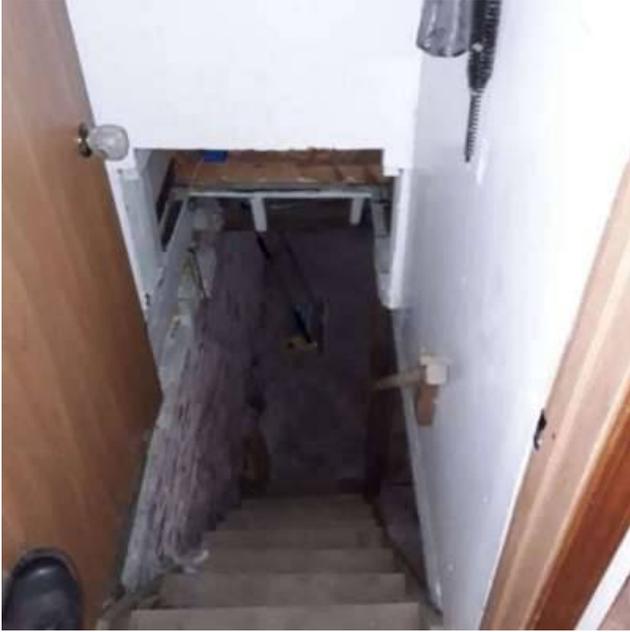
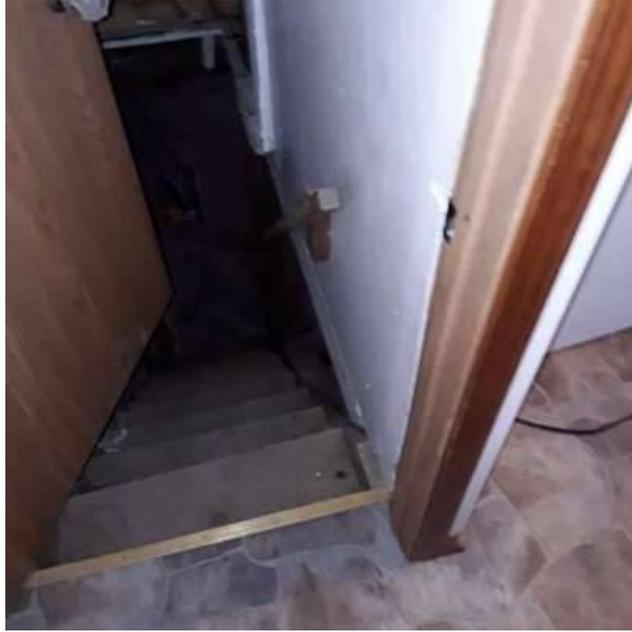
A door swung outward over one or more sets of stairs, and either no landing was installed, or the landing didn't extend at least 20 inches beyond the outermost swing area of the door. This is a safety hazard since someone standing on the stairs can fall or be pushed backwards if the door is opened. Recommend that a qualified contractor repair per standard building practices.

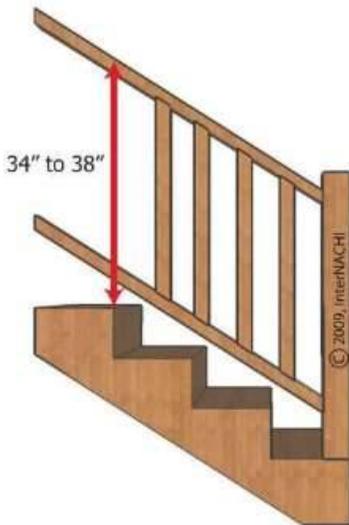
Photo 14-1

Handrails at one or more flights of stairs were too low or too high and pose a fall hazard. Handrails should be located at least 34 inches and at most 38 inches above the nose of each tread/riser. Recommend that a qualified person repair per standard building practices.

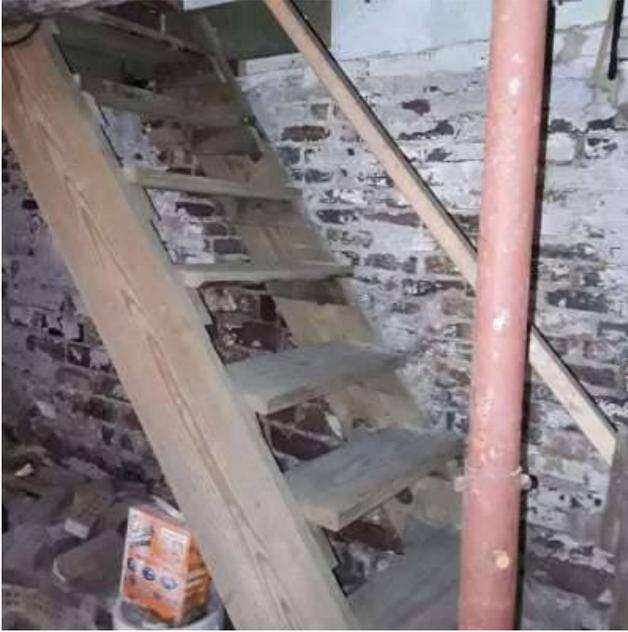
Photo 15-1

Guardrails at one or more locations with drop-offs higher than 30 inches had gaps that were too large. This poses a safety hazard for children (e.g. falling, getting stuck in railing). Guardrails should not have gaps or voids that allow passage of a sphere equal to or greater than 4 inches in diameter, or 6 inches in diameter at triangular spaces between stair edges and guardrails. At a minimum, the client should be aware of this hazard. Recommend that a qualified contractor repair or replace guardrails per standard building practices.

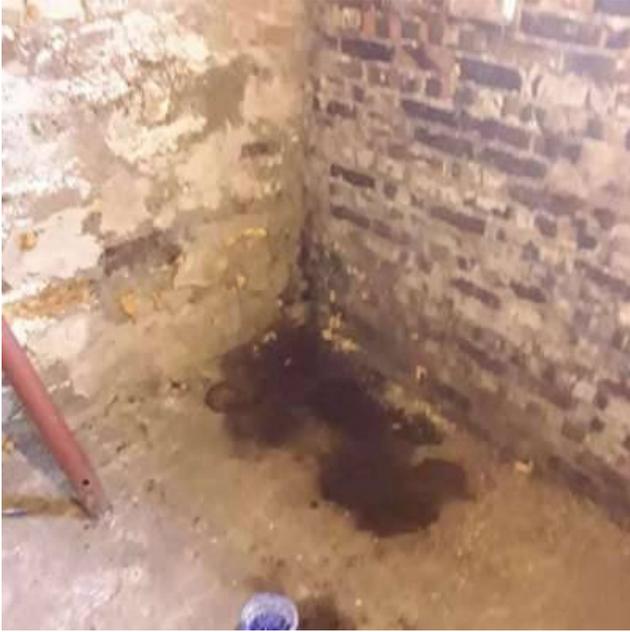
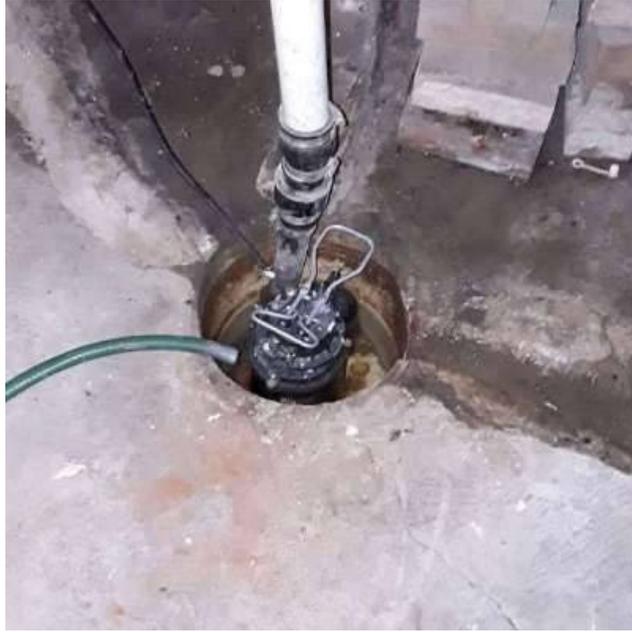
Evidence of prior water intrusion was found in one or more sections of the basement. For example, water stains or rust at support post bases, efflorescence on the foundation, etc. Accumulated water is a conducive condition for wood-destroying organisms and should not be present in the basement. Recommend reviewing any disclosure statements available and ask the property owner about past accumulation of water in the basement. The basement should be monitored in the future for accumulated water, especially after heavy and/or prolonged periods of rain. If water is found to accumulate, then recommend that a qualified contractor who specializes in drainage issues evaluate and repair as necessary. Typical repairs for preventing water from accumulating in basements include:

- Repairing, installing or improving rain run-off systems (gutters, downspouts and extensions or drain lines)
- Improving perimeter grading
- Repairing, installing or improving underground footing and/or curtain drains

Ideally, water should not enter basements, but if water must be controlled after it enters the basement, then typical repairs include installing a sump pump.

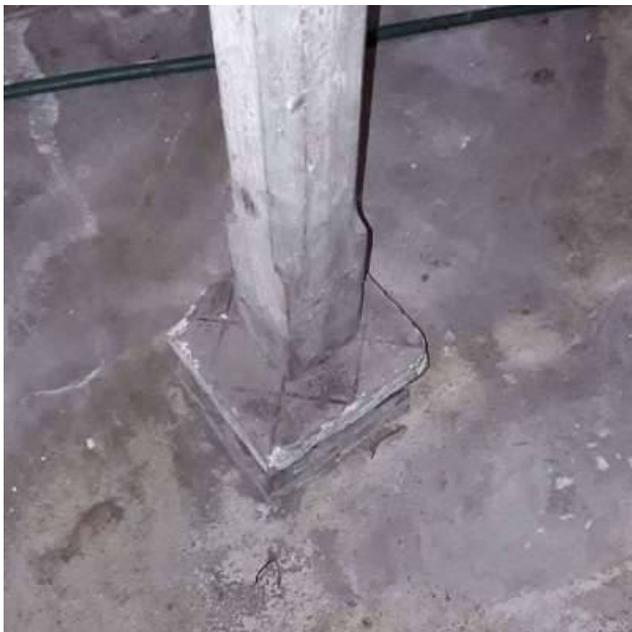
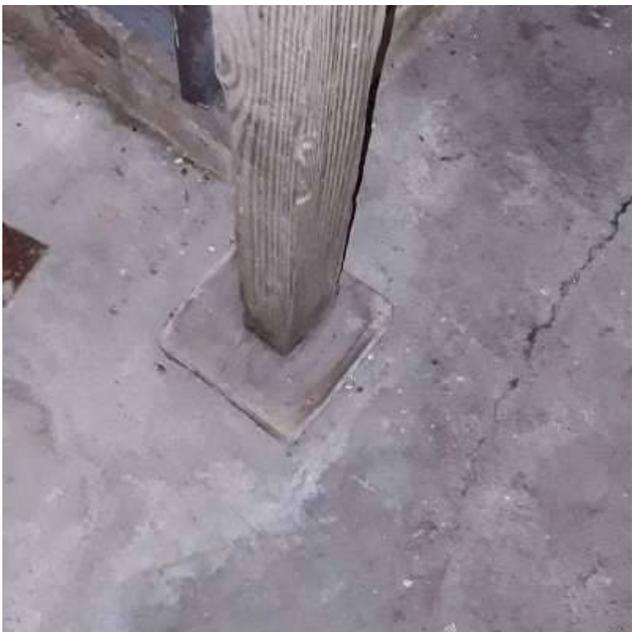
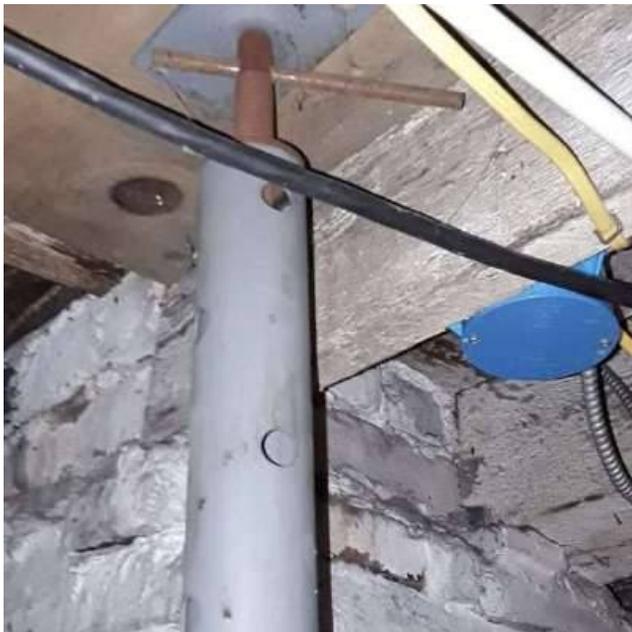
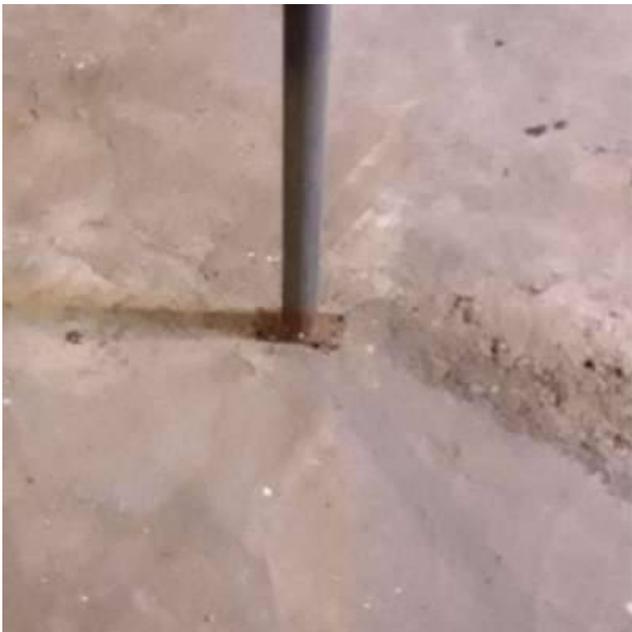
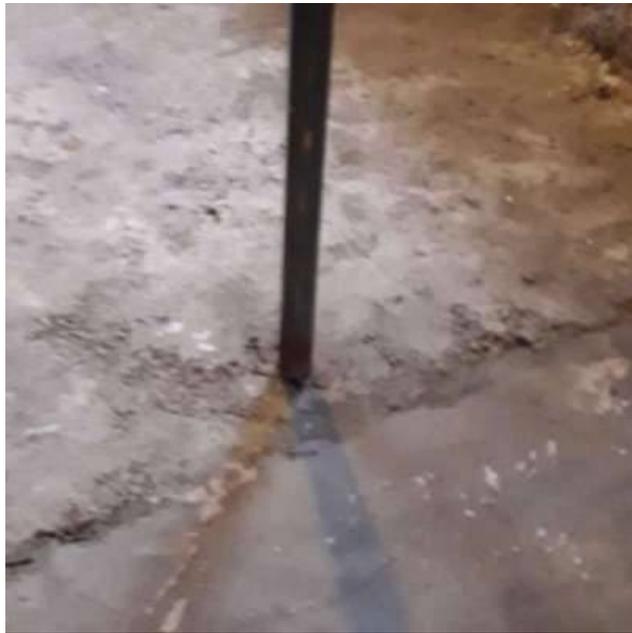
One or more adjustable steel columns were found. Some adjustable steel columns are rated for permanent use, but some are not. Based on the inspector's observations, columns in this building may not be rated for permanent use and may pose a safety risk for collapse. Recommend that a qualified contractor familiar with regulations surrounding use of such columns evaluate and repair if necessary, and per standard building practices.

Many of these columns were not properly supported by proper footings.

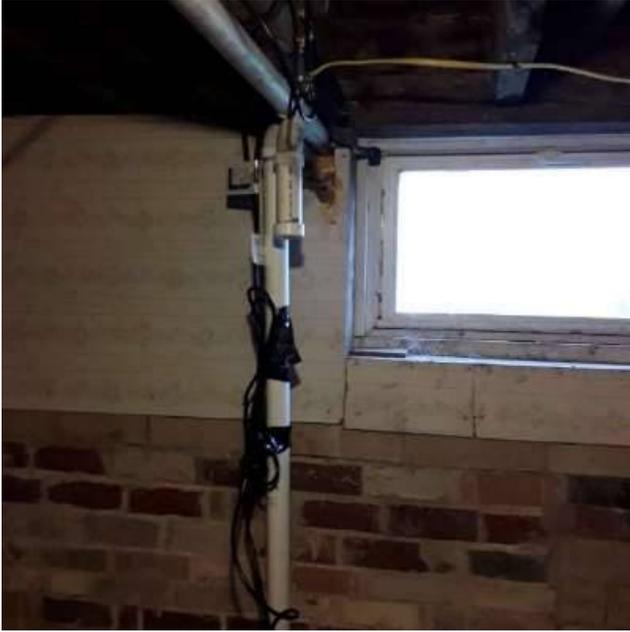
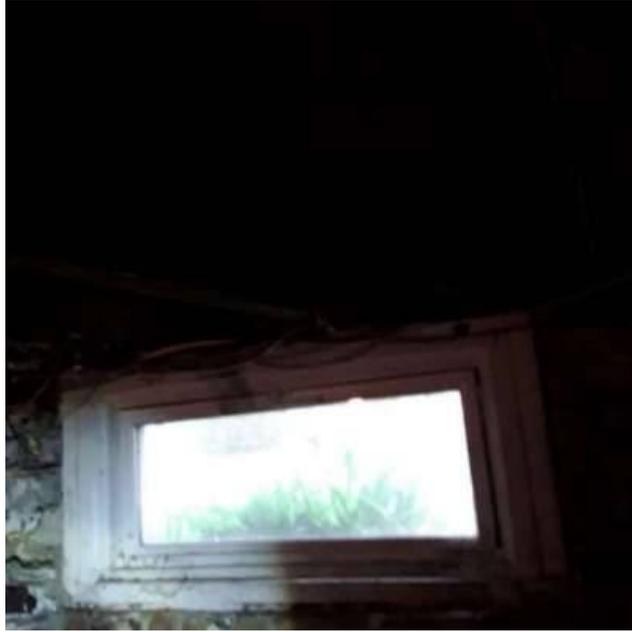
One or more windows that were designed to open and close were stuck shut. Recommend that a qualified person repair windows as necessary so they open and close easily.

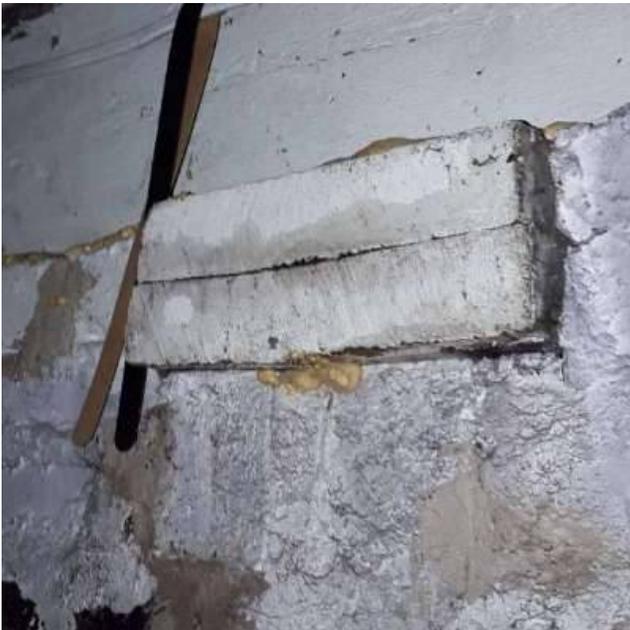
Photo 20-1

An area of note is where stairs go down to basement. It is observed that a beam has been cut for this access.

Recommend that a qualified contractor evaluate and repair as necessary, and per standard building practices.

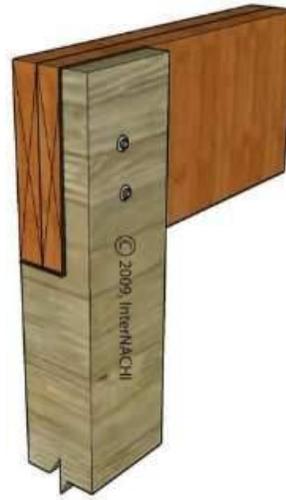
Photo 20-4

Post to Beam Connection

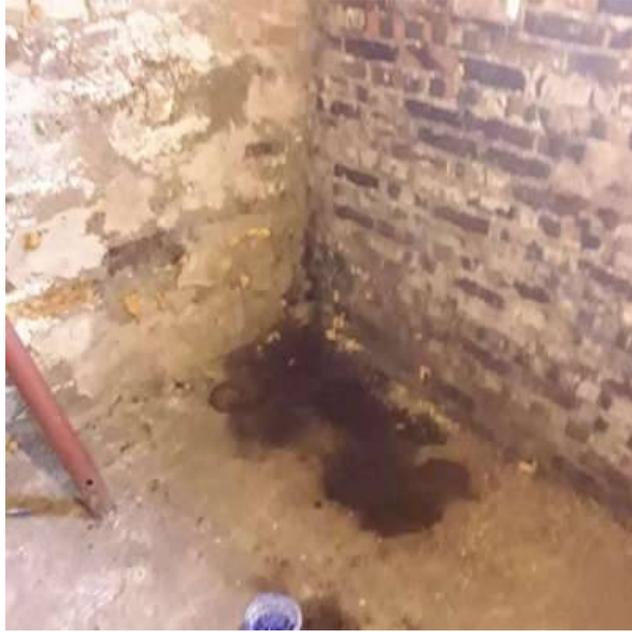
22) 🛠 Sealant or water-proofing coating was found on basement walls and/or floors. This may indicate that water has infiltrated or accumulated in the basement previously. Monitor the basement for excessive moisture conditions in the future, and review any disclosure statements related to accumulated moisture in the basement. Note that the inspector does not guarantee or warrant that water will not accumulate in the basement in the future.

Spray foam was observed in many locations throughout the walls of the basement. This combined with the moderate slope in the rear yard and lac of some gutter downspout extension may exacerbate any moisture issues in the future. I strongly consider consulting a qualified repair person familiar with basement moisture issues to make corrective repiars, inclusive.

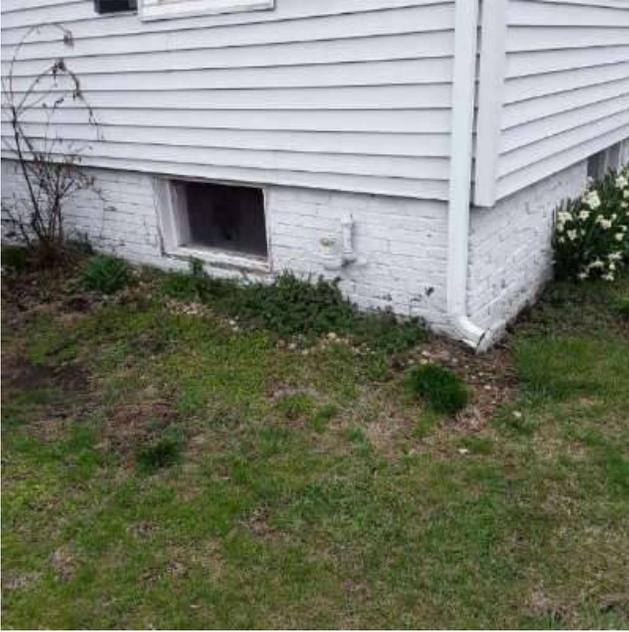
Photo 24-1

Extensions such as splash blocks or drain pipes for one or more downspouts were missing. Water can accumulate around the building foundation or inside crawl spaces or basements as a result. Recommend that a qualified person install, replace or repair extensions as necessary so rainwater drains away from the structure.

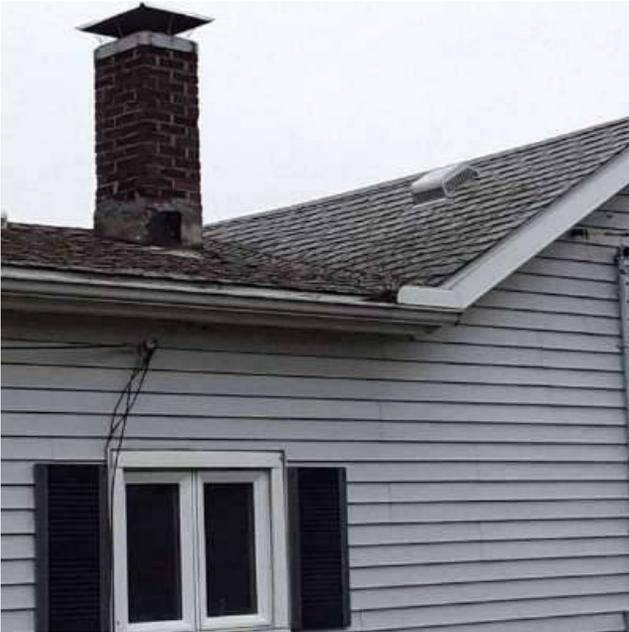
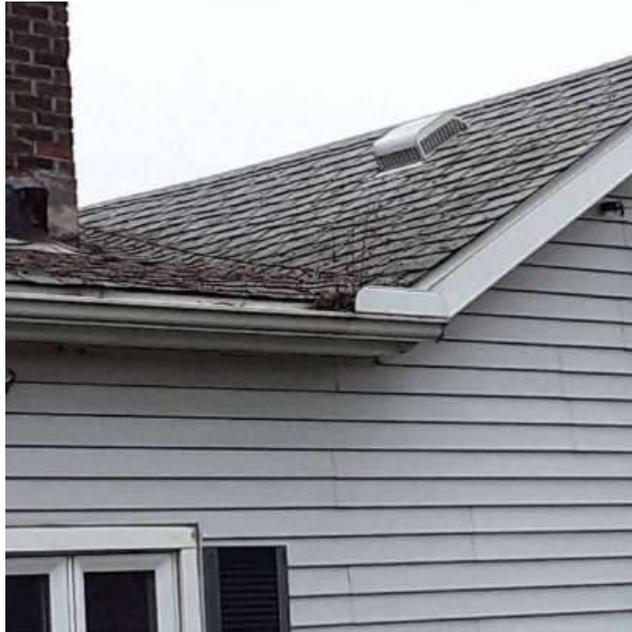
Significant amounts of debris have accumulated in one or more gutters or downspouts. Gutters can overflow and cause water to come in contact with the building exterior, or water can accumulate around the foundation. This is a conducive condition for wood-destroying organisms. Recommend cleaning gutters and downspouts now and as necessary in the future.

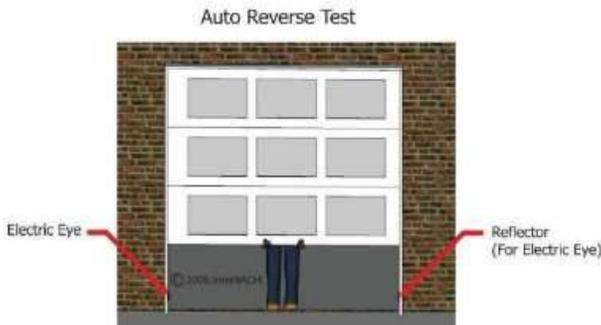
Photo 27-1

One or more garage vehicle doors wouldn't close with the automatic opener because the opener auto-reversed while the door was closing. This can be caused by photoelectric sensors being out of adjustment, the door binding, the mechanical auto-reverse sensor having problems, etc. Note that because of this, the inspector was unable to verify that the auto-reverse functions for the automatic opener were operable. A qualified person should evaluate, repair as necessary and verify that auto-reverse functions are working.

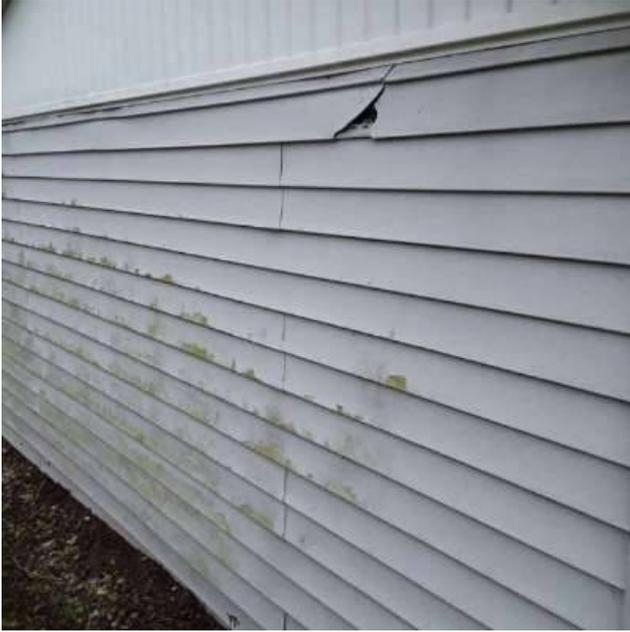
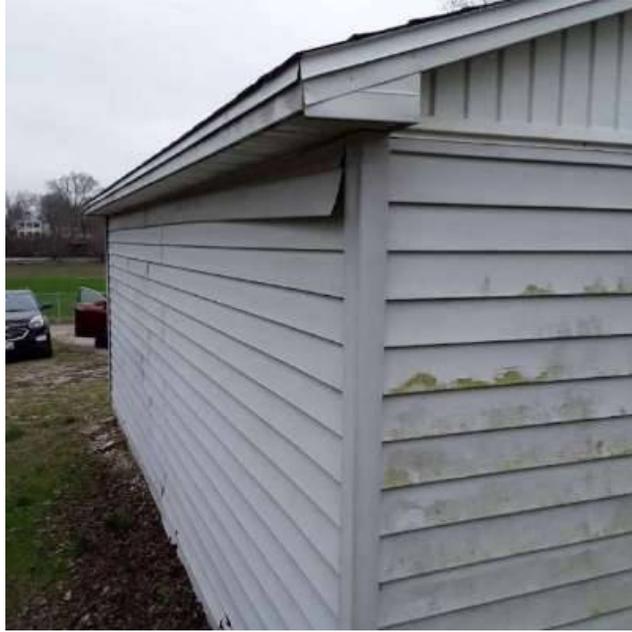
Some sections of siding and/or trim were loose and/or damaged. Recommend that a qualified person repair, replace or install siding or trim as necessary.

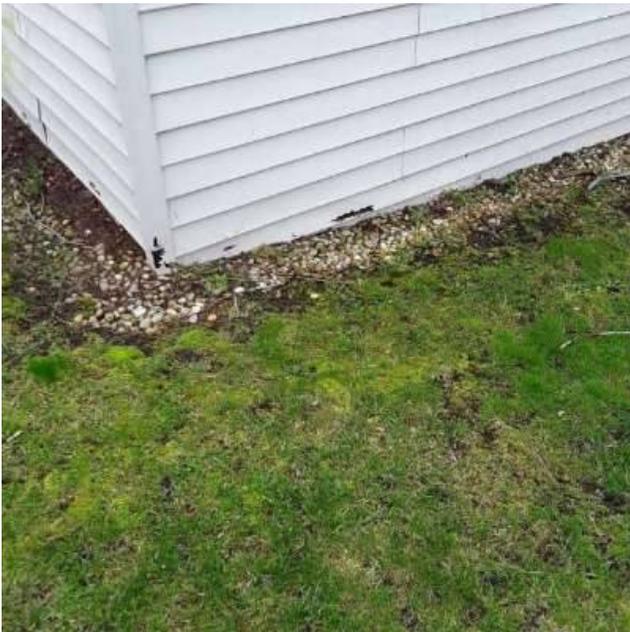
Photo 29-1

Soil was in contact with or less than 6 inches from siding or trim. Regardless of what material is used for siding, it should not be in contact with the soil. If made of wood, siding or trim will eventually rot. For other materials, ground or surface water can infiltrate siding or trim and cause damage to the wall structure. Wood-destroying insects are likely to infest and damage the wall structure. This is a conducive condition for wood-destroying organisms. Recommend grading or removing soil as necessary to maintain a 6-inch clearance. Note that damage from fungal rot and/or insects may be found when soil is removed, and repairs may be necessary.

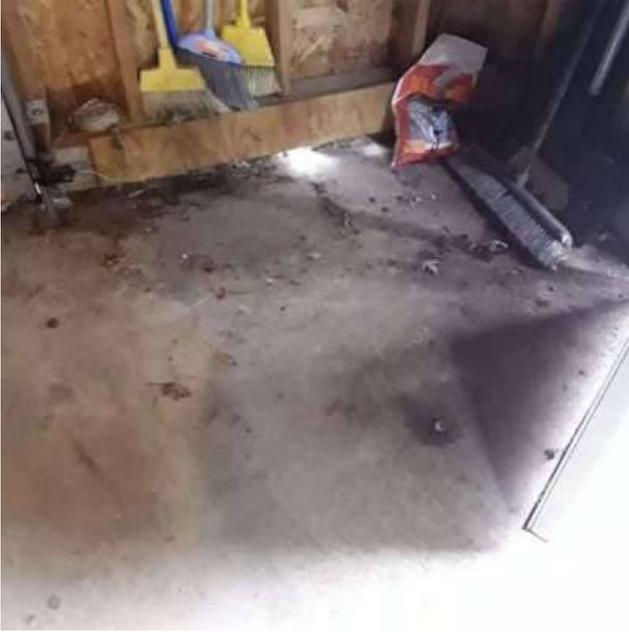
Photo 30-1

An area of garage foundation/footing has a "clean-cut" opening to the left of vehicle door when looking at garage. This does not appear to be damage. Light is visible from the inside. Consider having this repaired.

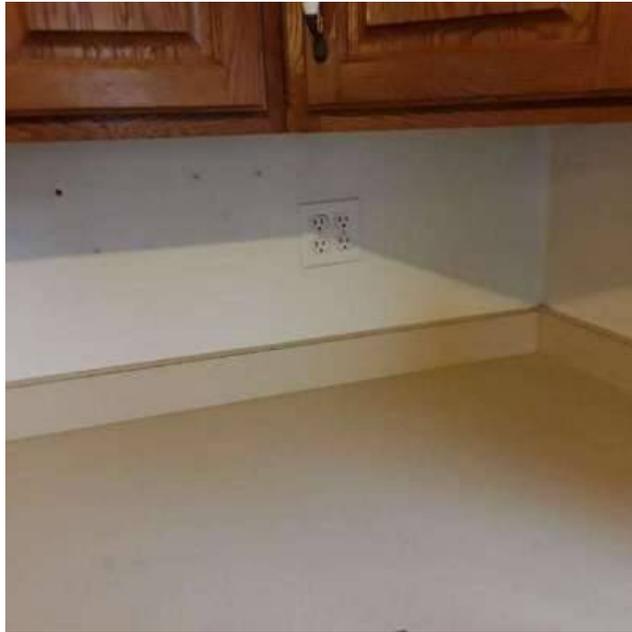
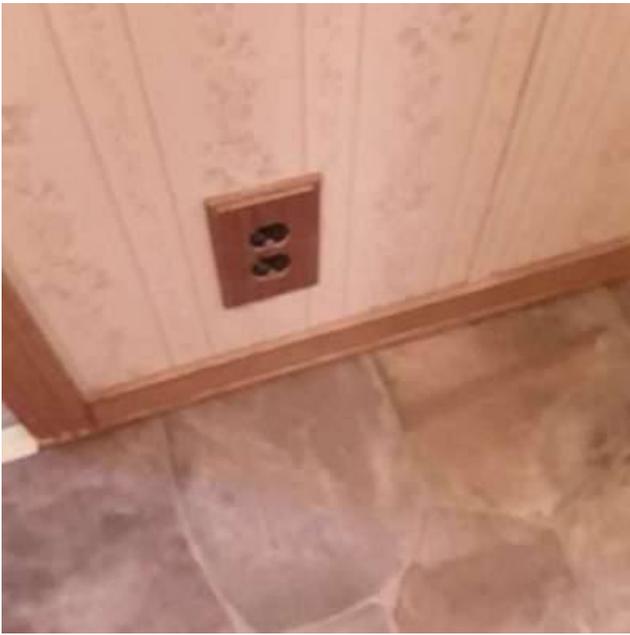
One or more electric receptacles at the kitchen, full bath and/or laundry area had no visible ground fault circuit interrupter (GFCI) protection, or the inspector was unable to determine if GFCI protection was present. If not GFCI-protected, receptacles in wet areas pose a shock hazard. Recommend that a qualified electrician evaluate and install GFCI protection if necessary and per standard building practices. General guidelines for GFCI-protected receptacles include the following locations:

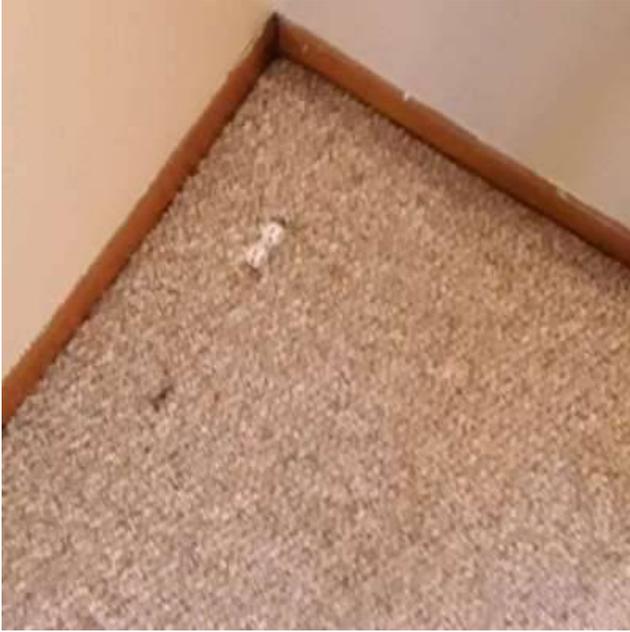
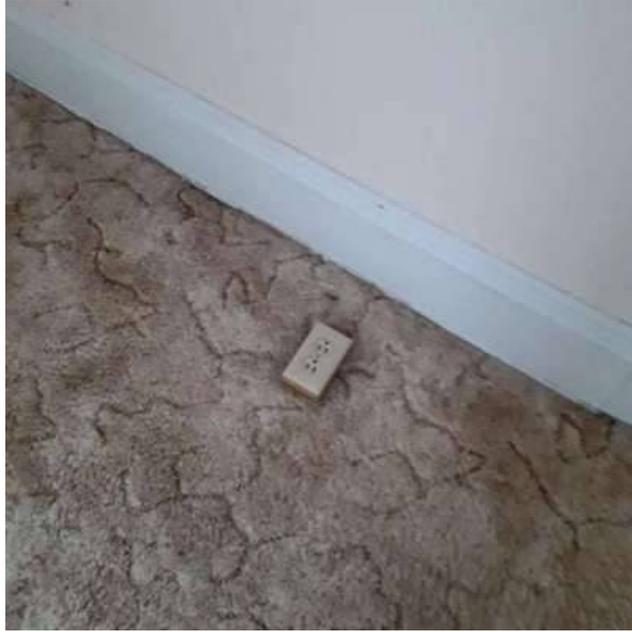
One or more floor-mounted electric receptacles or their cover plates were substandard and/or not approved for this application. This is a potential safety hazard. Typically such receptacles have metal cover plates and prevent liquids such as pet urine from entering the receptacle. A qualified contractor should repair per standard building practices.

Location A (master bed) and location C (living, dining).

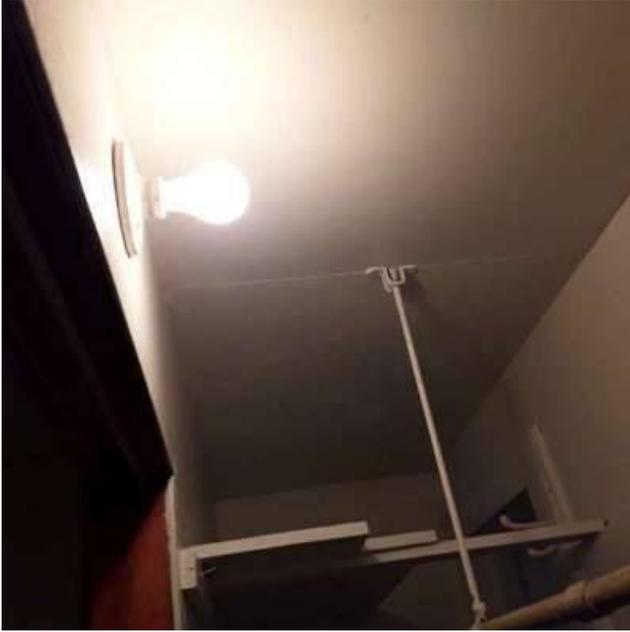
Photo 36-1

Light fixtures with fully or partially exposed incandescent bulbs were installed in one or more closets. This is a fire hazard. Flammable stored items can come into contact with hot bulbs, or hot fragments from broken bulbs can fall on combustible materials. Closet lighting should use fluorescent light fixtures or fully enclosed incandescent fixtures. Installing a compact fluorescent lamp in a lamp holder is not an acceptable practice. If globes or covers are missing, they should be replaced. Otherwise recommend that a qualified electrician replace closet lights per standard building practices.

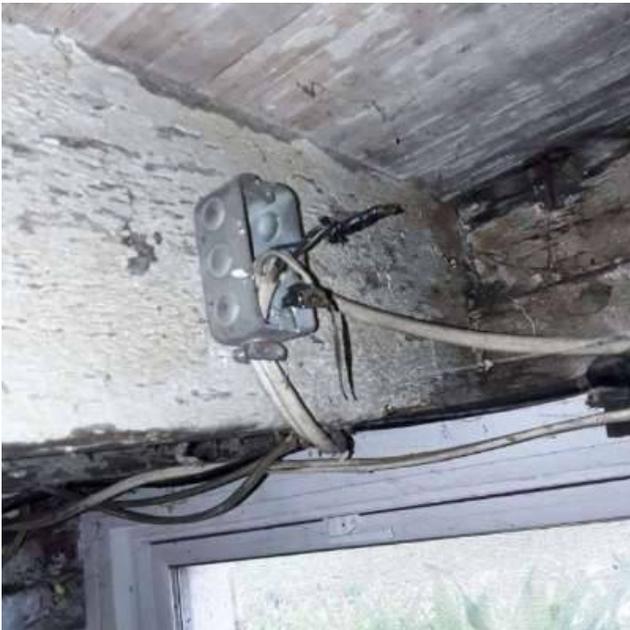
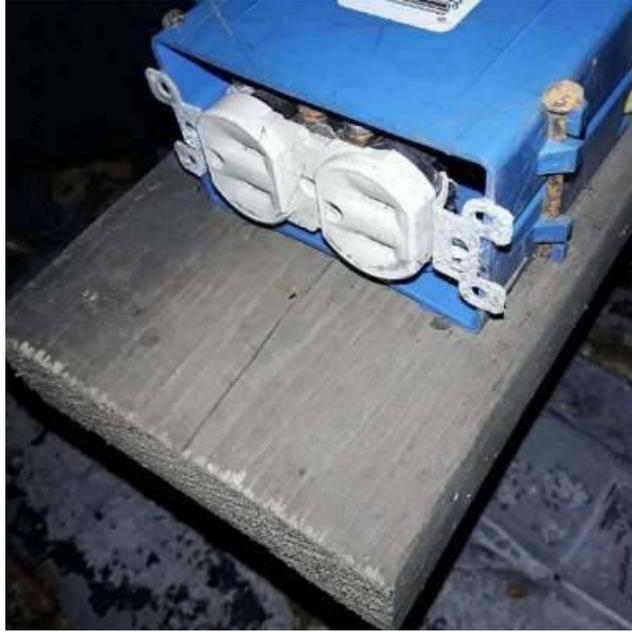
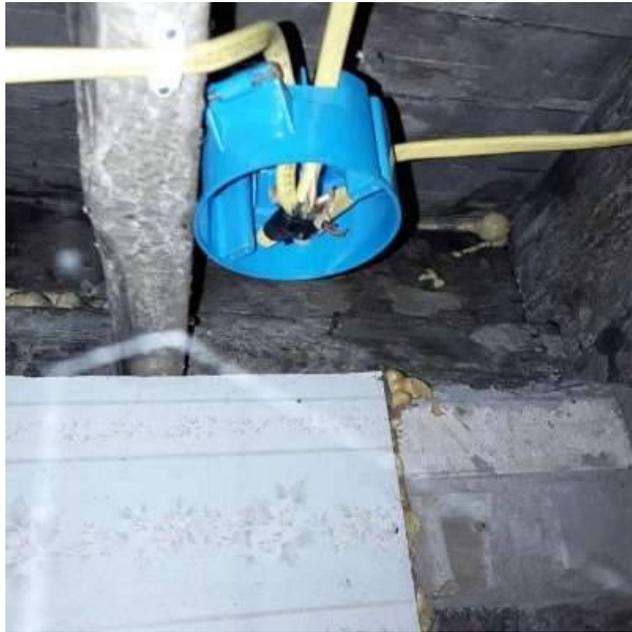
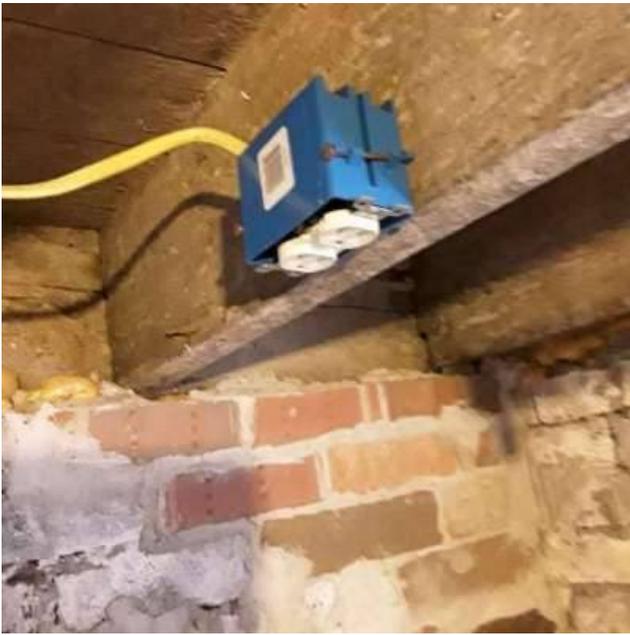
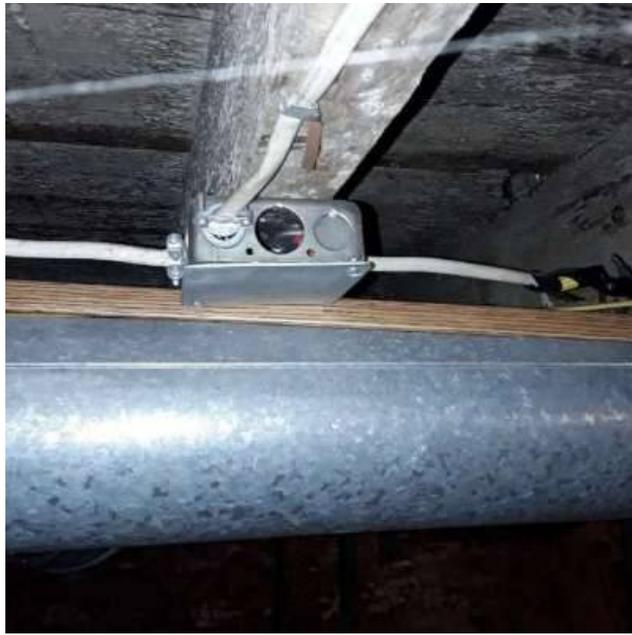
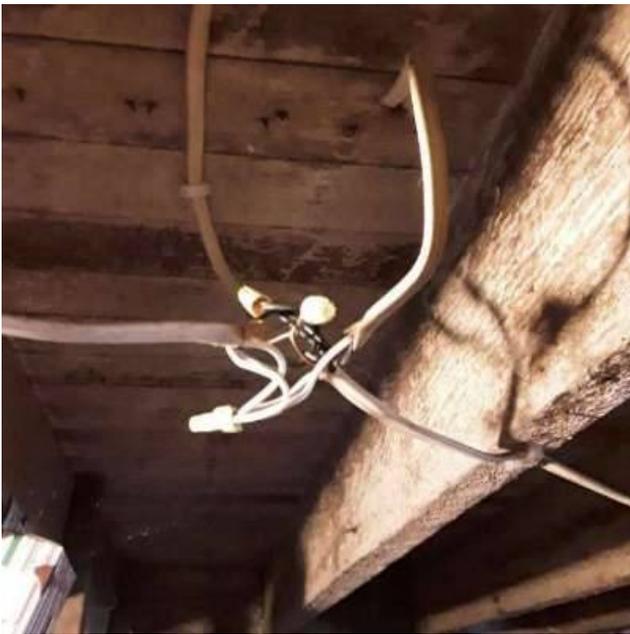
In the basement there are several junction boxes without covers, some are missing knockouts. There are some open splices not in junction boxes. There are some receptacles without covers.

Consult a qualified electrician to make proper repairs.

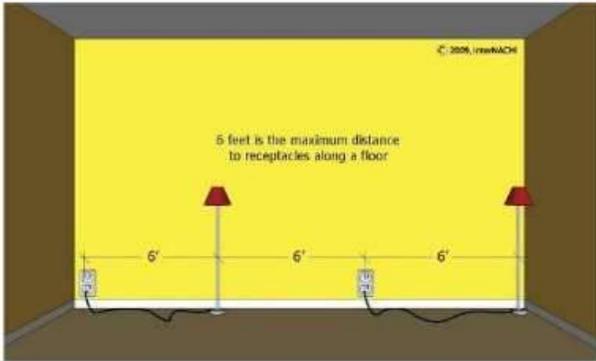
Photo 40-1

Few receptacles were installed in one or more areas by modern standards. This can result in "octopus" wiring with extension cords, which is a fire hazard. Consult with a qualified electrician about upgrading circuits with additional receptacles per standard building practices.

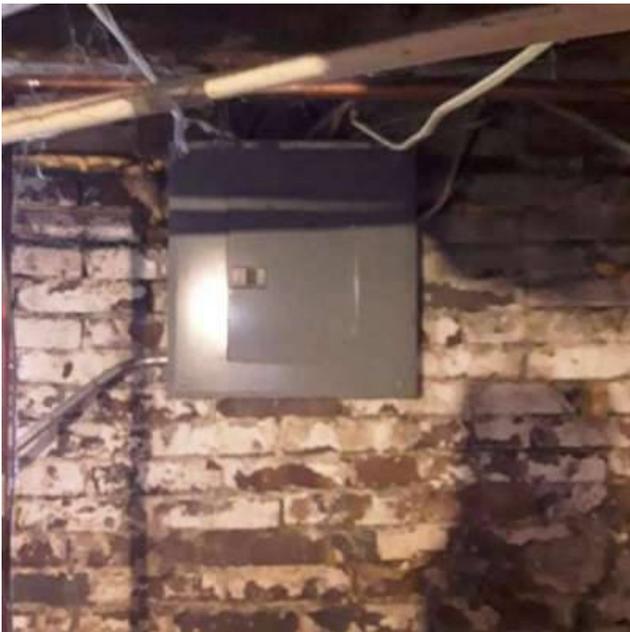
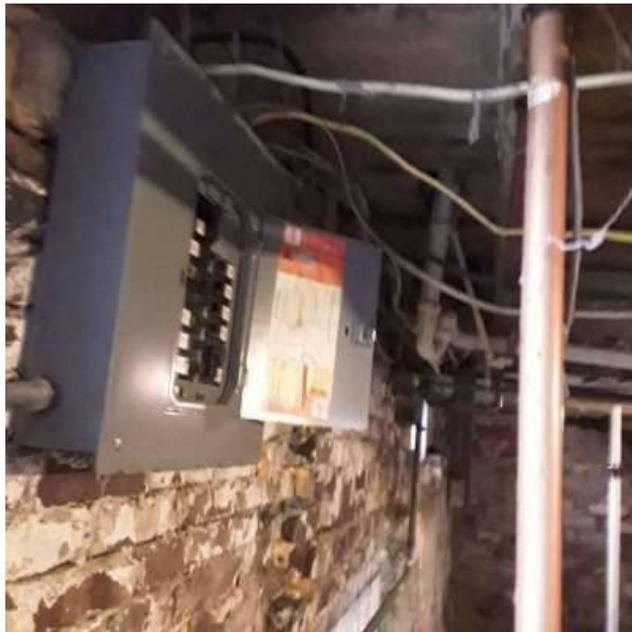
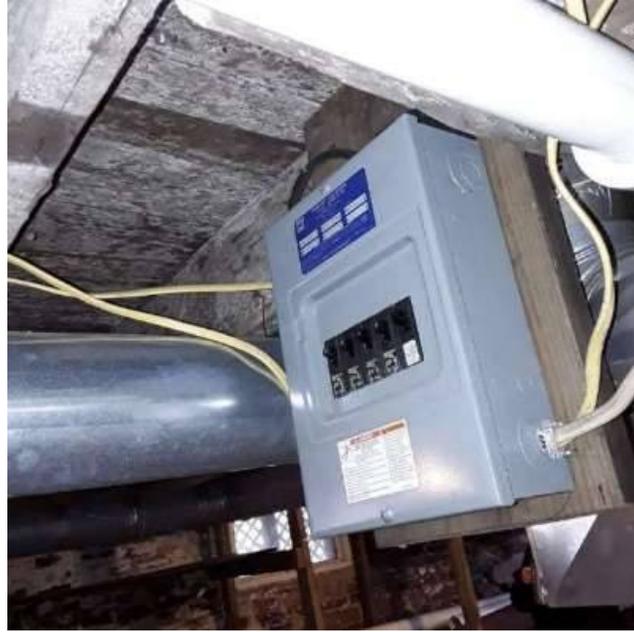
The inspector was unable to open and evaluate panel(s) #A and B because service wire hanging low from the panel itself. These panel(s) are excluded from this inspection. Recommend that repairs, modifications and/or cleanup should be made as necessary so panels can be opened and fully evaluated.

For safety reasons, service wire is not moved for panel A and lack of clearance for panel B.

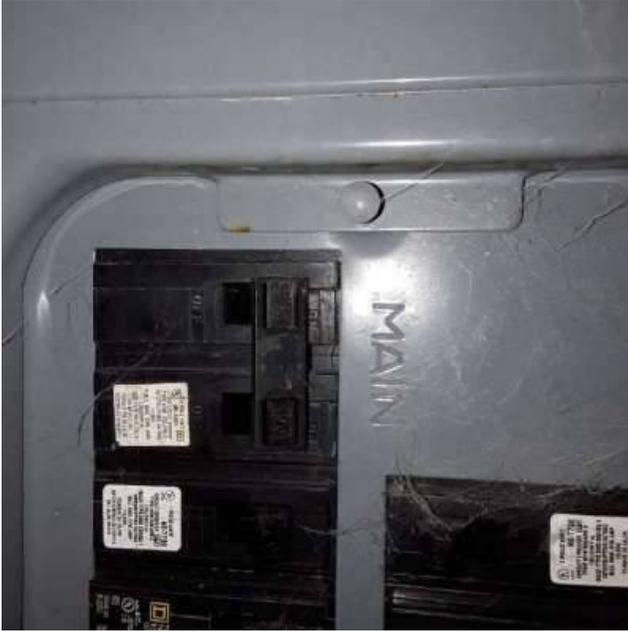
Photo 42-1

The electric service to this property appeared to be rated at substantially less than 200 amps and may be inadequate. Depending on the client's needs, recommend consulting with a qualified electrician about upgrading to a 200 amp service. Note that the electric service's rating is based on the lowest rating for the meter base, the service conductors, the main service panel and the main disconnect switch. One or more of these components may need replacing to upgrade.
