RIGHT AT HOME

Property Inspection Report

Property address: **3500 Shields**

Inspection date: **Wednesday, February 14, 2018**

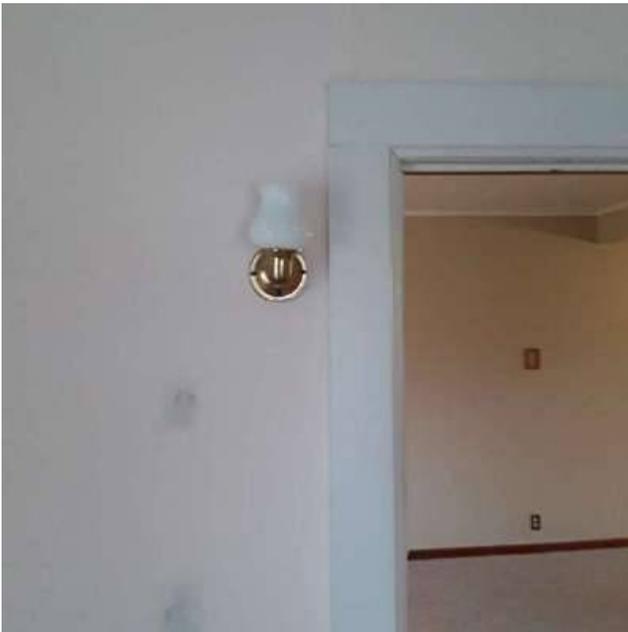
Photo 43-1

One or more light fixtures were inoperable (didn't turn on when nearby switches were operated). Recommend further evaluation by replacing bulbs and/or consulting with the property owner. If replacing bulbs doesn't work and/or no other switch(es) can be found, then recommend that a qualified electrician evaluate and repair or replace light fixtures as necessary.

Location A bulb is missing.

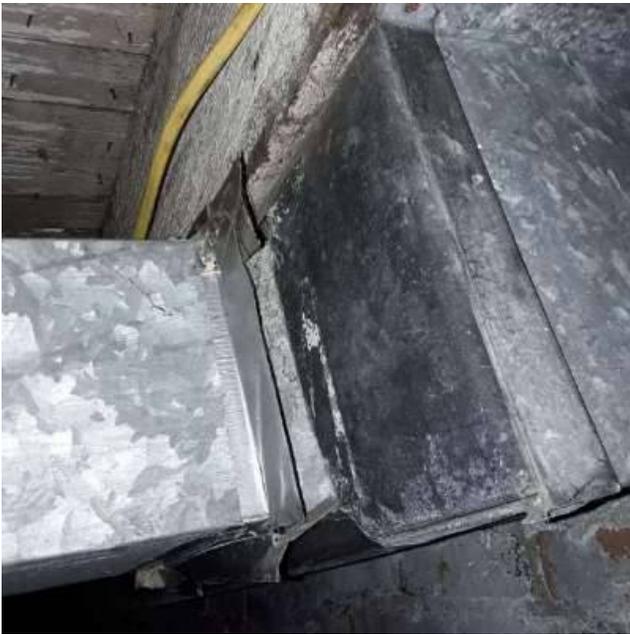
Photo 47-1

Return air duct has a visible gap where it penetrates the floor. Consult a qualified HVAC repair person to make proper repairs.

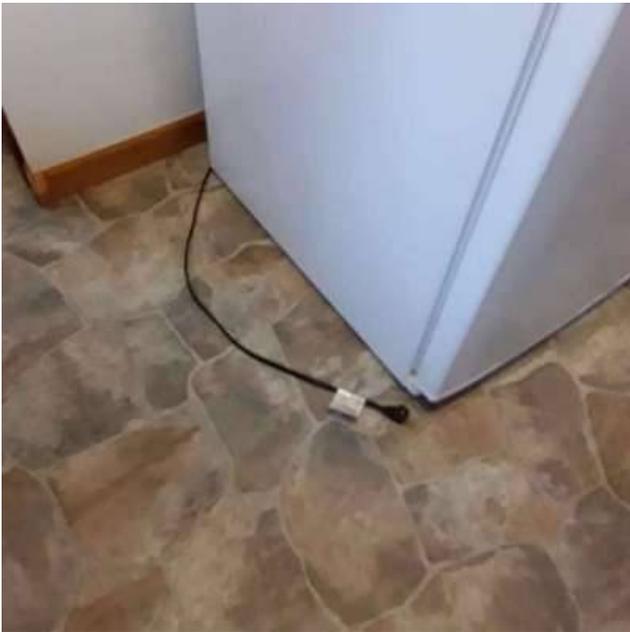
Photo 51-1

The electric supply for the refrigerator was inoperable (e.g. turned off, not plugged in, circuit breaker off) and the inspector was unable to fully evaluate. Repairs may be needed. If concerned, have a qualified person fully evaluate.

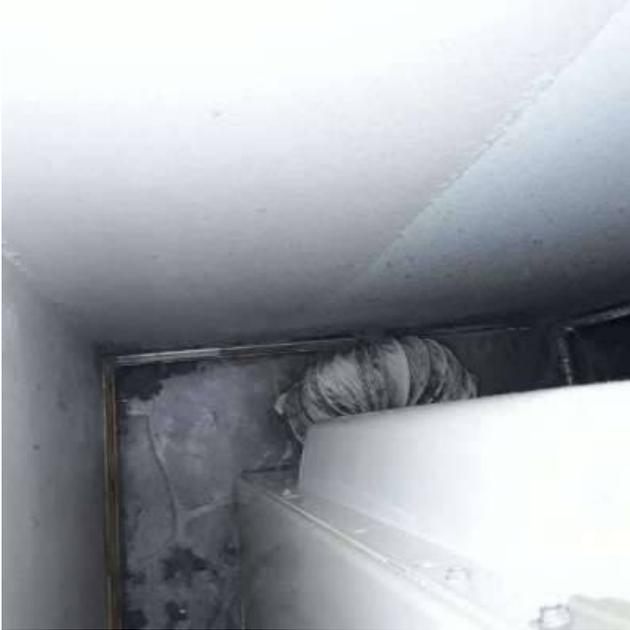
Photo 52-1

The clothes dryer was equipped with a vinyl or mylar, accordion-type, flexible exhaust duct. The U.S. Consumer Product Safety Commission considers these types of ducts to be unsafe, and a fire hazard. They can trap lint and are susceptible to kinks or crushing, which can greatly reduce the air flow and cause overheating. Recommend that such ducts be replaced with a rigid or corrugated semi-rigid metal duct, and by a qualified contractor if necessary. For more information, visit:

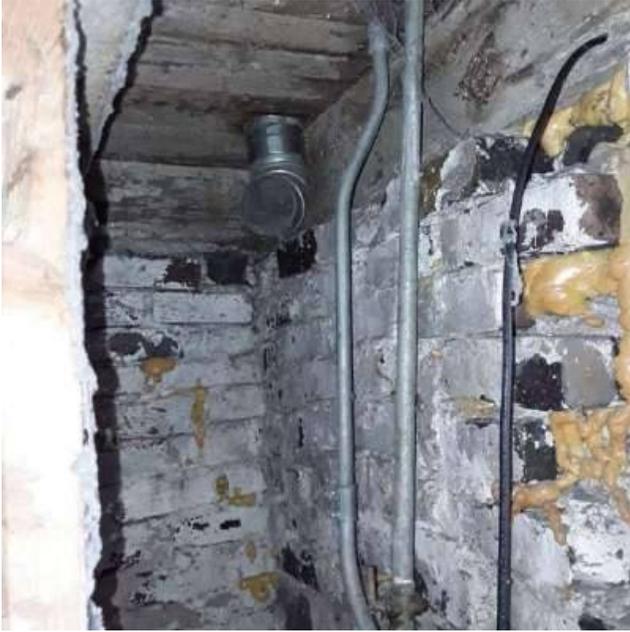
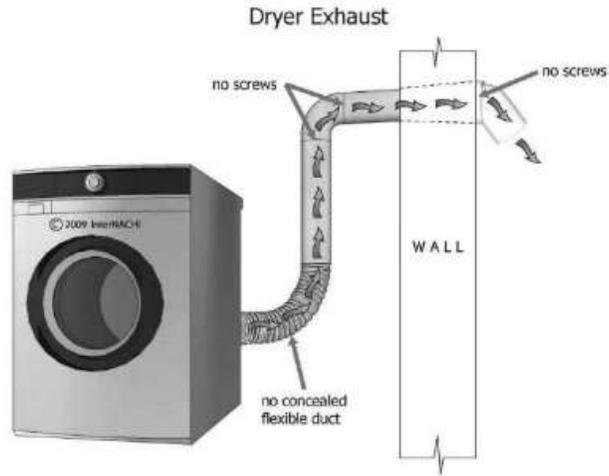
The clothes dryer exhaust duct terminated in the basement. Clothes dryers produce large amounts of moisture which should not enter structure interiors. Moisture may accumulate and result in mold, bacteria or fungal growth. Recommend that a qualified person install, repair or replace the duct as necessary so it terminates outdoors, and per standard building practices. For more information, visit:

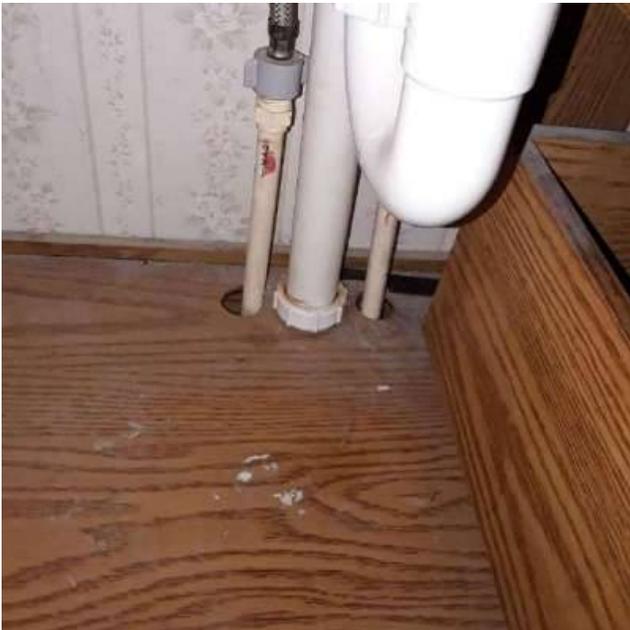
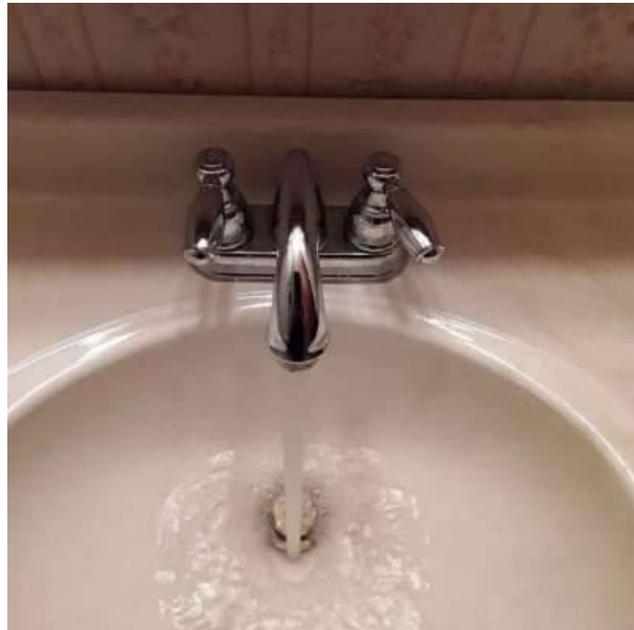
55) 🛠️💧 One or more sink drains were leaking at location(s) #A. A qualified person should repair as necessary.

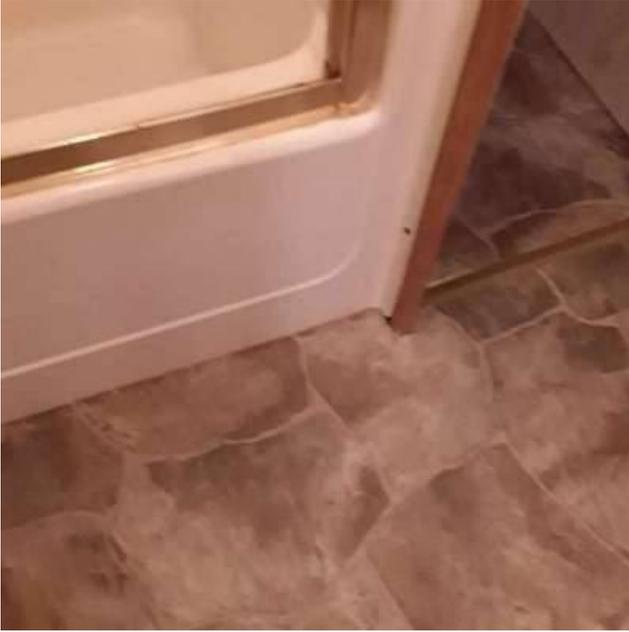
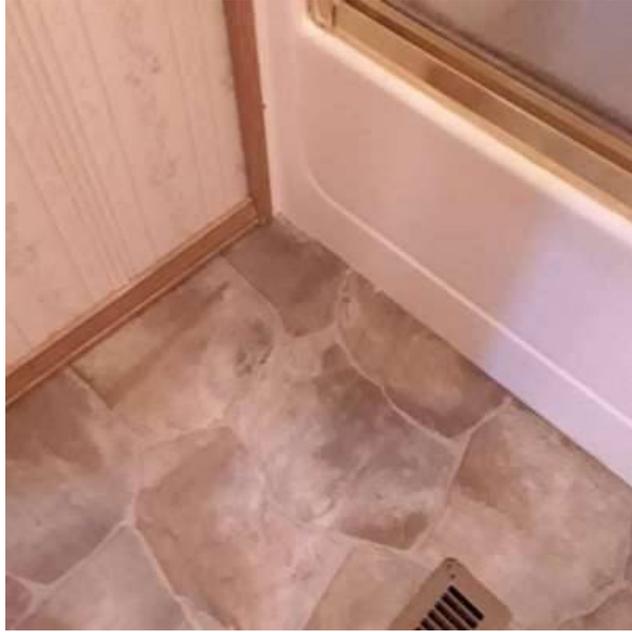
56) 🛠️💧 Gaps, no caulk, or substandard caulking were found between the bathtub and the floor at location(s) #A. Water may penetrate these areas and cause damage. Recommend that a qualified person re-caulk or install caulking as necessary.

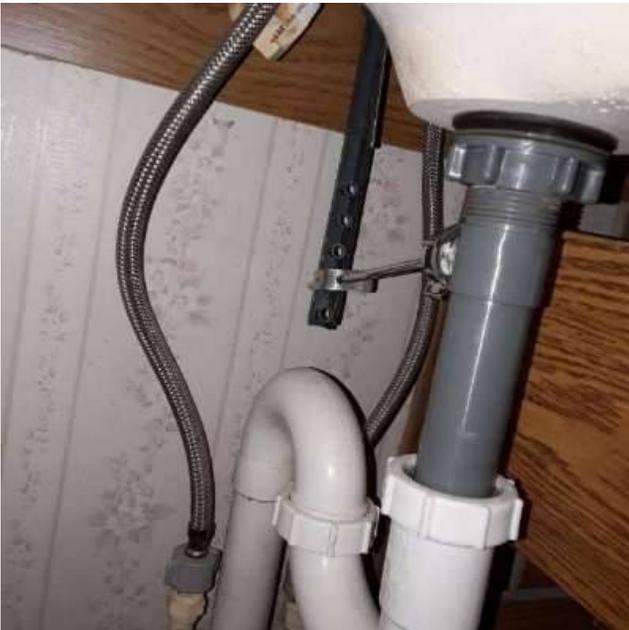
Photo 57-1

The sink drain stopper mechanism at location(s) #A was inoperable. Recommend that a qualified person repair or replace as necessary.

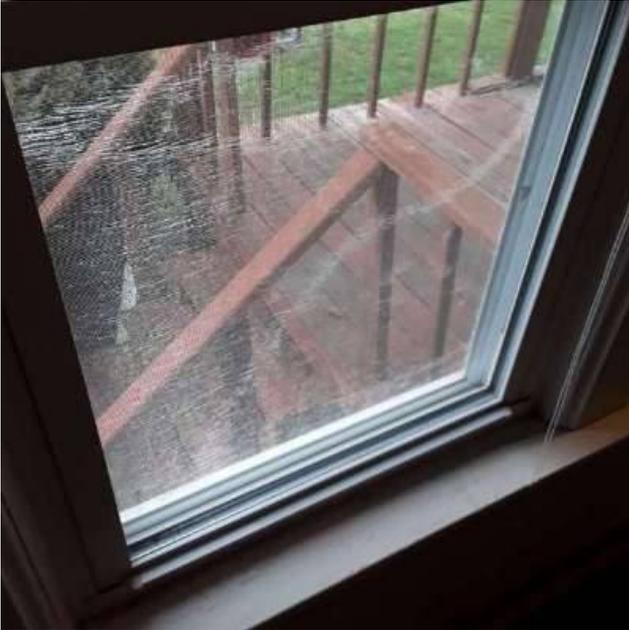
Photo 60-1

Front side window screens are damaged.

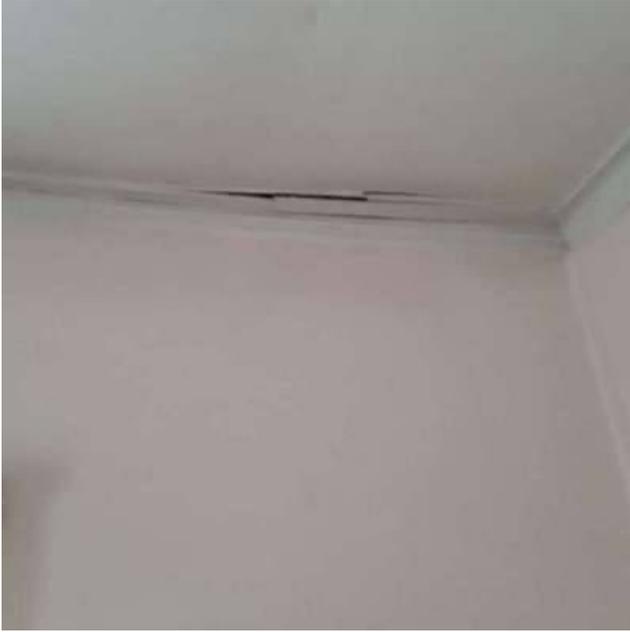
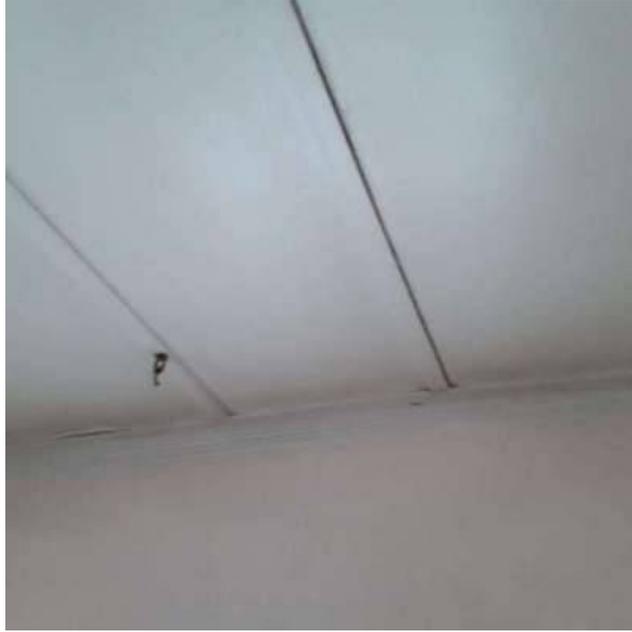
In location A part, the ceiling appears to be paneling. A portion of the paneling is buckling.

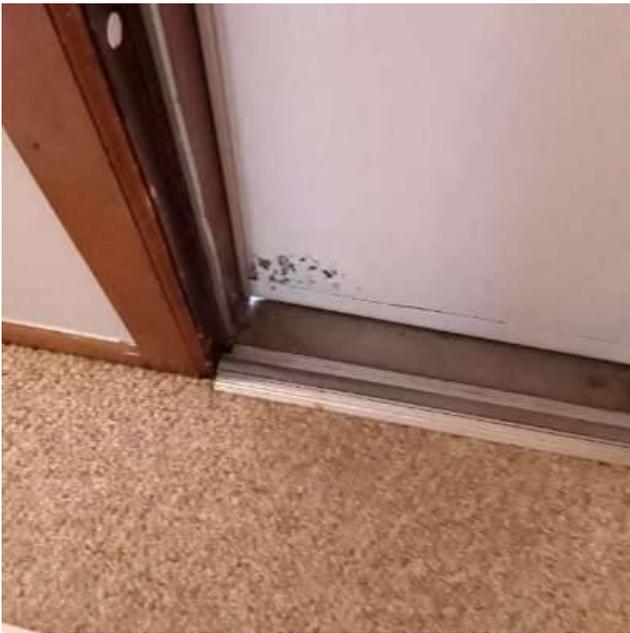
Photo 62-1

62) 🛠️ Weatherstripping around one or more exterior doors was damaged. Water may enter the building, or energy efficiency may be reduced. Recommend that a qualified person repair or replace weatherstripping as necessary.

Front door is concern.

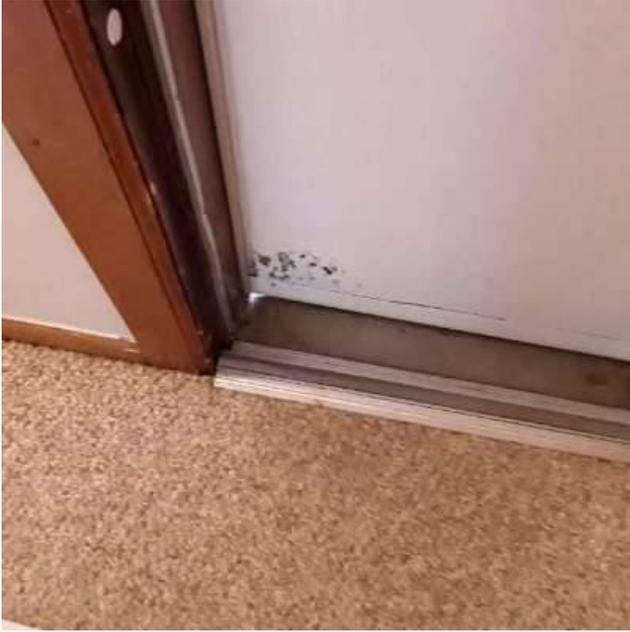
Photo 63-1

63) ⓘ One or more exterior doors had minor damage and/or deterioration. Although serviceable, the client may wish to repair or replace such doors for appearances' sake.

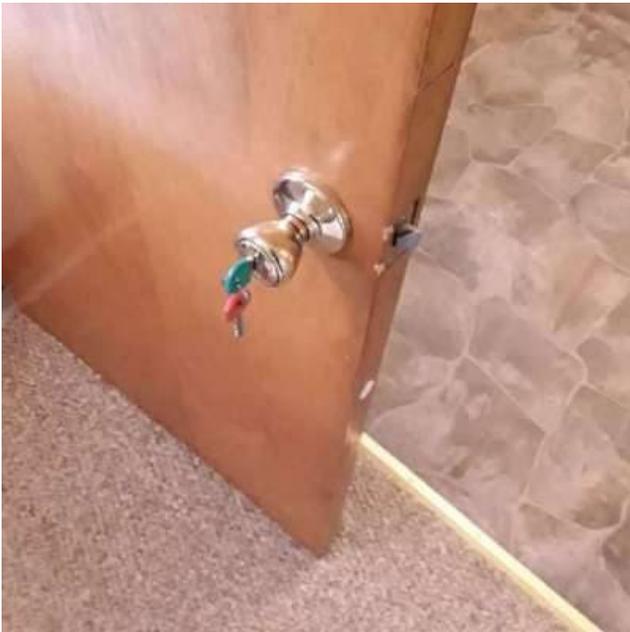
Photo 64-1

64) **i** One or more hinged exterior doors had no deadbolt lock installed and relied solely on the entry lockset for security. Recommend installing locksets on exterior doors where missing for added security.
