RIGHT AT HOME

Home Inspection Report

Property address: **1060 West Addison
Chicago, Il 60611**

Inspection date: **Saturday, April 14, 2018**

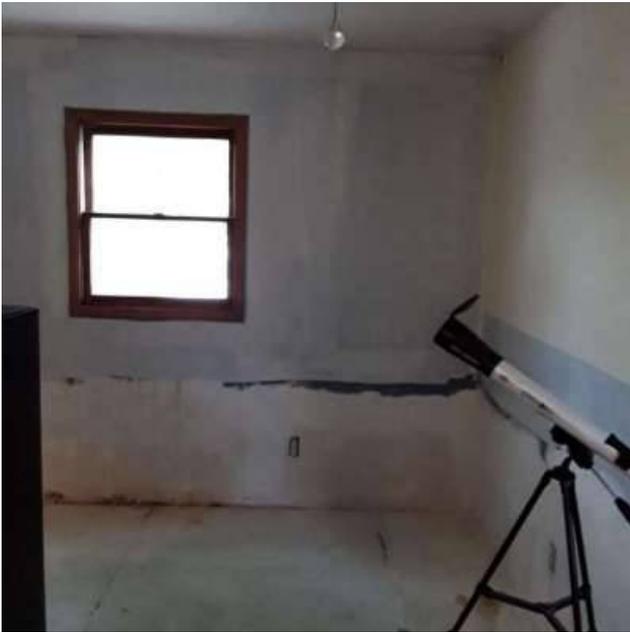
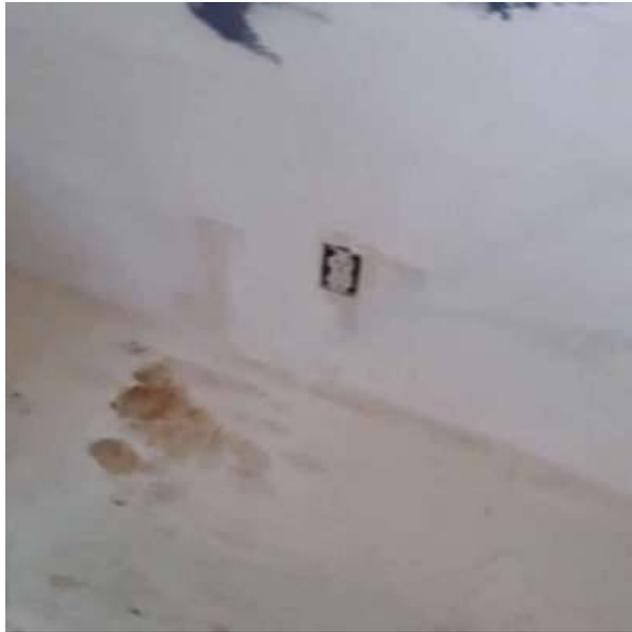
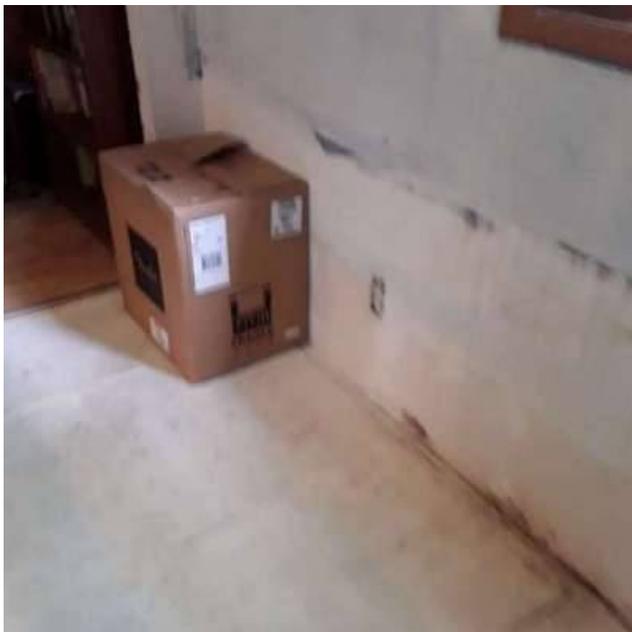
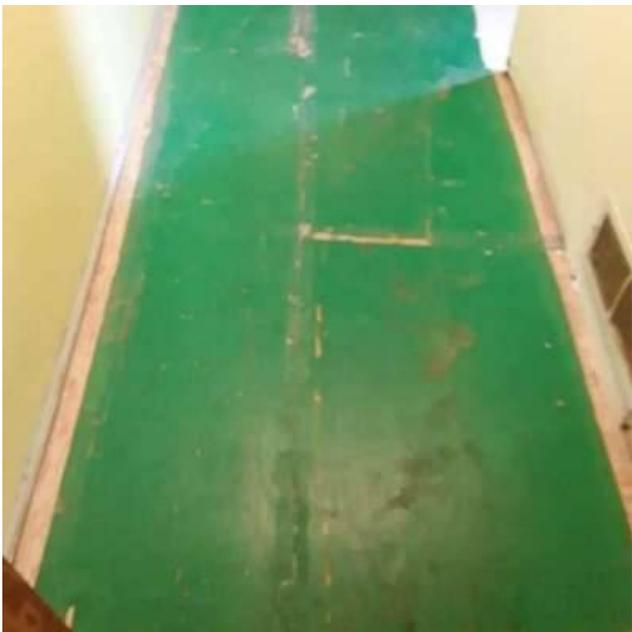
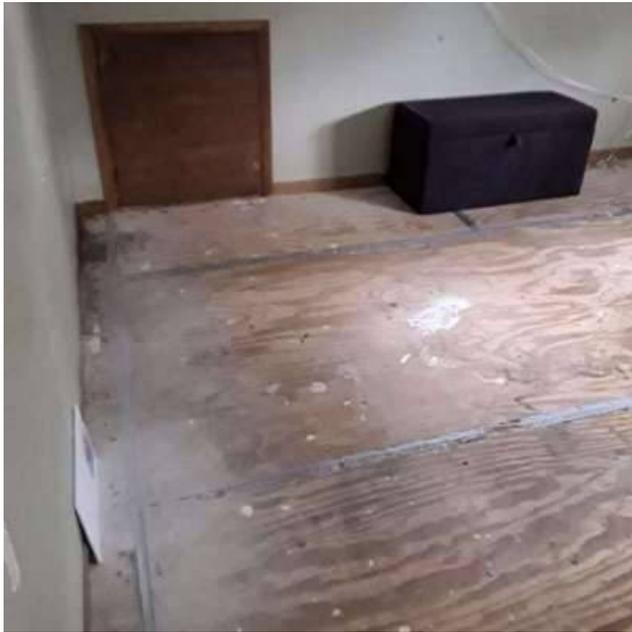
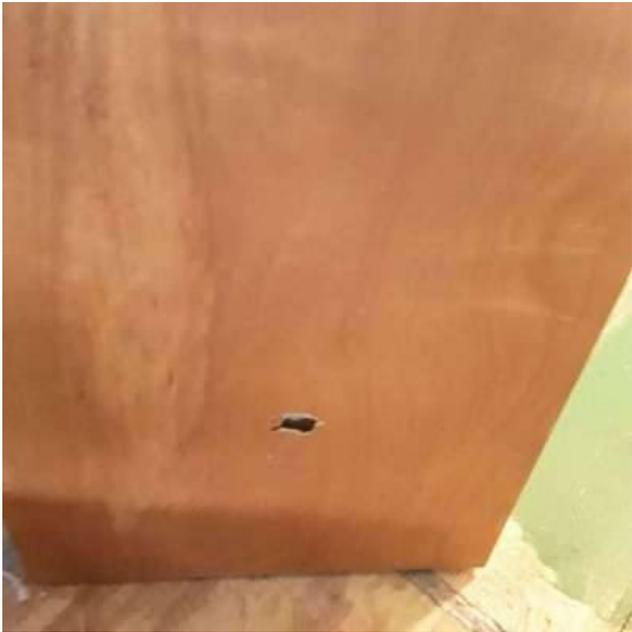
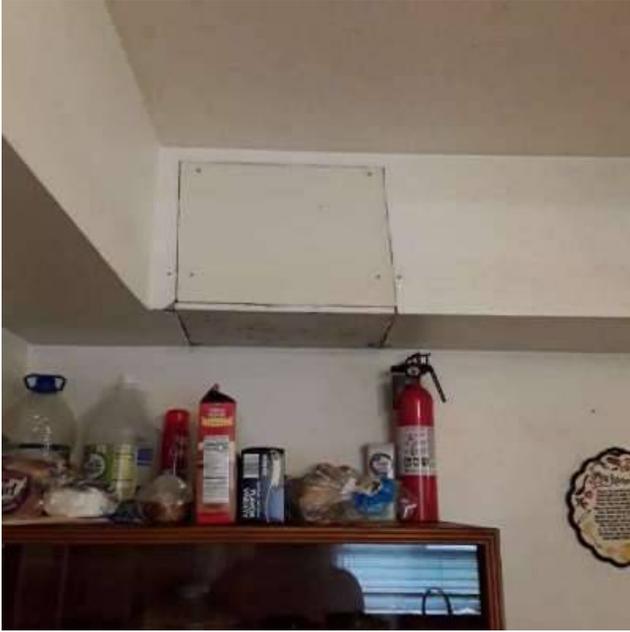
Several rooms in the house have unfinished floors and half painted walls. Some walls have holes in them or unfinished patches to them. Some doors have holes in them.

Recommend having and appropriate qualified repair person make proper repairs.

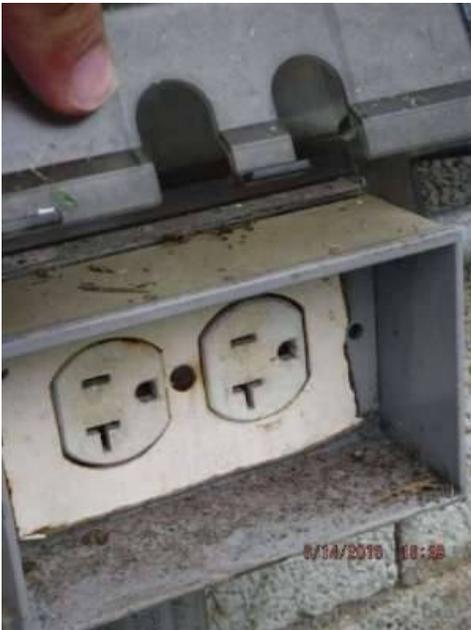
Photo 5-1

One or more outdoor electric receptacles appear to have no ground fault circuit interrupter (GFCI) protection. This is a safety hazard due to the risk of shock. A qualified electrician should evaluate to determine if GFCI protection exists, and if not, repairs should be made so that all outdoor receptacles within six feet six inches of ground level have GFCI protection. For example, install GFCI receptacles or circuit breaker(s) as needed.

Area of concern is front left of house.

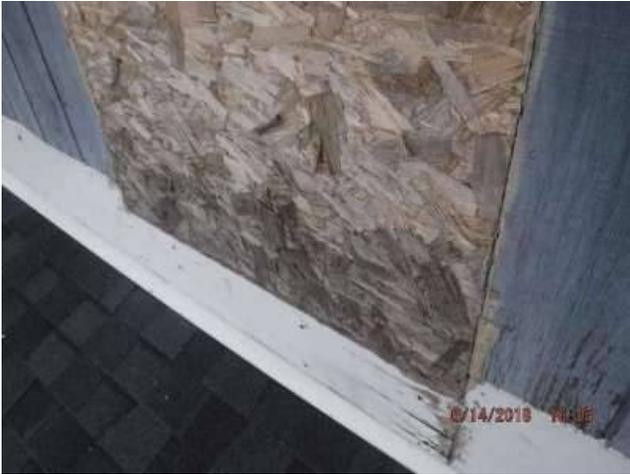
Photo 7-1

Siding is damaged and/or deteriorated in one or more areas. A qualified contractor should evaluate and make repairs and/or replace siding as necessary to prevent water and vermin intrusion.

Several areas on the house are of concern.

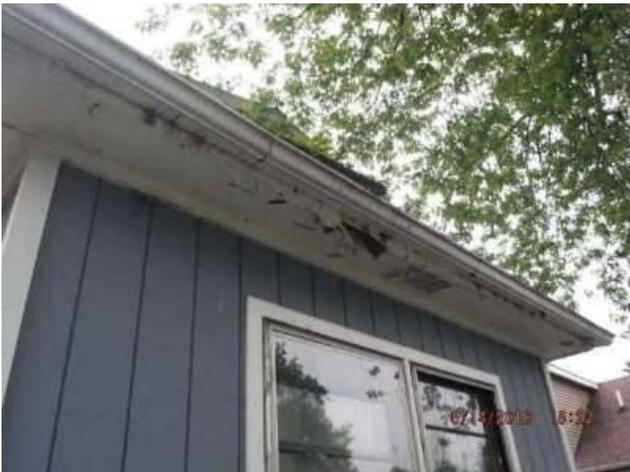
Photo 8-1

Soffit boards are damaged or deteriorated in one or more areas. A qualified contractor should evaluate and make repairs as necessary.

Several areas of the house are of concern.

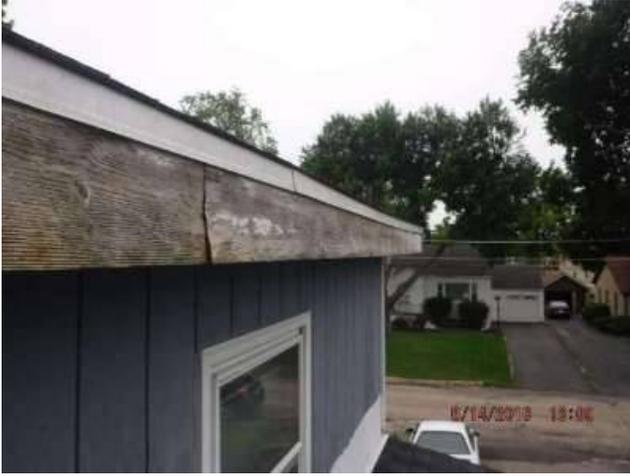
Photo 9-1

Fascia boards are damaged or deteriorated in one or more areas. A qualified contractor should evaluate and make repairs as necessary.

Several areas of the house are of concern.

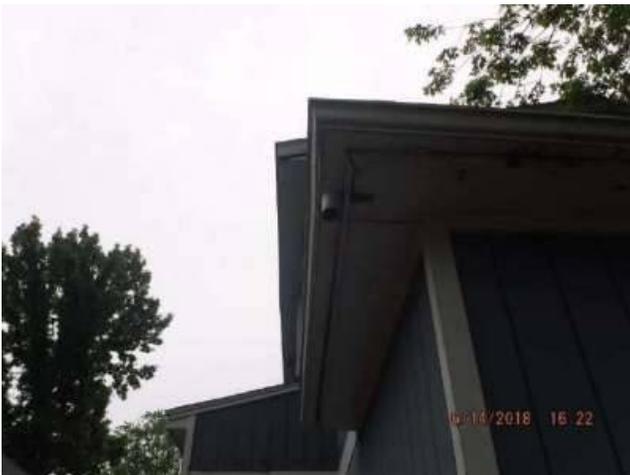
Photo 10-1

One or more downspouts are missing. This can result in water accumulating around the structure's foundation, or in basements and crawl spaces if they exist. Accumulated water is a conducive condition to wood destroying insects and organisms, and may also cause the foundation to settle and possibly fail over time. A qualified contractor should install downspout(s) where missing. Also recommend installing extensions such as splashblocks or tie-ins to underground drain lines as necessary to carry rainwater away from the house.

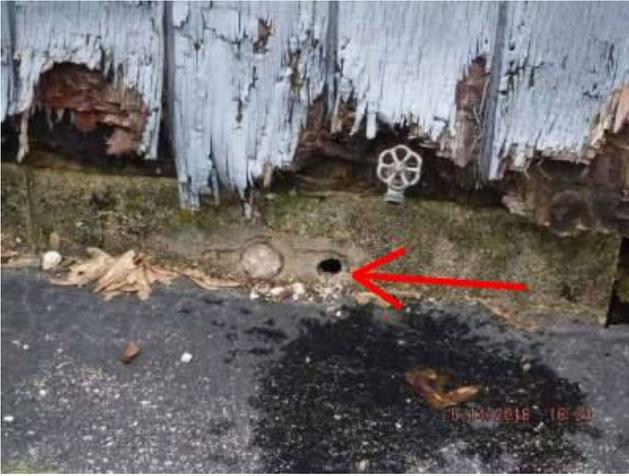
Photo 12-1

One or more minor cracks (1/8 inch or less) were found in the foundation. These don't appear to be a structural concern, but recommend sealing them to prevent water infiltration and monitoring them in the future. Numerous products exist to seal such cracks including:

This is indicated only to the fact that the foundation is constructed of field stone, and there are natural cracks/seams between the courses of stone. The same concern should be taken as if there are cracks. The parging on the outside appears to be failing as well.

There is a hole in foundation on right side of house next to water spigot.

- Hydraulic cement. Requires chiseling a channel in the crack to apply.
- Resilient caulks (easy to apply).
- Epoxy sealants (both a waterproof and structural repair).

I recommend evaluation by a structural engineer or qualified foundation repair contractor with experience in this type of foundation and repair as needed.

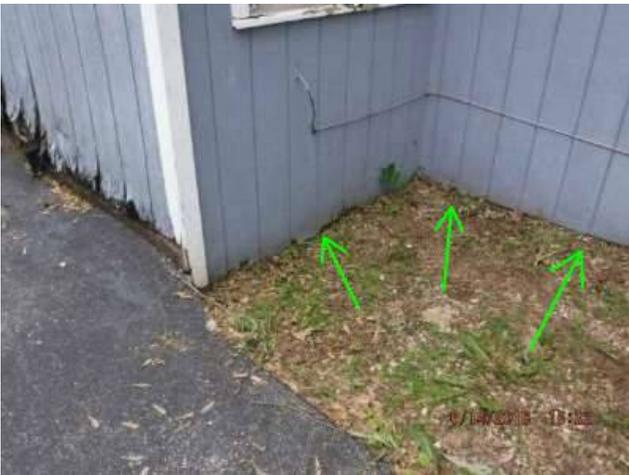
Photo 13-1

Soil is in contact with or less than six inches from siding and/or trim. This is a conducive condition for wood destroying insects and organisms. Soil should be graded and/or removed as necessary so there are at least six inches of space between the siding and trim and the soil below.

Area of concern is right side toward rear.

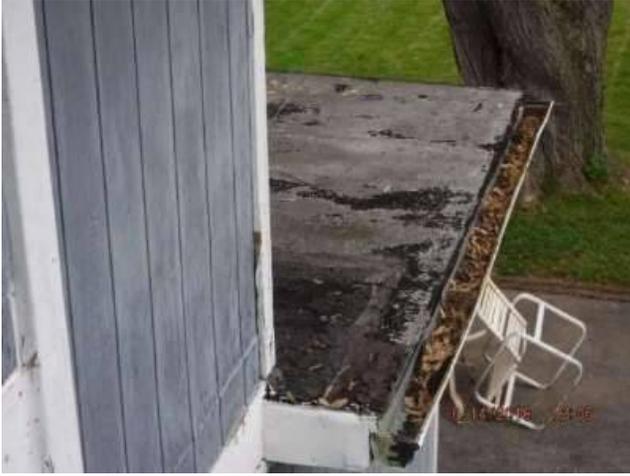
Photo 22-1

The coating on the flat roof has deteriorated and may result in a shortened service life. A qualified roofing contractor should apply a new roof coating now and as necessary in the future. Typically this is done every four to five years.

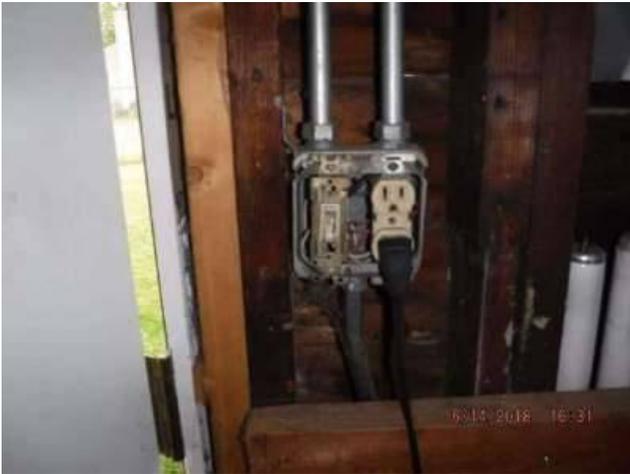
Photo 23-1

23) 🚧🔌 Cover plate(s) are missing from one or more electric boxes, such as for receptacles, switches and/or junction boxes. They are intended to contain fire and prevent electric shock from exposed wires. This is a safety hazard due to the risk of fire and shock. Cover plates should be installed where missing.

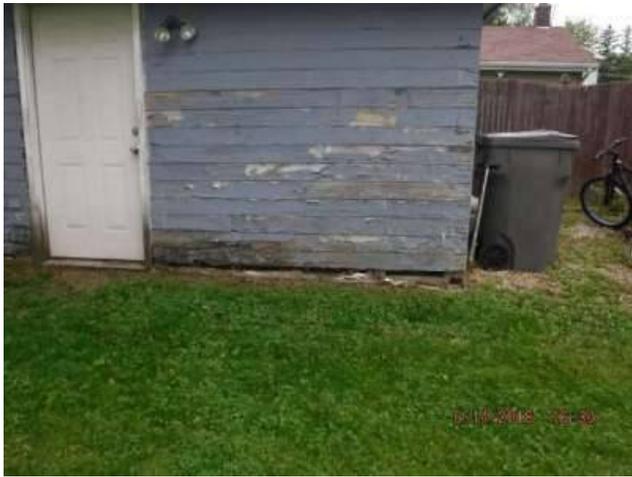
Photo 24-1

24) 🪛 Many areas of the wood siding are deteriorated, and there holes in some areas of siding. Consider consult a qualified repair person to make proper repairs.

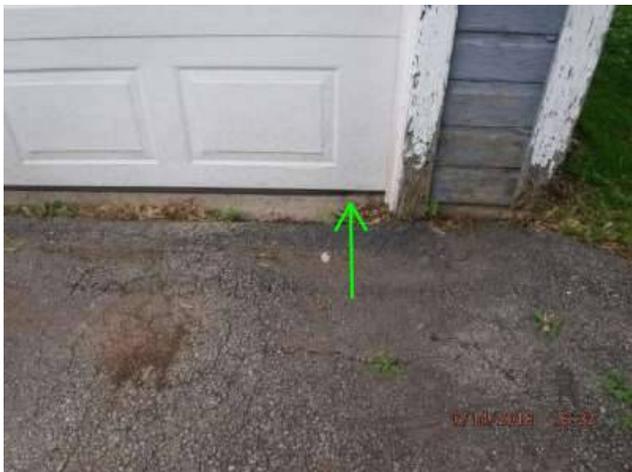
Photo 26-1

Weatherstrip at the sides and/or bottom of the vehicle door is damaged and/or deteriorated. It should be replaced where necessary to prevent water and vermin intrusion.
Area of concern is the right side when looking from outside.

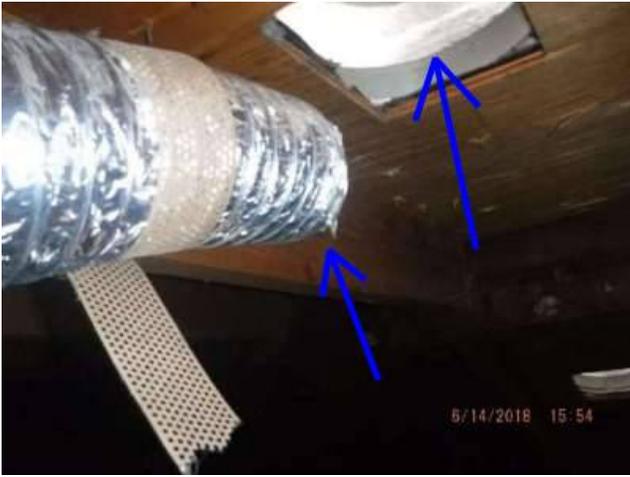
Photo 28-1

28) **w** One or more exhaust fan ducts terminate in attic because no vent cap is installed at the roof or exterior wall surfaces. This is a conducive condition for wood destroying insects and organisms due to increased moisture levels in the attic from the exhaust air. A qualified contractor should evaluate and install vent caps where missing and as per standard building practices, so all exhaust air is vented outside. The bathroom vent terminates just below the vent cal. The should be installed in a more positively attached manner to avoid any possible downdraft preventing moisture from being vented outside.

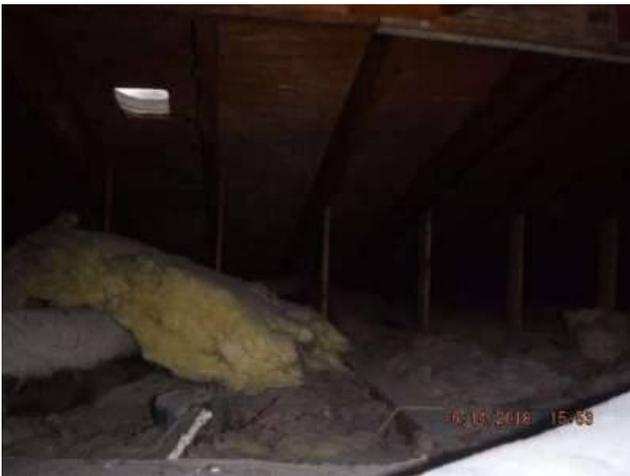
Photo 29-1

29) **w** Ceiling insulation is uneven in some areas. This is likely due to someone having walked on or through the insulation. Recommend installing additional insulation where necessary to restore the original R rating.

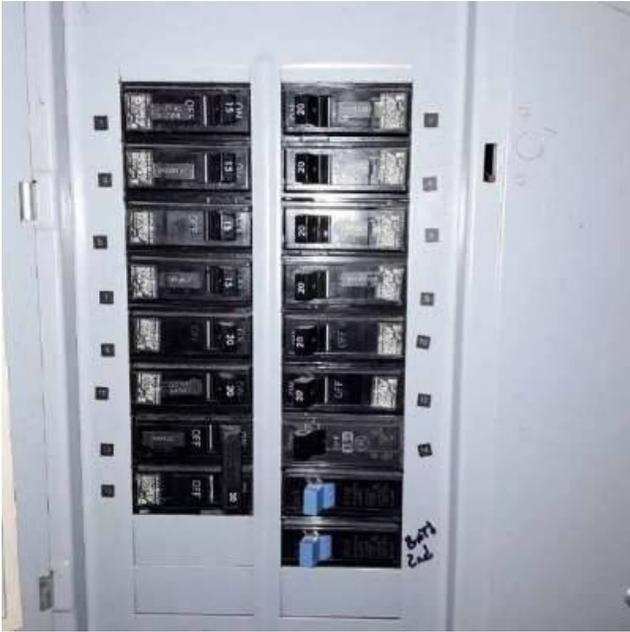
Photo 31-1

The electric service was configured so that too many hand movements were necessary to turn off all power for the service. Six or fewer circuit breakers should be required to turn off all power to a residence. This is a potential safety hazard during an emergency when the power needs to be turned off quickly. Recommend that a qualified electrician repair per standard building practices.

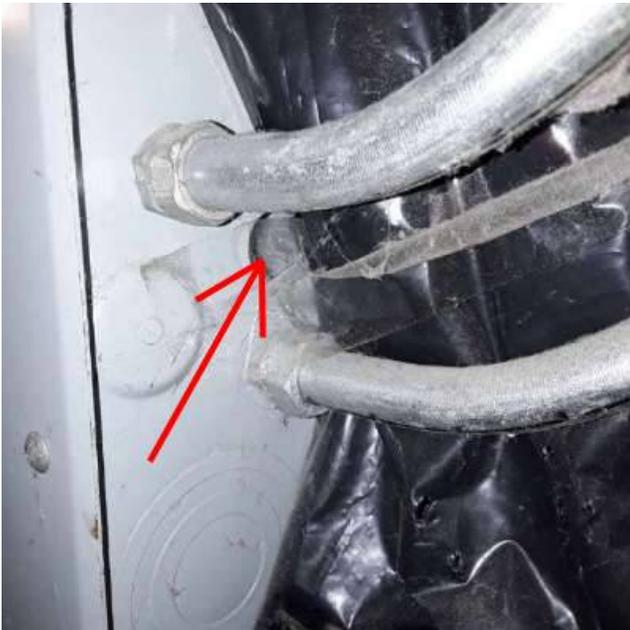
Photo 32-1

One or more knockouts were missing from panel(s) #A. Holes in panels are a potential fire hazard if a malfunction ever occurs inside the panel. Rodents can also enter panels through holes. Recommend that a qualified person install knockout covers where missing and per standard building practices.

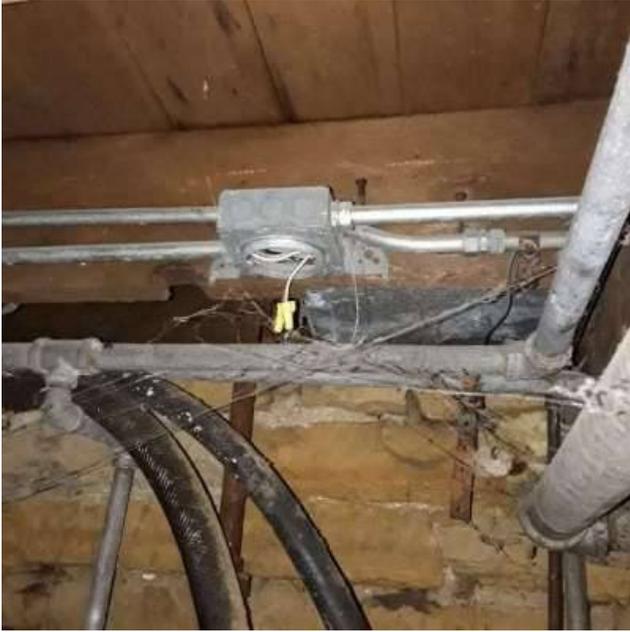
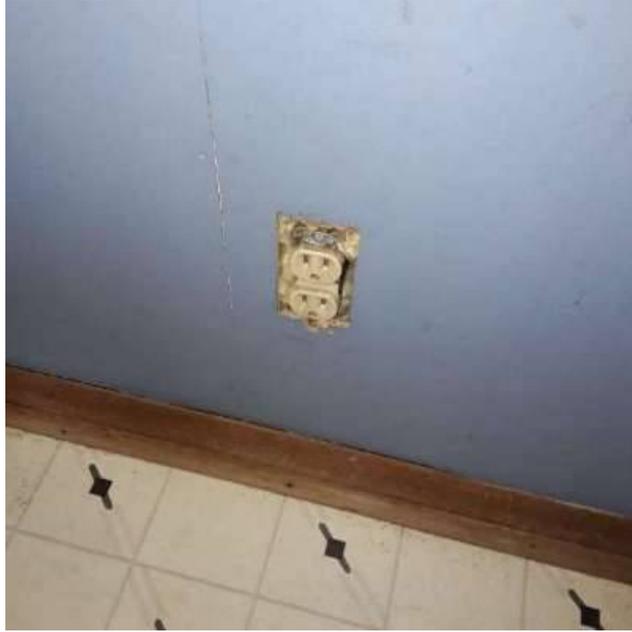
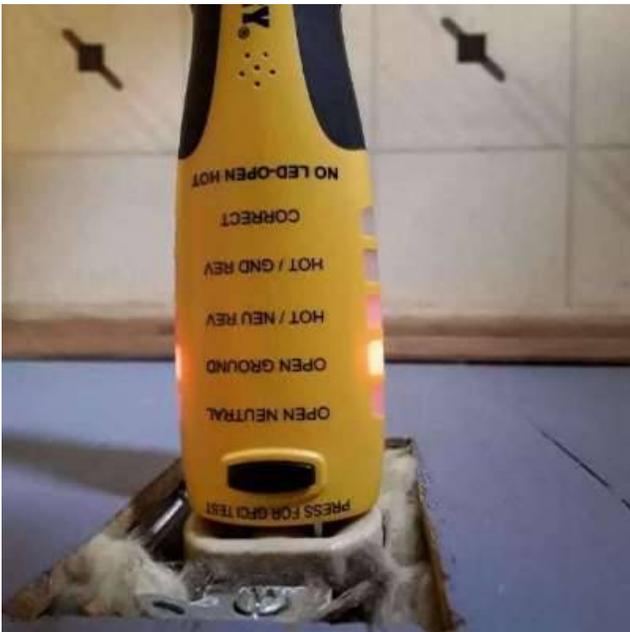
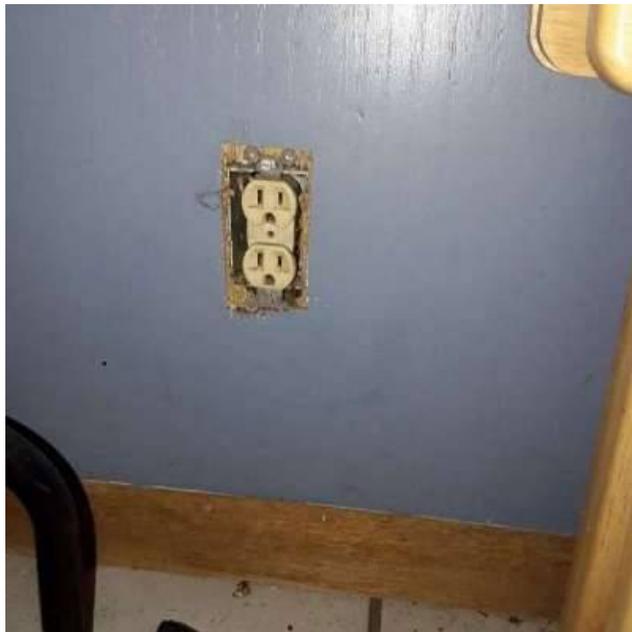
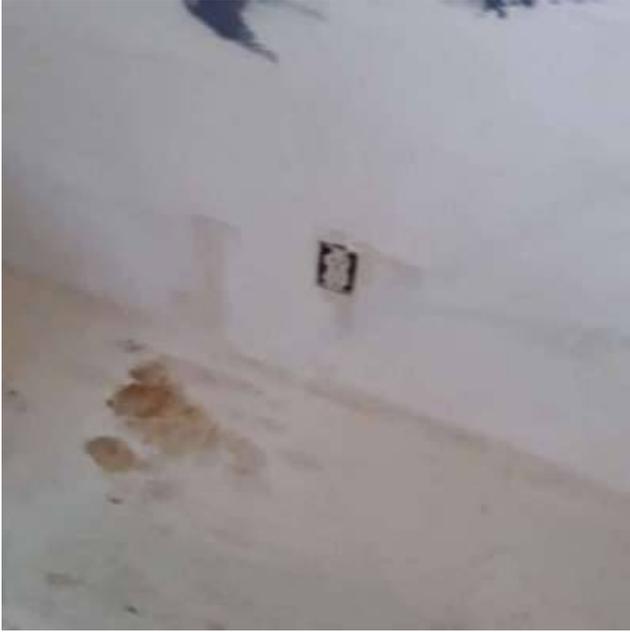
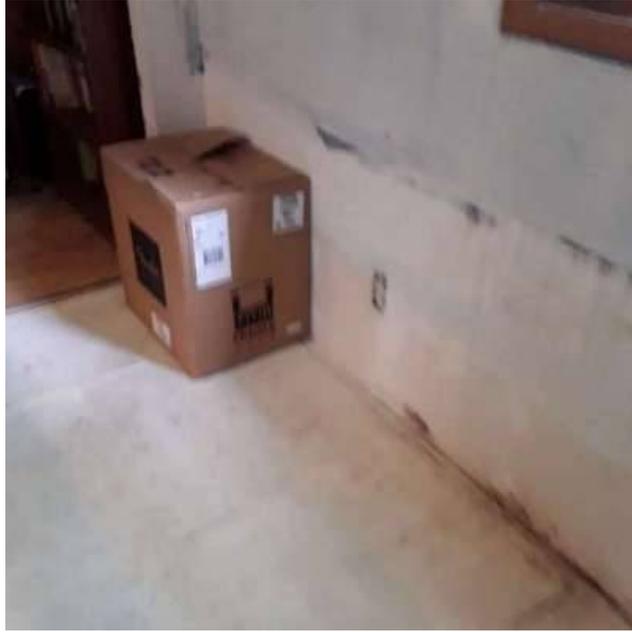
One or more cover plates for switches, receptacles or junction boxes were missing or broken. These plates are intended to contain fire and prevent electric shock from occurring due to exposed wires. Recommend that a qualified person install cover plates where necessary.

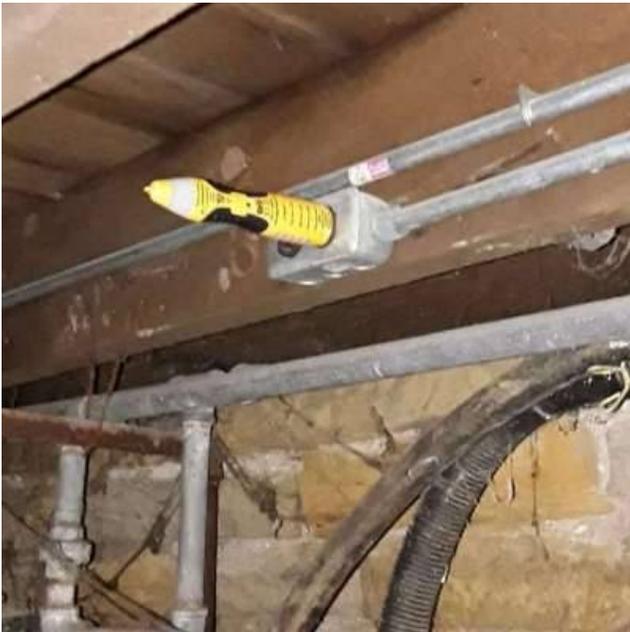
Photo 34-1

One or more electric receptacles appeared to have no power. Recommend asking the property owner about this. Switches may need to be operated or GFCI/AFCI protection may need to be reset to make some receptacles energized. If necessary, recommend that a qualified electrician evaluate and repair.

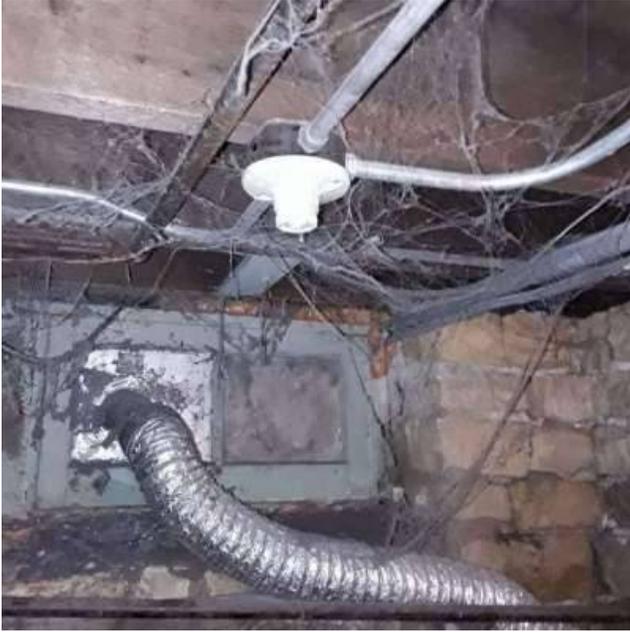
Photo 35-1

Bulbs in one or more light fixtures were missing or broken. These light fixtures couldn't be fully evaluated. If replacement bulbs are inoperable, then recommend that a qualified electrician evaluate and repair or replace light fixtures as necessary.

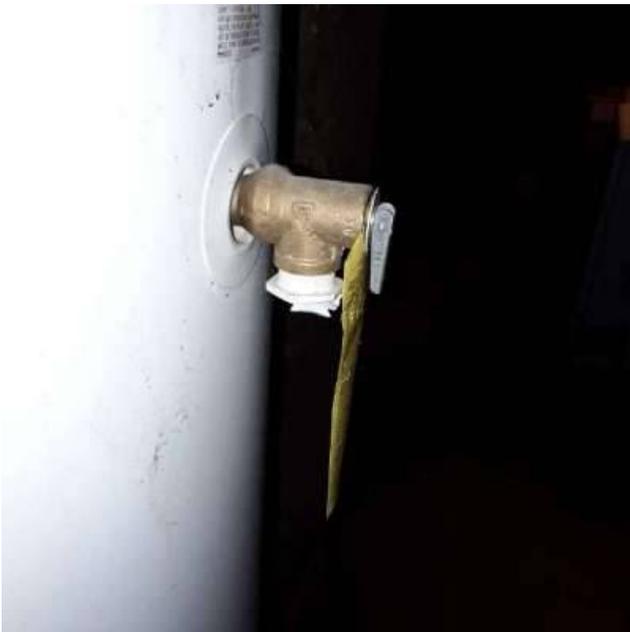
Photo 36-1

No drain line is installed for the temperature-pressure relief valve. This is a potential safety hazard due to the risk of scalding if someone is standing next to the water heater when the valve opens. A qualified plumber should install a drain line as per standard building practices. For example, extending to 6 inches from the floor, or routed so as to drain outside.

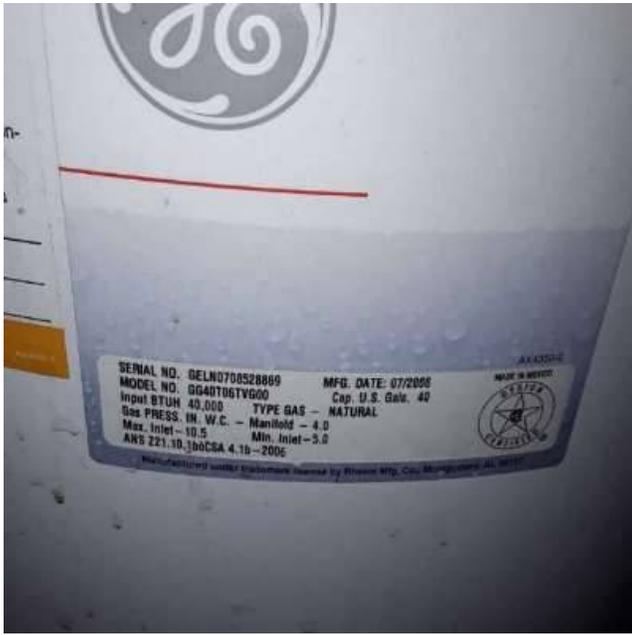
Photo 37-1

The estimated useful life for most water heaters is 8 to 12 years. This water heater appears to be at this age or older and may need replacing at any time. Recommend budgeting for a replacement in the near future.

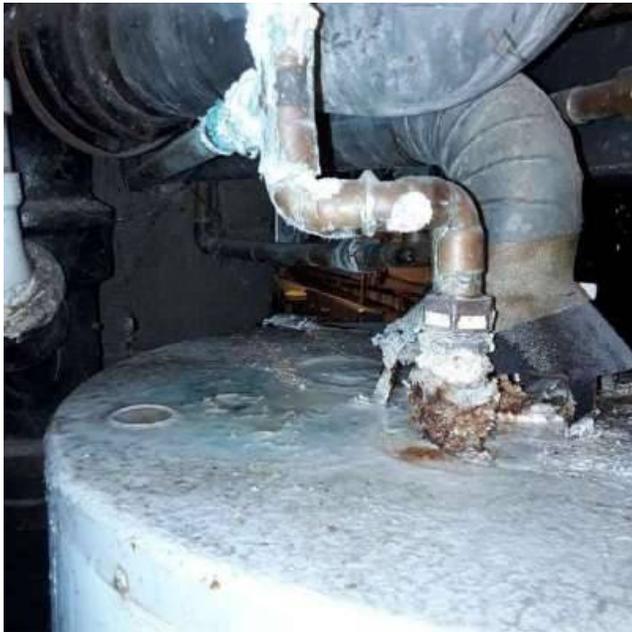
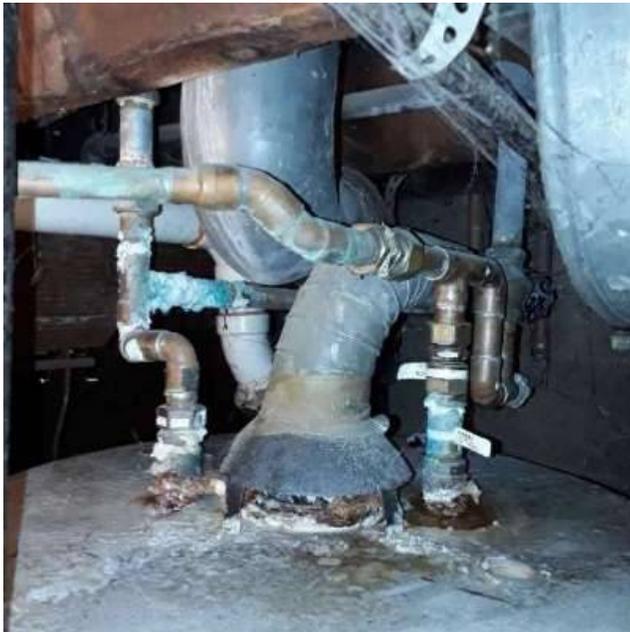
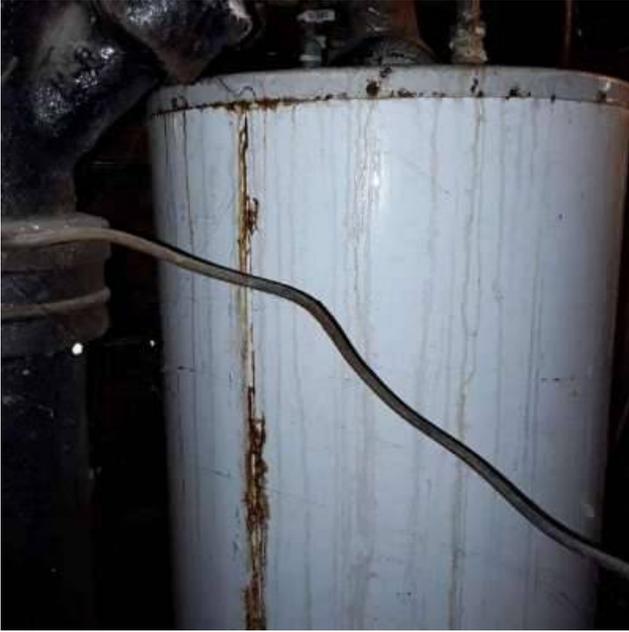
38) 🔧🔍💧 Corrosion was found in one or more areas on the water heater, and water stains were found below. The water heater may be failing. A qualified plumbing contractor should evaluate and replace water heater if necessary.

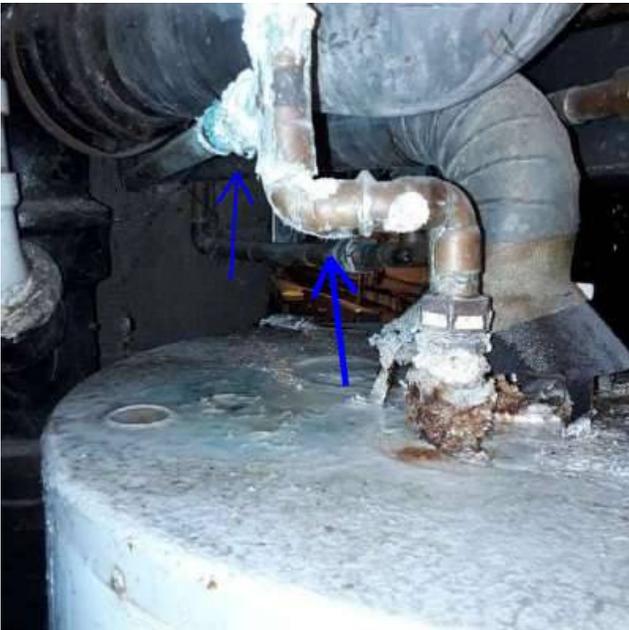
Photo 39-1

Active water leak in piping of water heater. Consult a qualified repair person for repairs.

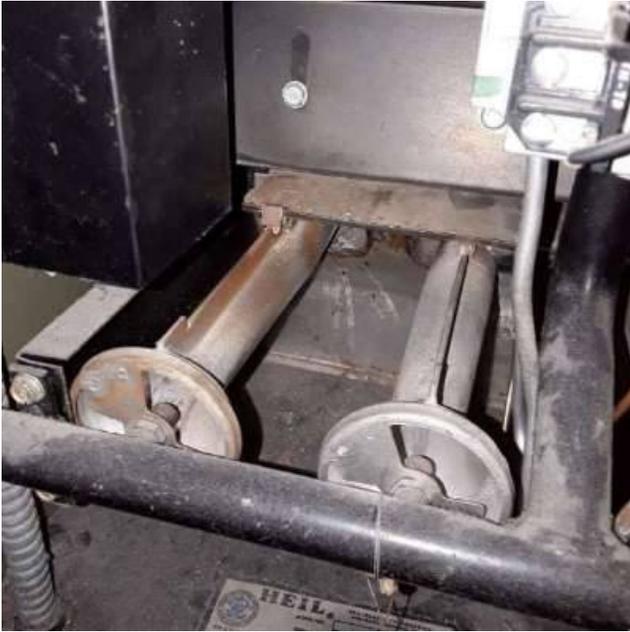
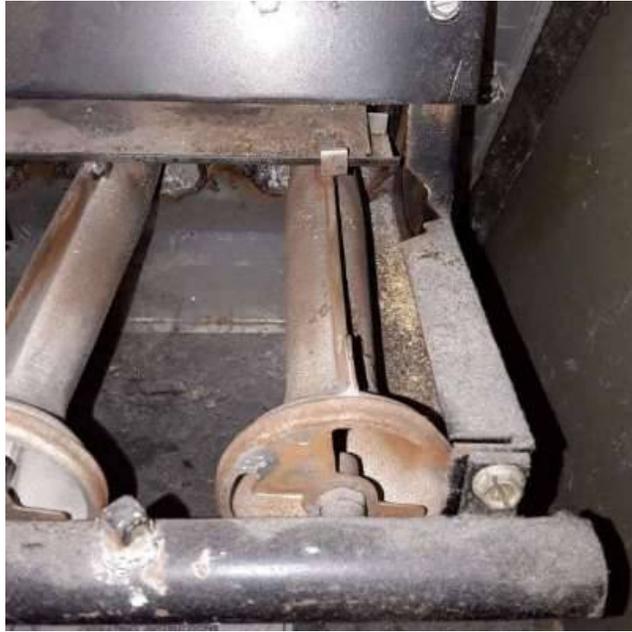
There is rust on the heat exchanger. Rust poses a particular danger to your furnace and you: corrosion across the heat exchanger. If a heat

exchanger starts to corrode, it can develop cracks which will allow carbon monoxide exhaust to escape into the cabinet and possibly into your living spaces. Consult a qualified repair person for repairs.

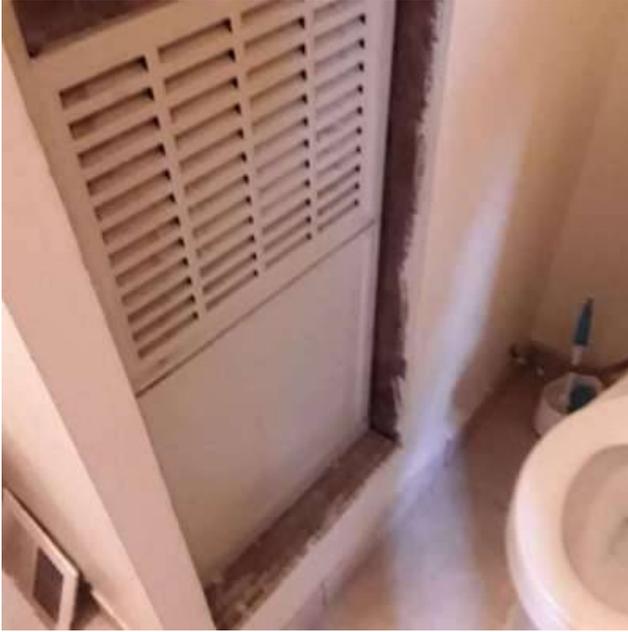
Photo 44-1

This unit is located in a wet environment of the 2nd floor bath. This is a conducive condition for moisture problems within the system.

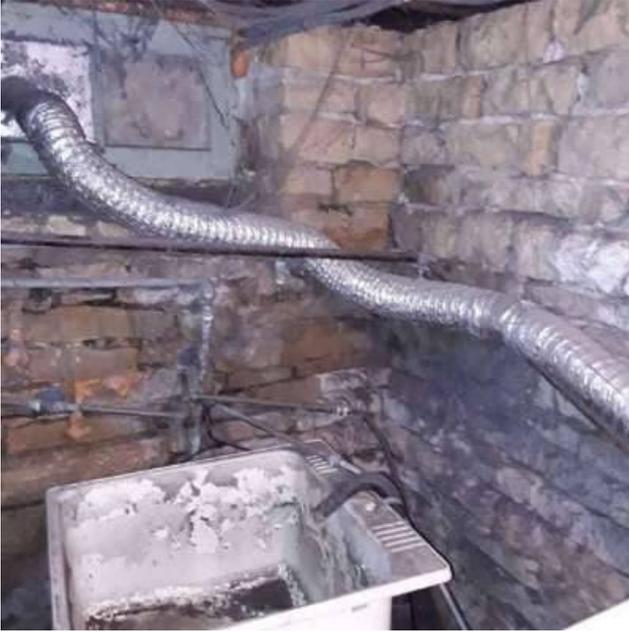
Photo 46-1

The clothes dryer is equipped with a vinyl or foil, accordion-type, flexible exhaust duct. The U.S. Consumer Product Safety Commission considers these types of ducts to be unsafe, and a fire hazard. These types of ducts can trap lint and are susceptible to kinks or crushing, which can greatly reduce the air flow. This duct should be replaced with a rigid or corrugated semi-rigid metal duct, and by a qualified contractor if necessary. Most clothes dryer manufacturers specify the use of a rigid or corrugated semi-rigid metal duct. For more information, visit:

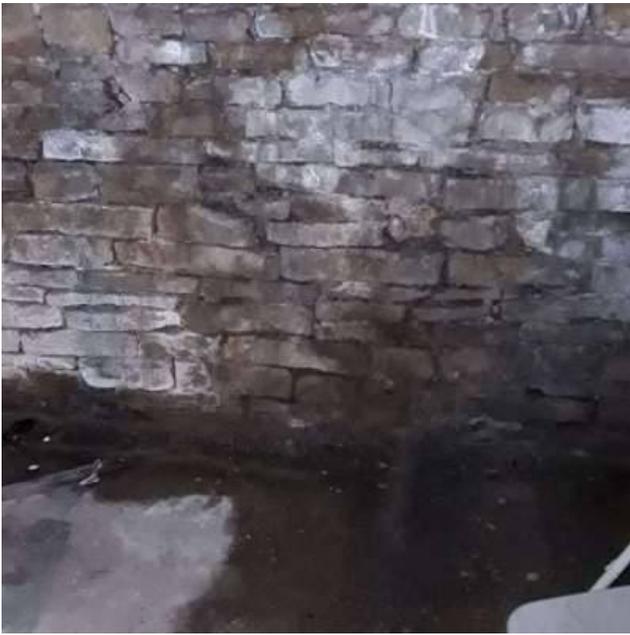
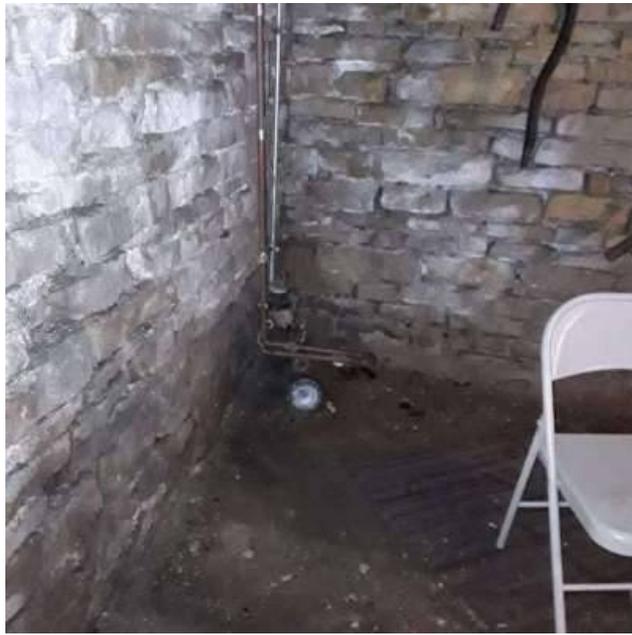
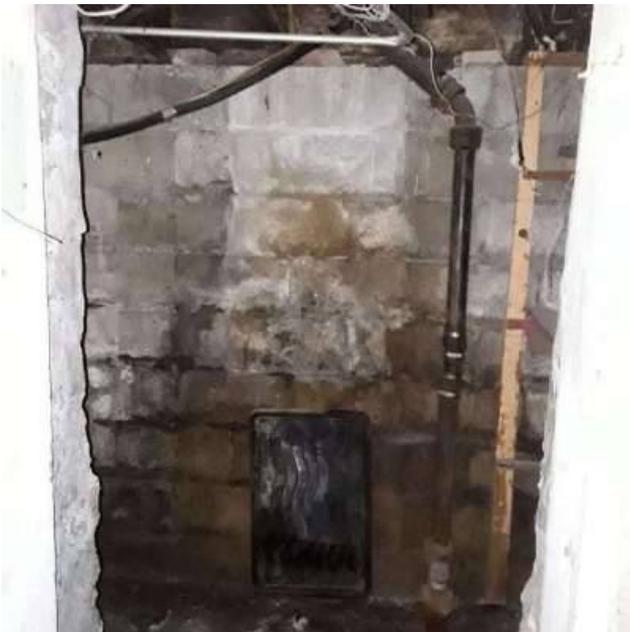
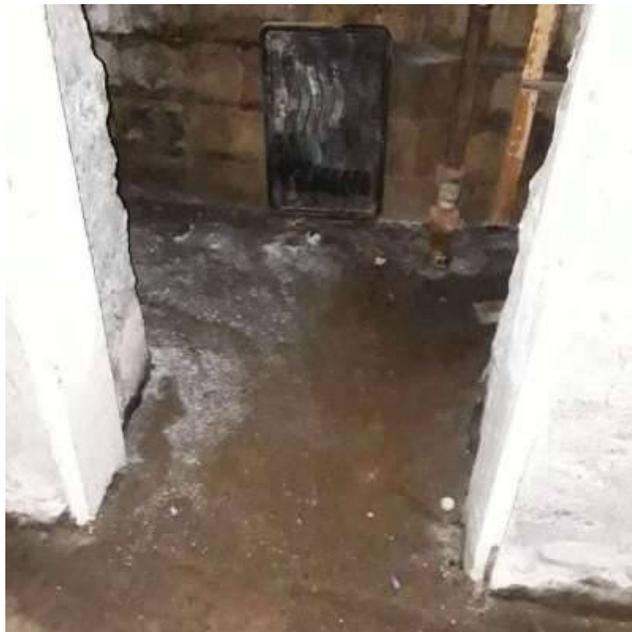
Standing water and/or wet areas were found in one or more sections of the basement. Accumulated water is a conducive condition for wood destroying insects and organisms and should not be present in the basement. A qualified contractor who specializes in drainage issues should evaluate and repair as necessary. Typical repairs for preventing water from accumulating in the basement include:

There is a laundry tub that does not have water lines run to it, rather the washer drains into it. It was excessively wet underneath and then following the natural slope in basement floor. The floor drain adjacent to tub had water to the top of it. Ideally, water should not enter the basement, but if water must be controlled after it enters the basement, then typical repairs include installing sump pump(s) or interior perimeter drains.

- Repairing, installing or improving rain run-off systems (gutters, downspouts and extensions or drain lines)
- Improving perimeter grading
- Repairing, installing or improving underground footing and/or curtain drains

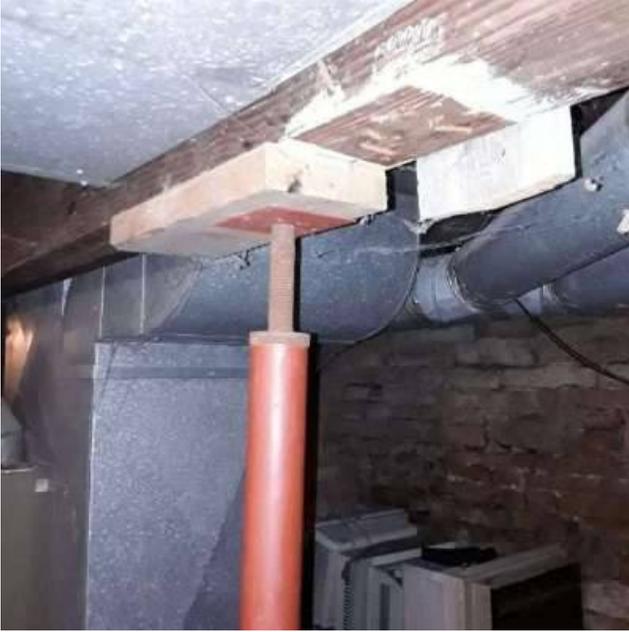
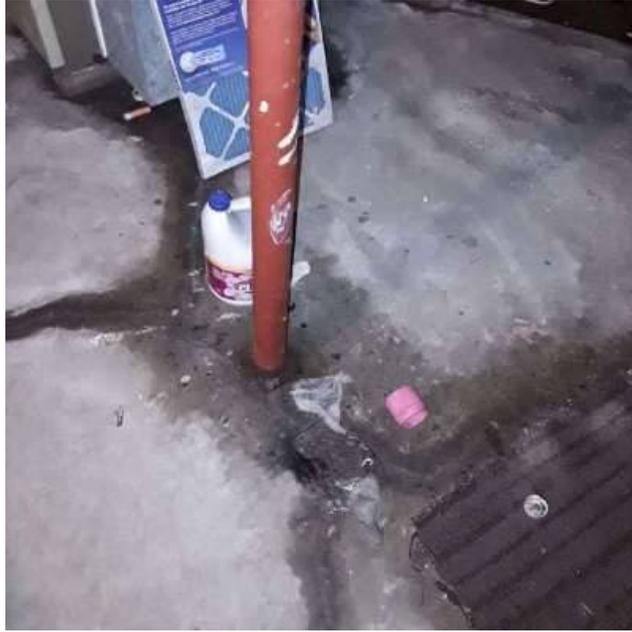
One or more adjustable steel columns were found. Some adjustable steel columns are rated for permanent use, but some are not. Based on the inspector's observations, columns in this building may not be rated for permanent use and may pose a safety risk for collapse. Recommend that a qualified contractor familiar with regulations surrounding use of such columns evaluate and repair if necessary, and per standard building practices and any applicable local codes.

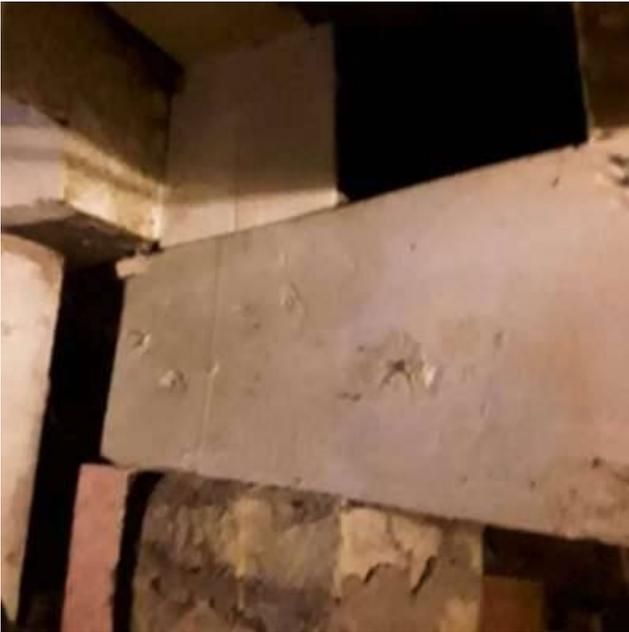
Photo 52-1

One or more support posts were constructed of multiple pieces of lumber instead of one continuous piece. Such posts lack strength and are subject to collapse during an earthquake. A single, solid piece of lumber that extends from the footing below to the beam above should be used for wooden support posts. Recommend that a qualified contractor repair per standard building practices.

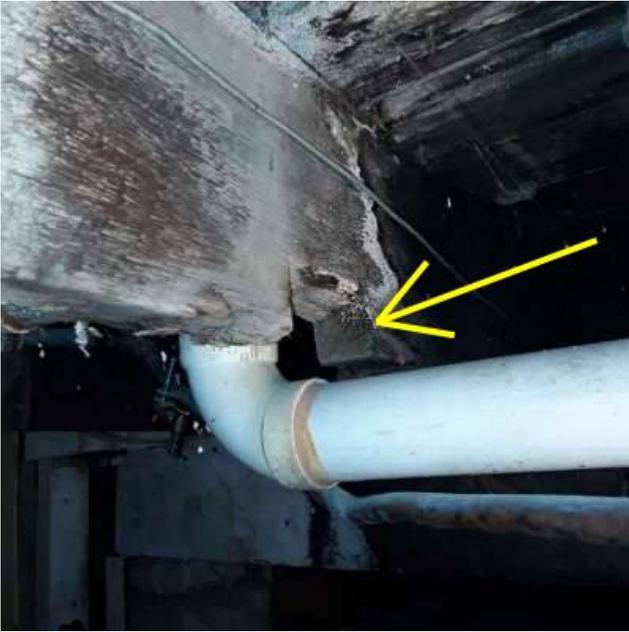
Photo 53-1

Moisture from above was noted in this area as well.

Recommend that a qualified contractor evaluate and repair as necessary, and per standard building practices.

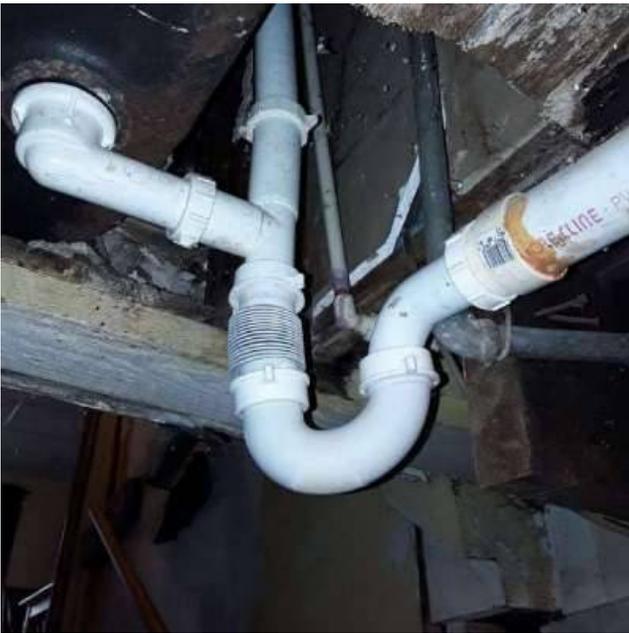
Photo 54-1

Flex pipe visible in basement for the tub above. This is incorrect material as it will be easier to clog in future. Consider consulting a qualified plumber for proper repairs.

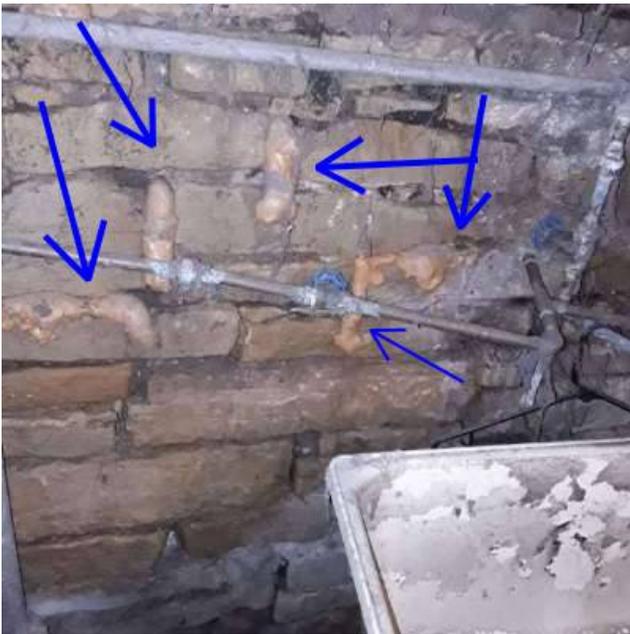
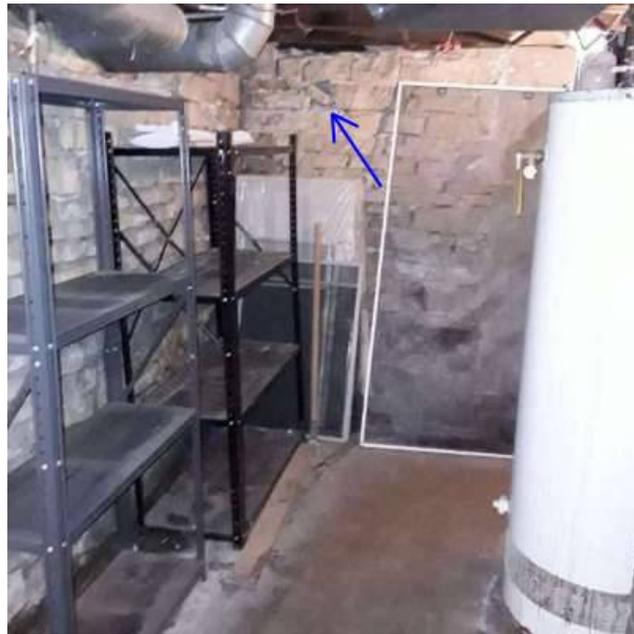
Some gaps within the foundation stones have been filled with spray foam. This is not the proper materials and method to repairing the foundation.

Photo 56-1 Spray foam.

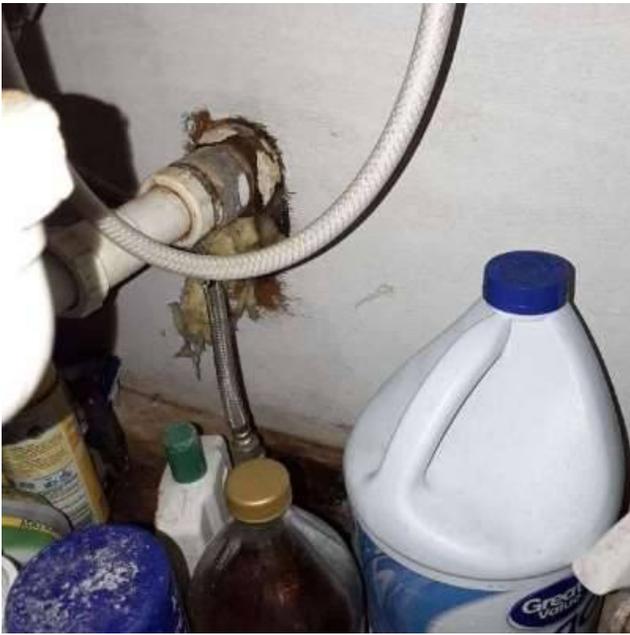
Photo 59-1

The sink sprayer at the kitchen sink is inoperable or defective. It should be replaced, and by a qualified plumber if necessary. Sprayer has active leak.
