RIGHT AT HOME

Home Inspection Report

Property address: **1060 West Addison
Chicago, Il 60611**

Inspection date: **Saturday, April 14, 2018**

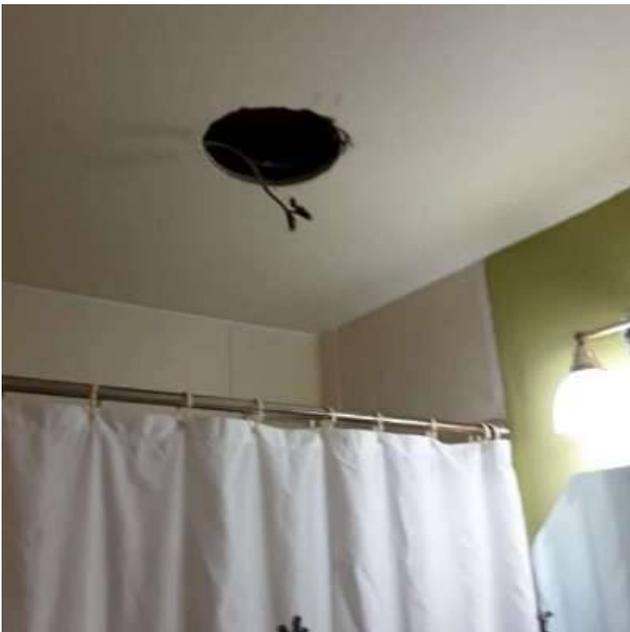
Photo 61-1

61) ⚠️ Cover plate(s) are missing from one or more electric boxes, such as for receptacles, switches and/or junction boxes. They are intended to contain fire and prevent electric shock from exposed wires. This is a safety hazard due to the risk of fire and shock. Cover plates should be installed where missing. Area of concern is location B.

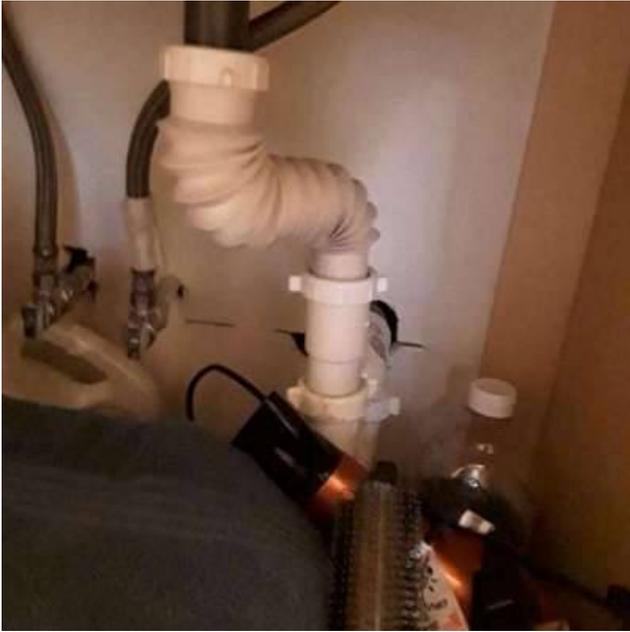
Photo 63-1

One or more sink drains use flexible drain pipe. This type of drain pipe is more likely to clog than smooth wall pipe. Recommend having a qualified plumber replace this pipe with standard plumbing components (smooth wall pipe) to prevent clogged drains. Area of concern is location A.

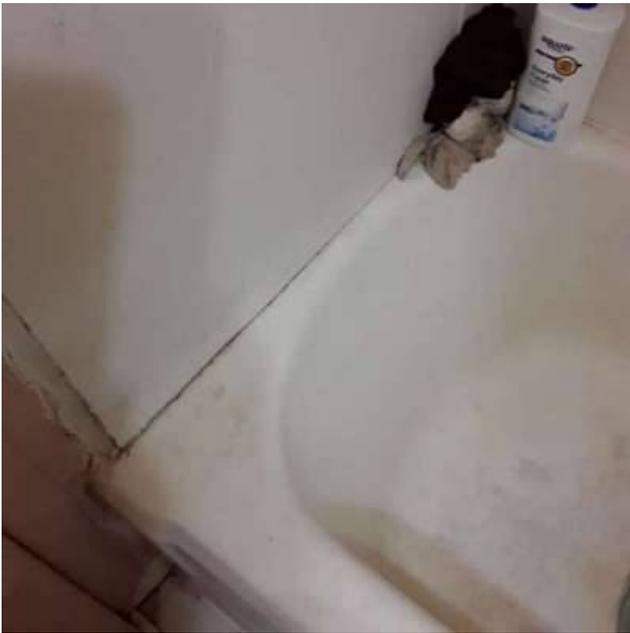
Photo 64-1

Caulk is missing or deteriorated above one or more bathtubs, where the tub surround meets the tub. It should be replaced where deteriorated and/or applied where missing to prevent water intrusion and damage to the wall structure.

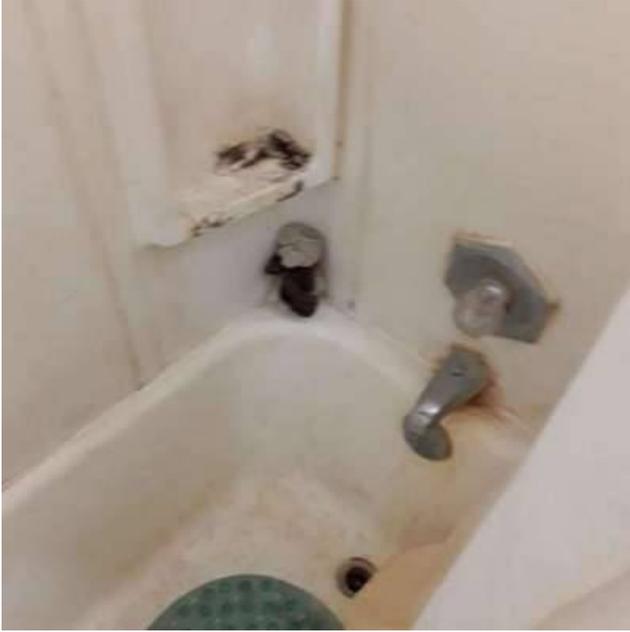
Photo 65-1

The location B shower surround may have organic growth on it.

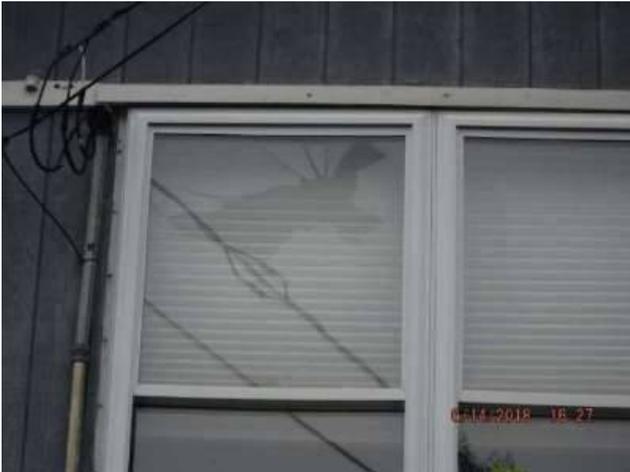
Photo 66-1

66) 🛠️ Glass in one or more windows is broken. A qualified contractor should replace glass where necessary.

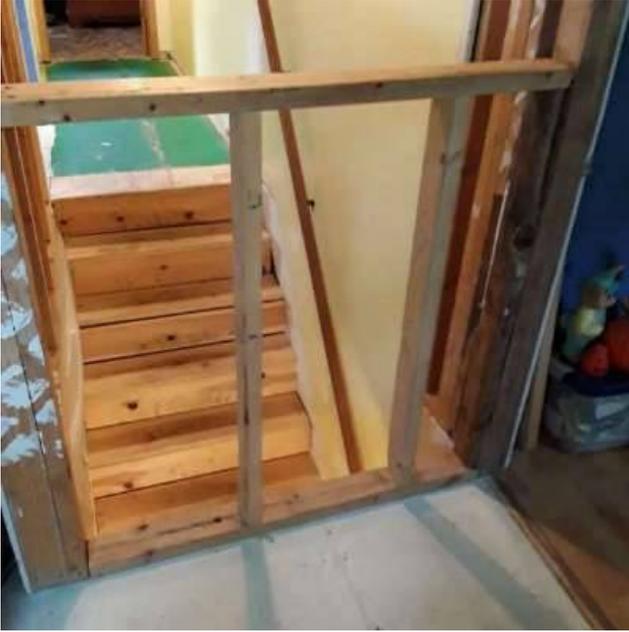
Photo 68-1

68) 🛠️🚑 Gaps larger than four inches were found in one or more guardrails. This is a safety hazard, especially for small children. A qualified contractor should make modifications as necessary so gaps in guardrails do not exceed four inches. For example, installing additional balusters or railing components. Area of concern is near loft.

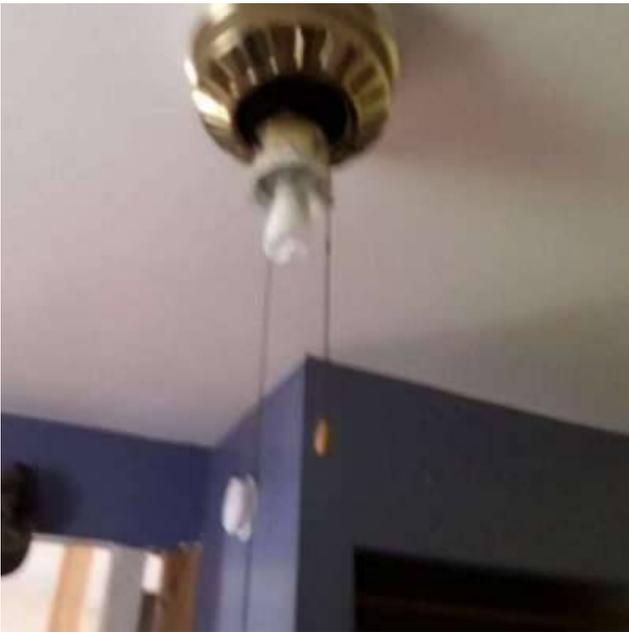
Photo 70-1

Ceiling fan in bedroom off loft area missing blades.

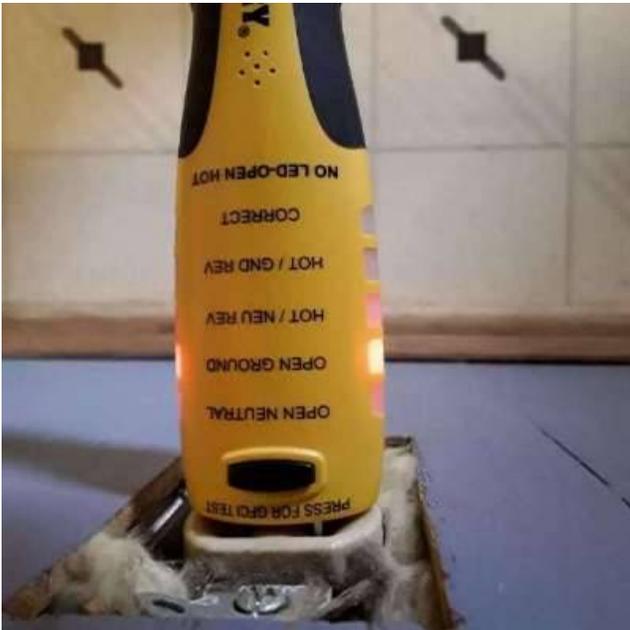
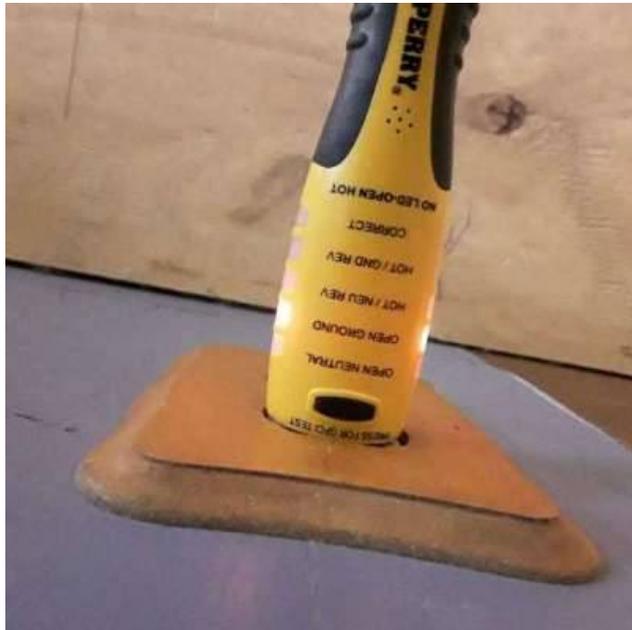
One or more open ground, three-pronged electric receptacles were found. This is a safety hazard due to the risk of shock. A qualified electrician should evaluate and make repairs as necessary. For example, replacing receptacles or correcting wiring circuits.

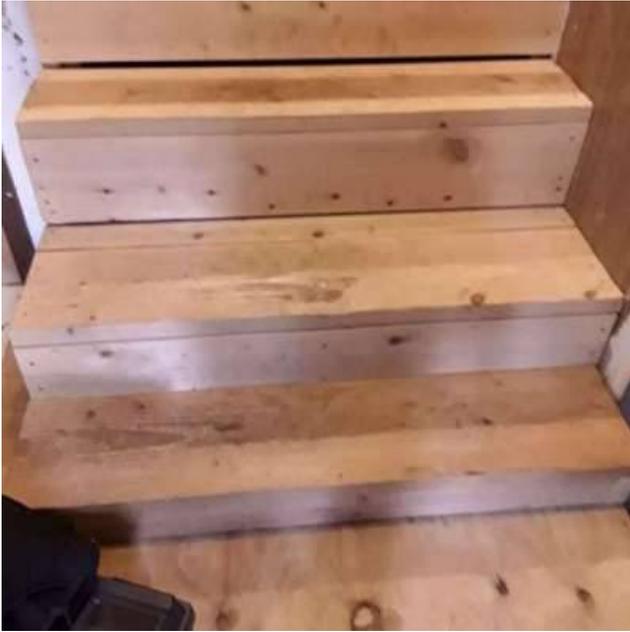
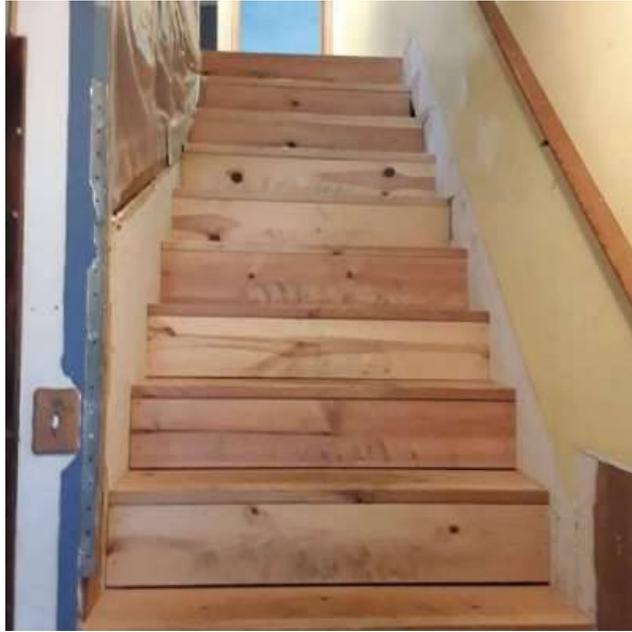
Trip hazard(s) exist at stairs due to non-uniform riser heights. Standard building practices call for riser heights not to vary more than 3/8 inch on a flight of stairs. At a minimum, the client(s) should be aware of this hazard, especially when guests who are not familiar with the stairs are present. Ideally a qualified contractor should evaluate and repair or replace stairs so all riser heights are within 3/8 inch of each other.

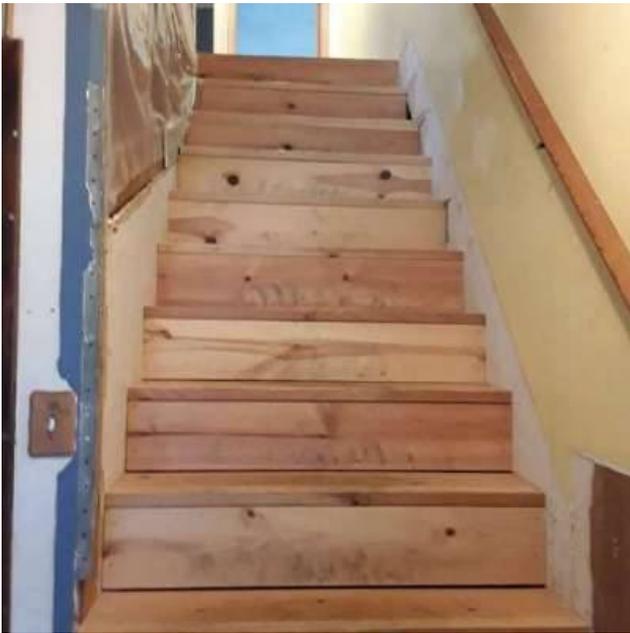
Photo 75-1

Handrail(s) at some stairs are ungraspable and are a safety hazard. Handrails should be sized and shaped so your hand can encircle them. A qualified contractor should make repairs or modifications as necessary. For example, replacing existing handrails or installing additional handrails.

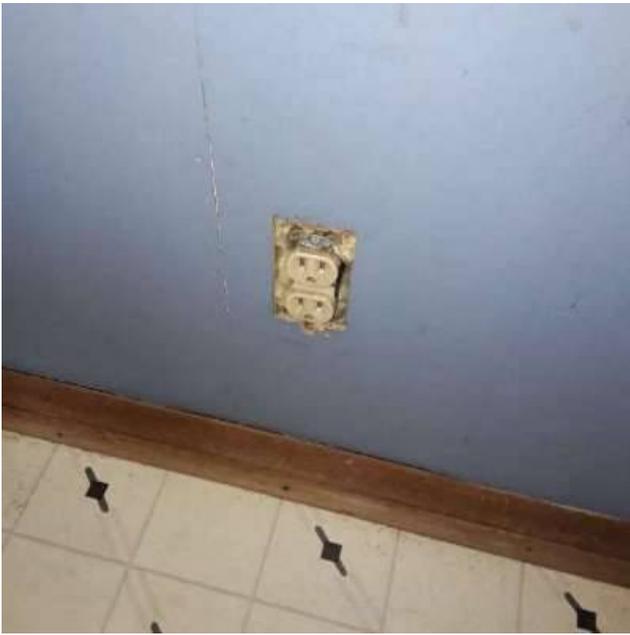
Photo 76-1

Cover plate(s) are missing from one or more electric boxes, such as for receptacles, switches and/or junction boxes. They are intended to contain fire and prevent electric shock from exposed wires. This is a safety hazard due to the risk of fire and shock. Cover plates should be installed where missing.

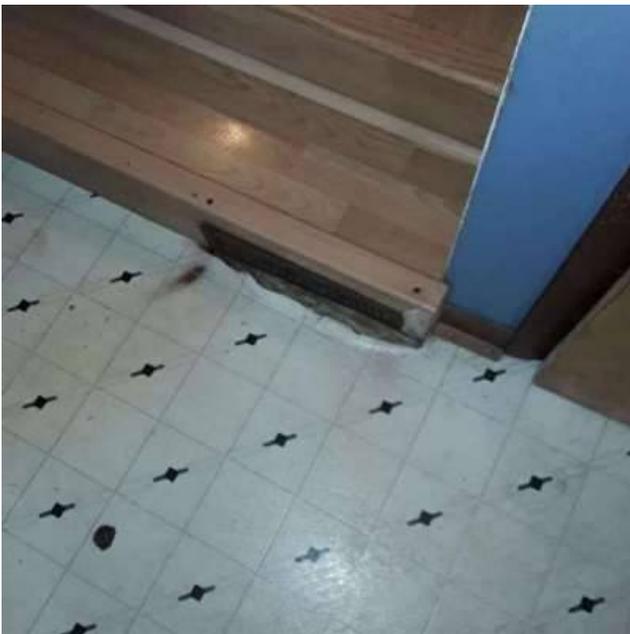
Photo 77-1

Vinyl flooring is damaged and/or deteriorated in one or more areas. A qualified contractor should replace or repair the damaged flooring. Area of concern is near floor HVAC register.

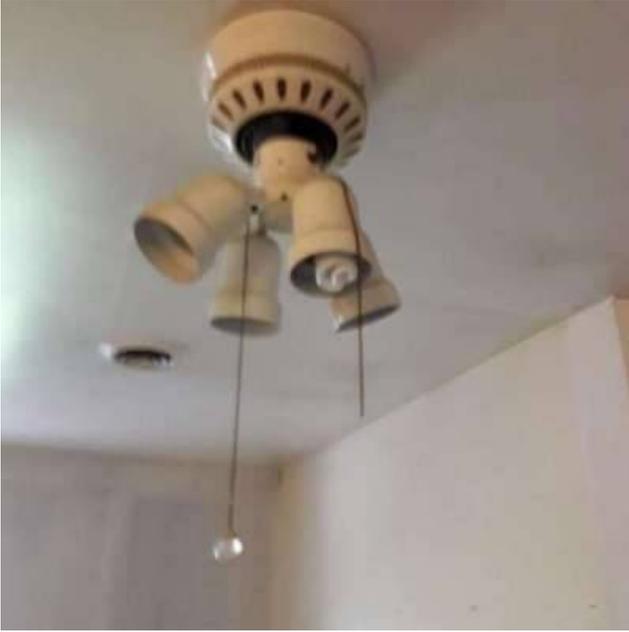
Photo 78-1

Ceiling fan in loft area upstairs missing blades and bulbs.
