Limited Asbestos Investigation Report

Lake Brownwood State Park – Roof Replacements
State Hwy Park Rd 15, Brownwood, TX 76801

Baer Engineering Project No. 201030.02 & Document No. 201030-8i.020

January 29, 2021

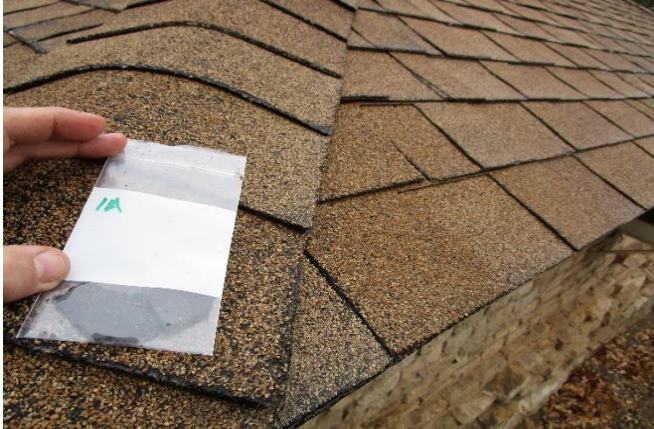
<p>Material #1</p> <p>Roof Shingle & Black Felt Paper</p> <p>Cabin #6</p> <p>Result:</p> <p>No Asbestos Detected (NAD)</p>

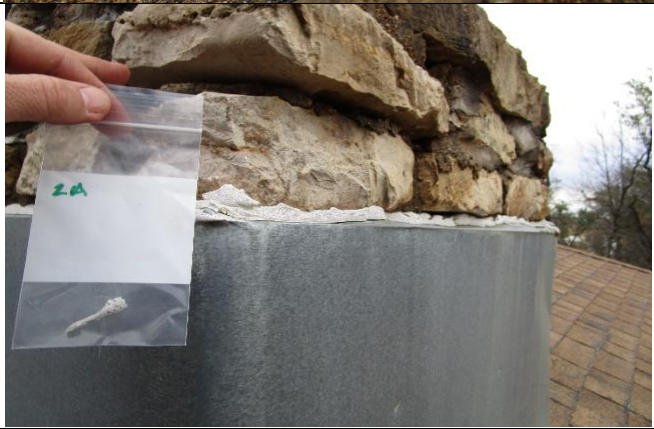
<p>Material #2</p> <p>White Caulk</p> <p>Cabin #6</p> <p>Result:</p> <p>NAD</p>

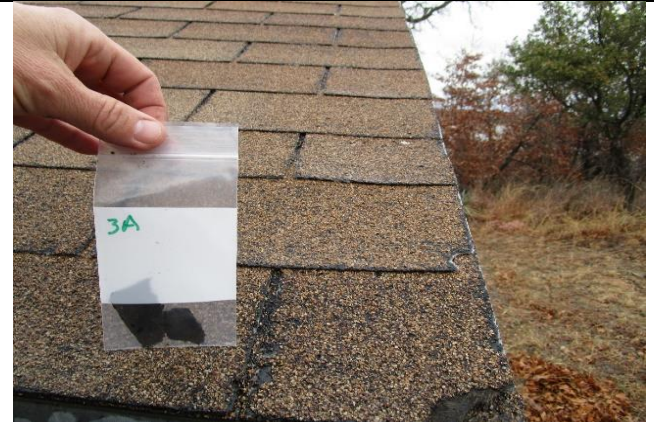
<p>Material #3</p> <p>Roof Shingle & Black Felt Paper</p> <p>Cabin #5</p> <p>Result:</p> <p>NAD</p>

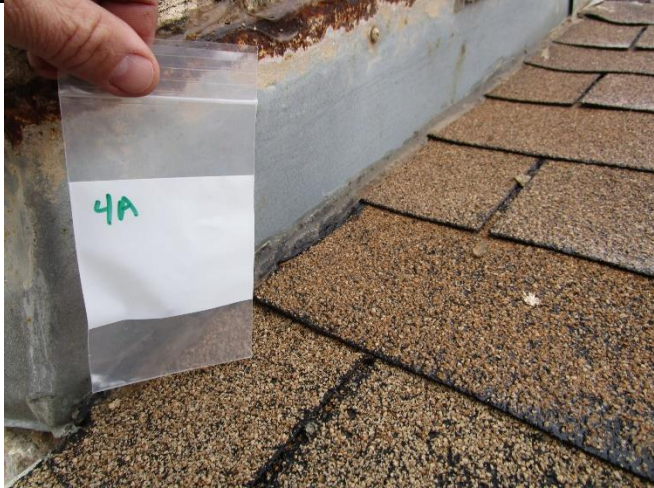
<p>Material #4 Brown Caulk Cabin #5 Result: NAD</p>

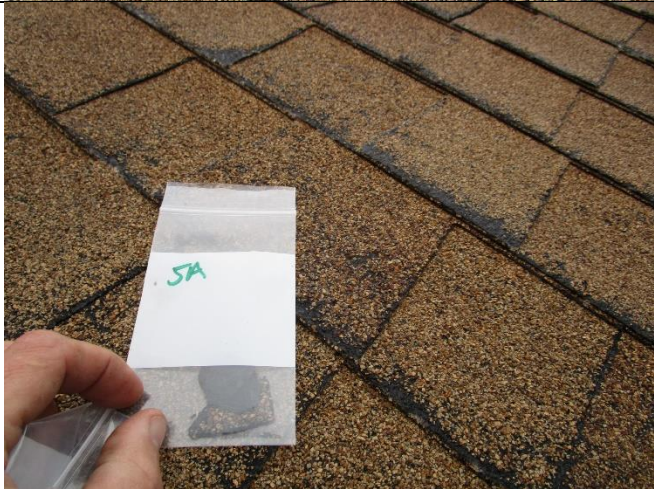
<p>Material #5 Roof Shingle & Black Felt Paper Cabin #7 Result: NAD</p>

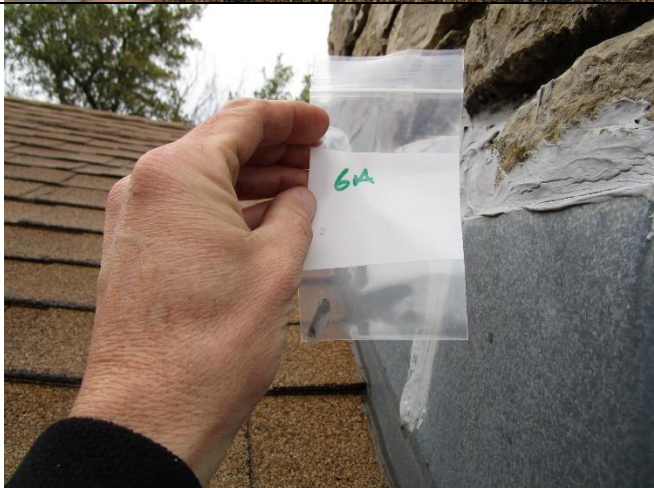
<p>Material #6 Gray Caulk Cabin #7 Result: NAD</p>

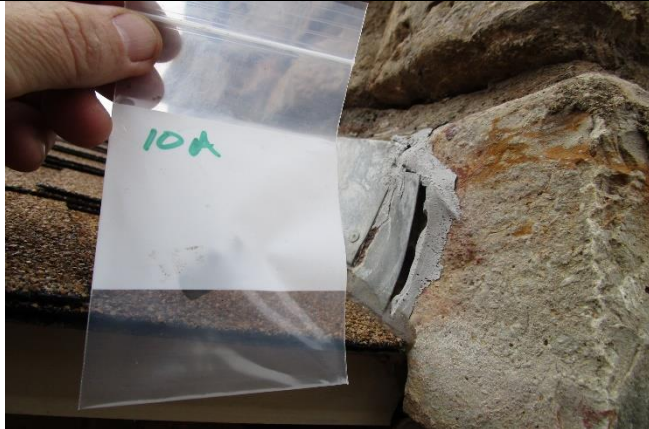
<p>Material #10 Gray Caulk Cabin #10 Result: NAD</p>

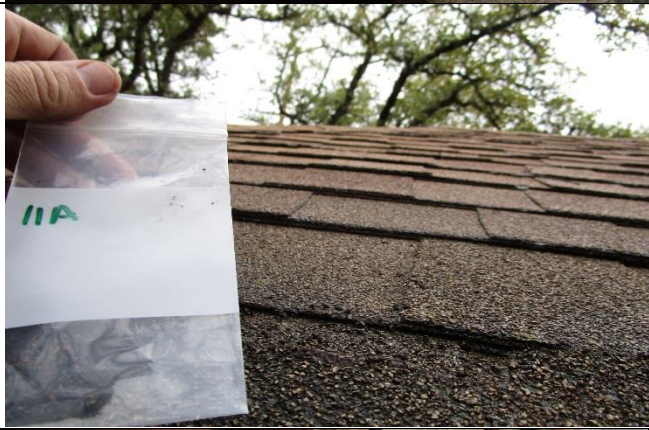
<p>Material #11 Roof Shingle & Black Felt Paper Cabin #11 Result: NAD</p>

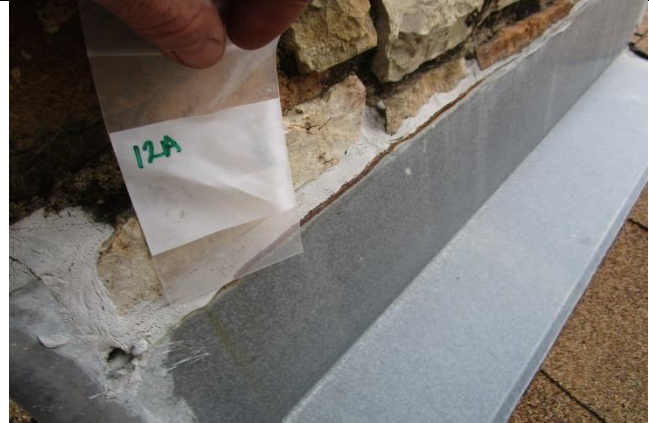
<p>Material #12 White Caulk Cabin #11 Result: NAD</p>

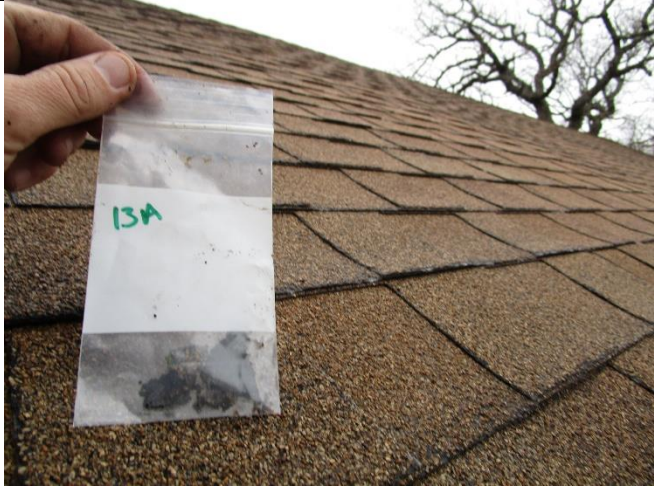
<p>Material #13 Roof Shingle & Black Felt Paper Cabin #12 Result: NAD</p>

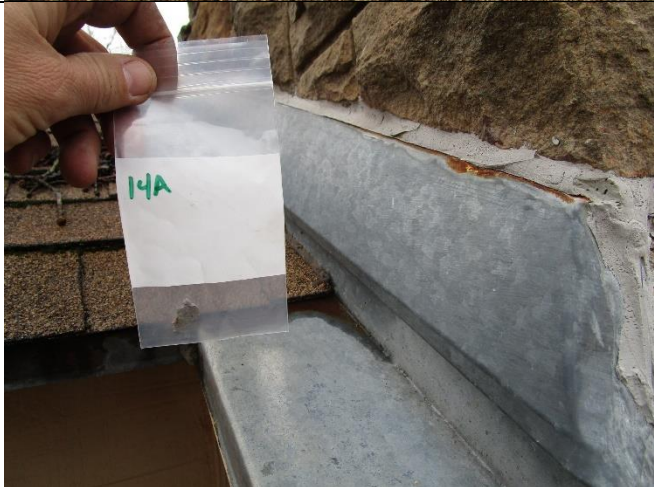
<p>Material #14 Gray Caulk Cabin #12 Result: NAD</p>

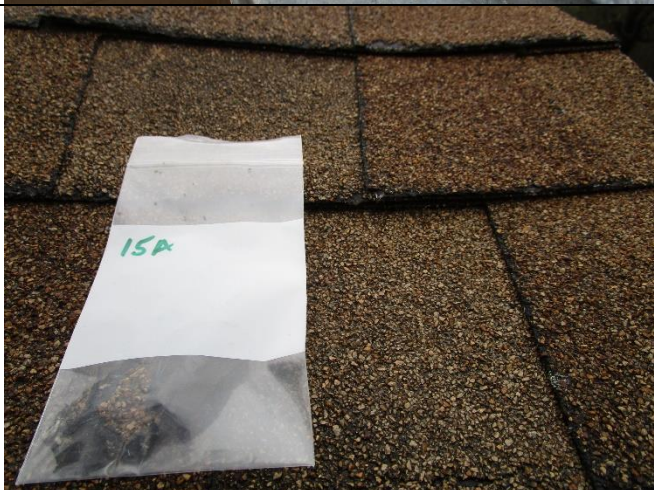
<p>Material #15 Roof Shingle & Black Felt Paper Cabin #13 Result: NAD</p>

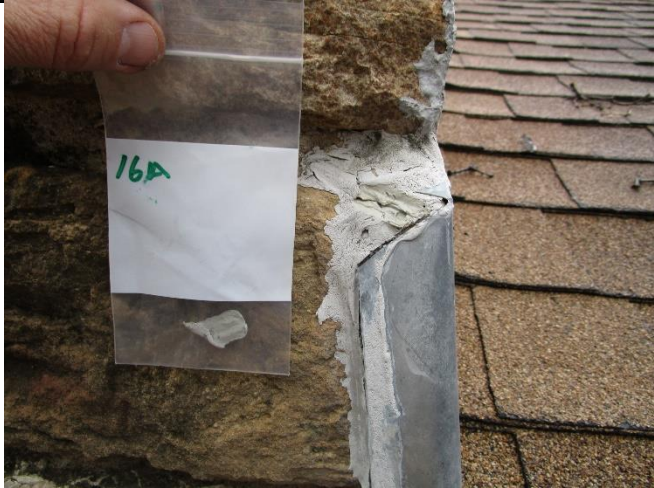
<p>Material #16 Gray Caulk Cabin #13 Result: NAD</p>

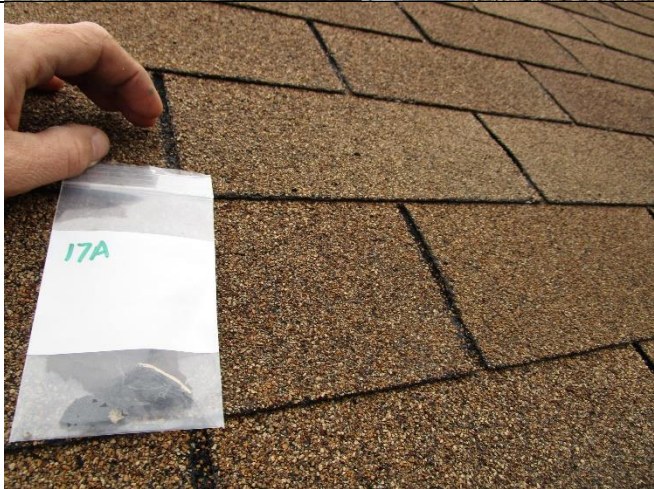
<p>Material #17 Roof Shingle & Black Felt Paper Cabin #14 Result: NAD</p>

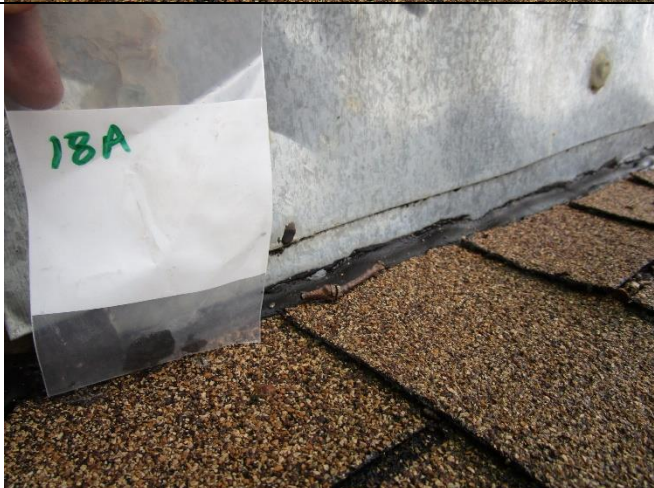
<p>Material #18 Black Roof Tar Cabin #14 Result: NAD</p>

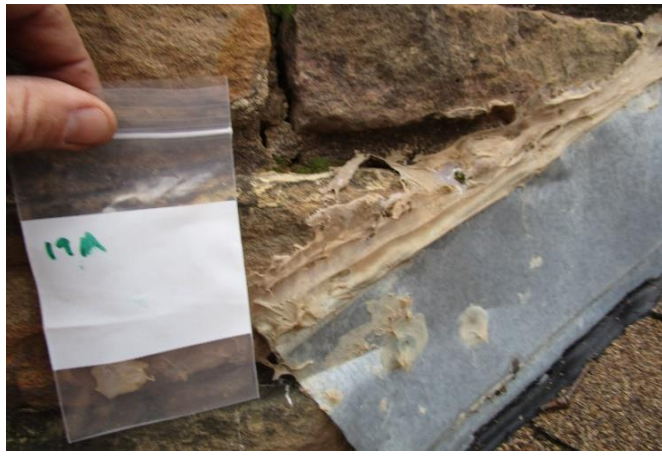
<p>Material #19 Tan Caulk Cabin #14 Result: NAD</p>

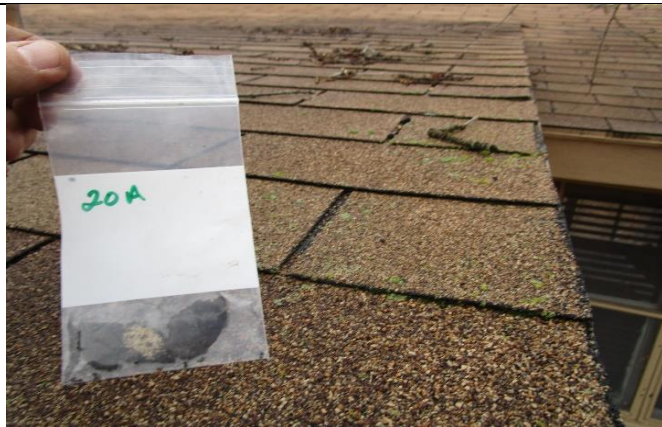
<p>Material #20 Roof Shingle & Black Felt Paper Cabin #15 Result: NAD</p>

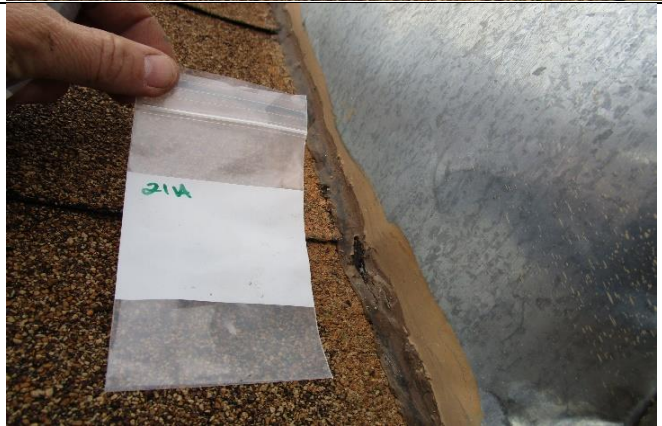
<p>Material #21 Black Roof Tar Painted Brown Cabin #15 Result: NAD</p>

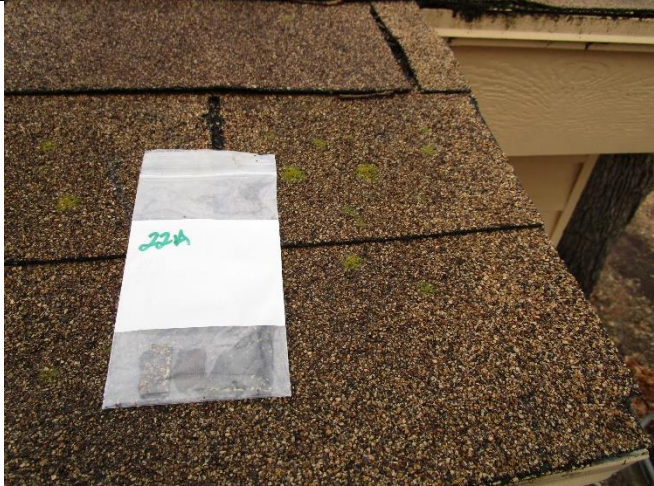
<p>Material #22 Roof Shingle & Black Felt Paper Cabin #16 Result: NAD</p>

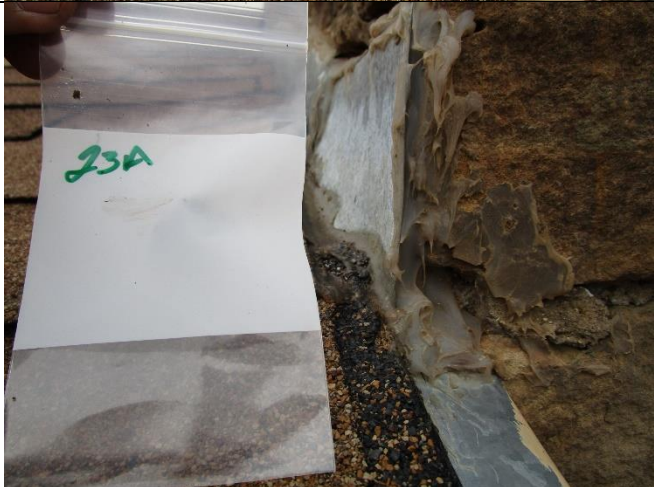
<p>Material #23 Brown Caulk Cabin #16 Result: NAD</p>

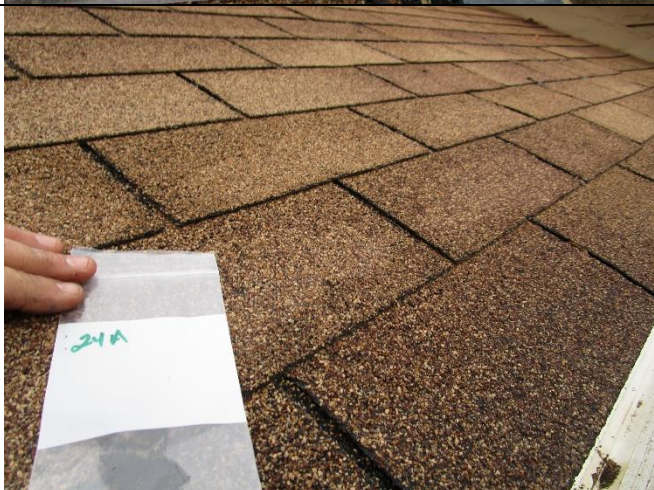
<p>Material #24 Roof Shingle & Black Felt Paper Cabin #17 Result: NAD</p>

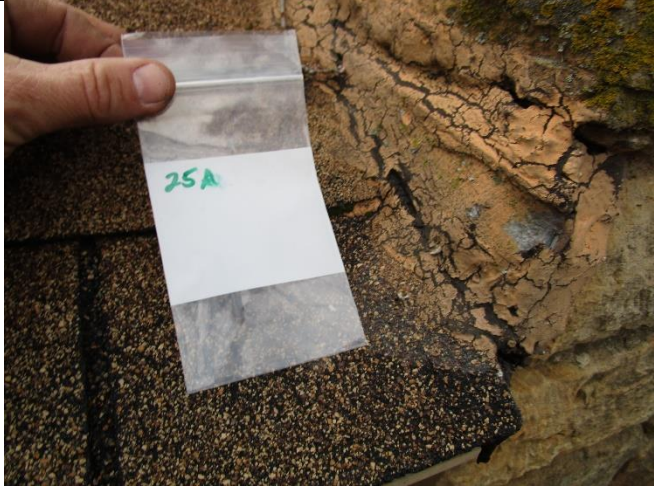
<p>Material #25 Black Roof Tar Painted Brown/Orange Cabin #17 Result: NAD</p>

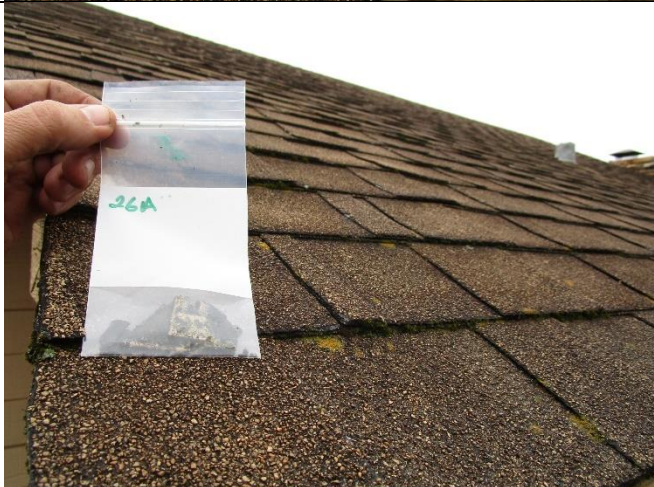
<p>Material #26 Roof Shingle & Black Felt Paper Loma Vista Lodge Result: NAD</p>

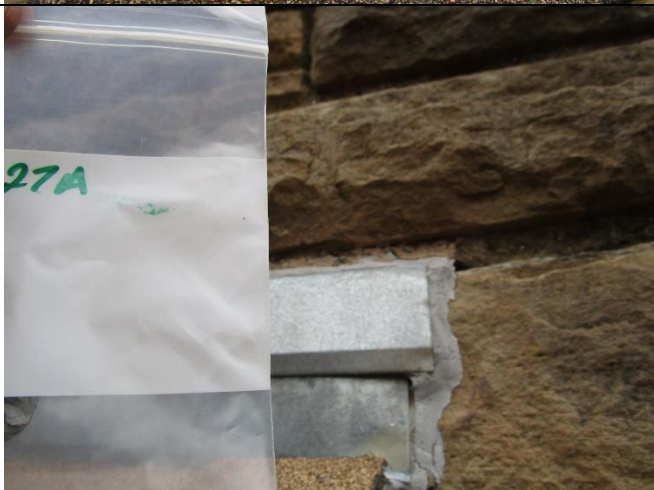
<p>Material #27 Gray Caulk Loma Vista Lodge Result: NAD</p>

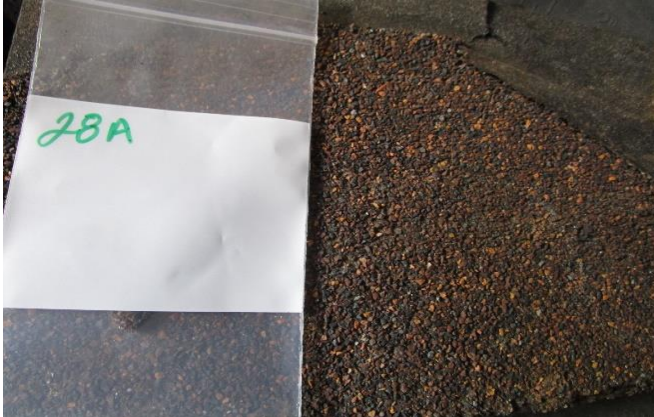
A close-up photograph of a roof shingle and black felt paper. A white label with the handwritten text "28A" in green is attached to the left side of the sample. The shingle is dark brown with a granular texture, and the felt paper is black.	<p>Material #28</p> <p>Roof Shingle & Black Felt Paper</p> <p>Staircase Pavilion</p> <p>Result:</p> <p>NAD</p>

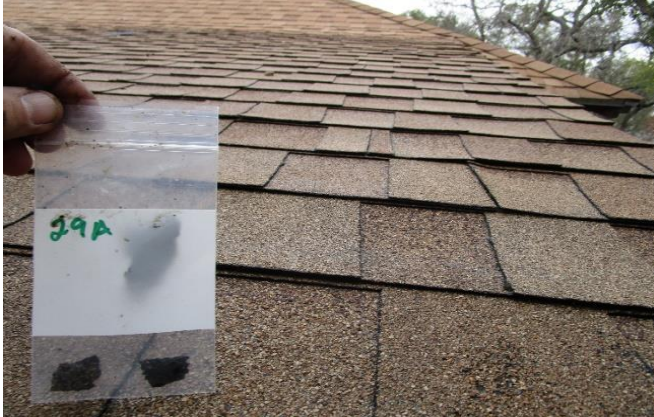
A photograph of a roof shingle and black felt paper sample. A white label with the handwritten text "29A" in green is attached to the left side of the sample. The shingle is brown with a granular texture, and the felt paper is black.	<p>Material #29</p> <p>Roof Shingle & Black Felt Paper</p> <p>Group Recreation Hall</p> <p>Result:</p> <p>NAD</p>

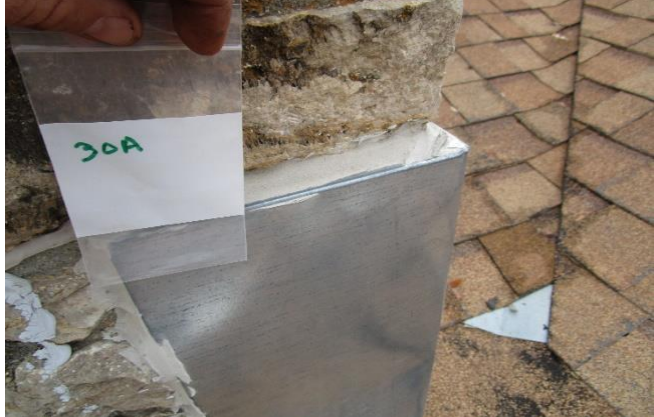
A photograph of a gray caulk sample. A white label with the handwritten text "30A" in green is attached to the left side of the sample. The caulk is a thick, gray, fibrous material.	<p>Material #30</p> <p>Gray Caulk</p> <p>Group Recreation Hall</p> <p>Result:</p> <p>NAD</p>
