ASBESTOS INSPECTION REPORT

Brookshires #006 212 E. Coke Winnsboro, TX

JOB# CS19528

August 14, 2019

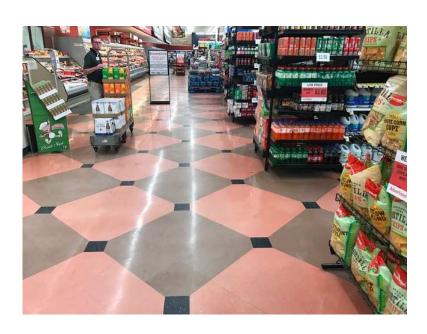
BES Job #		Lab #		Client					Building Name / ID					
CS 19528 19528 L		LS		BROOKSHIRE GROCERY COMPANY			OKSHIRE GROCERY COMPANY		BROOKSHIRES #006					
Building Type				Inspec	Inspection Date			Street Address		City / State				
	P	UBLIC			August 5, 2019			August 5, 2019		212 E. COKE		WINNSE	BORO, TX	
Future Use		Full	Limited	1	Limited To		Size	Occupied	Age	Floors				
PUBLIC					Х					24,450 SF	YES	30	1	
MATERIAL CATEGORY	AREA#	SAMPLE #s	MAT	MATERIAL DESCRIPTION			LOCATION		FRIABLE / NON-FRIABLE	CONDITION / COMMENTS	QUANTITY	РНОТО#	ASBESTOS	
FLOORING	Α	A1-3	PEACH 12'	PEACH 12" X 12" VINYL COMPOSITE TILE				MAIN FLOOR - DOUBLE LAYER W/BLACK MASTIC	NONFRIABLE	GCLD	22748 SF	2	NO	
FLOORING	В	B1-3	BROWN 12	"X 12" VINYL COMPOSITI	ETILE			MAIN FLOOR - DOUBLE LAYER W/BLACK MASTIC	NONFRIABLE	GCLD	22748 SF	2	NO	
FLOORING	С	C1-3	BLACK 12"	X 12" VINYL COMPOSITE	TILE			MAIN FLOOR - DOUBLE LAYER W/BLACK MASTIC	NONFRIABLE	GCLD	22748 SF	2	NO

PHOTO 2 - PEACH 12" X 12" VINYL COMPOSITE TILE BROWN 12" X 12" VINYL COMPOSITE TILE BLACK 12" X 12" VINYL COMPOSITE TILE

Lab Sample No.	Client Field I.D.	Sample Description/Location	Asbestos Content
CL742976	Al	Peach 12" X 12" VCT - Main Floor, Double Layer w/Black Mastic	None Detected - Floor Tile 1 None Detected - Yellow Mastic None Detected - Leveling Compound None Detected - Yellow Mastic None Detected - Floor Tile 2 None Detected - Black Mastic
CL742977	A2	Peach 12" X 12" VCT - Main Floor, Double Layer w/Black Mastic	None Detected - Floor Tile 1 None Detected - Yellow Mastic None Detected - Floor Tile 2 None Detected - Black Mastic
CL742978	A3	Peach 12" X 12" VCT - Main Floor, Double Layer w/Black Mastic	None Detected - Floor Tile 1 None Detected - Yellow Mastic None Detected - Leveling Compound None Detected - Yellow Mastic None Detected - Floor Tile 2 None Detected - Black Mastic
CL742979	В1	Brown 12" X 12" VCT - Main Floor, Double Layer w/Black Mastic	None Detected - Floor Tile 1 None Detected - Yellow Mastic None Detected - Black Mastic None Detected - Floor Tile 2 None Detected - Black Mastic

CL742980	В2	Brown 12" X 12" VCT - Main Floor, Double Layer w/Black Mastic	None Detected - Floor Tile 1 None Detected - Yellow Mastic None Detected - Floor Tile 2 None Detected - Black Mastic
CL742981	В3	Brown 12" X 12" VCT - Main Floor, Double Layer w/Black Mastic	None Detected - Floor Tile 1 None Detected - Yellow Mastic None Detected - Leveling Compound None Detected - Yellow Mastic None Detected - Floor Tile 2 None Detected - Black Mastic

Lab Sample No.	Client Field I.D.	Sample Description/Location	Asbestos Content
CL742982	C1	Black 12" X 12" VCT - Main Floor, Double Layer w/Black Mastic	None Detected - Floor Tile 1 None Detected - Yellow Mastic None Detected - Black Mastic None Detected - Leveling Compound None Detected - Floor Tile 2 None Detected - Yellow Mastic
CL742983	C2	Black 12" X 12" VCT - Main Floor, Double Layer w/Black Mastic	None Detected - Floor Tile 1 None Detected - Yellow Mastic None Detected - Floor Tile 2 None Detected - Black Mastic
CL742984	С3	Black 12" X 12" VCT - Main Floor, Double Layer w/Black Mastic	None Detected - Floor Tile 1 None Detected - Yellow Mastic None Detected - Leveling Compound None Detected - Yellow Mastic None Detected - Floor Tile 2 None Detected - Black Mastic
CL742985	D1	White 12" X 12" VCT - Back Hall & Break Room	None Detected - Floor Tile None Detected - Black Mastic
CL742986	D2	White 12" X 12" VCT - Back Hall & Break Room	None Detected - Floor Tile None Detected - Yellow Mastic None Detected - Black Mastic

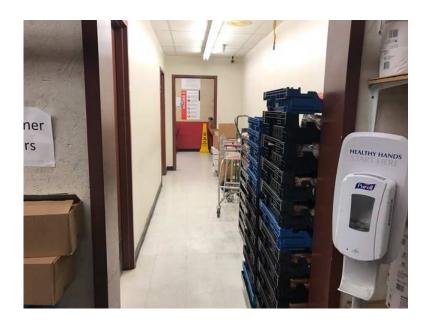
FLOORING	D	D1-3	WHITE 12"	X 12" VINYL COMPOSITE	TILE			BACK HALL & BREAK ROOM	NONFRIABLE	GCLD	268 SF	3	NO	
FLOORING	E	E1-3	RE	RED APPLIED FLOORING				RESTROOMS, BAKERY, MEAT, CUSTODIAL	NONFRIABLE	DD	1167 SF	4	NO	
WALLS	F	F1-3	;	SHEETROCK WALLS				BACK HALL, BAKERY	FRIABLE	GCLD	8336 SF	5	NO	
WALLS	G	G1-3	FIBERGLAS	FIBERGLASS REINFORCED PANEL WALLS			BAKERY, PRODUCE NO		NONFRIABLE	FCLD	9345 SF	6	NO	
CEILING	Н	H1-3		2' X 4' CEILING TILE			THROUGHOUT MAIN FLOOR & BACK	NONFRIABLE	FCLD	25145 SF	7	NO		
CEILING	1	I1-3	2' X 4'	2' X 4' SHEETROCK CEILING TILE			BAKERY, PRODUCE MEAT MARKET	NONFRIABLE	GCLD	1154 SF	8	NO		
CEILING	J	J1-3	S	SHEETROCK CEILING			RESTROOM MEN & LADIES	NONFRIABLE	FCLD	198 SF	9	NO		
TSI	К	K1		TSI ELBOW				COMPRESSOR ROOM	FRIABLE	FCLD	1426 SF	10	NO	
MISC	L	L1		EFIS MATERIAL				EXTERIOR	NONFRIABLE	FCLD			NO	
MISC	М	M1	į	EXTERIOR TEXTURE				GAS KIOSK	NONFRIABLE	FCLD		11	NO	
INSPECTOR'S NAME LICENSE

PHOTO 3 - WHITE 12" X 12" VINYL COMPOSITE TILE

CL742987	D3	White 12" X 12" VCT - Back Hall & Break Room	None Detected - Floor Tile None Detected - Yellow Mastic
CL742988	E1	Red Applied Flooring - Restrooms, Bakery, Meat, Custodial	None Detected
CL742989	E2	Red Applied Flooring - Restrooms, Bakery, Meat, Custodial	None Detected
CL742990	E3	Red Applied Flooring - Restrooms, Bakery, Meat, Custodial	None Detected
CL742991	F1	Sheetrock Walls - Back Hall, Bakery	None Detected - Paint Texture None Detected - Joint Tape None Detected - Joint Compound None Detected - Paper None Detected - Wallboard Material

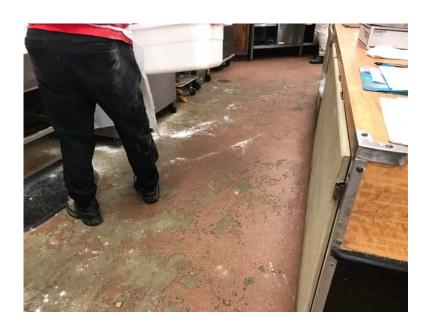
PHOTO 4 - RED APPLIED FLOORING

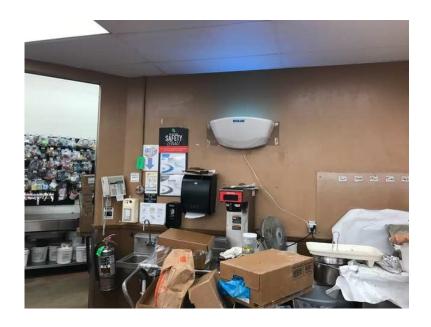
PHOTO 5- SHEETROCK WALLS

Client Field I.D.	Sample Description/Location	Asbestos Content
F2	Sheetrock Walls - Back Hall, Bakery	None Detected - Paint Texture None Detected - Paper None Detected - Wallboard Material
F3	Sheetrock Walls - Back Hall, Bakery	None Detected - Paint Texture None Detected - Joint Tape None Detected - Joint Compound None Detected - Paper None Detected - Wallboard Material
G1	FRP Walls - Bakery, Produce	None Detected - Wall Paneling None Detected - Yellow Mastic
G2	FRP Walls - Bakery, Produce	None Detected - Wall Paneling None Detected - Yellow Mastic
G3	FRP Walls - Bakery, Produce	None Detected - Wall Paneling None Detected - Yellow Mastic
H1	2' X 4' Ceiling Tile - throughout Main Floor & Back	None Detected
H2	2' X 4' Ceiling Tile - throughout Main Floor & Back	None Detected
Н3	2' X 4' Ceiling Tile - throughout Main Floor & Back	None Detected
I1	2' X 4' Sheetrock Ceiling Tile - Bakery, Produce Meat Market	None Detected

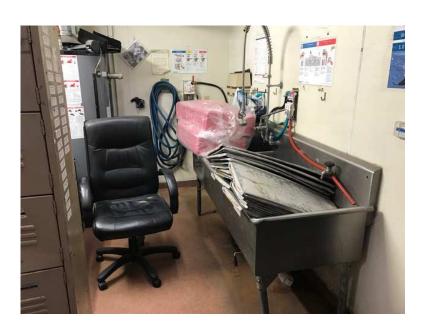
PHOTO 6 - FIBERGLASS REINFORCED PANEL WALLS

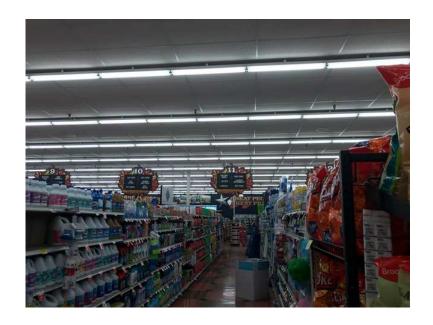
PHOTO 7 - 2' X 4' CEILING TILE

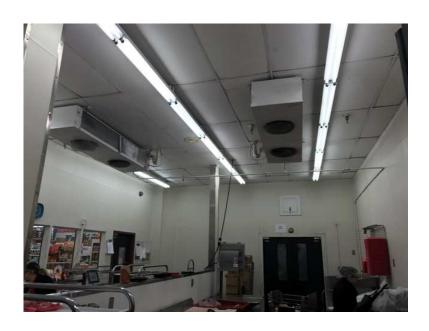
PHOTO 8 - 2' X 4' SHEETROCK CEILING TILE

12	2' X 4' Sheetrock Ceiling Tile - Bakery, Produce Meat Market	None Detected
I3	2' X 4' Sheetrock Ceiling Tile - Bakery, Produce Meat Market	None Detected
J1	Sheetrock Ceiling - Restroom Men & Ladies	None Detected - Paint Texture None Detected - Paper None Detected - Wallboard Material
J2	Sheetrock Ceiling - Restroom Men & Ladies	None Detected - Paint Texture None Detected - Paper None Detected - Wallboard Material
	F2 F3 F3 G1 G2 G3 H1 H2 H3 I1 I2 I3 J1	F2 Sheetrock Walls - Back Hall, Bakery F3 Sheetrock Walls - Back Hall, Bakery G1 FRP Walls - Bakery, Produce G2 FRP Walls - Bakery, Produce G3 FRP Walls - Bakery, Produce H1 2' X 4' Ceiling Tile - throughout Main Floor & Back H2 2' X 4' Ceiling Tile - throughout Main Floor & Back H3 2' X 4' Ceiling Tile - throughout Main Floor & Back H3 2' X 4' Sheetrock Ceiling Tile - Bakery, Produce Meat Market 12 2' X 4' Sheetrock Ceiling Tile - Bakery, Produce Meat Market 13 2' X 4' Sheetrock Ceiling Tile - Bakery, Produce Meat Market 14 Sheetrock Ceiling Tile - Bakery, Produce Meat Market 15 Sheetrock Ceiling - Restroom Men & Ladies

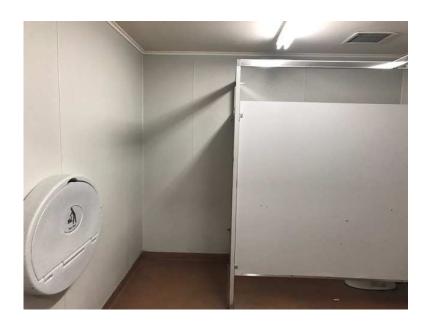
PHOTO 9 - SHEETROCK CEILING

Lab Sample No.	Client Field I.D.	Sample Description/Location	Asbestos Content
CL743005	Ј3	Sheetrock Ceiling - Restroom Men & Ladies	None Detected - Paint Texture None Detected - Paper None Detected - Wallboard Material
CL743006	K1	TSI Elbow - Compressor Room	None Detected - White Mastic None Detected - Wrap None Detected - Insulation
CL743007	L1	EFIS Material - Exterior	None Detected
CL743008	M1	Exterior Texture - Gas Kiosk	None Detected

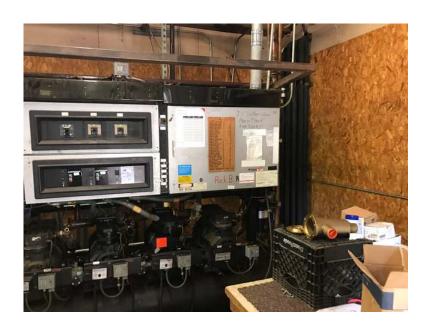
PHOTO 10 - TSI ELBOW

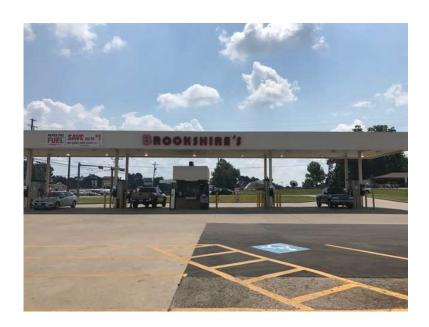
PHOTO 11 - EXTERIOR TEXTURE
