Lead-Based Paint Inspection And Risk Assessment Report

Inks Dam National Fish Hatchery
Quarters 73
Route 2
Burnet, TX 78611
(512) 793 2474

11 September 2000

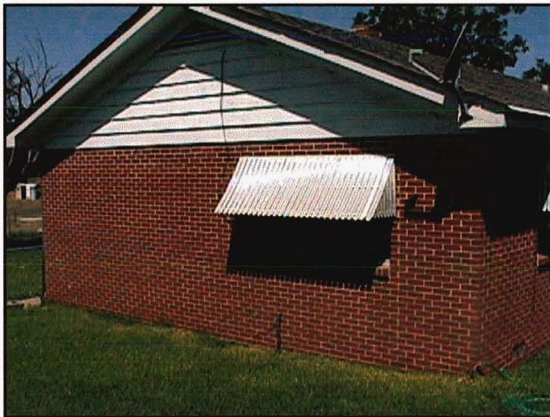
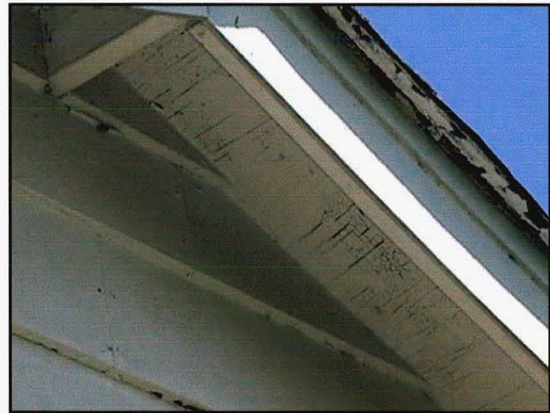
Exterior Left

The exterior white paint on the carport's wood surfaces (soffit, roof trim) is in "unsatisfactory" condition and in need of repair/repainting. The exterior white paint on the Left-side Gable and its associated soffit/roof trim is also in "unsatisfactory" condition, and also should be repaired/repainted. All five items contain LBP. Only trained and licensed professionals should repair all five items.

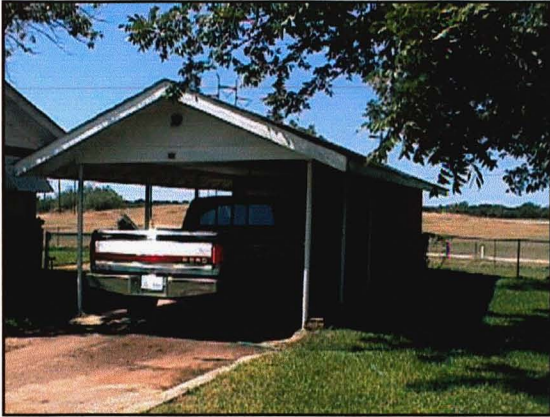
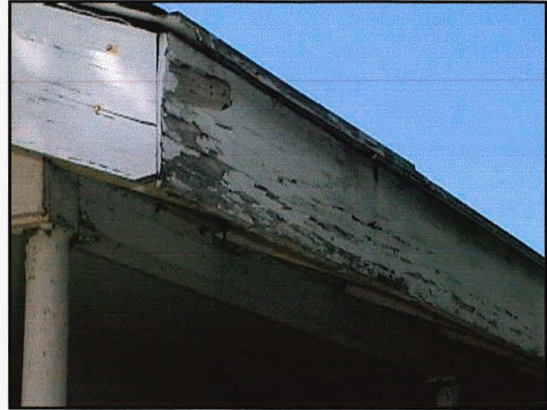
1. The exterior white paint on the soffit and roof trim of the carport was rated to be in "unsatisfactory" condition, and contains more than 10ft² of LBP. Only trained and licensed professionals should repair this paint.
2. The exterior white paint on the gable, soffit and roof trim on the south side of this home was also rated to be in "unsatisfactory" condition, and comprised more than 10ft² of LBP. Trained and licensed professionals should also only repair this paint.

- c. Cost estimate to repair/repaint the Carport soffit and roof trim is \$400.00. (Approximately 128 ft²)
- d. Cost estimate to repair/repaint the south gable, soffit and roof trim is \$375. (Approximately 123 ft²)

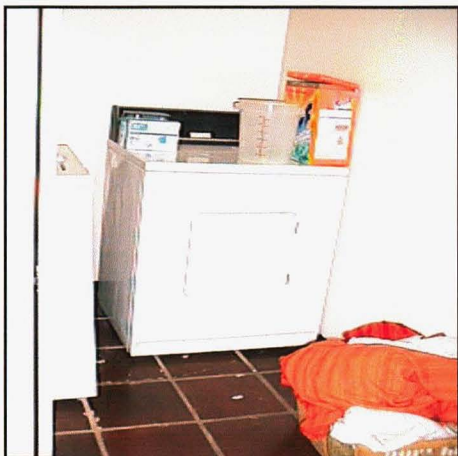
NOT A LEAD HAZARD—The ceramic tiles on the Full Bath backsplash and the Utility Room floor contain low or insignificant quantities of lead in their glazes. (The reader's attention is invited to see lines 520, and 541, column #9 of the Preliminary XRF Report).

In order to repair any chipped or damaged tiles in the future, these should first be washed with warm, soapy water, rinsed and dried. The homeowner using epoxy-resin-paint may then repair the damaged portion of the tile. This will re-seal the lead within the glaze.
