# ASBESTOS INSPECTION REPORT

**Building #1803**

Fort, Sill, OK 73503

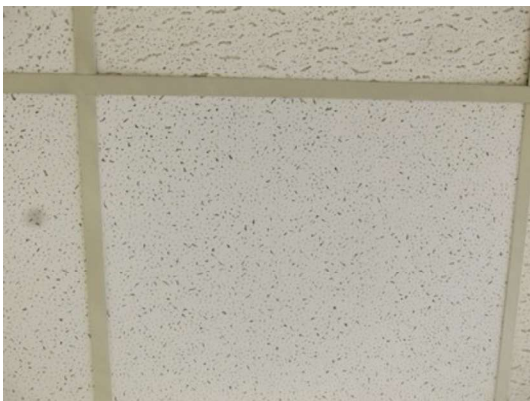
**(HA-04)**  
**No Asbestos Detected**

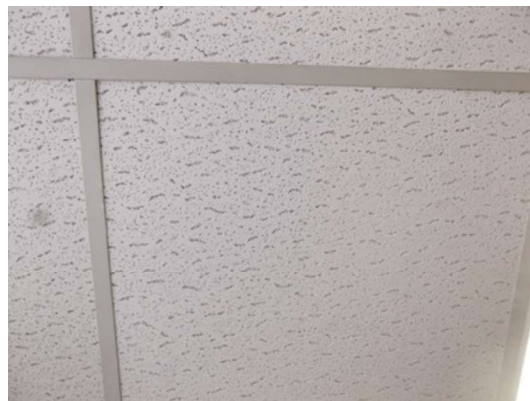
**(HA-05)**  
**No Asbestos Detected**

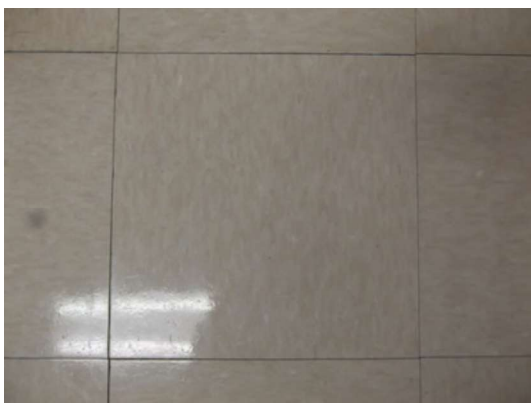
**(HA-08)**  
**No Asbestos Detected**

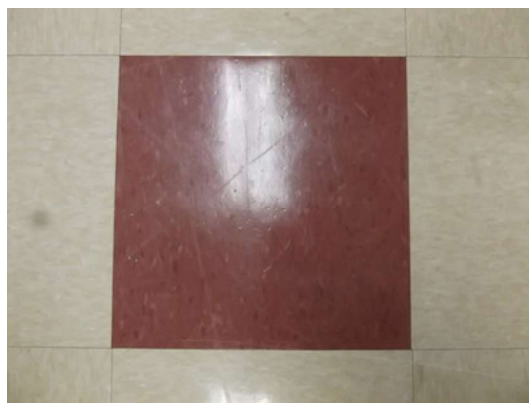
**(HA-09)**  
**No Asbestos Detected**

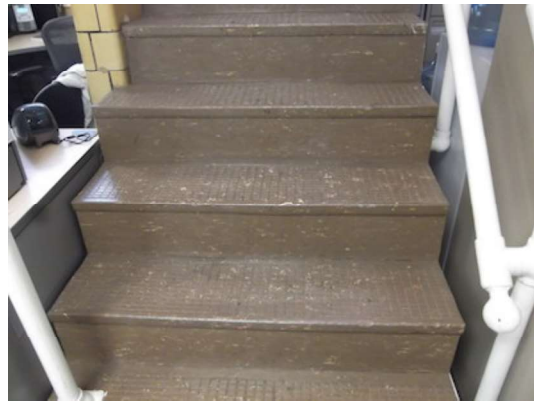
**(HA-15)**  
**No Asbestos Detected**

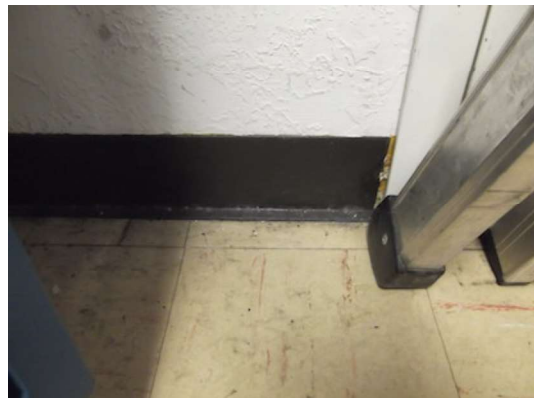
**(HA-17)**  
**No Asbestos Detected**

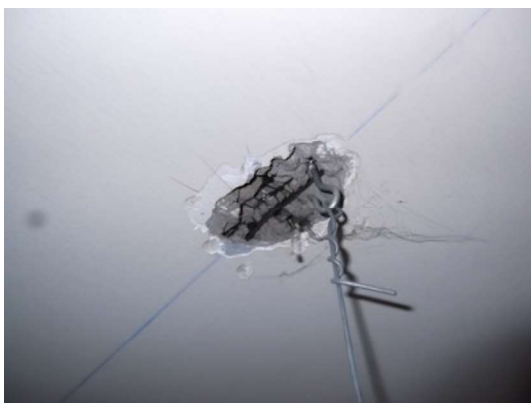
**(HA-20)**  
**No Asbestos Detected**

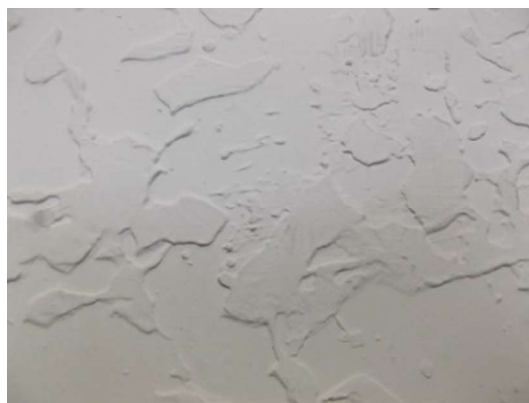
**(HA-21)**  
**No Asbestos Detected**

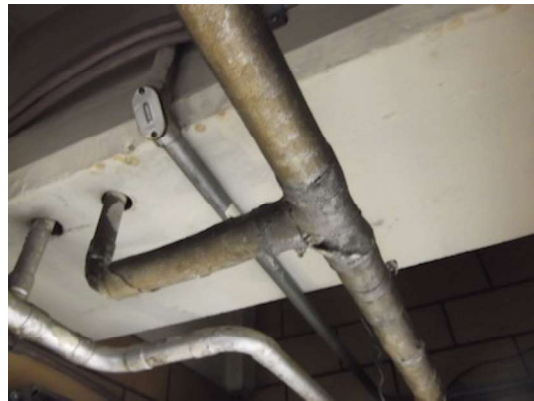
**(HA-27)**  
**Asbestos Detected**

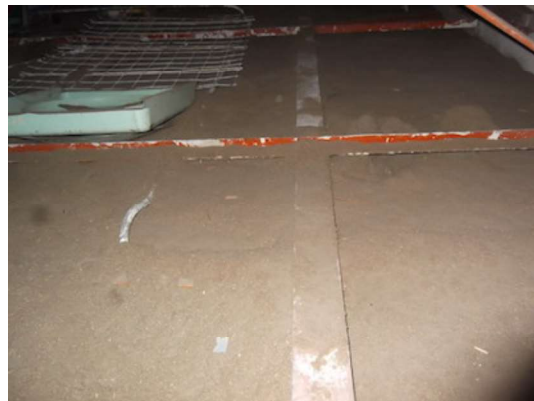
**(HA-29)**  
**Asbestos Detected**

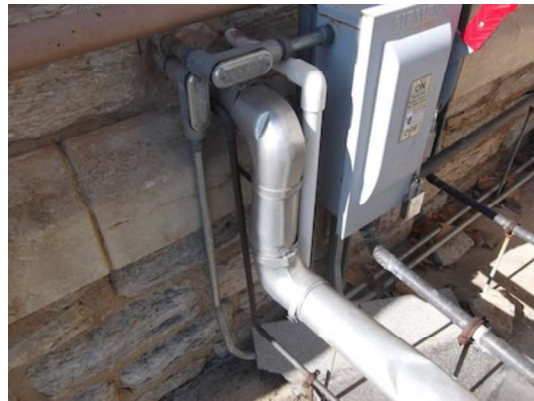
**(HA-33)**  
**Jacketed Fiberglass**

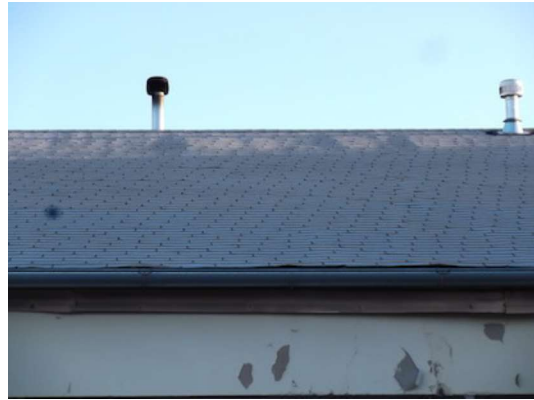
**(HA-01)**  
**No Asbestos Detected**

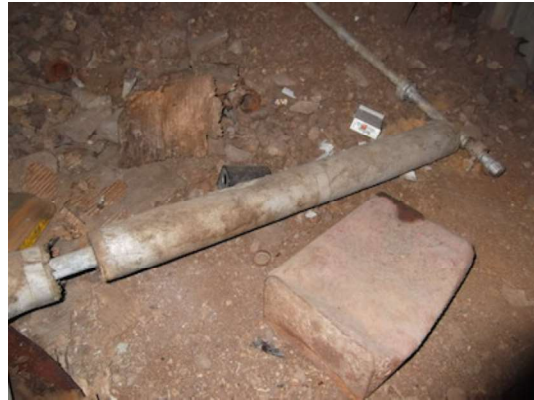
**(HA-03)**  
**No Asbestos Detected**

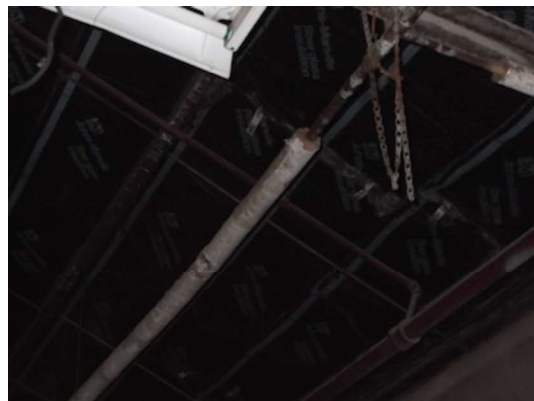
**(HA-05)**  
**Asbestos Detected**

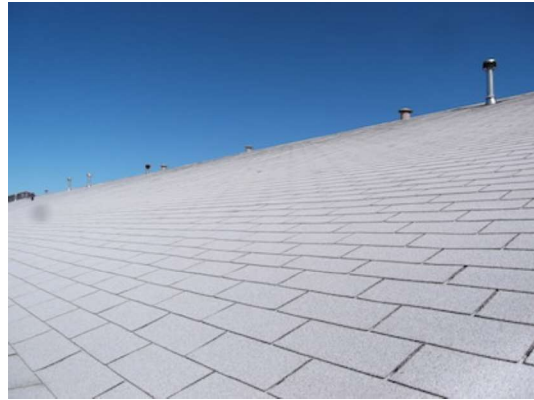
**(HA-01)**  
**No Asbestos Detected**

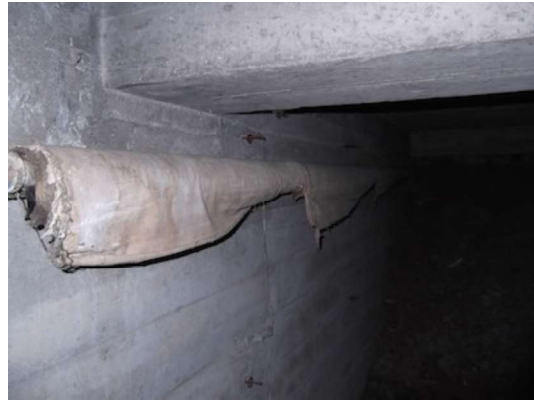
**(HA-03)**  
**No Asbestos Detected**

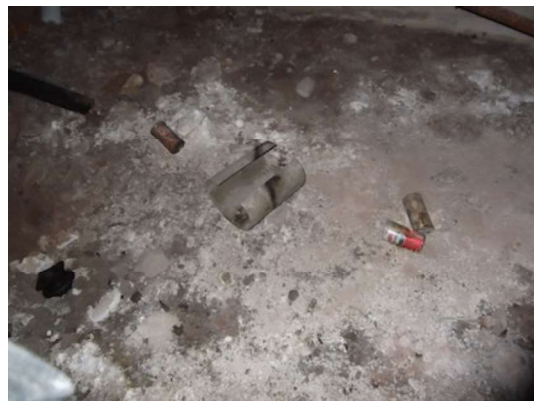
**(HA-05)**  
**Asbestos Detected**

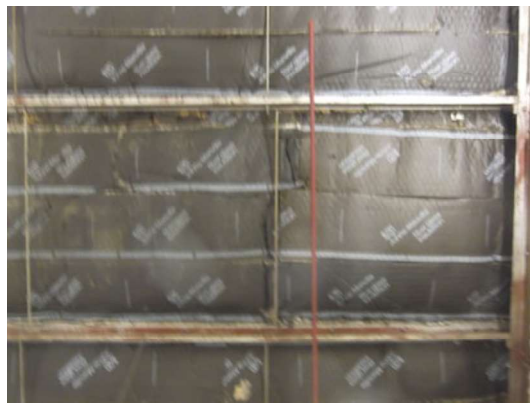
**(HA-08)**  
**No Asbestos Detected**

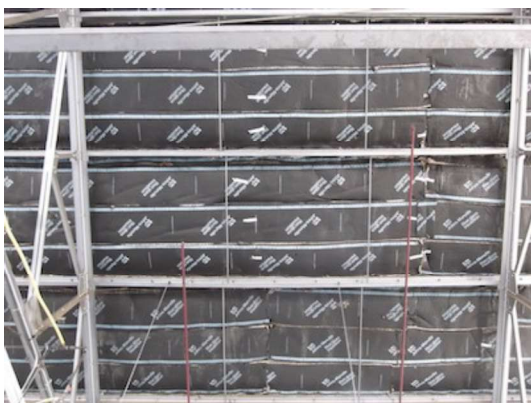
**(HA-04)**  
**No Asbestos Detected**

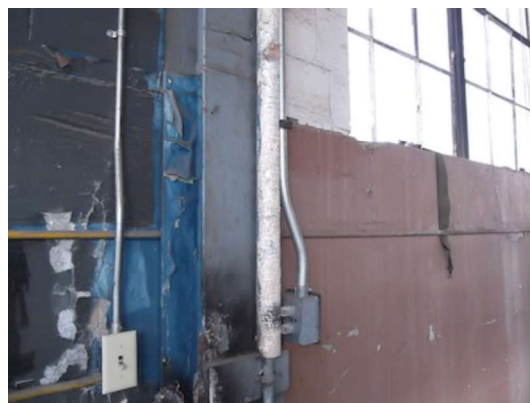
**(HA-05)**  
**Fiberglass**

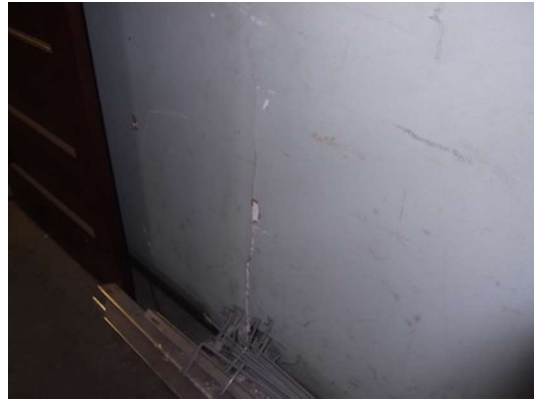
**(HA-01)**  
**Asbestos Detected**

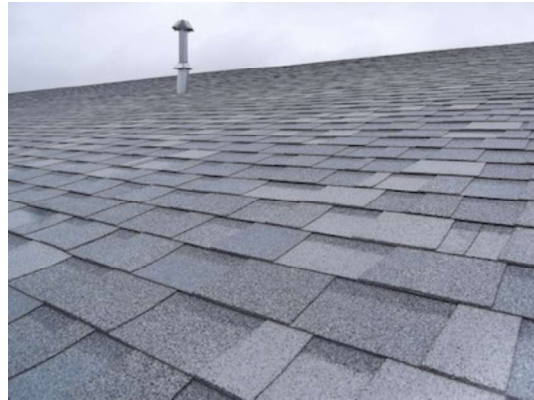
**(HA-03)**  
**No Asbestos Detected**

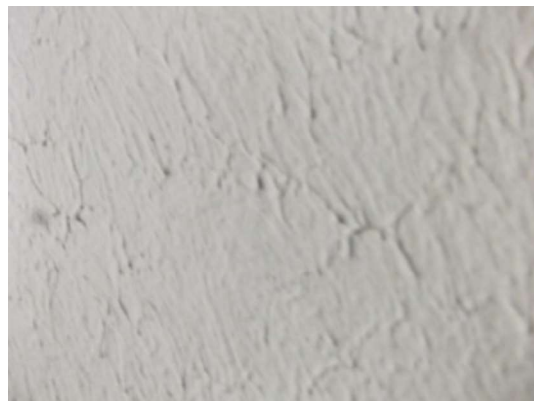
**(HA-05)**  
**No Asbestos Detected**

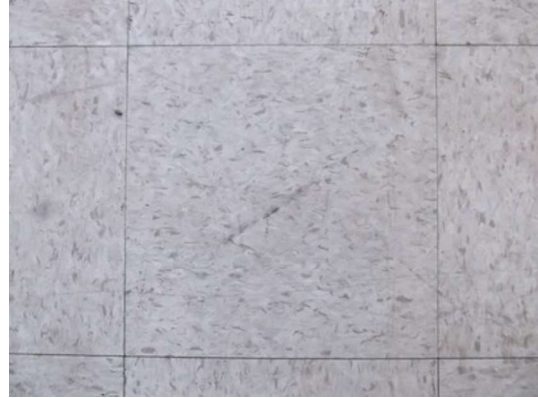
**(HA-01)**  
**Asbestos Detected**

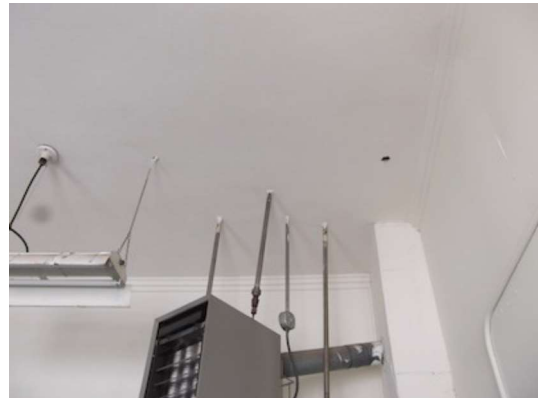
**(HA-03)**  
**No Asbestos Detected**
