## Gaskell and 152<sup>nd</sup> Well

### **Gaskell and 160<sup>th</sup>SE Well**

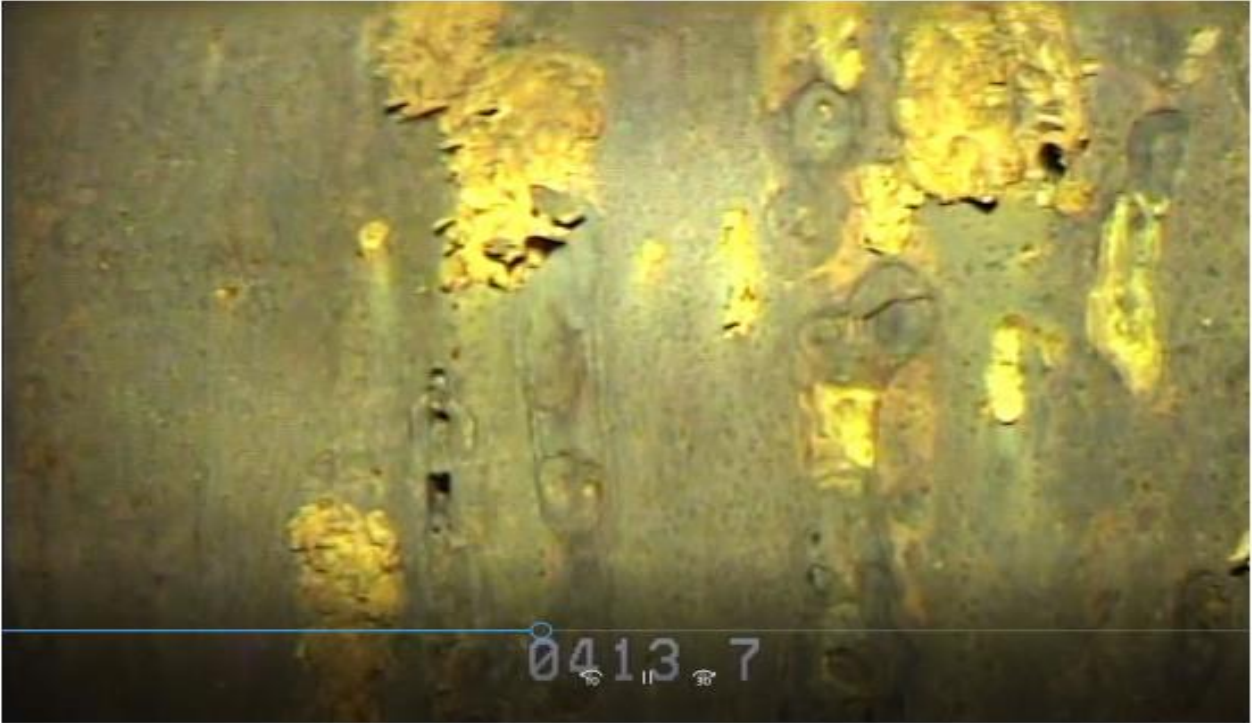
A well video log was performed to find out what was the issue was. The well casing was perforated with vertical slots approximately 1/8 inch in width and 1 inch in length, spaced about 2-inch intervals to let water into the well itself. Significant tuberculation (iron oxide blisters formed by aerobic bacteria known as biofouling) was observed. Below about 490 feet deep 80 percent of the casing slots were blocked (Figure 2), increasing to 100 percent of the casing slots blocked below 580 ft (the well is about 800 ft deep) as Figure 3 shows. This biofouling was an issue. Not only did it compromise the ability of the well to produce water but, under an APH scenario where we are putting water back down into the well, this would force the biofouling into the aquifer, contaminating the aquifer.

**Figure 2. Biofouling with some open casing perforations at 414 ft deep**

Rehabilitation of the well would include mechanically cleaning the casing, acidifying the well with phosphoric acid and swabbing it out, and purging the well to try and remove accumulated sediment. The cost of this rehabilitation would be several hundred thousand dollars with no guarantee of success – the biofouling on the well casing usually indicates that gravel pack and

formation on the outside of the casing is also plugged and simply cleaning the well casing will not solve the problem

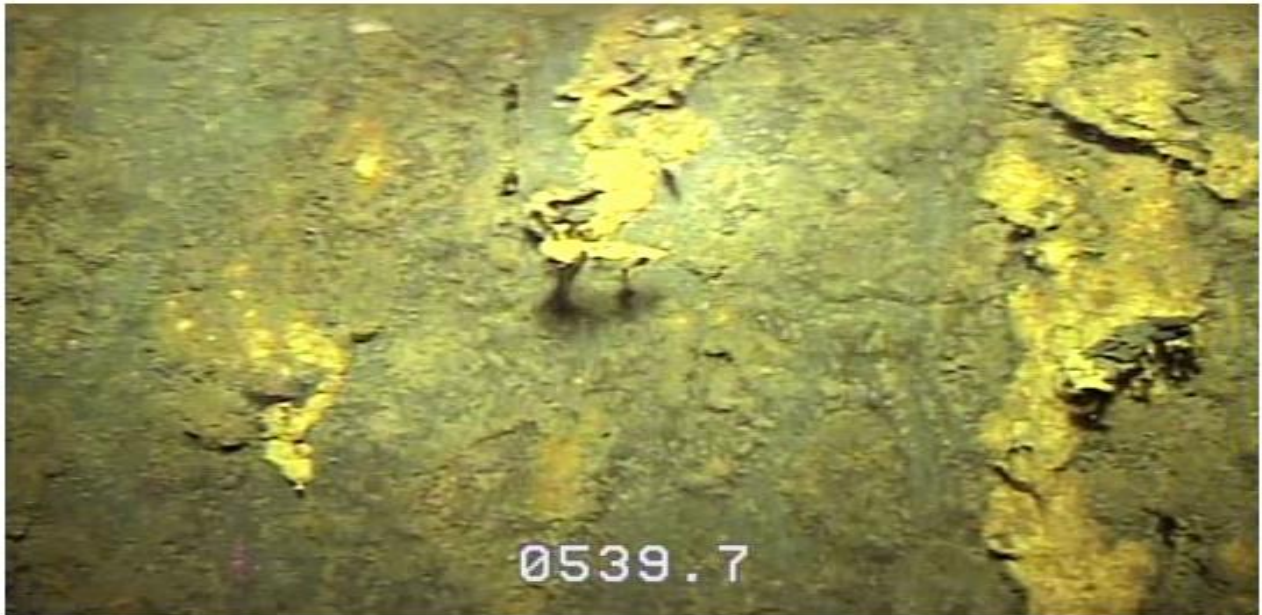
**Figure 3. Completely blocked casing perforations at 540 ft deep.**

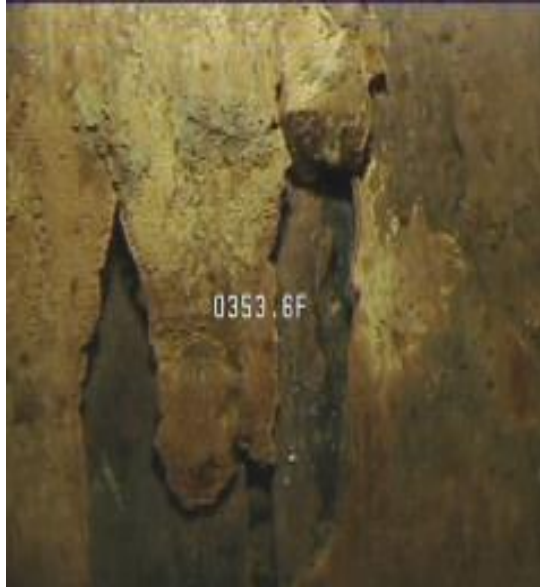
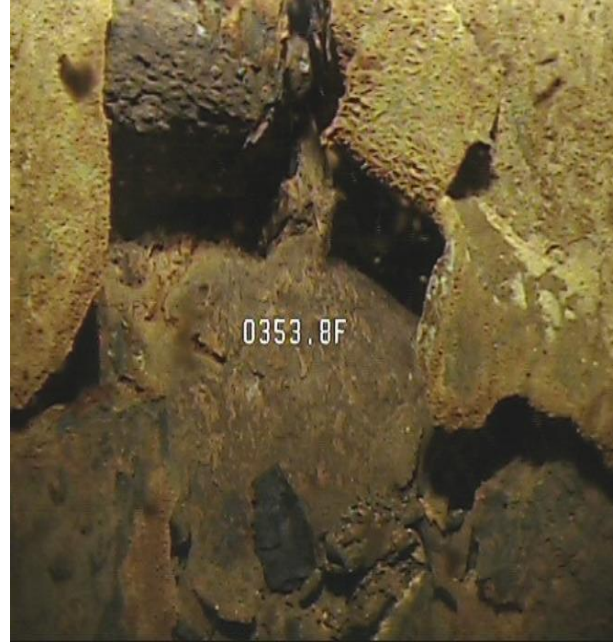
The well pipe hung up pulling it out of the well hole. While the drilling crew was able to pull the pipe out but we had to find out what the pipe caught on, so a well video log was conducted. At about 353 ft down there was a perforation in the well column that had been patched (basically taking a sheet of metal and pressing it up against the sides of the well column<sup>1</sup>) and the patch had deteriorated, resulting in a very rough internal surface to the well column (Figure 6).

**Figure 6. Patch and Obtrusions at 353 Ft.**

This was a serious problem. The APH valve at the bottom of the well operates using hydraulic tubing running down the side of the well pipes (Figure 7), and the protrusions at 553 ft would chafe and eventually sever the tubing, rendering the APH valve inoperable.

There was enough good pipe available that it was decided to install the APH valve (Figure 9) at a depth of above 350 ft, above where the torn patch was in the well<sup>2</sup>, and include a screen (Figure 10) above the valve to catch any debris that would fall through the pipes before it entered the APH valve. The APH valve was installed at the bottom of the well piping (Figure 11).

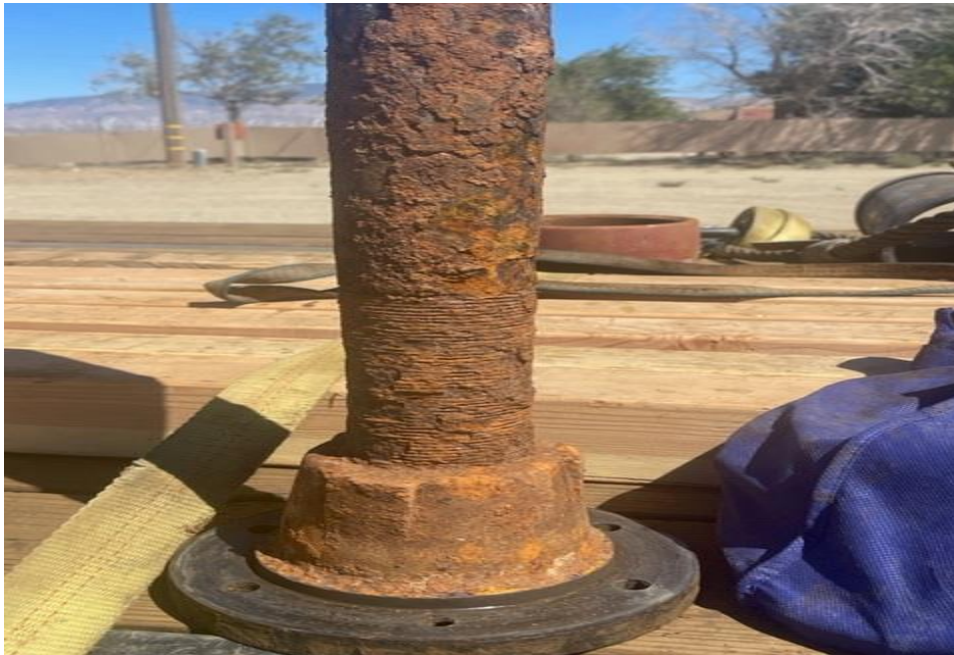
The second issue we ran into was severe rusting on some of the column pipes. The interior of some of the pipes was as bad or worse than the rusting shown in Figure 8. This was another concern. The pulsing of water in the well (pumping it out and then reinjecting it) would dislodge large areas of scale and rust on the pipes and clog the APH valve and can get trapped in the pump impellers and ruin them. The scaling can increase pipe friction and reduce the efficiency of the energy storage.

**Figure 8. Severe Rusting on Well Pipes**

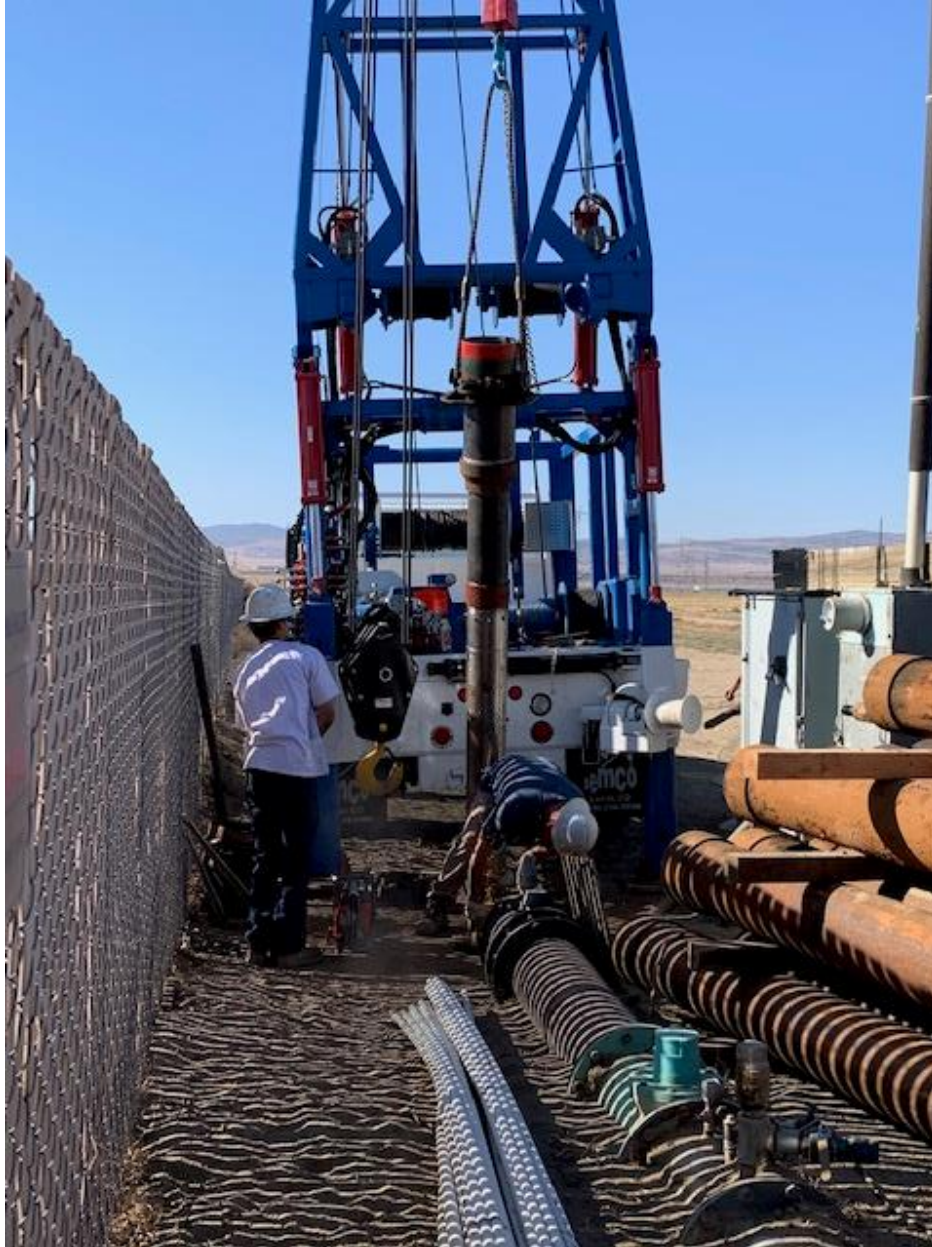
**Figure 11. APH Valve Installed at Bottom of Pipe Column**

The well at Gaskell and 160thSE installation with the APH valve was completed on September 6<sup>th</sup> and all the components tested out working correctly.
