# Infrared Inspection Report

Lake Beach Club  
Condo  
2600 Collins Ave  
Miami, Florida 33140

Lake Beach Apartments  
2600 Collins Ave  
Miami Beach, Florida 33140

Report Date: 06/20/2024  
Job Number: 2024-0135  
Type of Inspection: 40 yr  
Recertification Date of Inspection: 06-20-2024  
End user: Lake Beach Club  
Project Location: 2600 Collins Avenue  
Miami Beach, Florida 33140

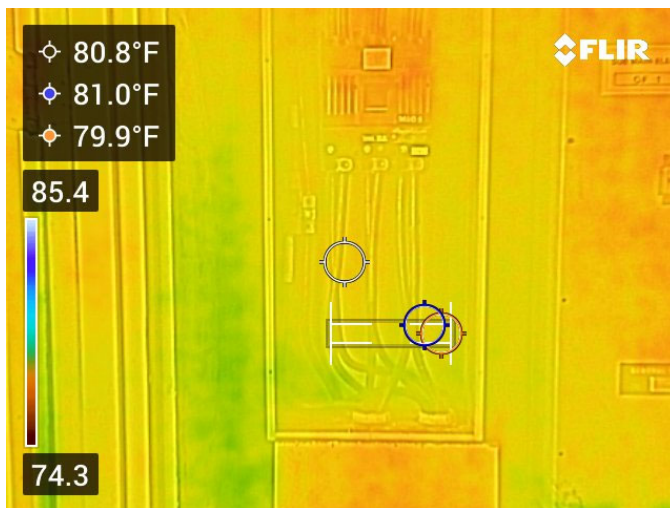
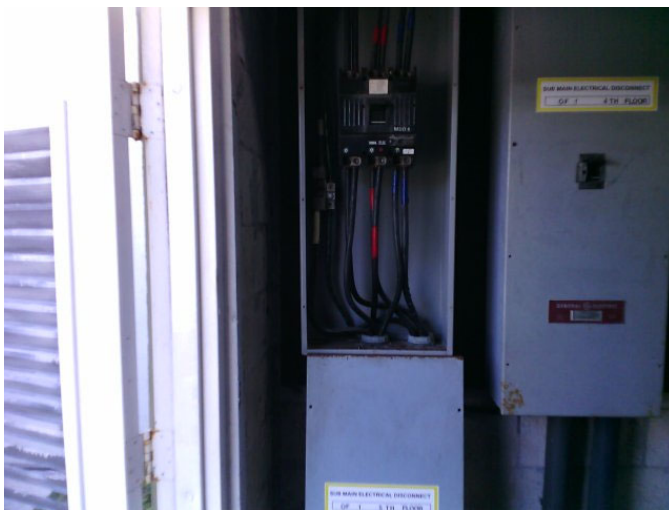
**DT 6 F above Amb Temp**  
Experience Based

**Avg. Priority:** 4

**Comments:** No thermal anomalies were noted from our thermal analysis

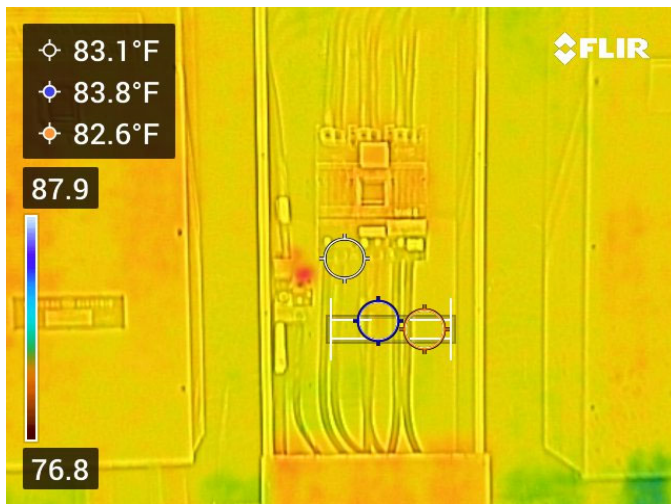
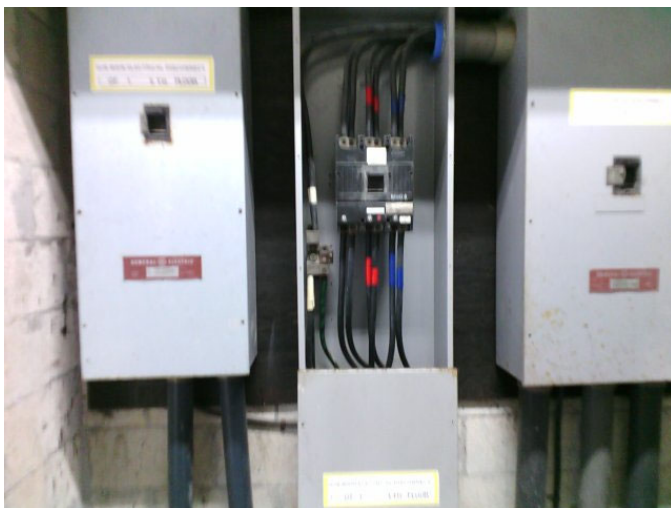
**DT 8 F above Amb Temp**  
**Experience Based**

**Avg. Priority:** 4

**Comments:** *No thermal anomalies were noted from our thermal analysis*

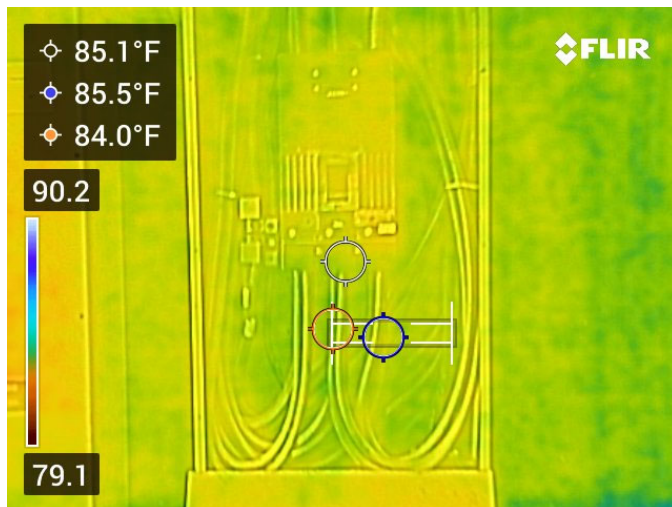
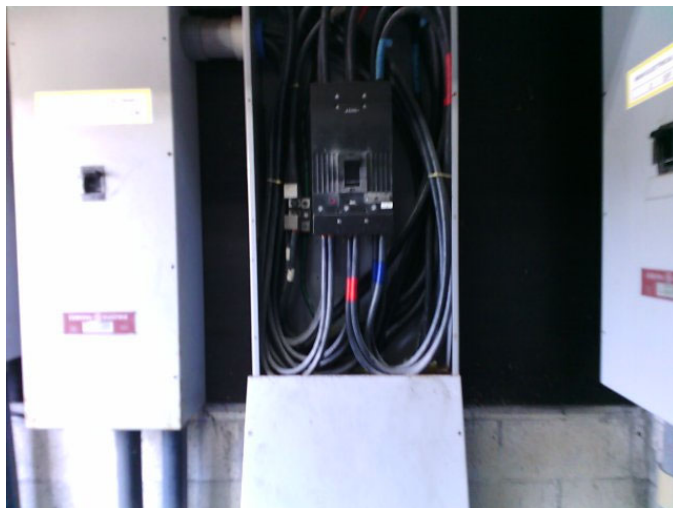
**DT 10 F** above Amb Temp  
Experience Based

**Avg. Priority:** 4

*Comments: No thermal anomalies were noted from our thermal analysis*

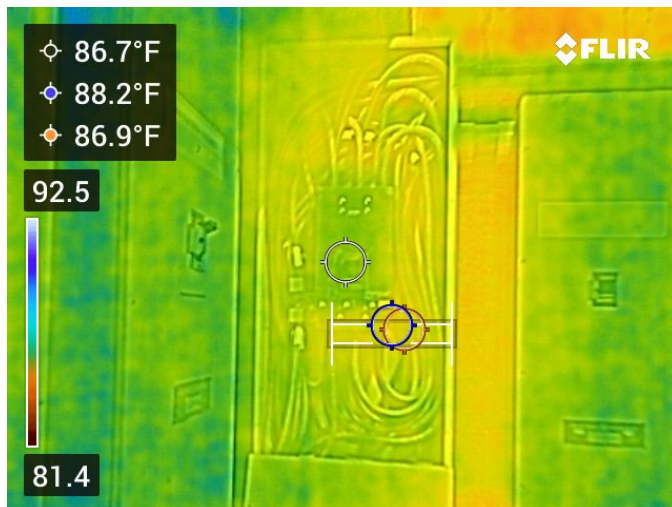
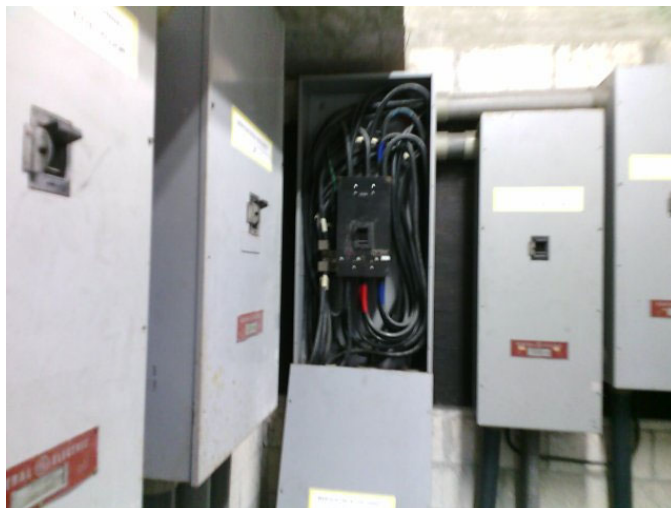
**DT 12 F above Amb Temp**  
Experience Based

**Avg. Priority:** 4

*Comments: No thermal anomalies were noted from our thermal analysis*

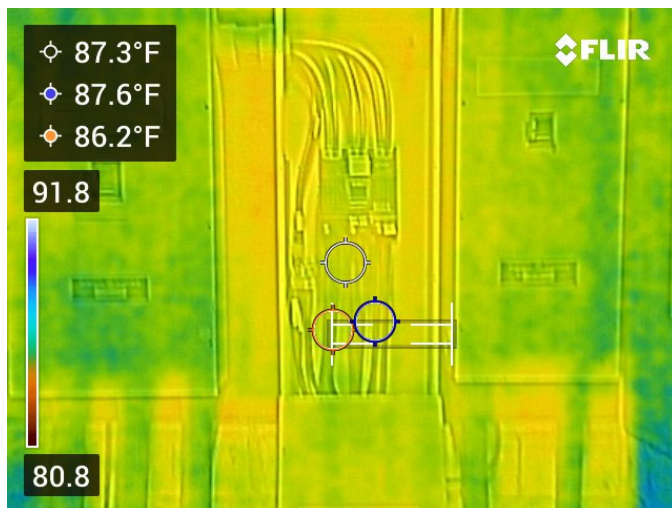
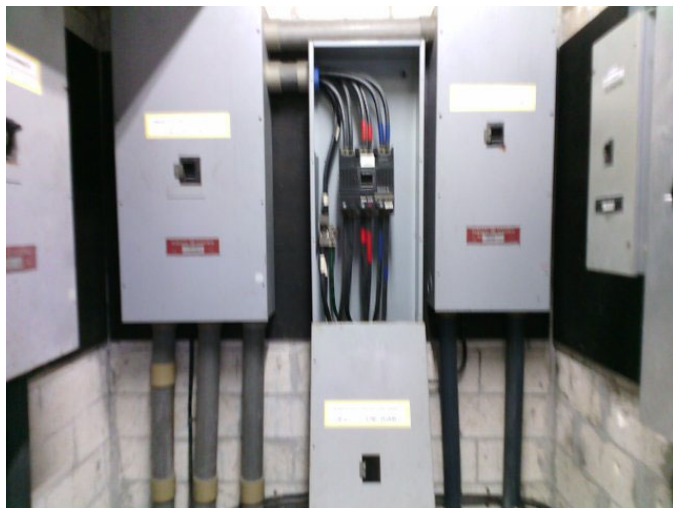
**DT** 12.3 F above Amb Temp  
Experience Based

**Avg. Priority:** 4

**Comments:** *No thermal anomalies were noted from our thermal analysis*

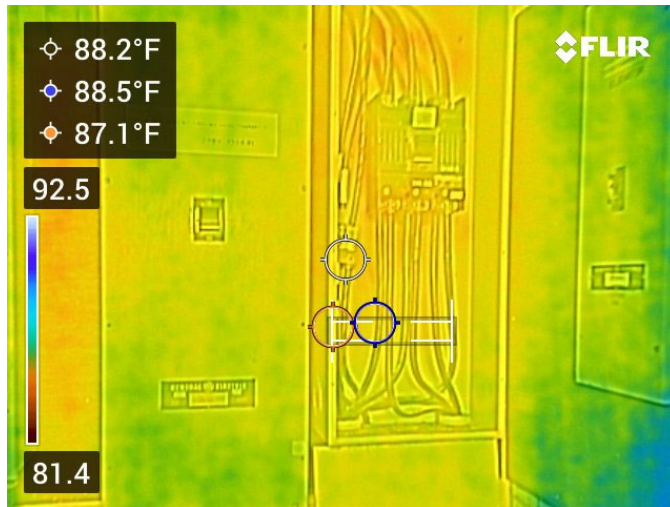
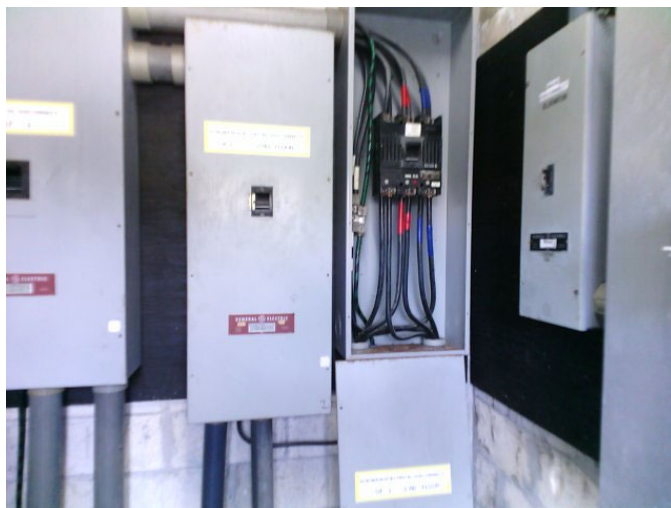
**DT** 13.2 F above Amb Temp  
Experience Based

**Avg. Priority:** 4

**Comments:** No thermal anomalies were noted from our thermal analysis

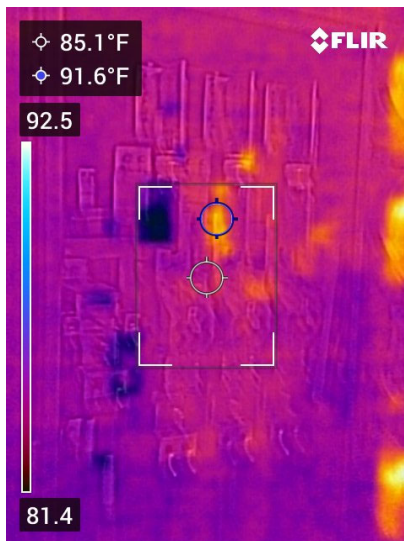
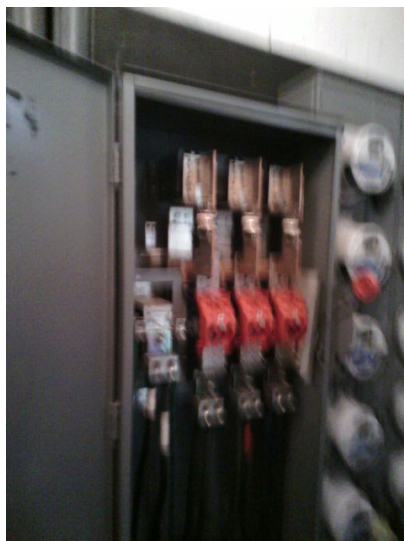
**DT 17 F above Amb Temp**  
Experience Based

**Avg. Priority:** 4

**Comments:** *No thermal anomalies were noted from our thermal analysis*

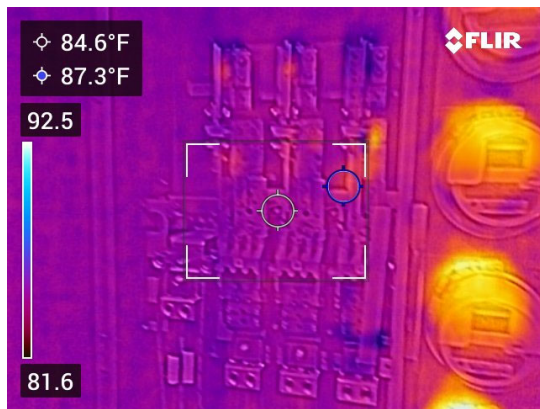
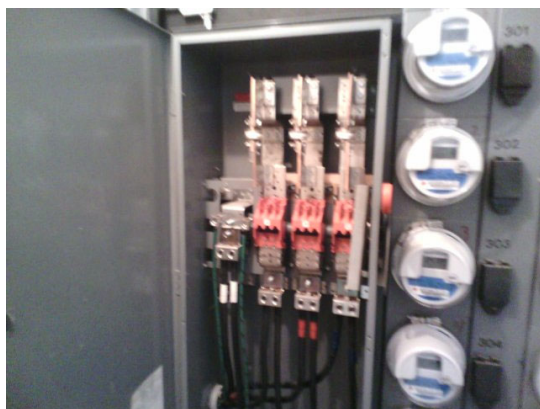
**DT** 12.3 F above Amb Temp  
Experience Based

**Avg. Priority:** 4

**Comments:** *No thermal anomalies were noted from our thermal analysis*

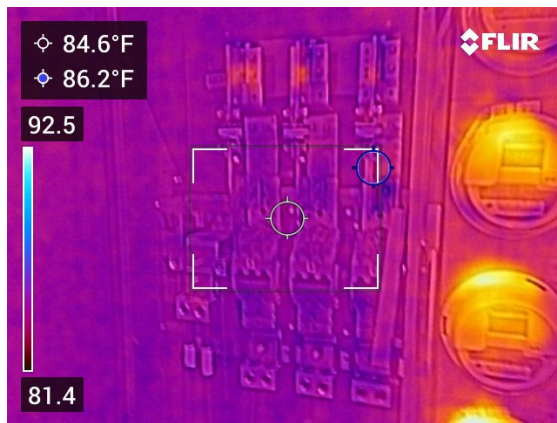
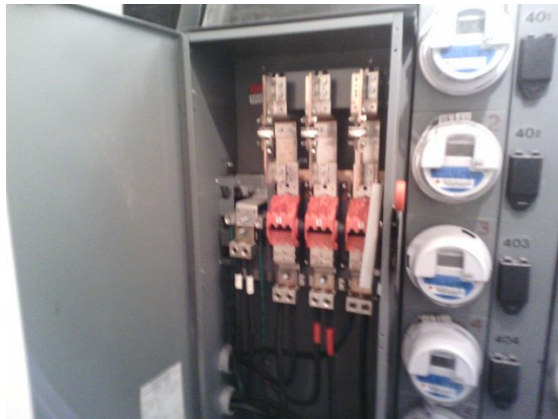
**DT 11.2 F above Amb Temp**  
**Experience Based**

**Avg. Priority:** 4

**Comments:** *No thermal anomalies were noted from our thermal analysis*

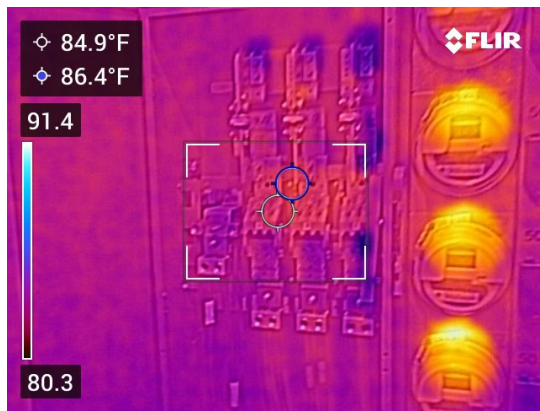
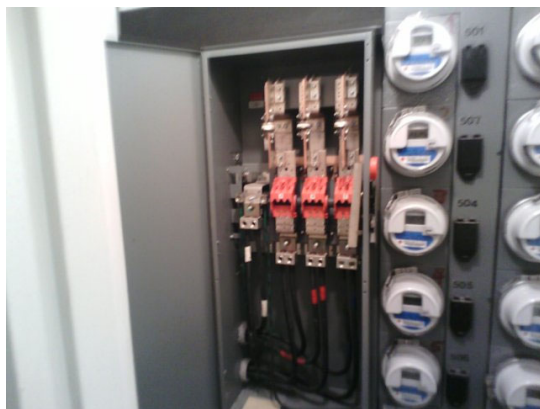
**DT 11.4 F** above Amb Temp  
Experience Based

**Avg. Priority:** 4

**Comments:** *No thermal anomalies were noted from our thermal analysis*
