Initial Post-Fire Mapping for East
Troublesome Fire Project Area Along the
North Fork Colorado River
Near Grand Lake Colorado
CDPHE#2022-3746

From Brief prepared for the Non-Point Source Group, CDPHE December 2022

1) UCRWG Post-Fire Watershed Assessment – Initial Mapping of the North Fork Colorado River (NFCR) Project Area

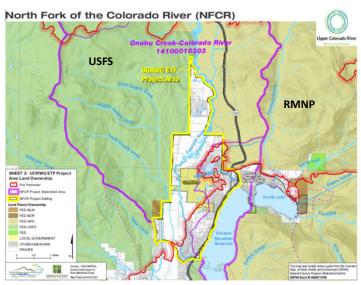
3) UCRWG ETF Project Area

- The UCRWG ETF Project area focuses on private and municipal lands between federal lands on west (National Forest Lands) and east (Rocky Mountain National Park)
- Efforts incorporate lessons learned by the Northern Colorado Water Conservancy District working with USFS on National Forest System lands, also Rocky Mtn National Park (RMNP) directives to allow natural processes to unfold

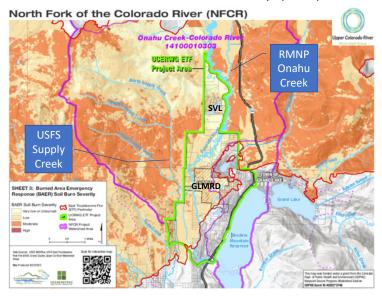
4) UCRWG ETF Project Area with BAER Soil Burn Severity (SBS)

- US Forest Service (USFS) post-fire rapid assessment Burned Area Emergency Response (BAER) is reported as "soil burn severity" (SBS), essentially how deeply were soils burned during the fire and a surrogate for local lands' ability to support natural recovery processes
- Most of the UCRWG ETF project area experienced very low to low SBS impacts, with notable moderate SBS in hilly terrain near Sun Valley Lake (SLV) and the Grand Lake Metro Recreation District (GLMRD)
- Upstream from the project area are large patches of higher SBS impacts on USFS National Forest System lands in the Supply Creek drainage on RMNP in the Onahu Creek drainage, both delivering increased flows and sediment loads to the NFCR

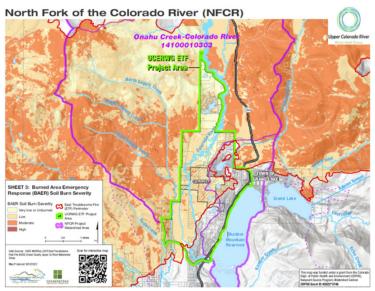
6) UCRWG ETF Project Area with BAER Soil Burn Severity (SBS)

- It should be noted that trees, shrubs, and most structures will burn in even low-SBS fires
- That said, natural recovery processes are already seen in many low-lying areas with plant communities that include sod-forming grass-wildflowers as well as plants like willow, aspen, rose, and cottonwood that have broad root systems

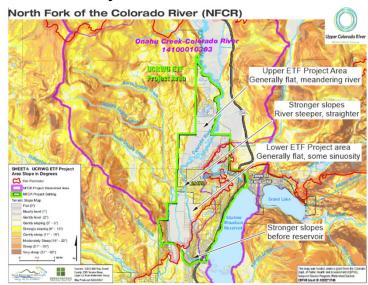
7) Slopes In and Around the Project Area Influenced SBS

- The NFCR valley floor in the UCRWG ETF project area, with notable areas of hilly terrain in the Sun Valley Lake and GLMRD areas
- Flatter areas coincide with lower SBS impacts
- Hilly areas show higher SBS impacts
- Compare with Figure 6 above
- This map originally shared as Sheet 4: UCRWG ETF Project Area Slope in Degrees

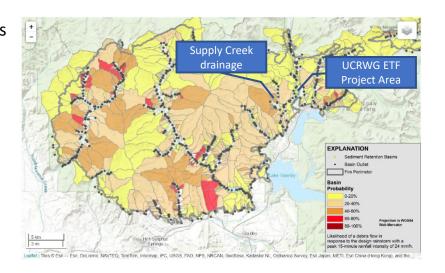
9) USGS Post-Fire Hazard Assessment for Debris Flows

- Debris flow risks is considered relatively low in the UCRWG ETF project area but upstream basins range up to 80% probability
- Published as Emergency Assessment of Post-Fire Debris-Flow Hazards

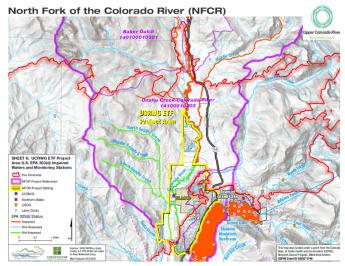
10) USEPA 303(d) Listed Impaired Waters and Monitoring Stations

- Shadow Mountain Reservoir is listed not meeting water quality standards for drinking water and cold water fisheries
- The NFCR in the middle and upper parts of the UCRWG ETF project area and primary tributary Supply Creek drainage are listed as "not impaired" but both reaches were heavily burned in the ETF
- Farther upstream along the NFCR is listed as impaired for Zinc
- Presented in Sept 2022 as Sheet 6: UCRWG ETF Project Area U.S. EPA 303(d) Impaired Waters and Monitoring Stations
