Inspection report for the property at
1234 Anywhere Lane , Bedford, IN

This report is prepared exclusively for **Practice Location**
Inspected On: **08-30-2025**

E3 Property Inspections LLC.
812-583-2150

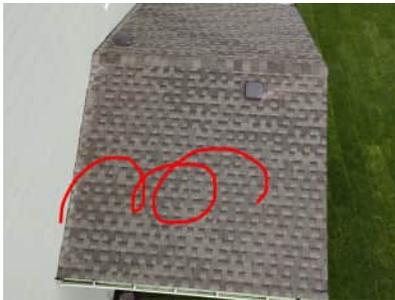
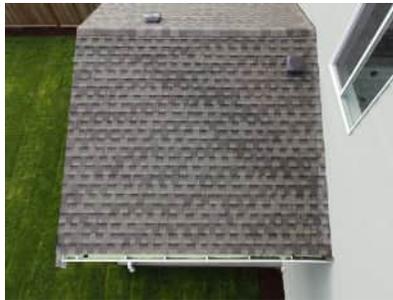
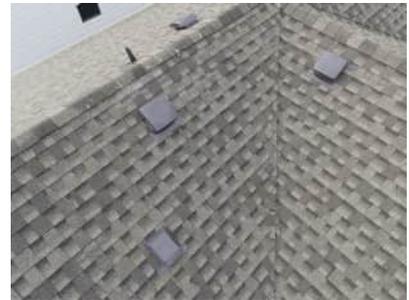
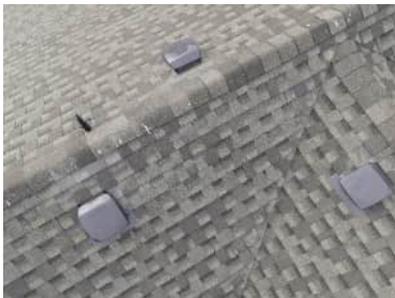
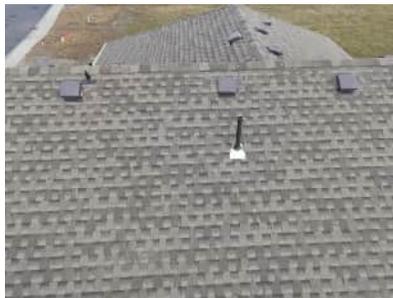
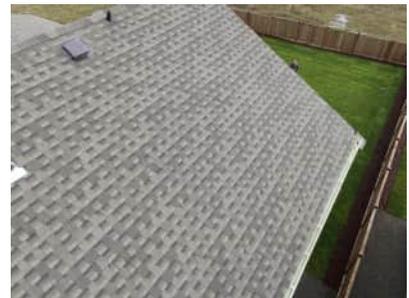
- A number of exposed fasteners were noted on the roof indicating sloppy fastening
- Several damaged shingles were noted on the lower roof
- Drip edge flashings have been installed on top of the underlayment. This is not correct above gutters.

Drip edge flashings have been installed on top of the underlayment. This is not correct above gutters

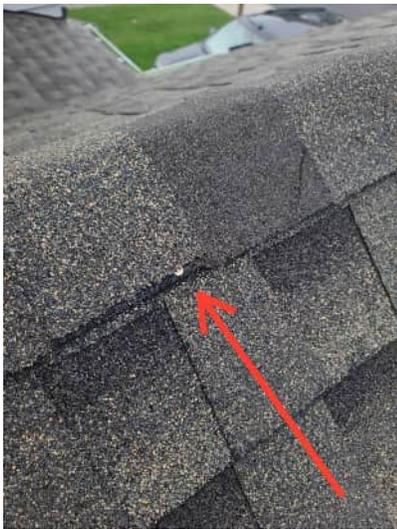
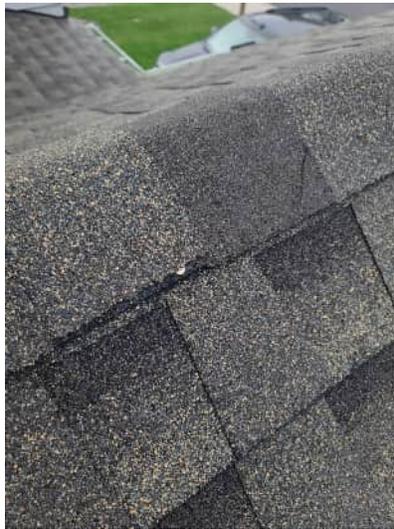
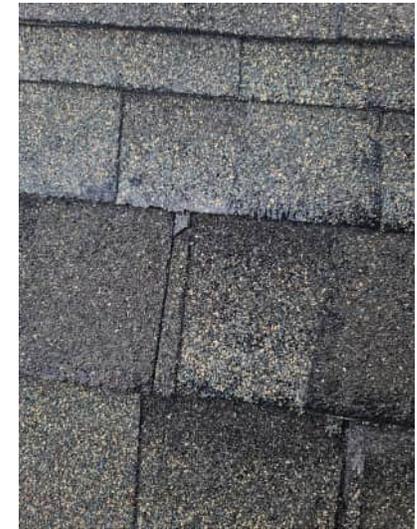
🔧 (RC-2) Repair: The roofing system was noted to be in marginal condition and will require repair or replacement in the near term. Examples of observations noted during inspection include:

A number of exposed fasteners were noted on the roof indicating sloppy fastening

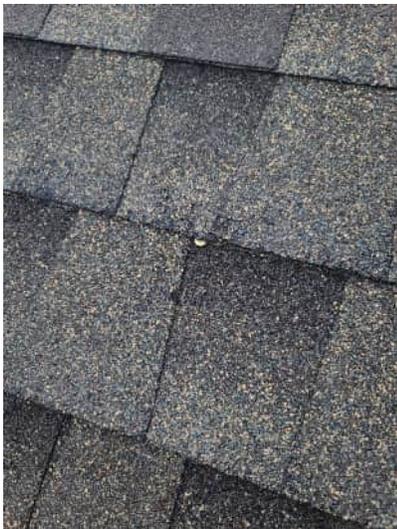
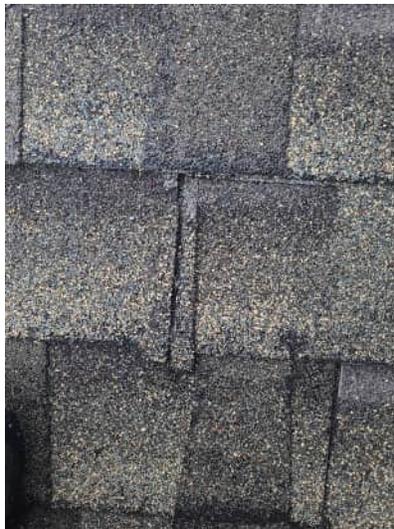
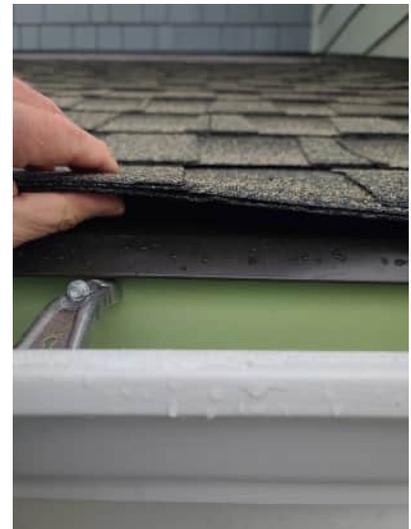
Several damaged shingles were noted on the lower roof

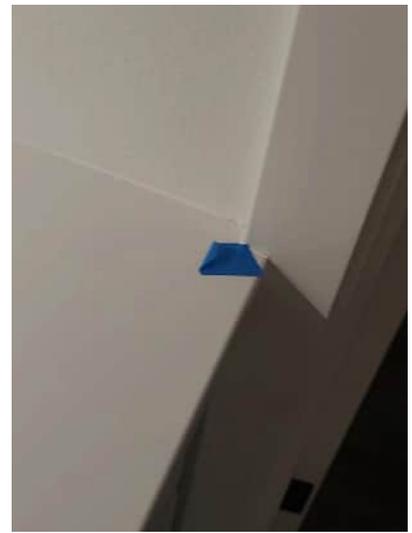
Tune-up repairs are needed to the cabinets. Complete repairs/installation of cabinets as needed.

*Repair caulking where failing on
countertops/cabinets*

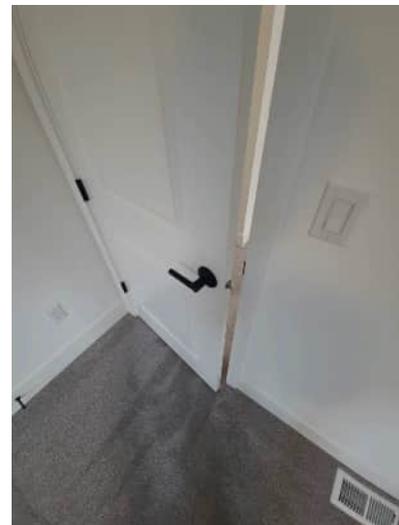
Repairs are needed to the door(s). See the family bedroom.

- The door is not latching when closed

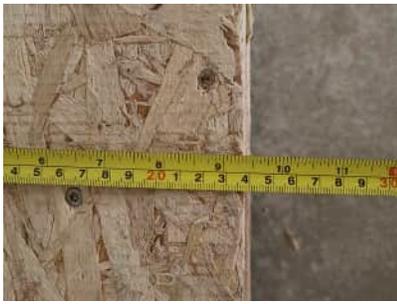
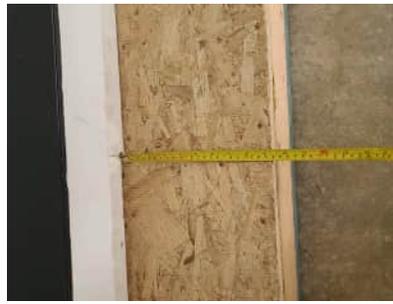
🔧 (I-2) Repair: Stairs to garage: Repairs are needed to the stairs to ensure safe and reliable performance. Stairs are a common safety issue in buildings. Some older stairs can be difficult to correct. Repairs/improvements are recommended for safety as feasible.

- Stair treads are too narrow - these should be a minimum of 11-inches if no nosing is present or 10-inches with a tread nosing.

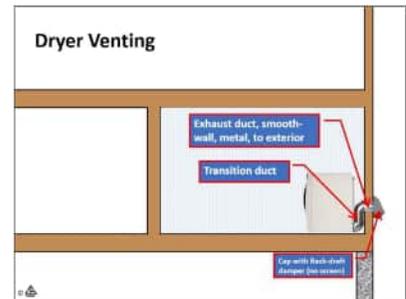
It is recommended to use rigid all-metal duct for the dryer exhaust. If rigid all-metal duct cannot be used, then flexible all-metal ducting should be used.

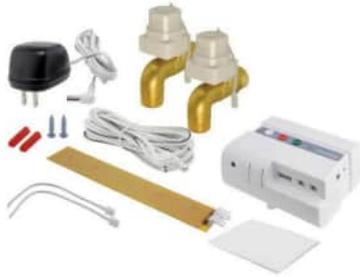
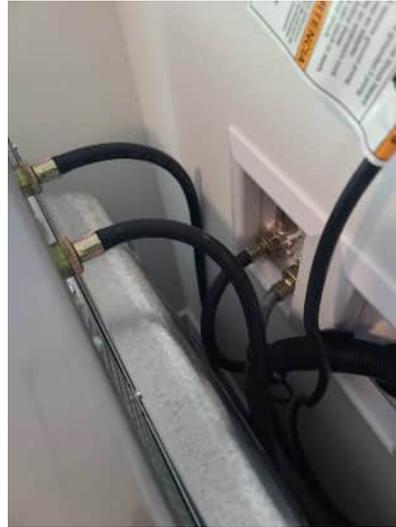
(LR-3) Description: A moisture alarm with water shut-off features is recommended under the washing machine to protect against accidental leaks in the supply hoses. Pans can be effective when there is a drain, but even these will not protect against a burst supply connector. A moisture alarm with automatic shut-off will. Watts is a brand I have seen installed: [Link](#).

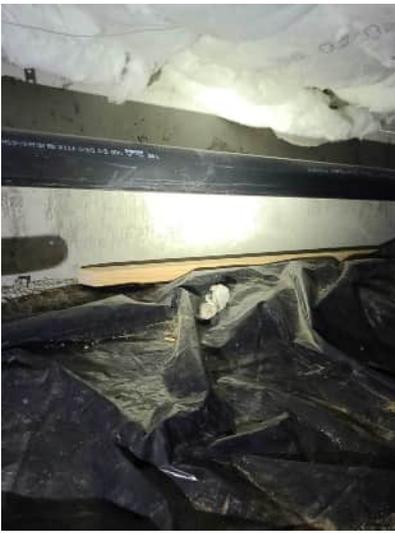
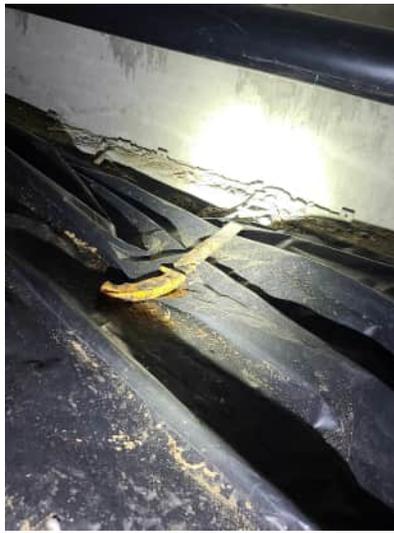
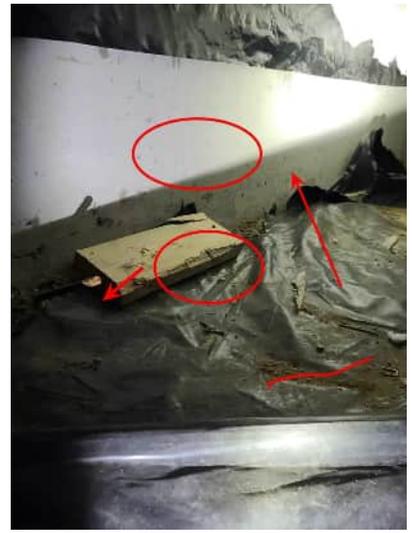
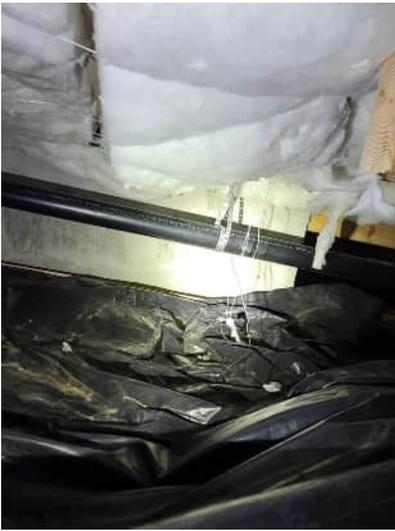
🔧 (CS-1) Repair: Wood and cellulose debris was noted in the crawl space. This is conducive to wood destroying organisms. Removal of wood debris is recommended.

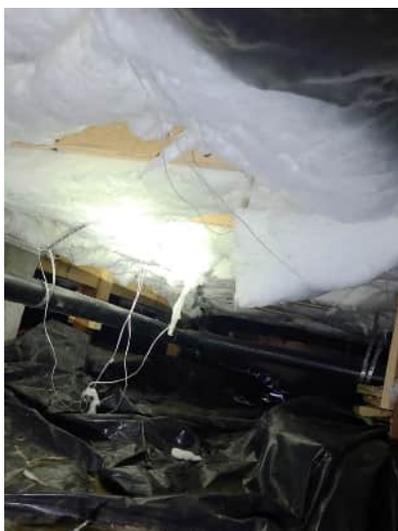
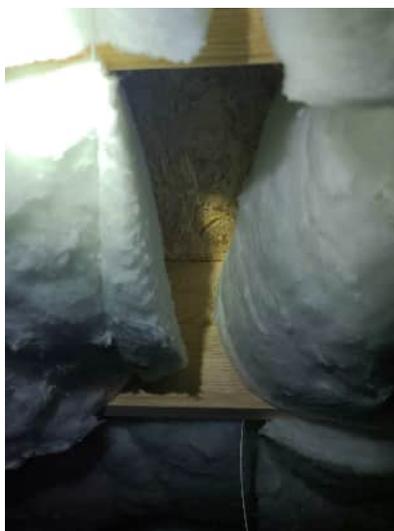
🔧 (CS-4) Repair: The sub-floor insulation is not correctly installed and requires repair or updating. See a few spots below the kitchen.

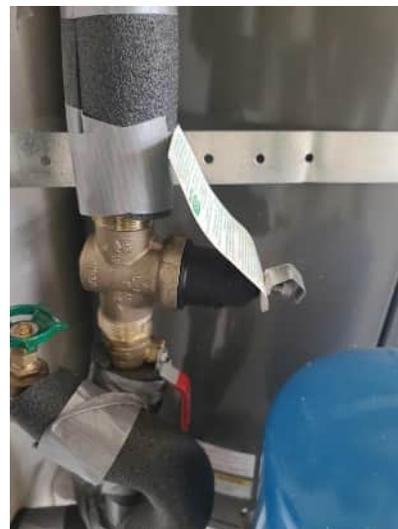
This shows the pressure reducing valve for the building. This indicates the house is a closed piping system, so some type of expansion device is recommended. This is typically provided through an expansion tank by the water heater.

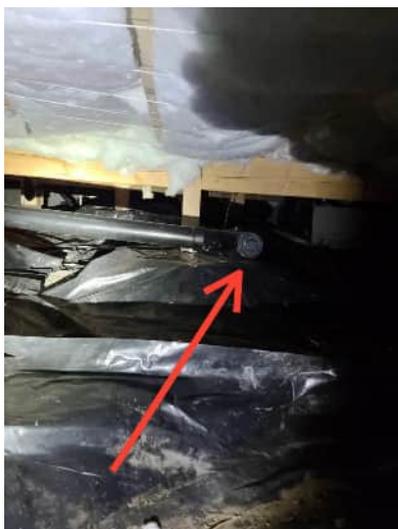
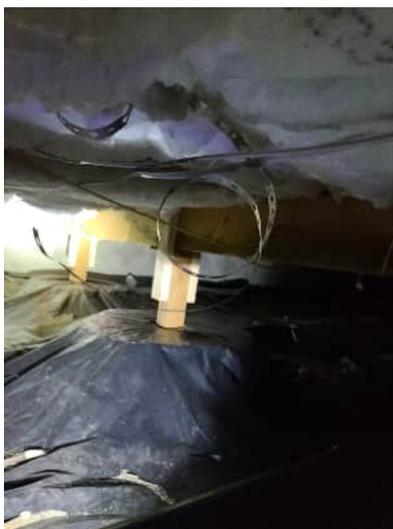
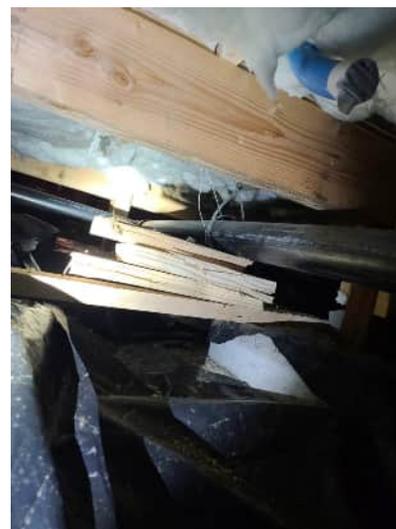
🔧 (P-4) Repair: The waste pipe has inadequate support. ABS and PVC type plastic pipe should be supported every 4 feet. This is an important repair to perform as the sagging pipes could collapse and fail. **Support is incomplete in the crawl space.**

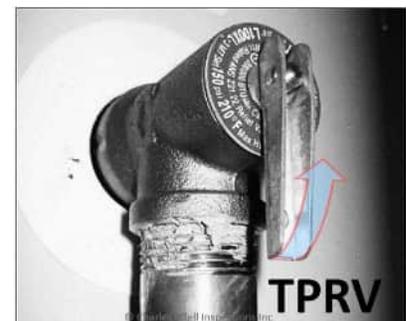
A temperature and pressure relief valve (TPRV) is required on all water heaters to discharge any excessive pressure within the tank. A discharge pipe should be attached to the valve and directed to a safe location away from body contact. Newer installations must be directed to the building exterior or to an approved indoor drain receptor. Most manufacturers suggest that homeowners test these valves at least once a year by lifting the lever to ensure the valve discharges properly and also recommend inspection of these safety devices every three years. The picture here shows a typical TPRV. They may also be found on the side of the heater on some models. I do not test these valves due to the possibility that they may leak after testing. A leaking or inoperative TPRV should be replaced immediately by a licensed plumber.

Due to inconsistencies between both UPC and IPC Plumbing codes, and water heater manufacturer's instructions, and TPRV manufacturer instructions, it is not actually possible to install the drain from the Water Heater TPRV "properly." There are conflicts with distance of termination to the floor/ground, types of pipes approved, and diameters of pipes approved. Additional confusion is added when jurisdictional inspectors approve installations/materials specifically not allowed by both codes and manufacturers. My recommendations will vary depending on the installation and will be included in the applicable narratives below. Most codes defer to manufacturer instructions and I favor those recommendations. The yellow tag on the valve states clearly the

termination should be 6" above the floor which is more consistent with the UPC code requirements.

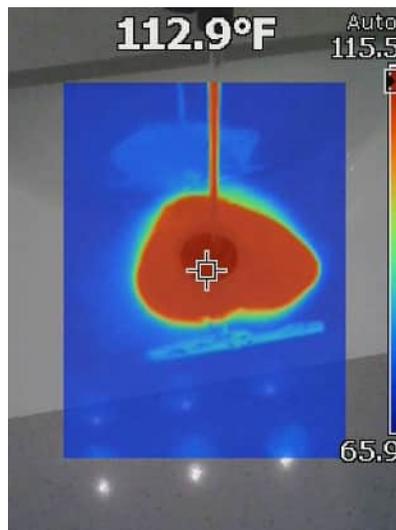
**(P-6) Recommended Maintenance:** The water temperature tested slightly below the recommended 120 degrees F. Adjust the water temperature as needed.

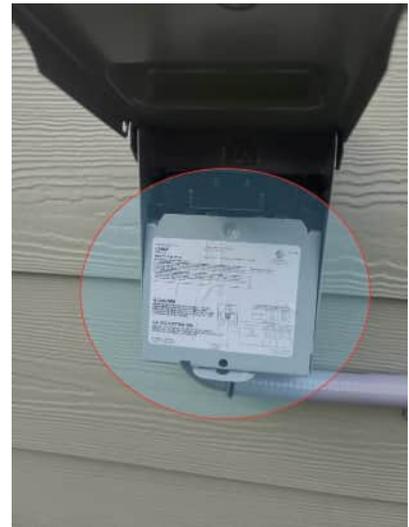
The cover for the heat pump disconnect is loose. Repair as needed for safety.

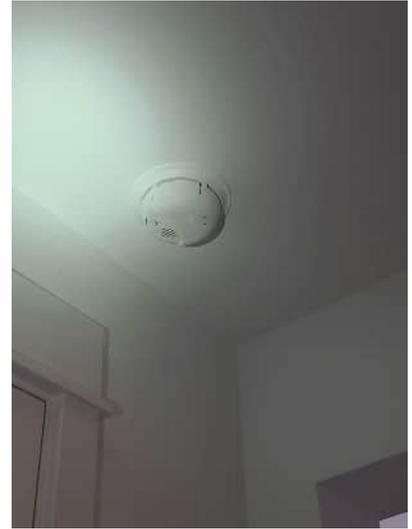
- One or more sleeping rooms were found that did not have a CO alarm outside the room.

The smoke alarm outside the main floor bedroom is just a smoke alarm and does not have CO protection.
