Inspection report for the property at  
4332 Bdawg Boulevard, Bedford Indiana 47421

This report is prepared exclusively for  
Inspected On: **01-03-2026**

E3 Property Inspections LLC.  
812-583-2150

Eric Hughes, Indiana State License  
#HI02400098

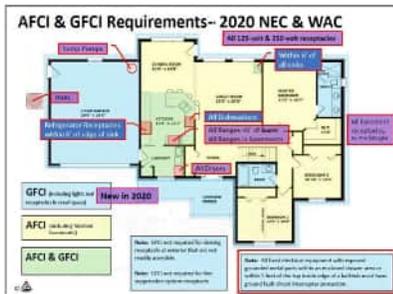
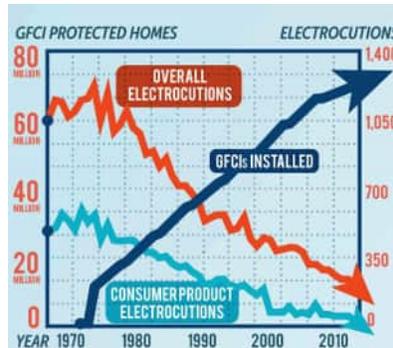
**(ES-1) Repair:** GFCI protection was incomplete or missing for exterior electric receptacles. Modern safety standards require GFCI protection for all exterior receptacles for improved safety. Repair as needed.

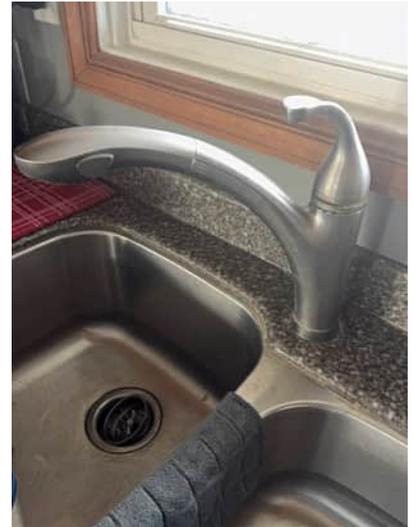
The sink faucet is loose and requires repair.

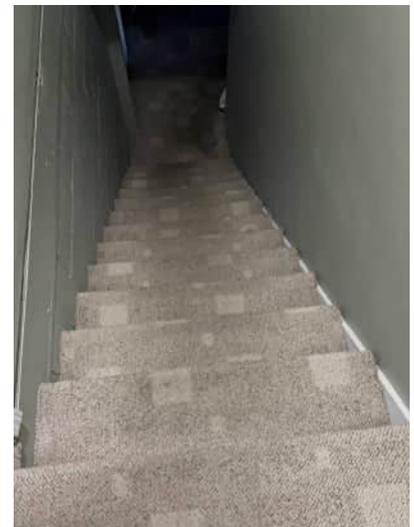
The handrail for the stairs is missing. A graspable handrail is recommended for safety

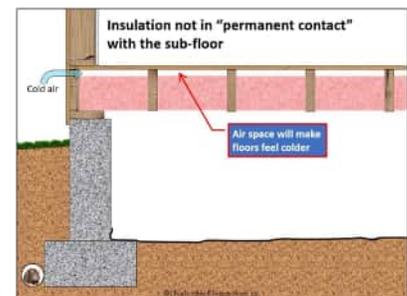
**(CS-7) Repair:**  
The sub-floor insulation is sagging and not touching the sub-floor. This can reduce the effectiveness of the insulation. Support as needed for reliable performance.

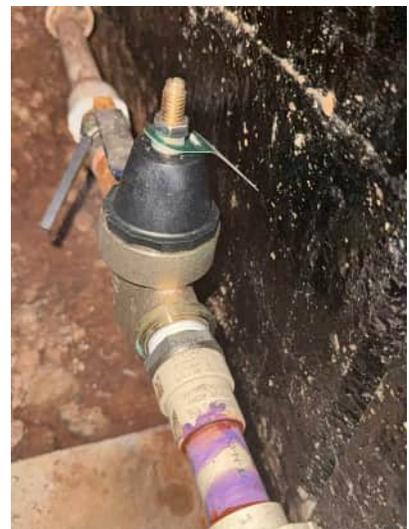
*Pressure Reducing Valve is located in the basement.*

*This shows the pressure reducing valve for the building. This indicates the house is a closed piping system, so some type of expansion device is recommended. This is typically provided through an expansion tank by the water heater.*

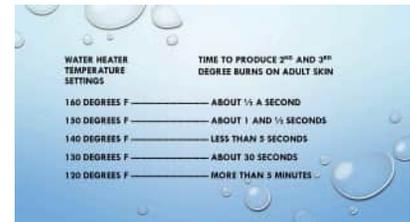
The water temperature tested slightly above the recommended 120 degrees F. Adjust the water temperature as needed.

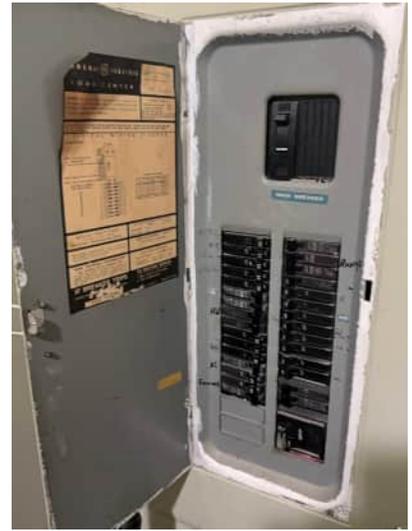
The labeling is incomplete for the main electric panel. Correct incomplete labeling as needed for safety.
