INFORMATION FOR MEMBERS OF THE PUBLIC ON CREUX HARBOUR

Visual Inspection & Geotechnical Assessment

Creux/Maseline Harbour & La Coupée, Isle of Sark

Report No. 3265-01

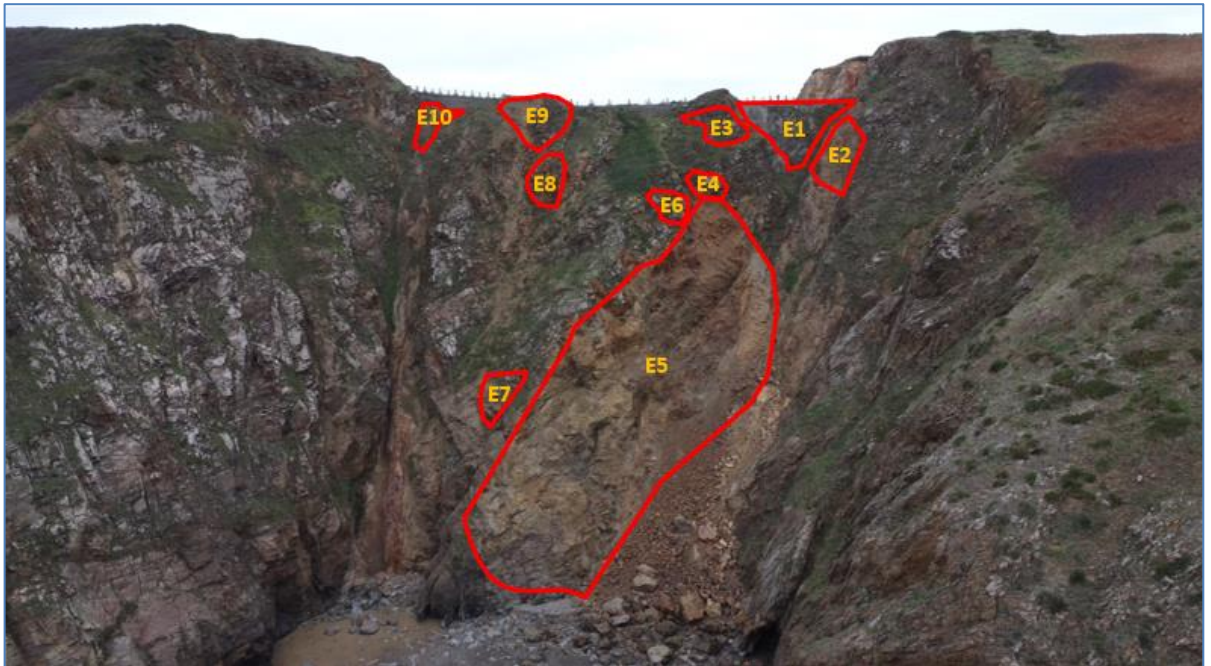
Figure 3 – East Face of La Coupée with Location Mark Up (E1-E10)

in **Figure 3**. These have not directly affected the crossing.

The rock is very blocky, crossed with several faults and fault zones. The regional dip of the foliation in the gneiss is present, however the resultant geological structure is very complex.

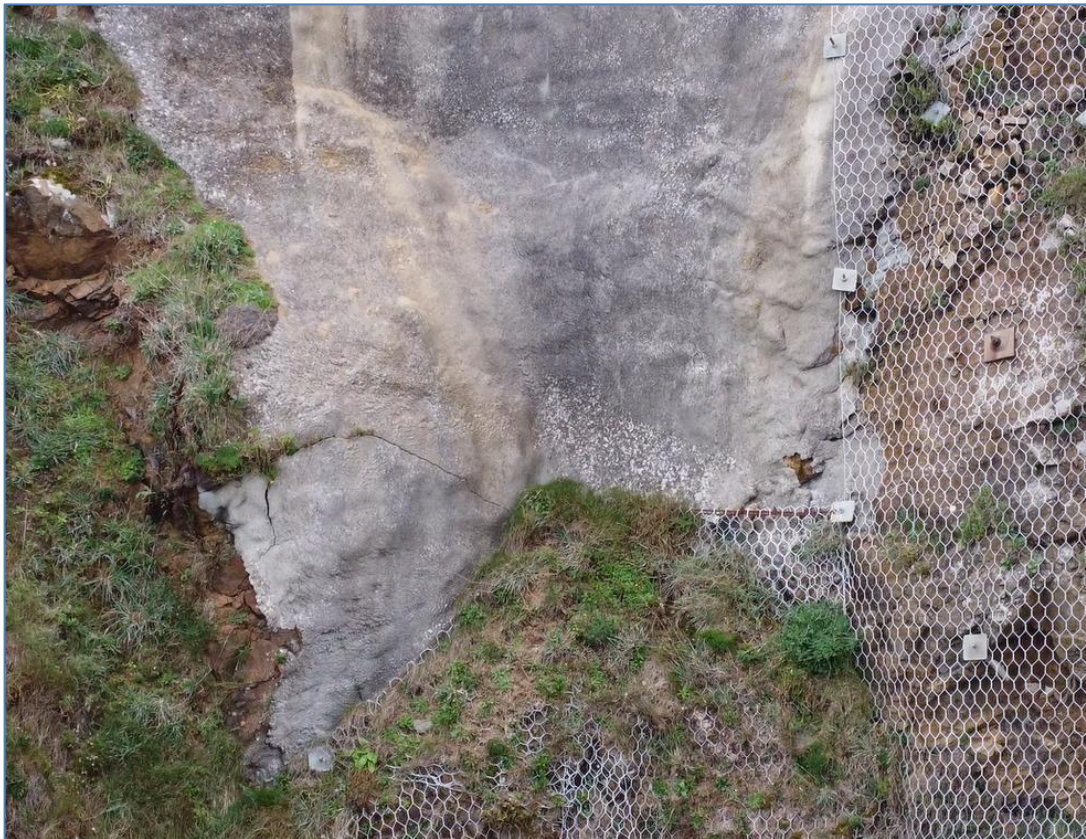
Generally, the stabilisation appears in adequate condition with some localised areas of corrosion evident on the wire ropes and grips. A minor rockfall has caused slight bulging in the netting and partially exposing anchors/dowels in the source area. The shotcrete area exhibits a crack across its lower portion, with a few minor cracks also being observed in other places. Where the larger crack is present, some minor vegetation growth was visible (see **Figure 4**)

No details on the stabilisation have been provided to Geomarine for review and comment. However, the system appears to be holding up well with minimal deterioration noted. Where the minor failure has occurred behind the rockfall netting, the netting appears to be functioning as is assumed to be intended by holding the fallen material in place.

Figure 4 – Close up of cracked shotcrete and several of the corroded element observed on the existing stabilisation

It is recommended a rope access inspection is undertaken in this area to inspect the overall condition of the stabilisation system and the structure above on the stabilisation works as well as on the upper structure to check the foundations and overall condition.

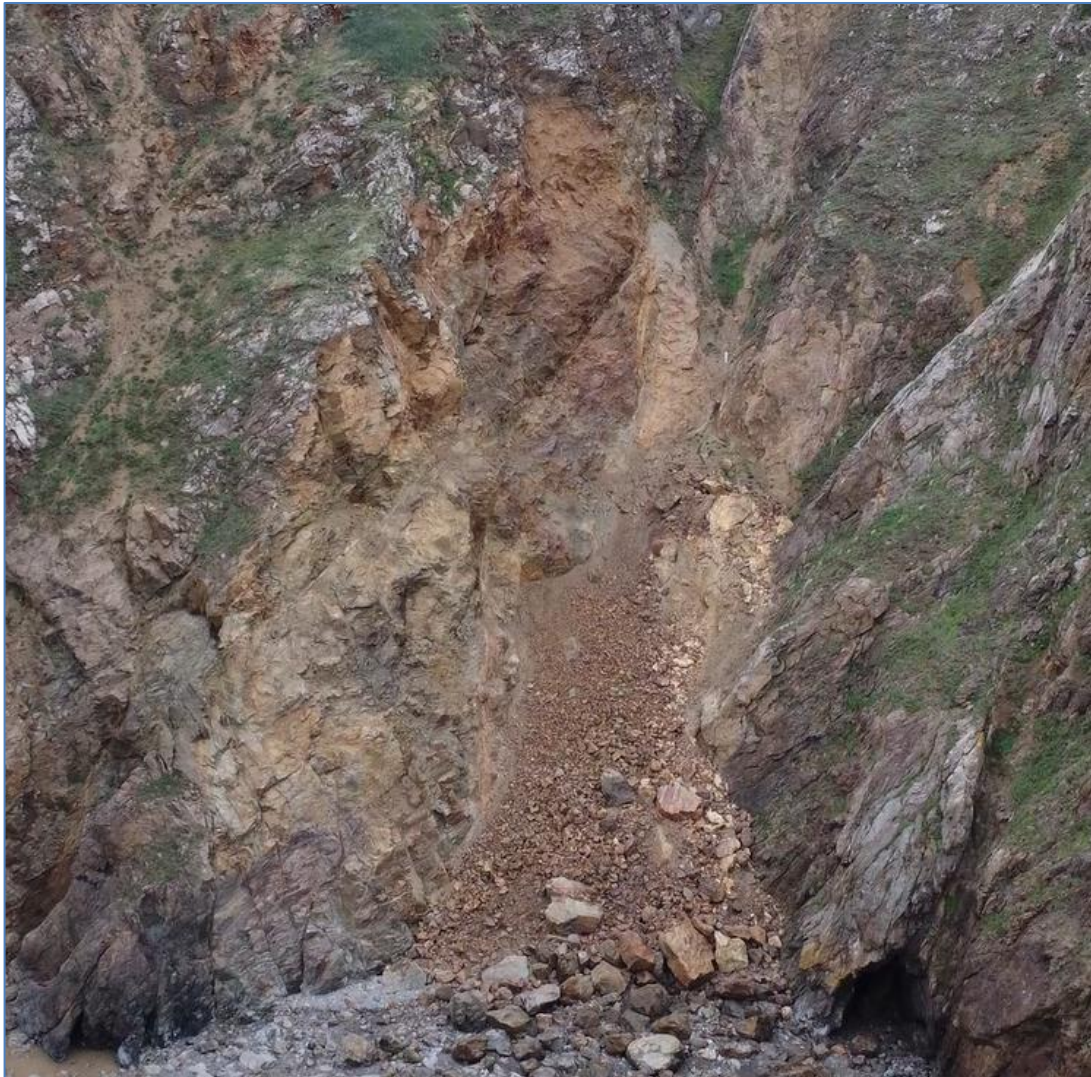
Figure 5 – Area 5

Areas E3, E4, E5, E6, E7 and E8 are considered at risk of small-scale blocky failure. These areas currently pose a relatively low risk to the structural integrity of La Coupée crossing, as any initial failures are unlikely to directly impact the crossing. However, subsequent failures may propagate/unravel backwards, eroding the rockface over time, potential compromising the structural integrity of the crossing in the future.

There is also a secondary risk to human health due to the potential falling material/debris to reach the beach below. As there is no pedestrian access to the beach the risk is considered to be low, however, there remains a small residual risk associated with access via boat.

Annual inspections are recommended to monitor the area's condition, establish erosion rates, and inform a long-term management plan to preserve La Coupée crossing

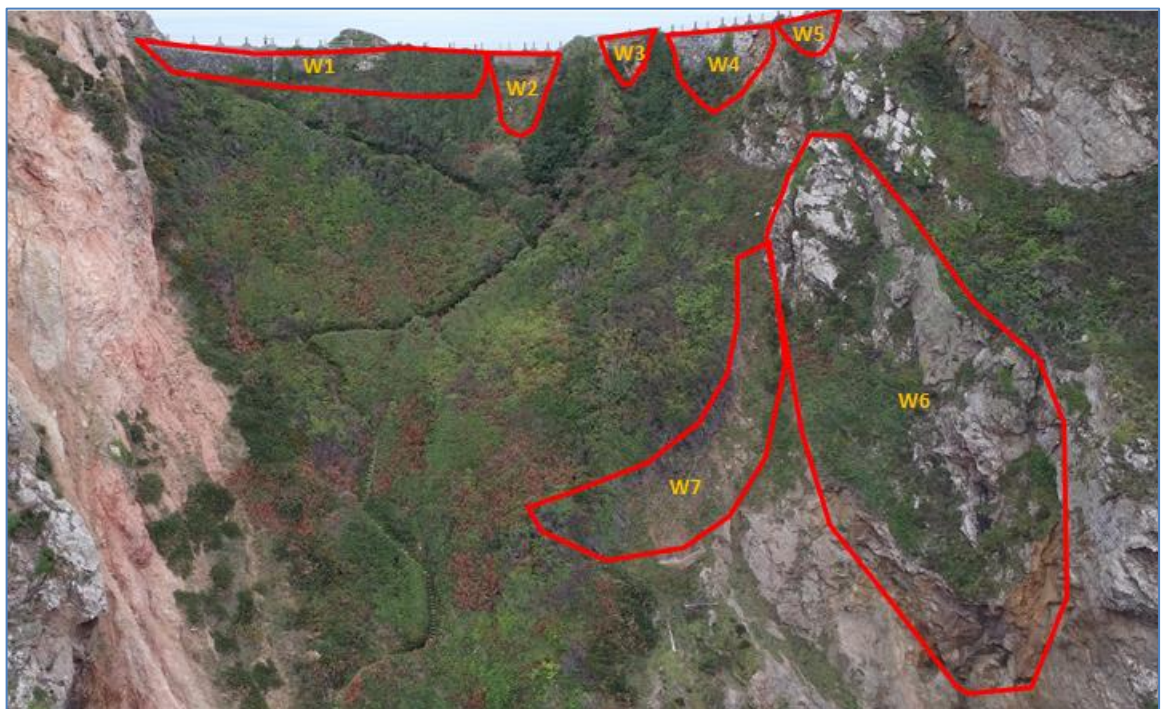
Figure 6 - West Face of La Coupée, with location mark up (W1-W7)

The west face has been divided into seven areas for the purpose of this assessment. See **Figure 6** for the location of each section. For photographs of each individual section please refer to **Appendix B**. This face is heavily vegetated with bracken, brambles, gorse and ivy. It appears that the rock is mantled with a layer of soil (perhaps wind-blown loess or periglacial head).

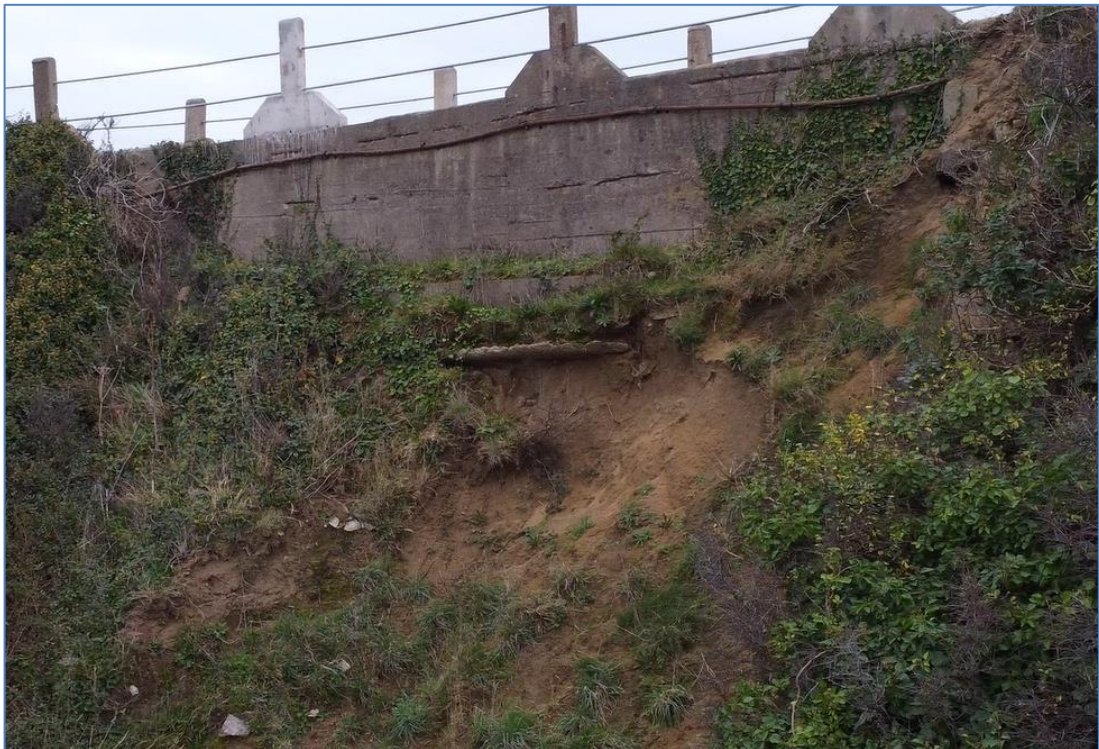
The inspection of Area W2, W3, W4, and W5, identified significant undermining and exposure of the foundation of the concrete structure. The foundation appears to rest on periglacial head deposits or similar unconsolidated materials, which are inherently less stable. This presents a critical concern for both public safety and the structural integrity of the crossing.

Evidence of fresh debris at on the rockface directly below indicates that failures are occurring regularly. These ongoing failures are likely to continue to undermine the foundation of the crossing, increasing the risk of a collapse of the wall retaining the road. The situation is exacerbated by the frequent passage of heavy agricultural plant over the crossing, which imposes additional dynamic loading.

Should a failure occur, the crossing would become unsafe for use, jeopardising access to Little Sark and potentially damaging the existing electricity supply infrastructure, which is essential for the island.

Figure 7 – Close up image of undermined section of La Coupée at Area W2

Urgent stabilisation and mitigation measures are strongly recommended to address these risks, likely to consist of a mix of rock dowels, soil nails, netting, shotcrete and potentially rebuilding of part of the walls

We recommend that a monitoring regime is started without delay, until repairs are undertaken. This should be visual inspection on a weekly basis to check for changes and during times for heavy rainfall, strong winds. Consideration should be given to advising users of the crossing of the risks. Metal road plates can be placed over the areas of concern to spread the loads of passing vehicles.

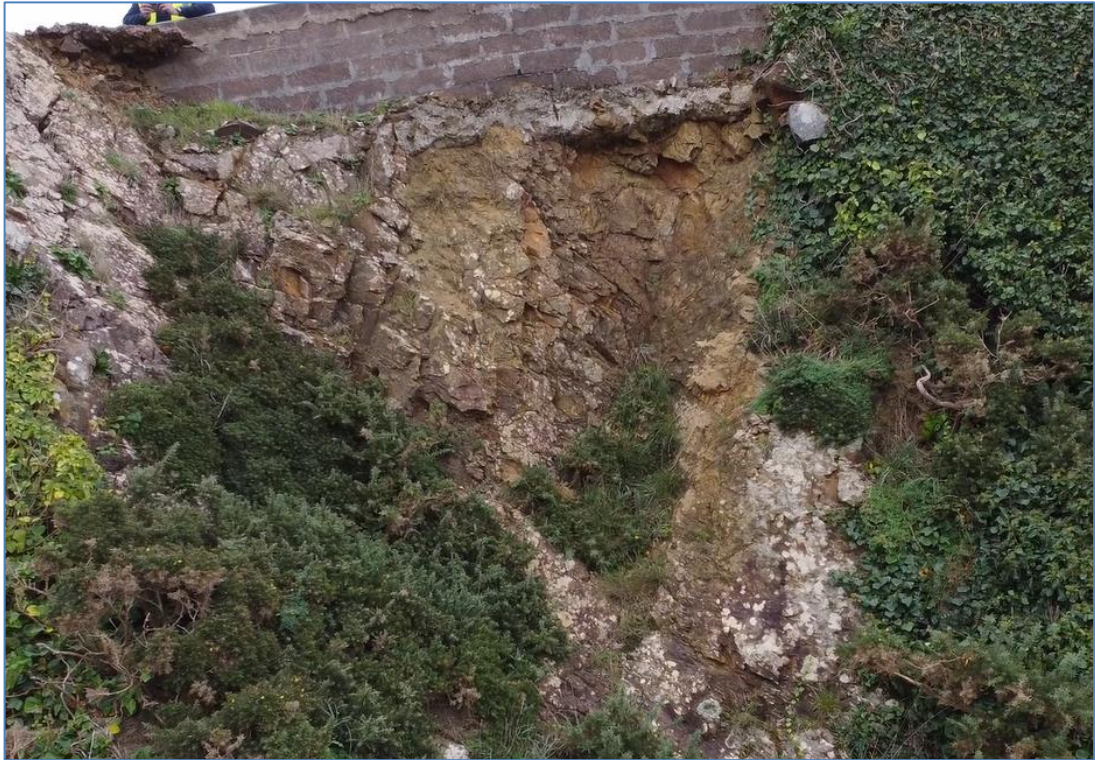
Figure 8 – Close up image of undermined section of La Coupée at Area W3

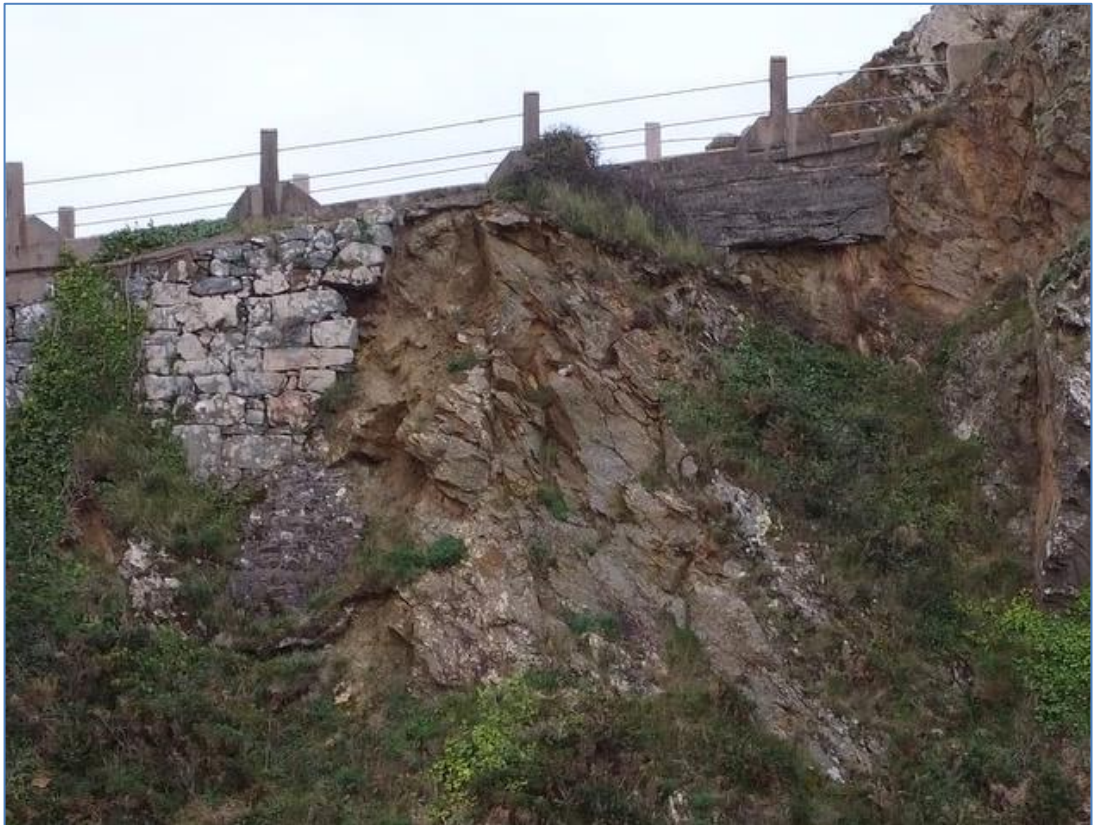
Figure 9 – Close up image of undermined section of La Coupée at Area W5

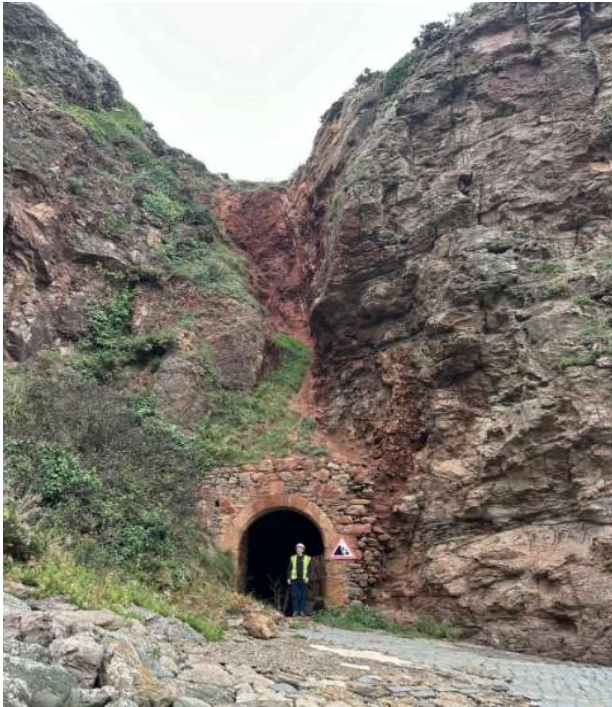
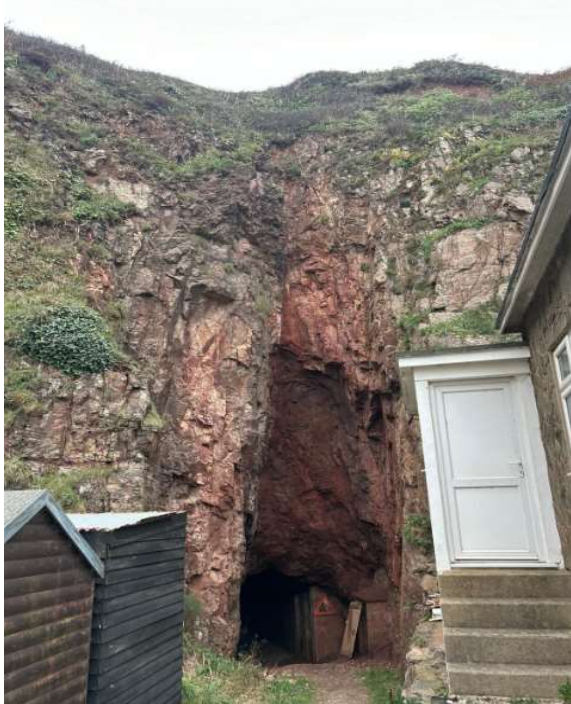
</div> <div><h1>Inspection Photographs</h1></div>		<div>H1</div>
Contract Name	Sark-Inspect	
Contract Number	3265	
Engineer	N/A	Page 1 of 12
Client	Chief Pleas of Sark	
<div>

Area	Location	Description	Key Risks	Recommendations
H1	Tunnel to Creux Harbour	Largely unlined tunnel through a fault zone in the cliffs	Tunnel roof collapse, and cliff fall above the tunnel entrances.	Close the tunnel and cordon off areas around the entrances or install a structural lining and stabilise the rock faces at tunnel entrances
H2	Beach at Creux Harbour	Cliffs above the beach and small cave	Risk of rockfall from the cliffs onto persons using the beach	Install signs warning the public of the danger or rockfall and advising not to sit under the cliffs. Place barriers or rocks to discourage people sunbathing under the cliffs Ongoing monitoring and inspections
H3	Slipway into Creux Harbour	Rock faces above slipways	Risk of rockfall from the cliffs onto persons using the slipway	Install signs warning the public of the danger or rockfall and advising not to sit under the cliffs. Ongoing monitoring and inspections

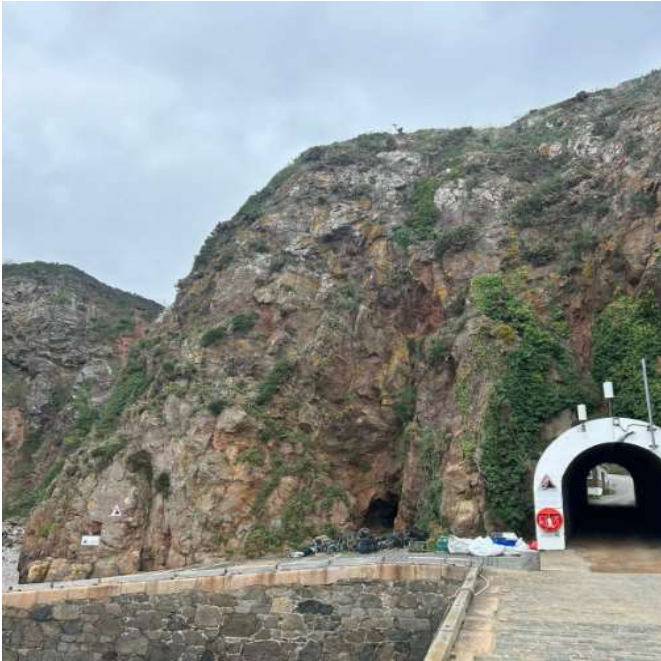
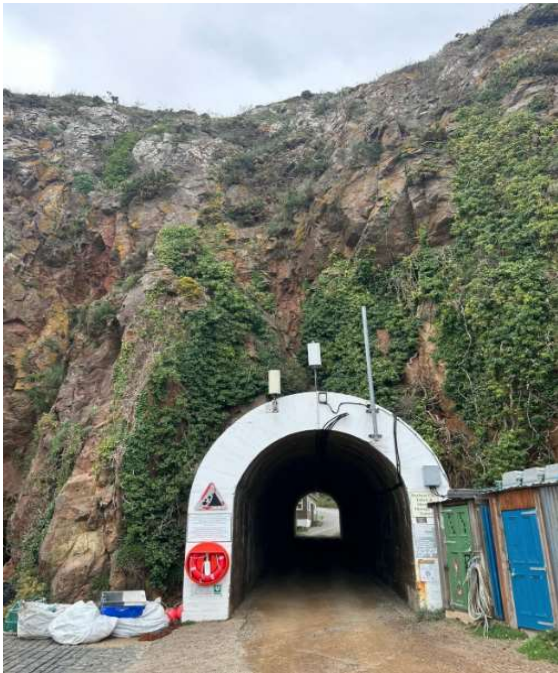
<h1>Inspection Photographs</h1>		<h2>H4 & H5</h2>
Contract Name	Sark-Inspect			
Contract Number	3265			
Engineer	N/A			Page 4 of 12
Client	Chief Pleas of Sark			
<p>H4:</p>

H4 & H5	Slipway and tunnel entrance into Creux Harbour	Rock faces above slipway and around tunnel entrance. Area at the top of the slip used for storage of lobster pots	Risk of rockfall from the cliffs onto persons using the slipway and tunnel	Install signs warning the public of the danger or rockfall and advising not to sit under the cliffs. Ongoing monitoring and inspections Fence off storage area to restrict access
H6	Storage areas at Creux Harbour	Rock faces above storage area and sheds used by fishermen	Rock falls have damaged sheds and equipment in this area and there is an ongoing risk of further rockfall	Undertake rockfall assessment, install rock catch fence and buffer zone at the base of the cliff and move all storage units outside the buffer zone.
H7	Norther tunnel entrance to Creux Harbour	Rock faces around the main (lined) tunnel to Creux Harbour.	Minor rock falls from the upper part of the slope directly above and around the entrance	Installation of rock fall netting to prevent rockfall

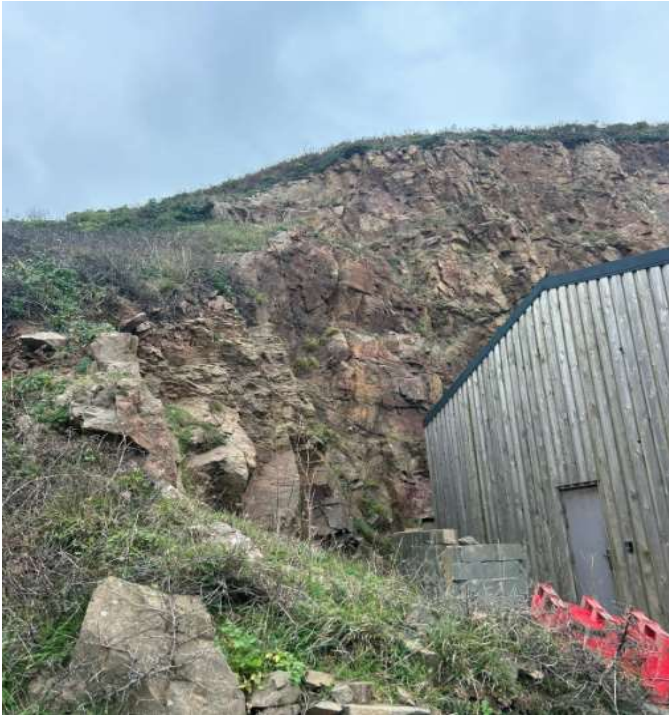
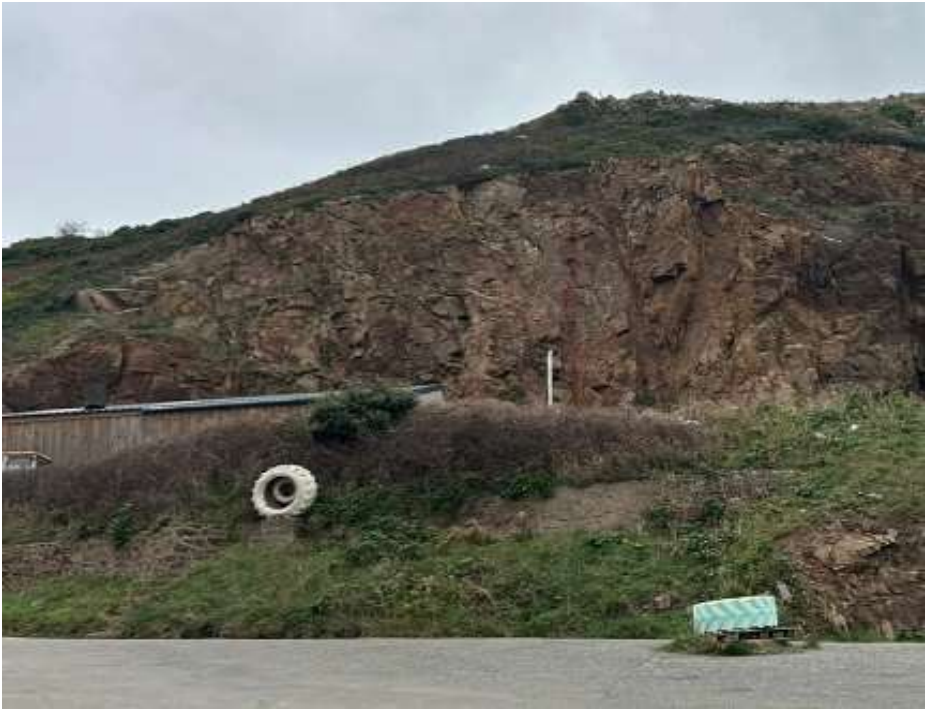
<div><div>GEOMARINE</div><div>Inspection Photographs</div></div>		H8
Contract Name	Sark-Inspect	
Contract Number	3265	
Engineer	N/A	Page 7 of 12
Client	Chief Pleas of Sark	
<div>

H8	Rock face behind incinerator building	Rock face above incinerator building and waste management areas	Risk of rockfall damaging building, occupants and users of the site	Drape netting to control rock falls, possible localised stabilisation with dowels and confirming net
H9, H10 & H11	Access road and trailer parking	Rock faces along edge of road and trailer parking area	Low risk of large rock falls causing significant impact, however there is a risk of injury / damage from smaller rock falls or isolated rocks	Combination of warning signs, installation of 2m high twist wire mesh fence and localised stabilisation/drape netting
H12 & H13	Tunnel entrances to Maseline Harbour	Rocky cliff above tunnel entrance	Risk of damage to vehicles and injury to persons from small rock falls or isolated falling rocks	Installation of rock stabilisation netting or catcher fence over tunnel entrance
H14	Maseline Harbour	Rock face along southern edge of harbour, adjacent to terminal building	Overhanging and fragmented rock at risk of falling. Area is used by the public when waiting for the ferry.	Scaling the rock face to remove loose rocks and installation of a barrier / fence to keep the public from the base of the cliff

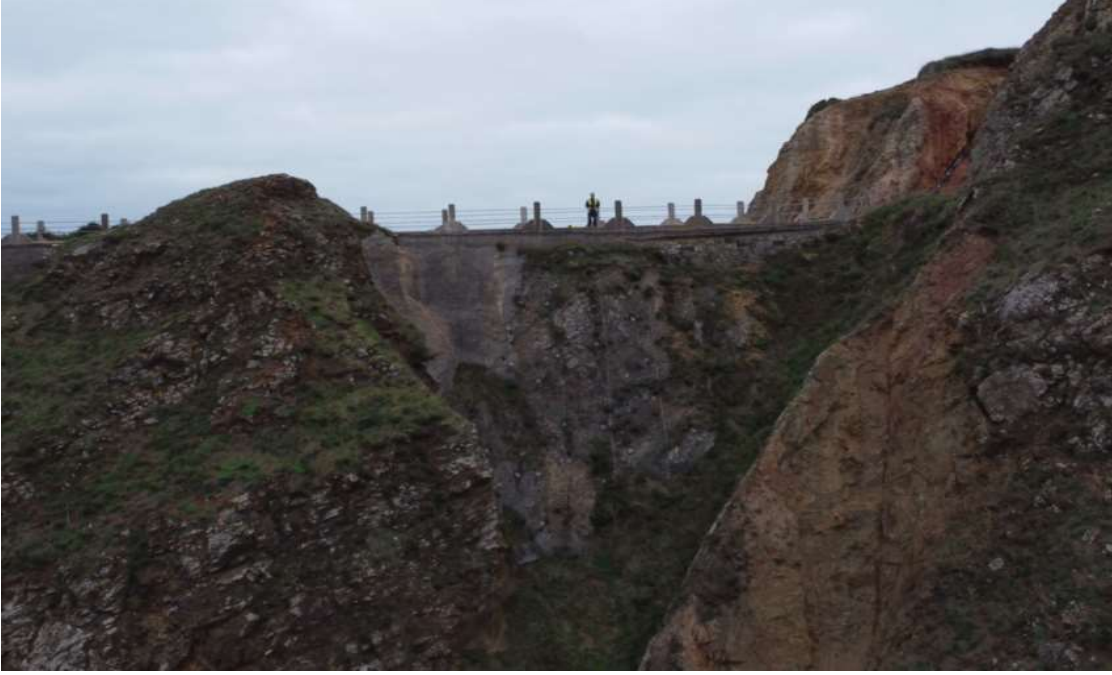
Inspection Photographs		E1
Contract Name		Sark-Inspect		
Contract Number		3265		
Engineer		N/A		Page 2 of 7
Client		Chief Pleas of Sark

Area E1, situated directly beneath the roadway, a wedge of exposed rock of which the crossing is founded upon, has been previously stabilised in the late 1990s using a combination of rockfall netting and rock anchors/dowels. Additionally, a southern section appears to have been stabilised with shotcrete or similar, although the presence of underlying mesh or anchors/dowels is uncertain.

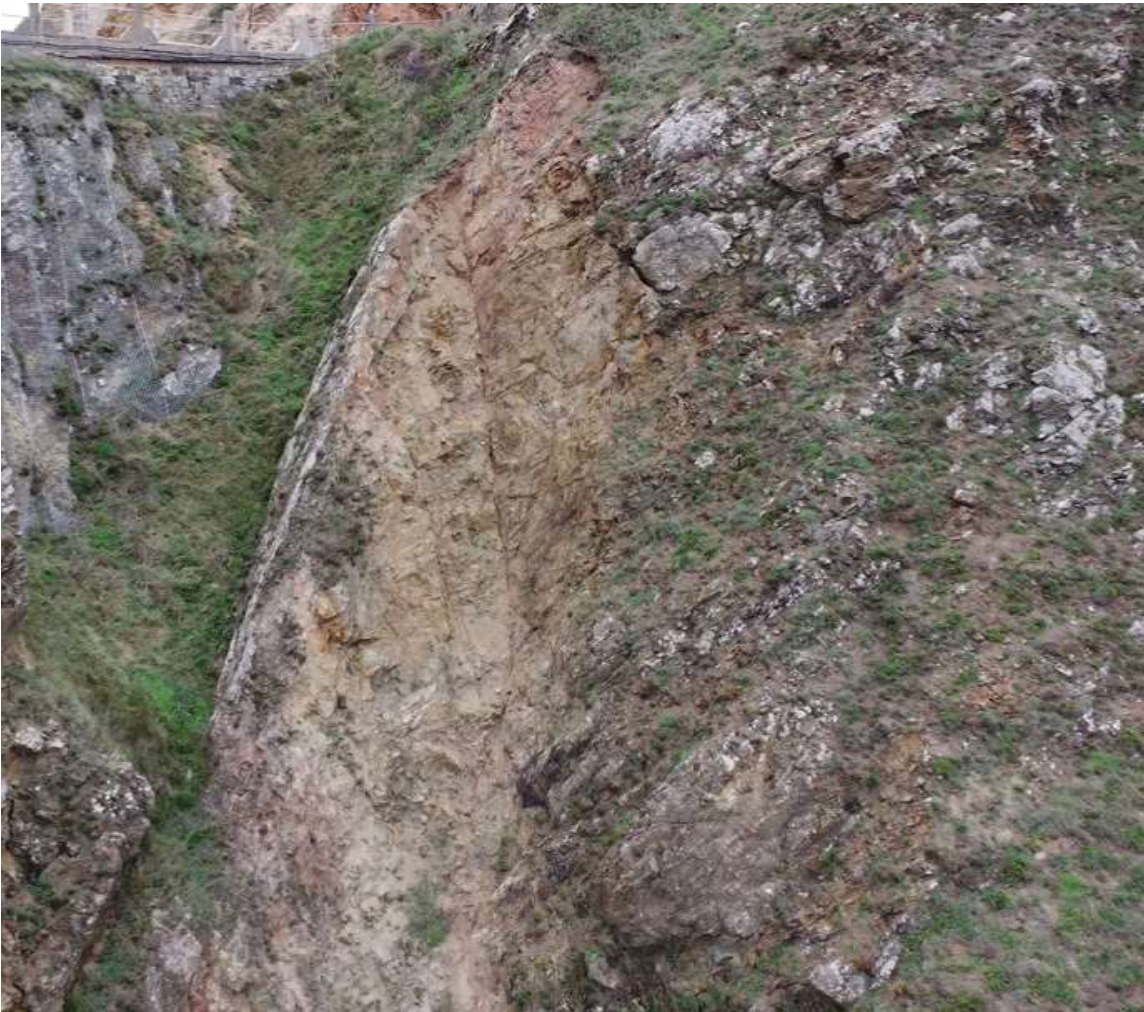
Inspection Photographs	E2
Contract Name	Sark-Inspect		
Contract Number	3265		
Engineer	N/A		Page 3 of 7
Client	Chief Pleas of Sark

Area E2 is identified as a potential toppling failure zone due to the near-vertical discontinuities within the rockface. This area currently poses a low risk to the structural integrity of La Coupée crossing as an initial failure is unlikely to directly impact the crossing. However, subsequent failures may propagate backwards, eroding the rockface over time, potential compromising the structural integrity of the crossing in the future.

Annual inspections are recommended to monitor the area's condition, establish erosion rates, and inform a long-term management plan to preserve La Coupée crossing

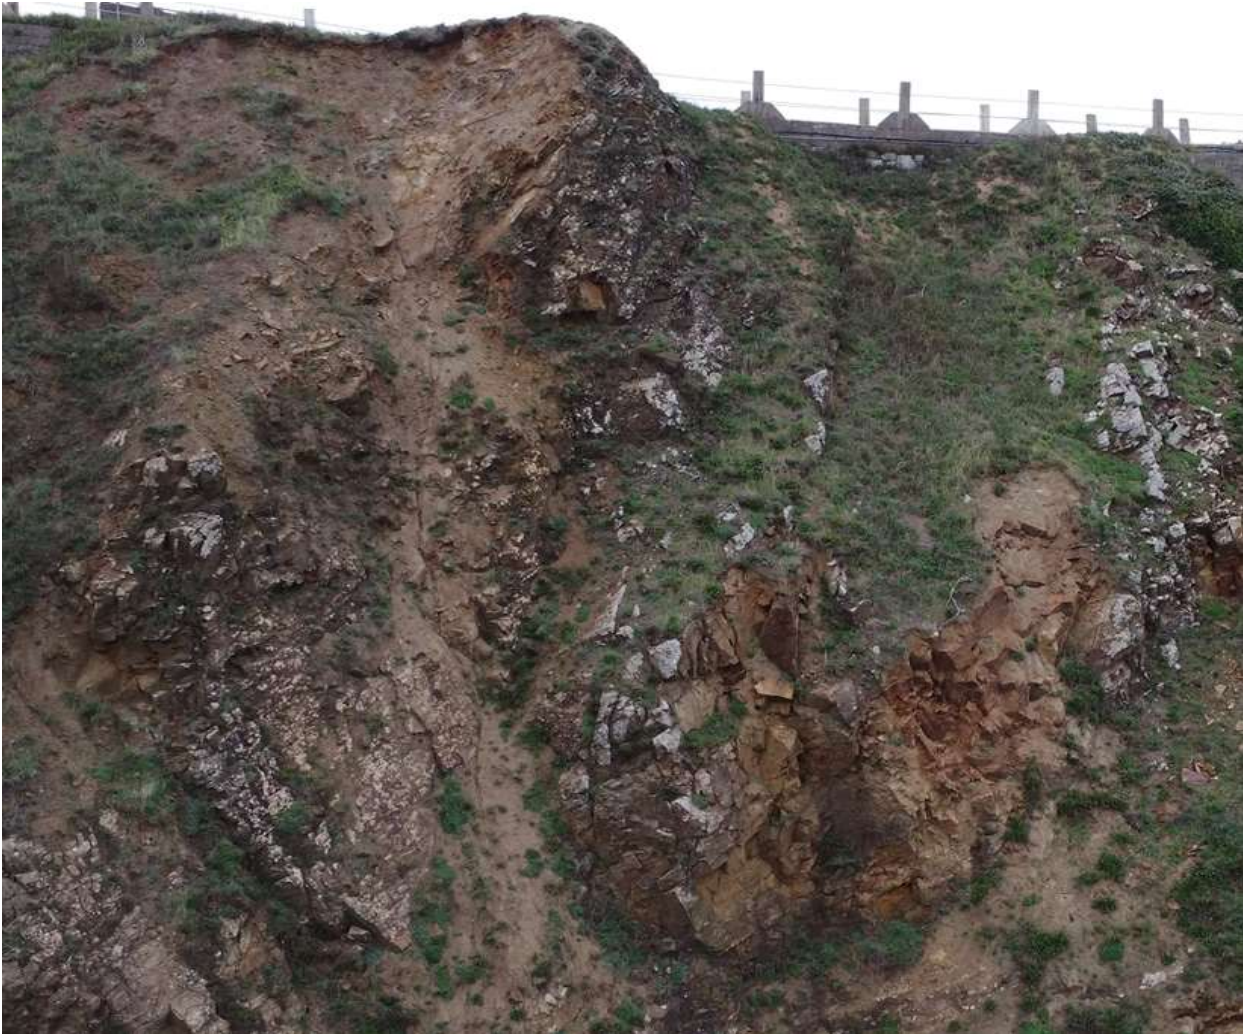
<div><div>GEOMARINE</div><div>Inspection Photographs</div></div>		E8 & E9
Contract Name	Sark-Inspect	
Contract Number	3265	
Engineer	N/A	
Client	Chief Pleas of Sark	
<div>

Area E9 was identified as an immediate risk to the structure of la Coupée crossing due to there being evidence of recent failures and its proximity to the crossing. It is deemed that if a large failure was to occur in this area, then it is possible it may remove the supporting ground, the crossing is founded upon and subsequently could lead to failure of the crossing itself.

Geomarine recommend that this is inspected as part of a rope access inspection and risk assessed based on the findings. Details such as discontinuity spacing, orientation, infilling and presence of water seepage need to be recorded and evidence of possible unstable blocks and potential failure mechanisms.

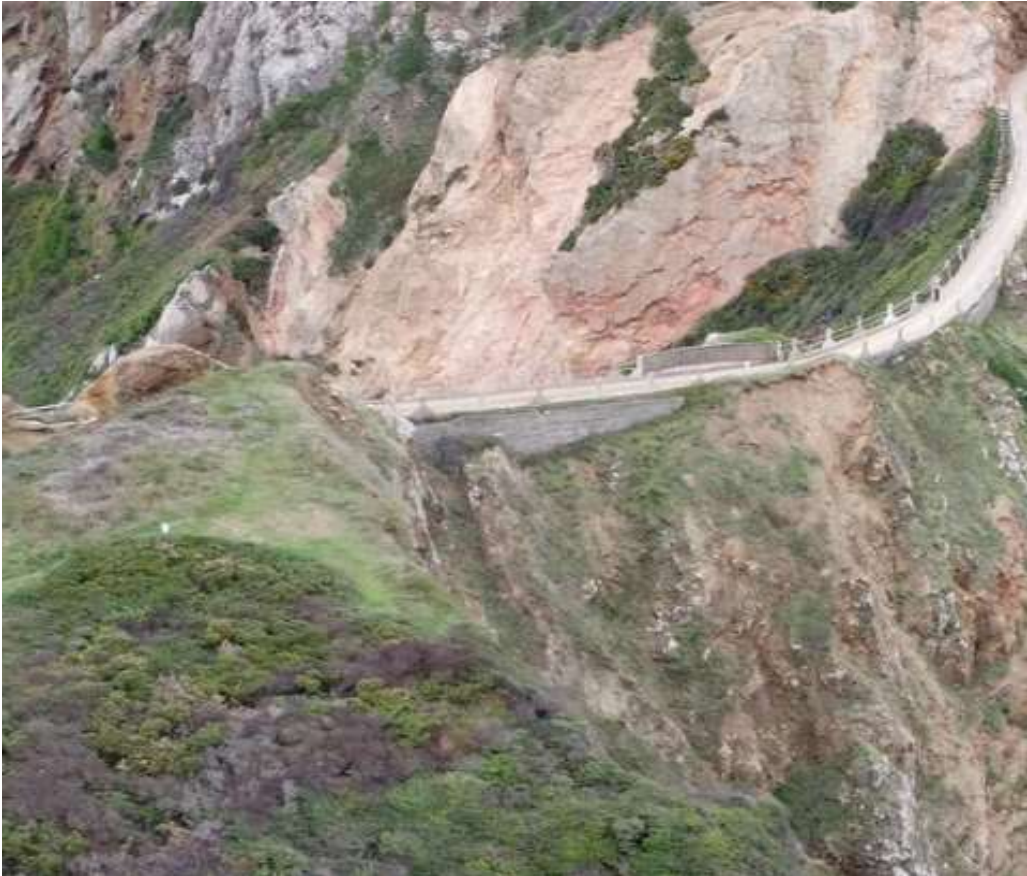
</div> <div><h1>Inspection Photographs</h1></div>		<div>E10</div>
Contract Name	Sark-Inspect	
Contract Number	3265	
Engineer	N/A	Page 7 of 7
Client	Chief Pleas of Sark	
<div>

The area E10 showed some evidence of failure and collapse. This is not thought to yet be undermining the structure of the roadway, but it is thought that further failures may be likely in this in the future, which may cause undermining.

Geomarine recommend that initially, this area is inspected as part of a rope access inspection works to the upper level of the east face with the same information gathered as for E9

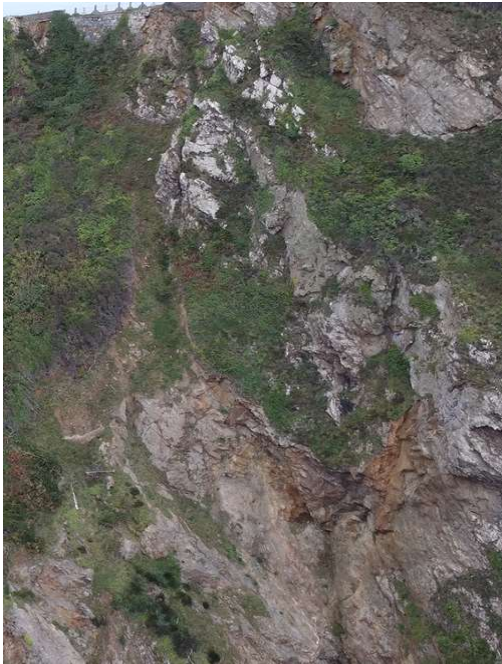
<div> </div> <div>Inspection Photographs</div>		W6 & W7
Contract Name	Sark-Inspect	
Contract Number	3265	
Engineer	N/A	Page 6 of 6
Client	Chief Pleas of Sark	
<div>W6:</div> <div>

Area W6 contains a large volume of rock that appears to be at risk of wedge failure. Observations suggest that the rock is ravelling upwards from the base. The principal concern is that a mass failure in this area could undermine support for the crossing above, potentially affecting the ground underlying the crossing and posing a risk to its structural stability

At the top of the area, multiple sections of rock are assessed to be at risk of toppling failure. However, these are likely to occur independently of the potential wedge failure and are not currently considered an immediate threat to the crossing's structural integrity.

It is recommended that further assessment is undertaken to determine the stability of this area and a long-term management plan established, as, while not posing an immediate threat continued collapses may eventually propagate backwards affecting the crossing.
