Report for
Chief Pleas of Sark

Visual Inspection & Geotechnical Assessment

Creux/Maseline Harbour & La Coupée, Isle of Sark

Report No. 3265-01

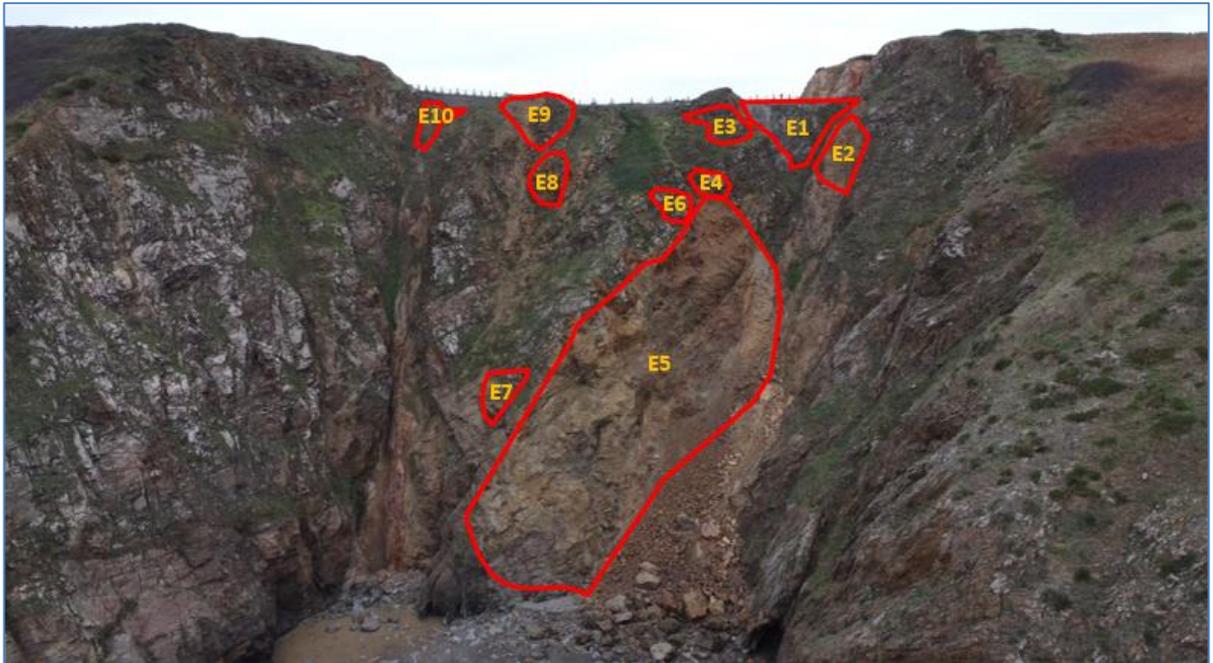
Figure 3 – East Face of La Coupée with Location Mark Up (E1-E10)

in **Figure 3**. These have not directly affected the crossing.

The rock is very blocky, crossed with several faults and fault zones. The regional dip of the foliation in the gneiss is present, however the resultant geological structure is very complex.

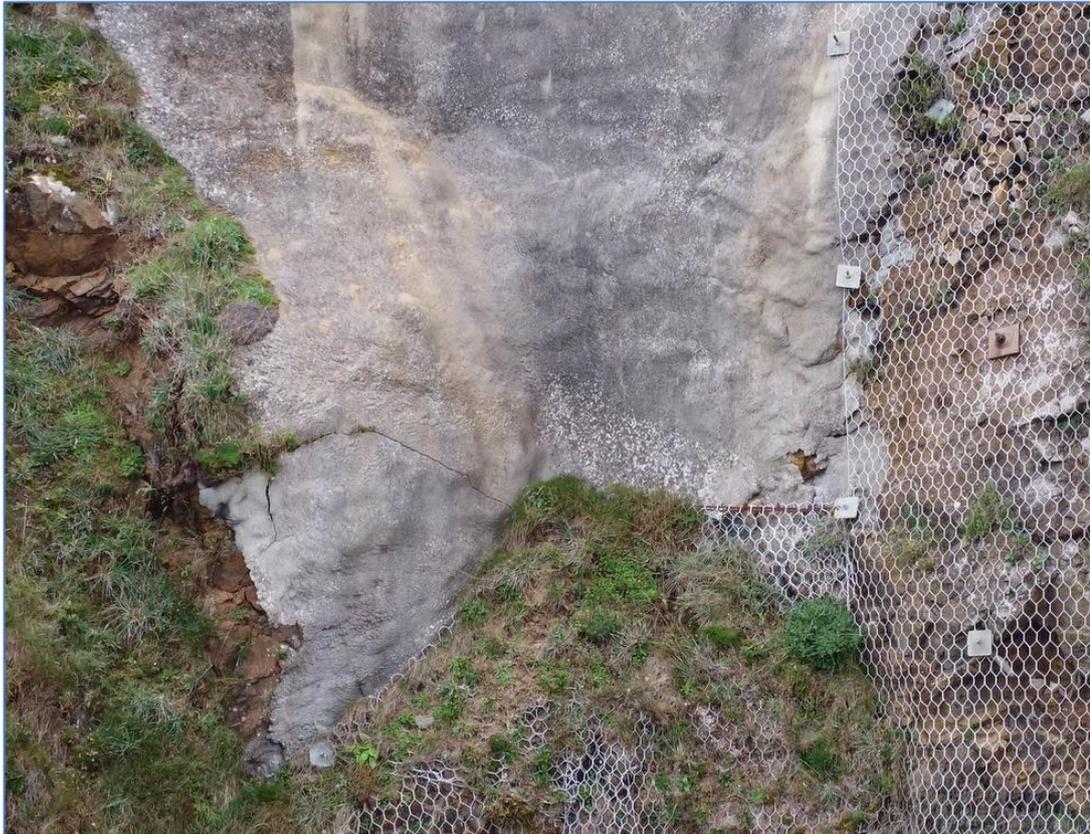
Area E1, situated directly beneath the roadway, a wedge of exposed rock of which the crossing is founded upon, has been previously stabilised in the late 1990s using a combination of rockfall netting and rock anchors/dowels. Additionally, a southern section appears to have been stabilised with shotcrete or similar, although the presence of underlying mesh or anchors/dowels is uncertain.

Generally, the stabilisation appears in adequate condition with some localised areas of corrosion evident on the wire ropes and grips. A minor rockfall has caused slight bulging in the netting and partially exposing anchors/dowels in the source area. The shotcrete area exhibits a crack across its lower portion, with a few minor cracks also being observed in other places. Where the larger crack is present, some minor vegetation growth was visible (see **Figure 4**)

No details on the stabilisation have been provided to Geomarine for review and comment. However, the system appears to be holding up well with minimal deterioration noted. Where the minor failure has occurred behind the rockfall netting, the netting appears to be functioning as is assumed to be intended by holding the fallen material in place.

Figure 4 – Close up of cracked shotcrete and several of the corroded element observed on the existing stabilisation

It is recommended a rope access inspection is undertaken in this area to inspect the overall condition of the stabilisation system and the structure above on the stabilisation works as well as on the upper structure to check the foundations and overall condition.

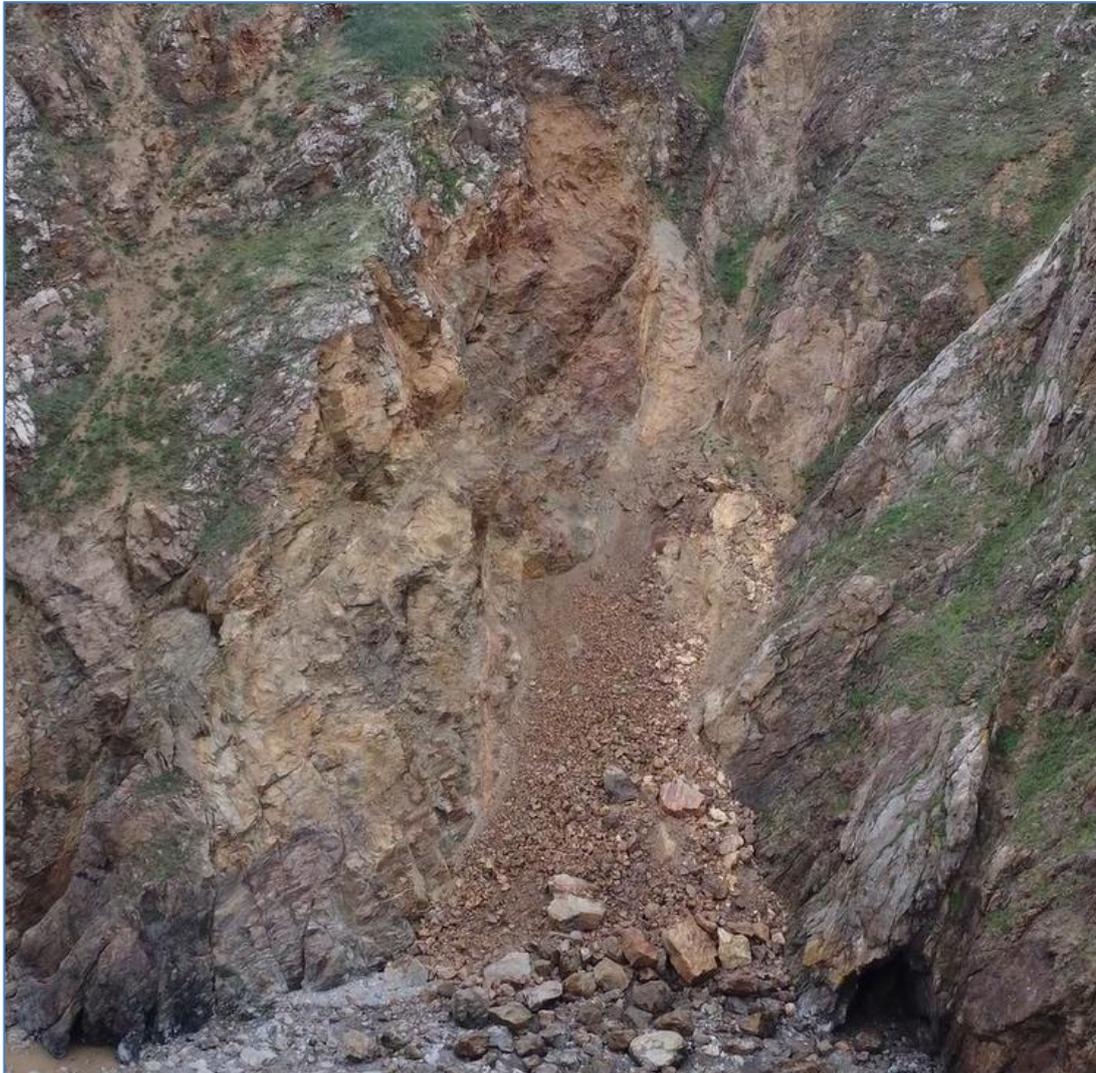
Figure 5 – Area 5

Areas E3, E4, E5, E6, E7 and E8 are considered at risk of small-scale blocky failure. These areas currently pose a relatively low risk to the structural integrity of La Coupée crossing, as any initial failures are unlikely to directly impact the crossing. However, subsequent failures may propagate/unravel backwards, eroding the rockface over time, potential compromising the structural integrity of the crossing in the future.

There is also a secondary risk to human health due to the potential falling material/debris to reach the beach below. As there is no pedestrian access to the beach the risk is considered to be low, however, there remains a small residual risk associated with access via boat.

Annual inspections are recommended to monitor the area's condition, establish erosion rates, and inform a long-term management plan to preserve La Coupée crossing

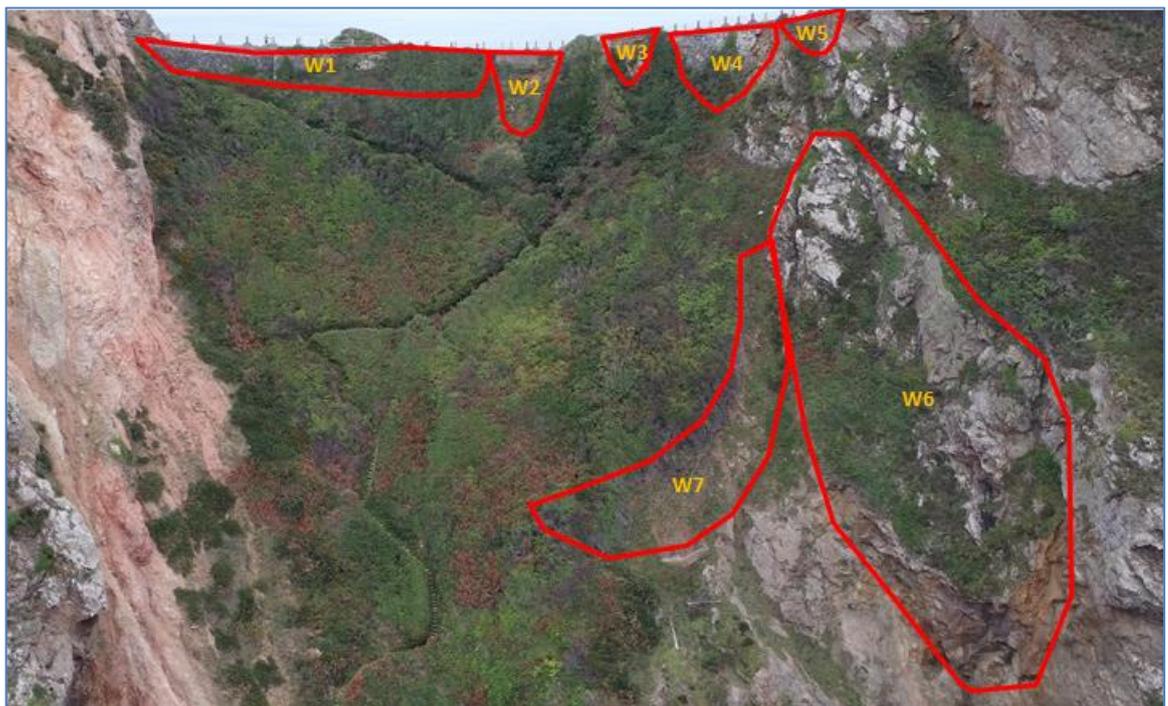
Figure 6 - West Face of La Coupée, with location mark up (W1-W7)

The west face has been divided into seven areas for the purpose of this assessment. See **Figure 6** for the location of each section. For photographs of each individual section please refer to **Appendix B**. This face is heavily vegetated with bracken, brambles, gorse and ivy. It appears that the rock is mantled with a layer of soil (perhaps wind-blown loess or periglacial head).

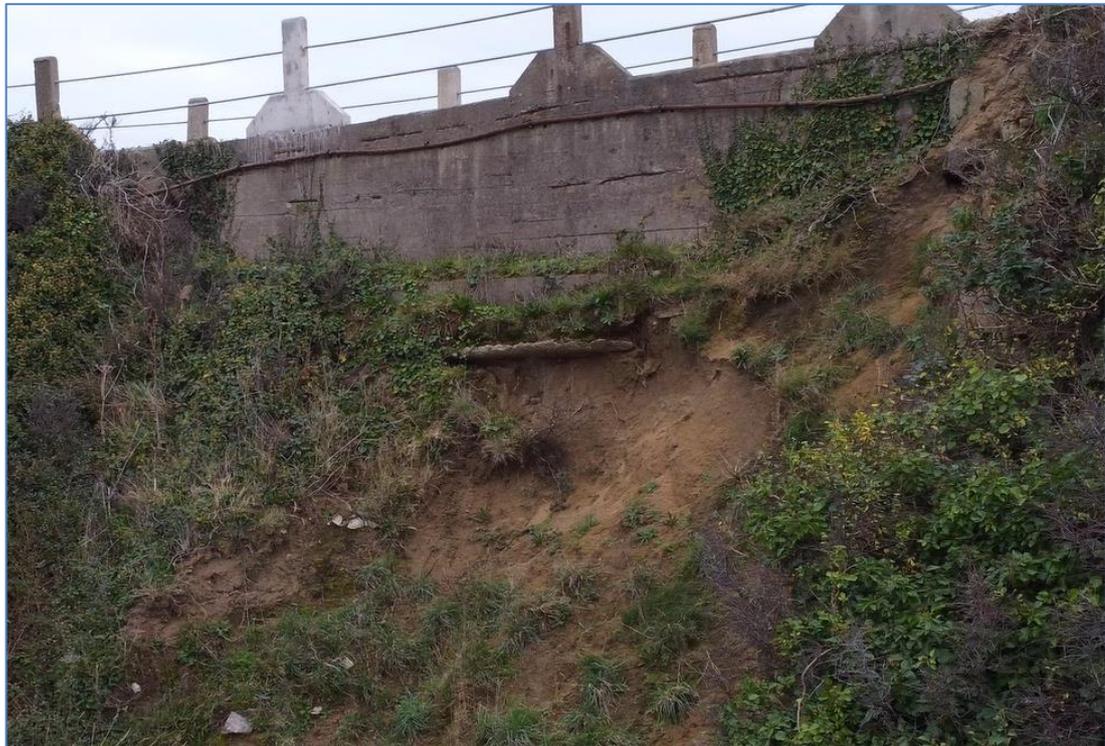
The inspection of Area W2, W3, W4, and W5, identified significant undermining and exposure of the foundation of the concrete structure. The foundation appears to rest on periglacial head deposits or similar unconsolidated materials, which are inherently less stable. This presents a critical concern for both public safety and the structural integrity of the crossing.

Evidence of fresh debris at on the rockface directly below indicates that failures are occurring regularly. These ongoing failures are likely to continue to undermine the foundation of the crossing, increasing the risk of a collapse of the wall retaining the road. The situation is exacerbated by the frequent passage of heavy agricultural plant over the crossing, which imposes additional dynamic loading.

Should a failure occur, the crossing would become unsafe for use, jeopardising access to Little Sark and potentially damaging the existing electricity supply infrastructure, which is essential for the island.

Figure 7 – Close up image of undermined section of La Coupée at Area W2

Urgent stabilisation and mitigation measures are strongly recommended to address these risks, likely to consist of a mix of rock dowels, soil nails, netting, shotcrete and potentially rebuilding of part of the walls

We recommend that a monitoring regime is started without delay, until repairs are undertaken. This should be visual inspection on a weekly basis to check for changes and during times for heavy rainfall, strong winds. Consideration should be given to advising users of the crossing of the risks. Metal road plates can be placed over the areas of concern to spread the loads of passing vehicles.

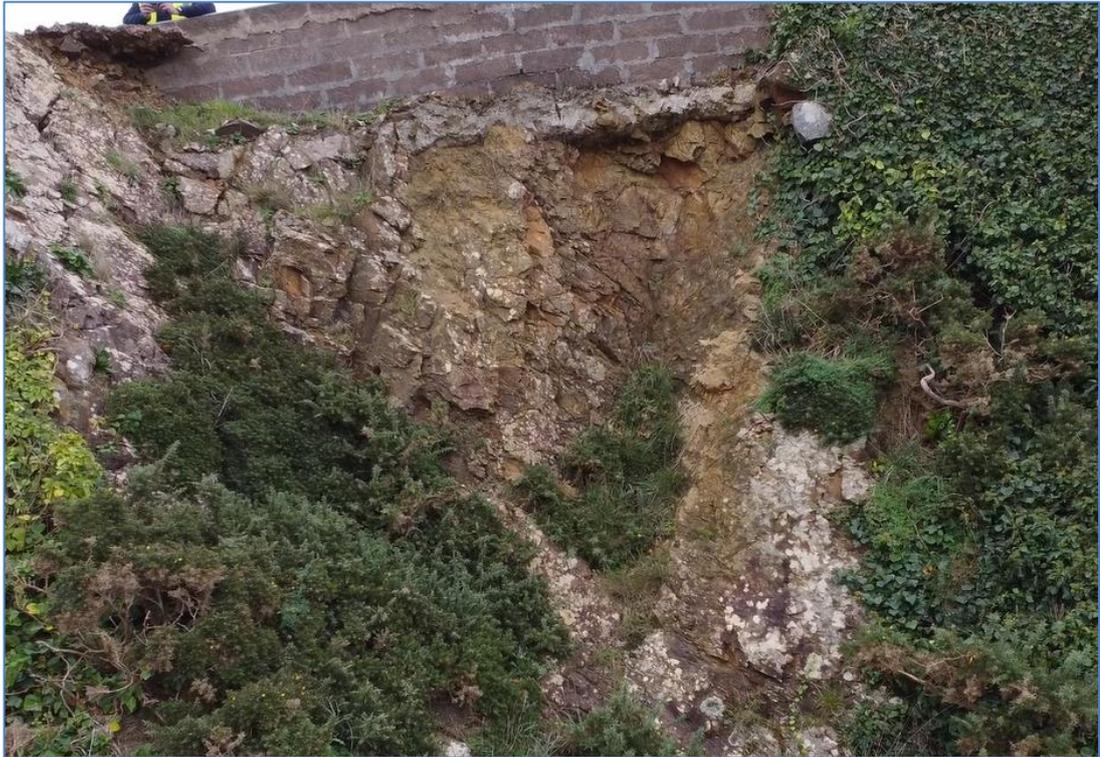
Figure 8 – Close up image of undermined section of La Coupée at Area W3

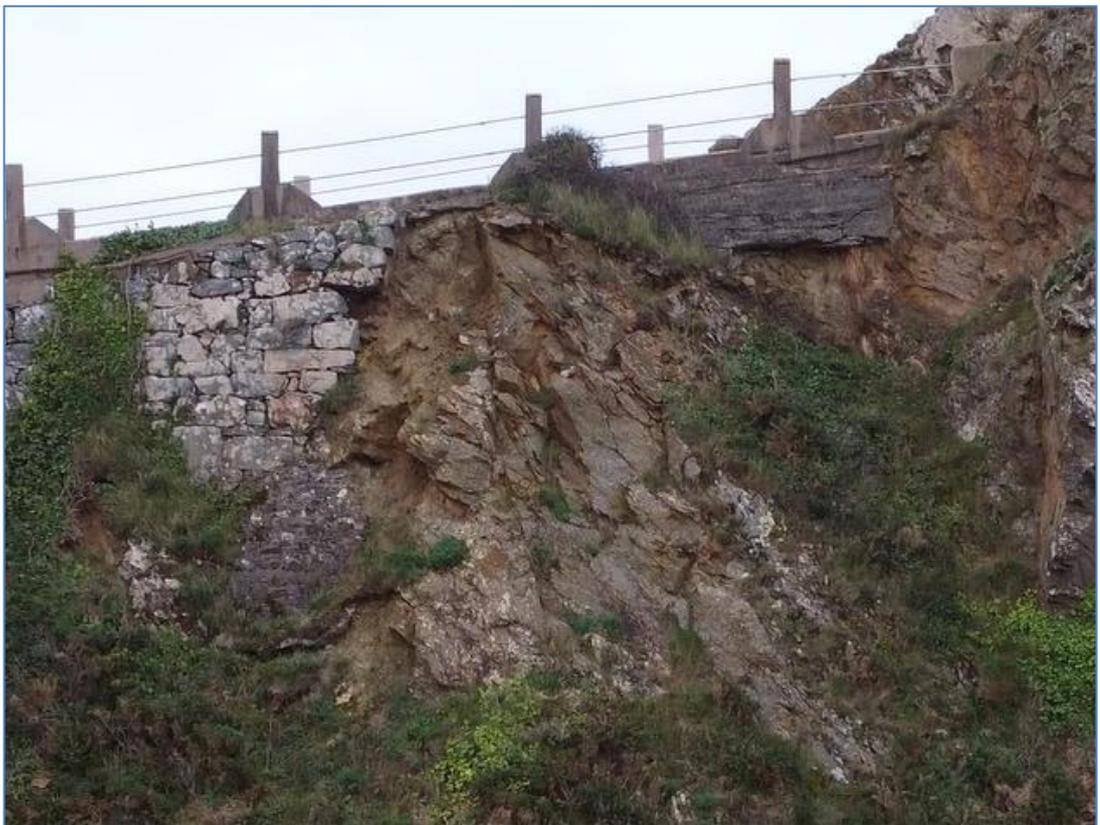
Figure 9 – Close up image of undermined section of La Coupée at Area W5

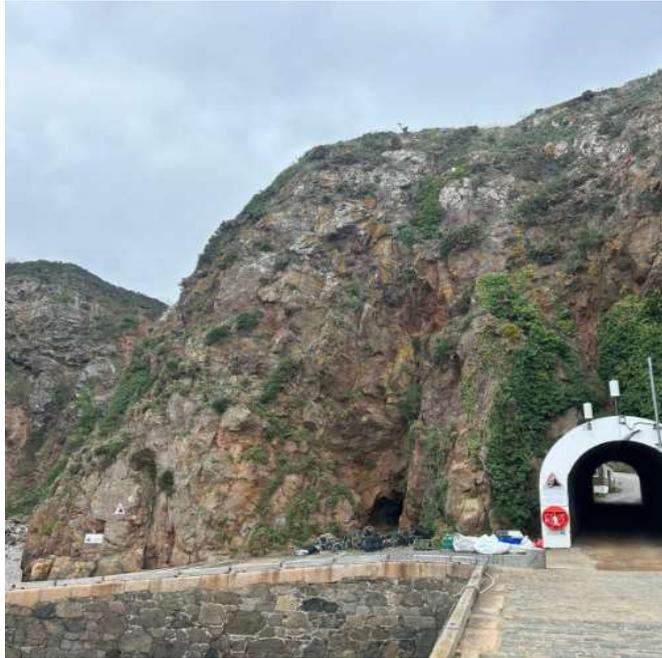
H4:

H4 & H5	Slipway and tunnel entrance into Creux Harbour	Rock faces above slipway and around tunnel entrance. Area at the top of the slip used for storage of lobster pots	Risk of rockfall from the cliffs onto persons using the slipway and tunnel	Install signs warning the public of the danger or rockfall and advising not to sit under the cliffs. Ongoing monitoring and inspections Fence off storage area to restrict access
H6	Storage areas at Creux Harbour	Rock faces above storage area and sheds used by fishermen	Rock falls have damaged sheds and equipment in this area and there is an ongoing risk of further rockfall	Undertake rockfall assessment, install rock catch fence and buffer zone at the base of the cliff and move all storage units outside the buffer zone.
H7	Norther tunnel entrance to Creux Harbour	Rock faces around the main (lined) tunnel to Creux Harbour.	Minor rock falls from the upper part of the slope directly above and around the entrance	Installation of rock fall netting to prevent rockfall

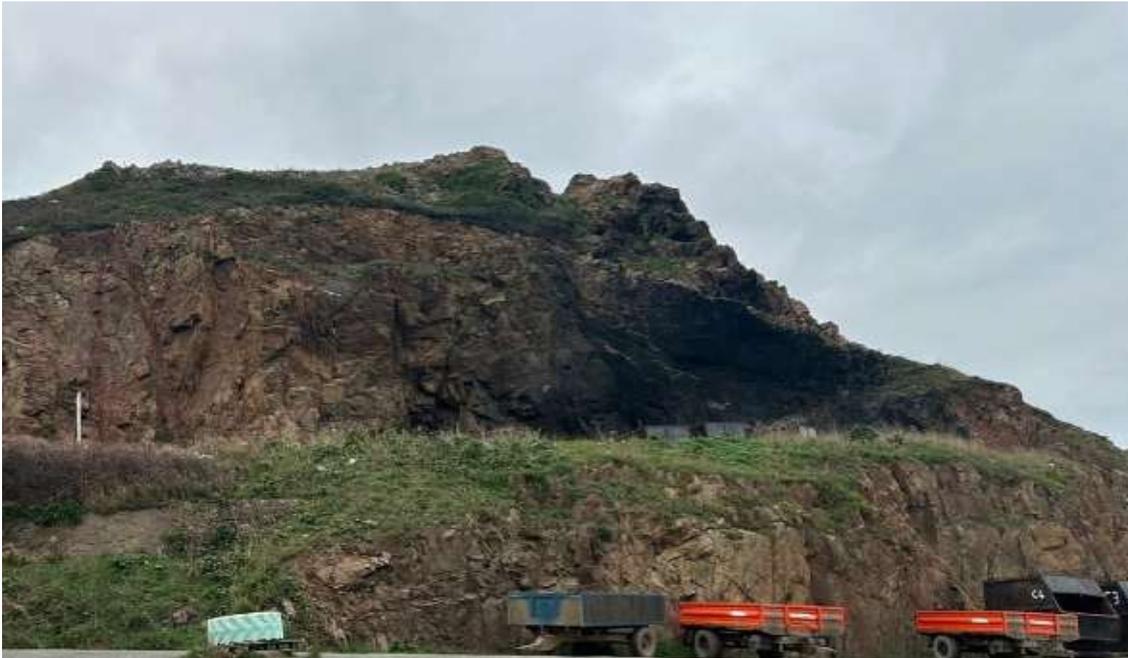
H9:

It should be noted that the invasive species of plant Sour Fig (Binomial name: *Carpobrotus Edulis*) was observed on the grass to the south of **Area H9**.

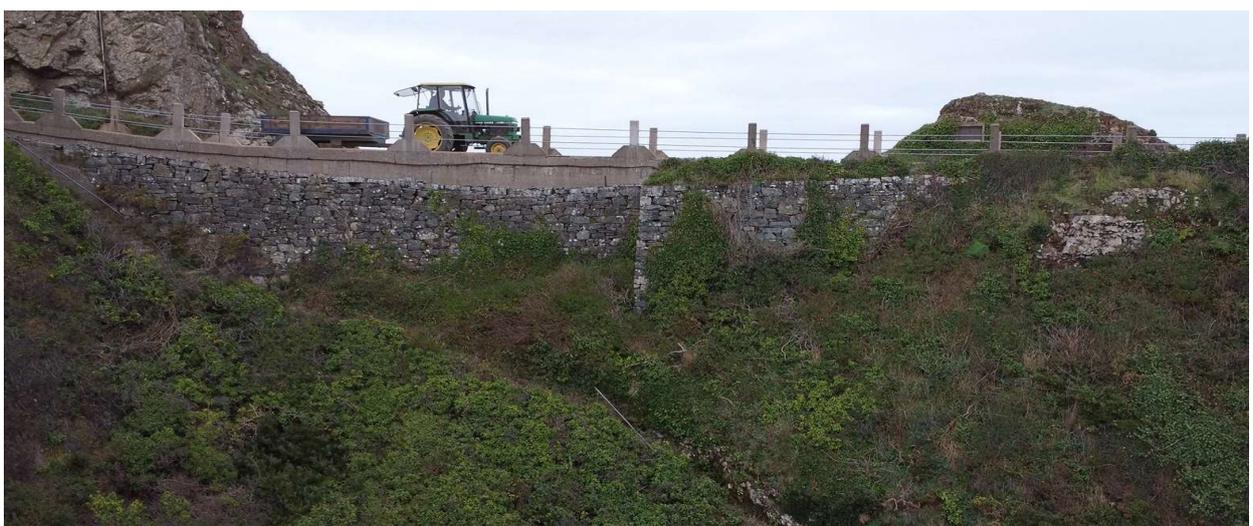
W1:

Area W1 consists of a blockwork wall under the above concrete structure of La Coupée crossing. The blockwork wall here appears generally to be in good condition with no evidence of failures directly beneath. However, much of the lower parts of the wall is obscured by vegetation.

It is recommended that de-vegetation works are undertaken so that the wall can be fully inspected. Additionally, it is recommended that a structural engineer inspects the structure of the crossing and walls below.

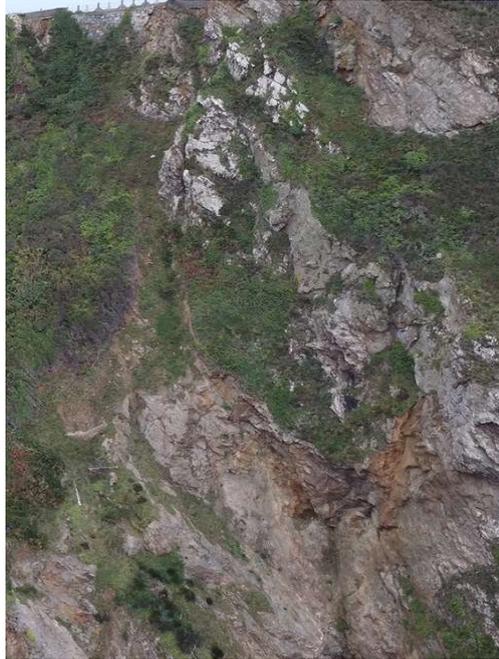
W6:

Area W6 contains a large volume of rock that appears to be at risk of wedge failure. Observations suggest that the rock is raveling upwards from the base. The principal concern is that a mass failure in this area could undermine support for the crossing above, potentially affecting the ground underlying the crossing and posing a risk to its structural stability

At the top of the area, multiple sections of rock are assessed to be at risk of toppling failure. However, these are likely to occur independently of the potential wedge failure and are not currently considered an immediate threat to the crossing's structural integrity.

It is recommended that further assessment is undertaken to determine the stability of this area and a long-term management plan established, as, while not posing an immediate threat continued collapses may eventually propagate backwards affecting the crossing.

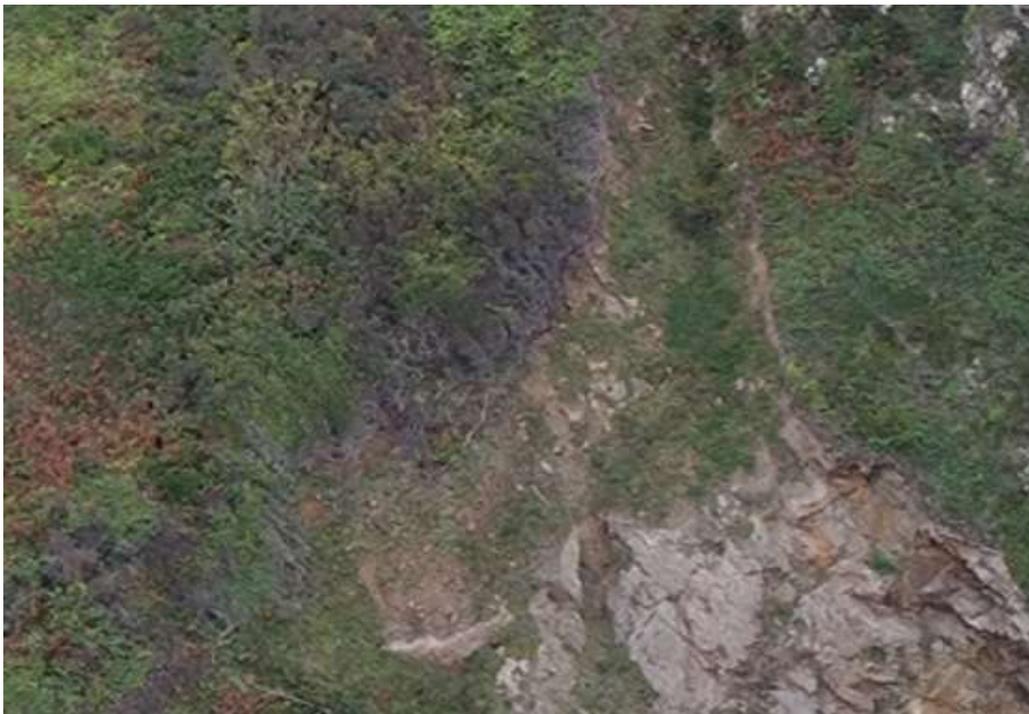
W7:

This area has been identified as exhibiting signs of slope failure, with the slope seemingly exceeding its safe angle of repose and undergoing slump failure. Given that the coastal path is currently closed, this failure does not pose a low threat to human health. Structurally, the failure is occurring at a sufficient distance from the foundations of La Coupée crossing, and thus, it is not currently considered a threat to the crossing's structural integrity.
