GENSER-FORMAN INC.

TRIUMPH DISTRIBUTORS

BULLETIN #T-60-7
DATE: FEBRUARY 23, 1960
SUBJECT: TR-3 REAR AXLE CROSS PIN
PART NO. 100844 EFFECTIVE FROM
COMMISSION NO. TS-56886 TO
TS-59204

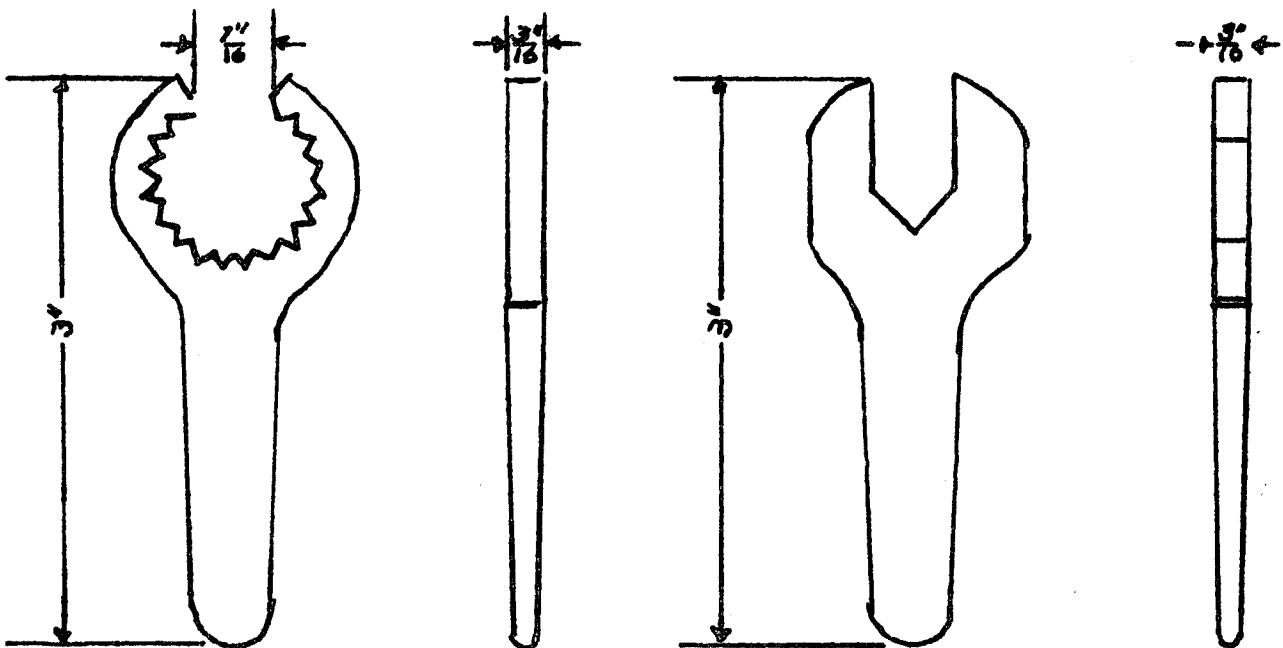
Correct adjustment is $.080$ " clearance between the clutch slave cylinder push rod nuts and the abutment bracket. This adjustment is scheduled in the Maintenance Voucher Book for checking at pre-delivery, 500 mile free service and at each subsequent 3,000 mile service period.

The right hand is used to insert the flare nut wrench between the chassis member and the exhaust pipe and pass over the push rod on to the lock nut. The open ended wrench is used in the left hand to engage the adjusting nut, and this is done by inserting the wrench between the left hand foot well and chassis frame.

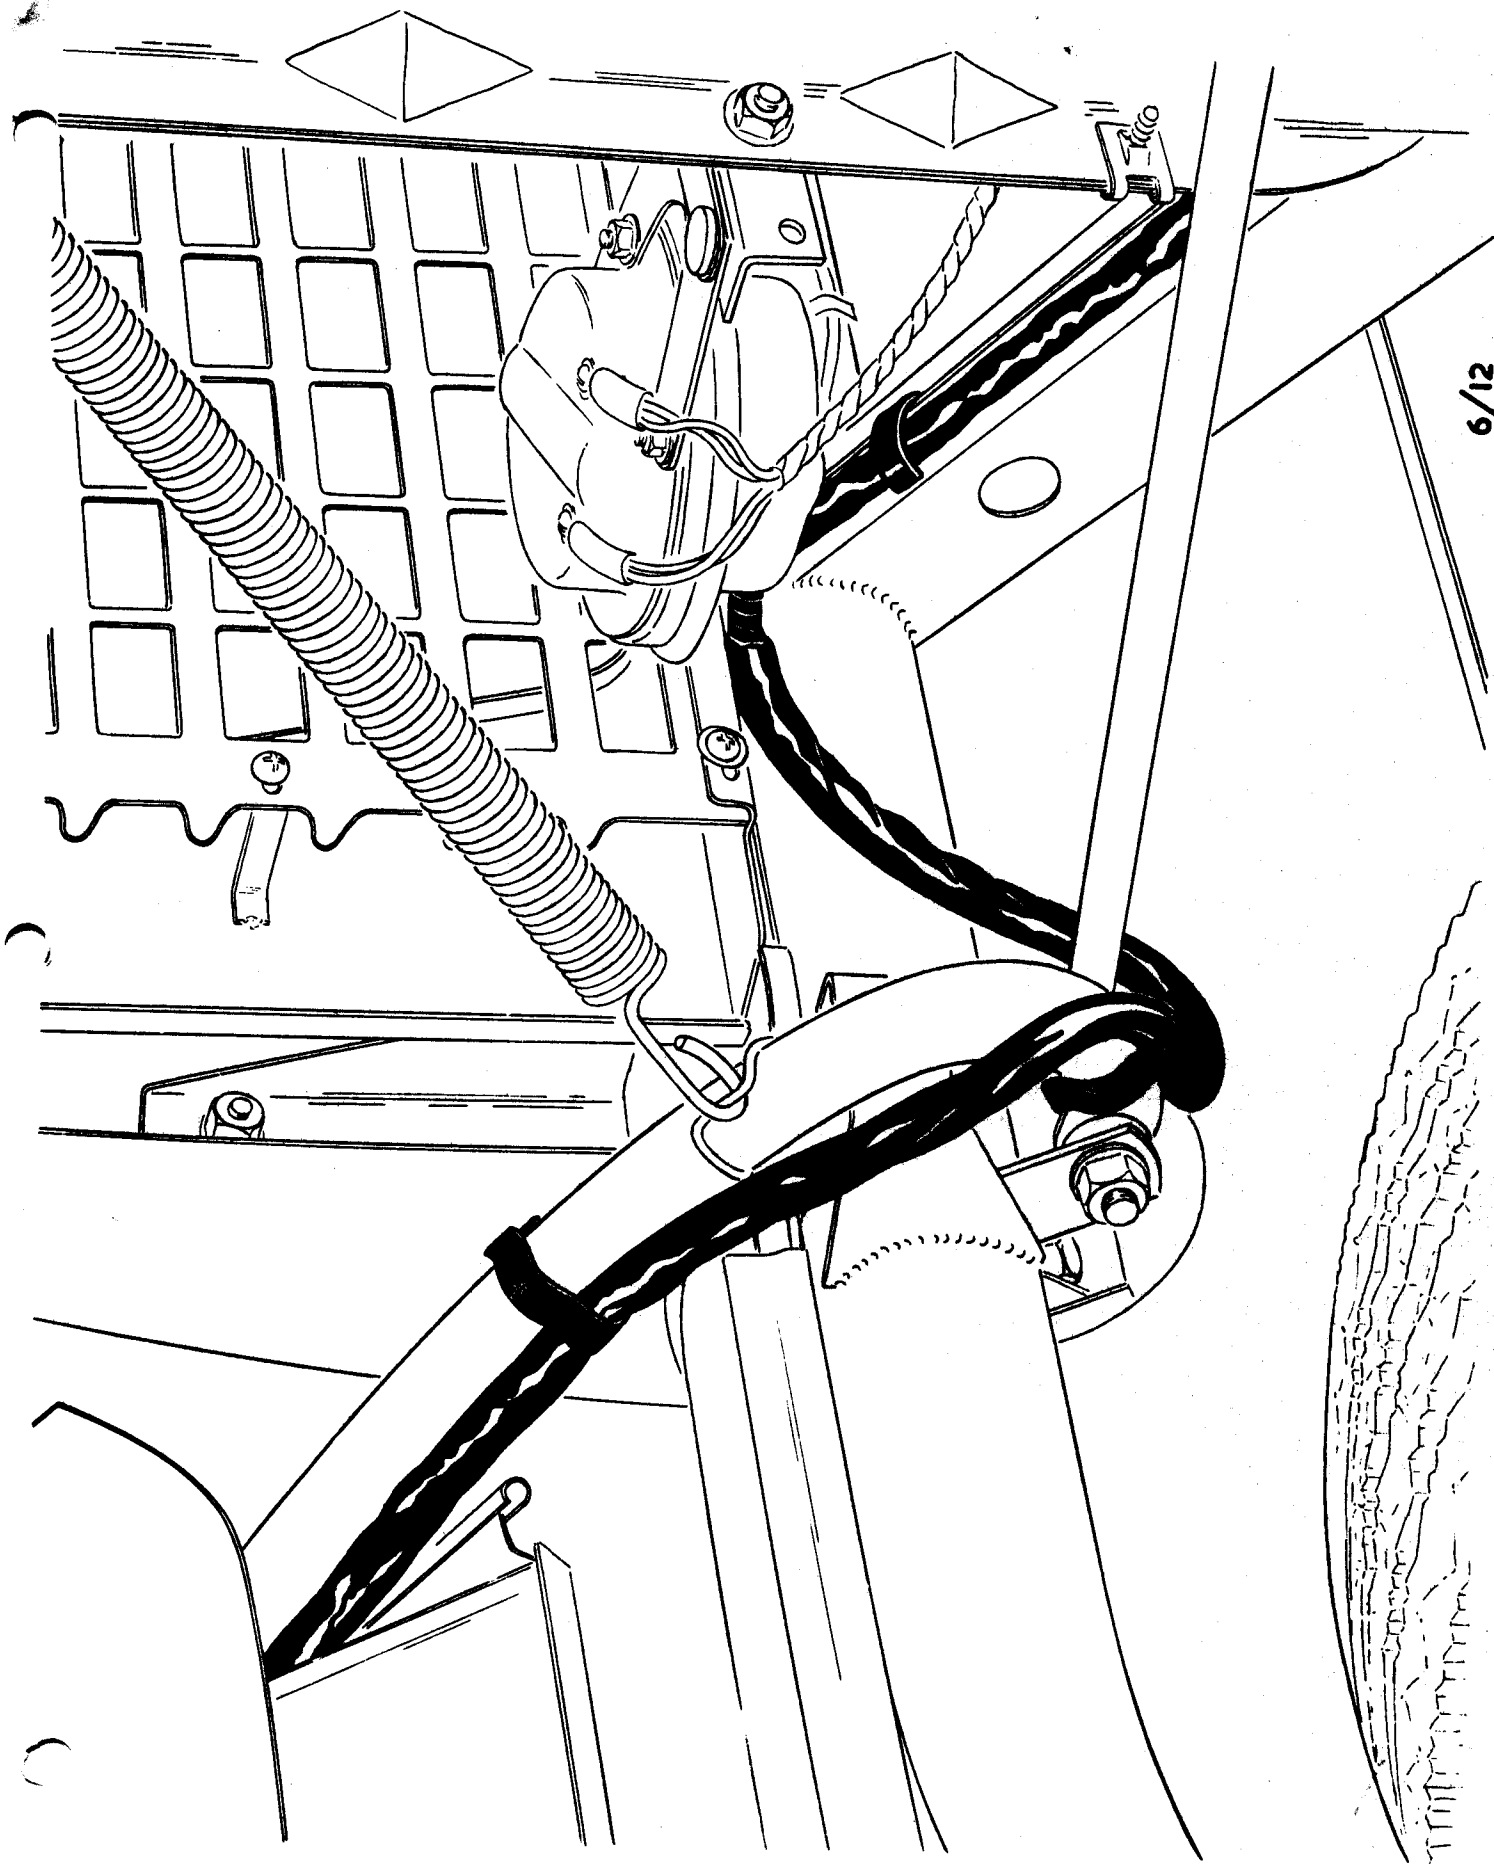
TRIUMPH HERALD WIRING LOOM POSITIONING

Positioning the cable harness on the inside of the tubular hinge member near the bonnet spring has caused, in a few instances, excessive chafing of the cable, resulting in some harnesses having been burned out.

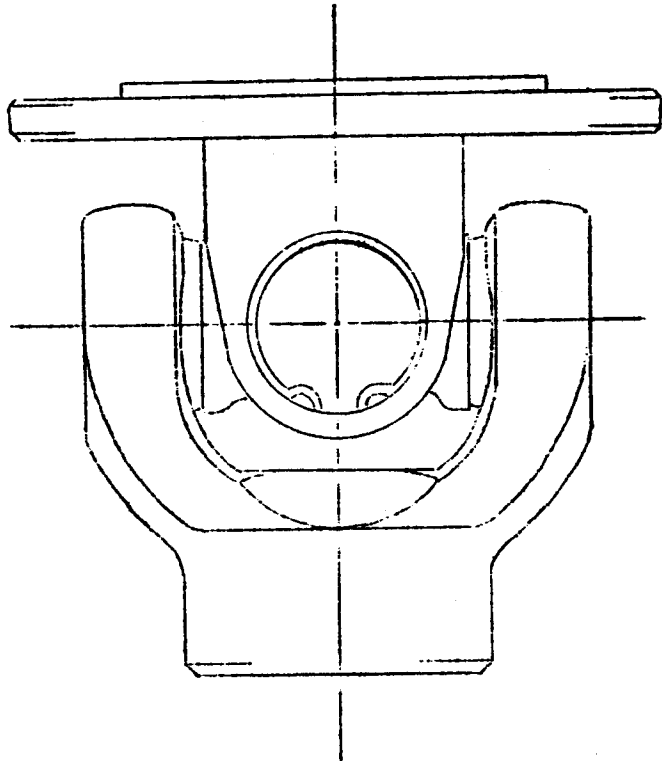
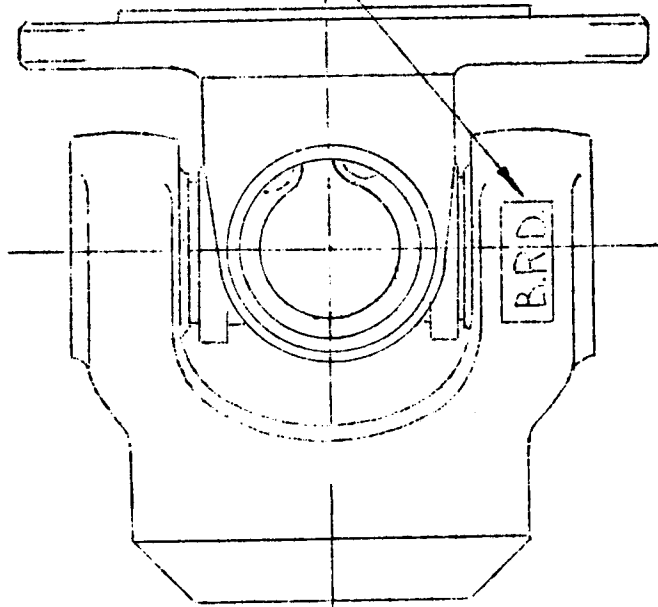
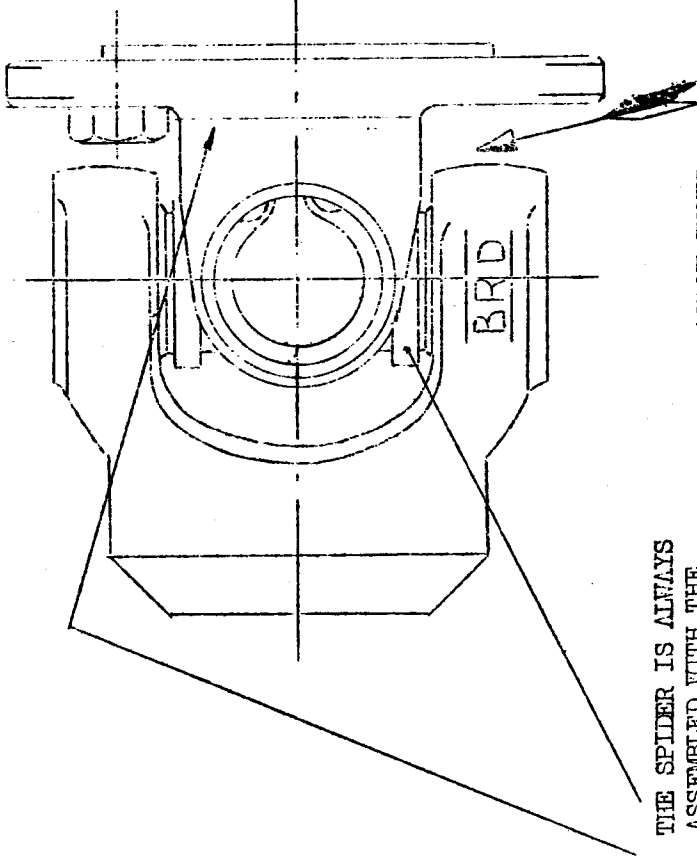
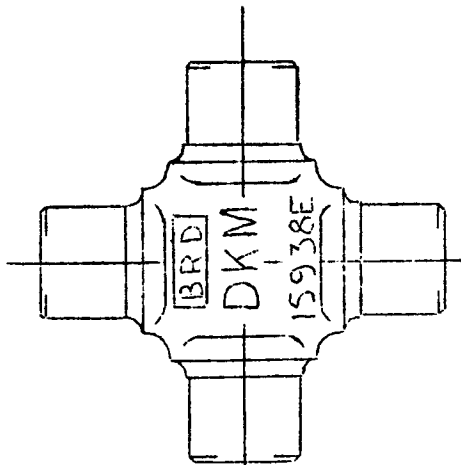
IDENTIFICATION OF B.R.D. U/Js ON 'HERALD'
OUTER AXLE SHAFTS

There will then be the possibility of a suspect universal joint spider being fitted and, as it is the spider that can fail, the following closer inspection must be given to observe whether the spider is stamped in the position shown on the attached drawing with the letters DKM. -

THE 'CAST SYMBOL' ON THE DEFECTIVE COMPONENT IS 'D.K.M.' AS SHOWN.

THE SPIDER IS ALWAYS
ASSEMBLED WITH THE
CAST SYMBOL FACING
THE FLANGE.

THE DEFECTIVE COMPONENT

i.e. THE SPIDER

- a. Remove the brake drum.
- b. Detach the hub cap, slacken and remove the hub nut and, using Churchill Extractor #S 109, draw the hub from the axle shaft.
- c. Replace the axle shaft complete and reassemble.

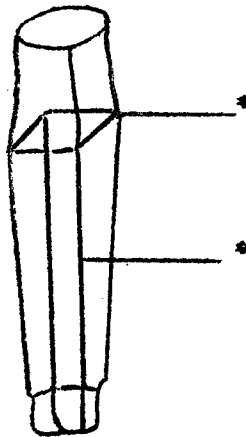
It has come to our attention that it is difficult to fit the Budget Lock Key to the Spare Wheel Lid.

In order to overcome this problem, it will be necessary to grind each edge of the key as indicated in the diagram.

* Grind off 1/16" of 4 corners as indicated.
