Starting a Drone Program

Steven Wolf,
GIS Specialist
Rochester Public Utilities

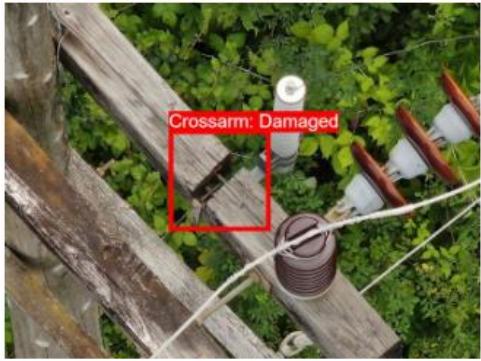
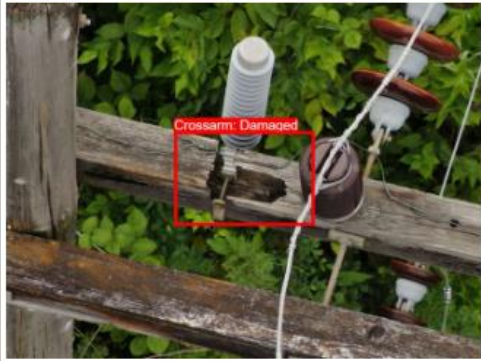
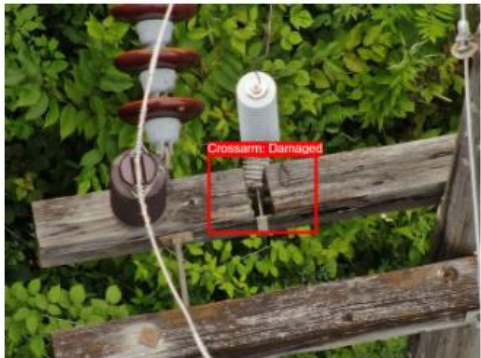
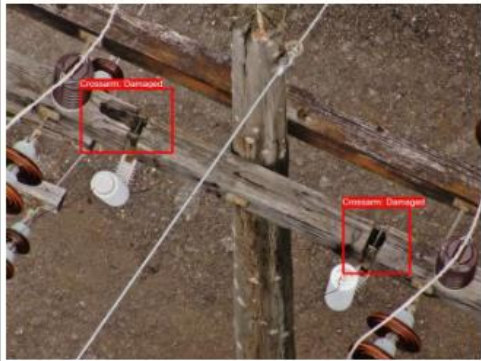
34.5kV Hydro Line			
TOWER NAME	24191	TOWER TYPE	Wood
INSPECTION DATE	22/07/2021	COORDINATE	44.2130182777778,-92.480973
TIME	04:36	AMBIENT TEMPERATURE	21.00 °C
HUMIDITY	55%	WEATHER	Partially cloudy
VISUAL INSPECTION	Distribution		
	-		
CROSSARM		DAMAGED	
VISUAL IMAGE

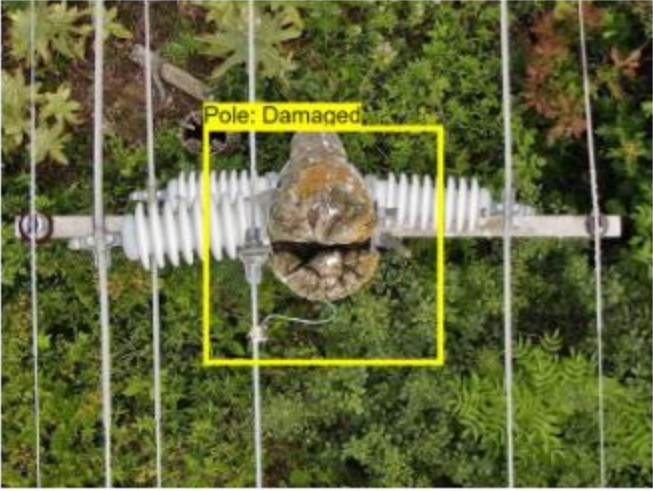
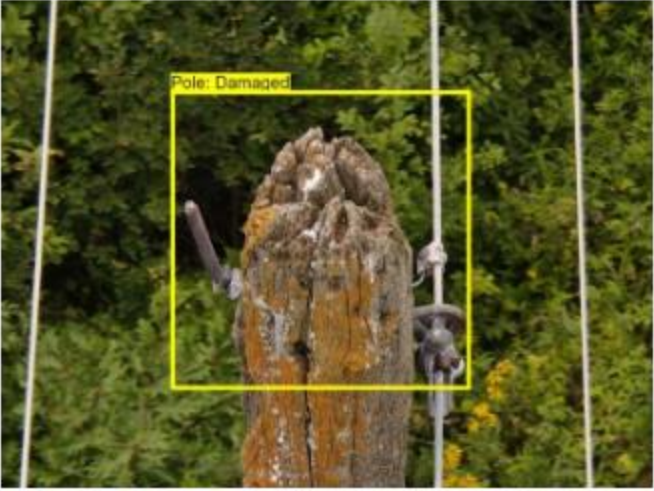
34.5kV Hydro Line			
TOWER NAME	24192	TOWER TYPE	Wood
INSPECTION DATE	22/07/2021	COORDINATE	44.2130229722222,-92.4815684722222
TIME	04:34	AMBIENT TEMPERATURE	21.00 °C
HUMIDITY	55%	WEATHER	Partially cloudy
VISUAL INSPECTION	Distribution		
	-		
POLE		DAMAGED	
VISUAL IMAGE

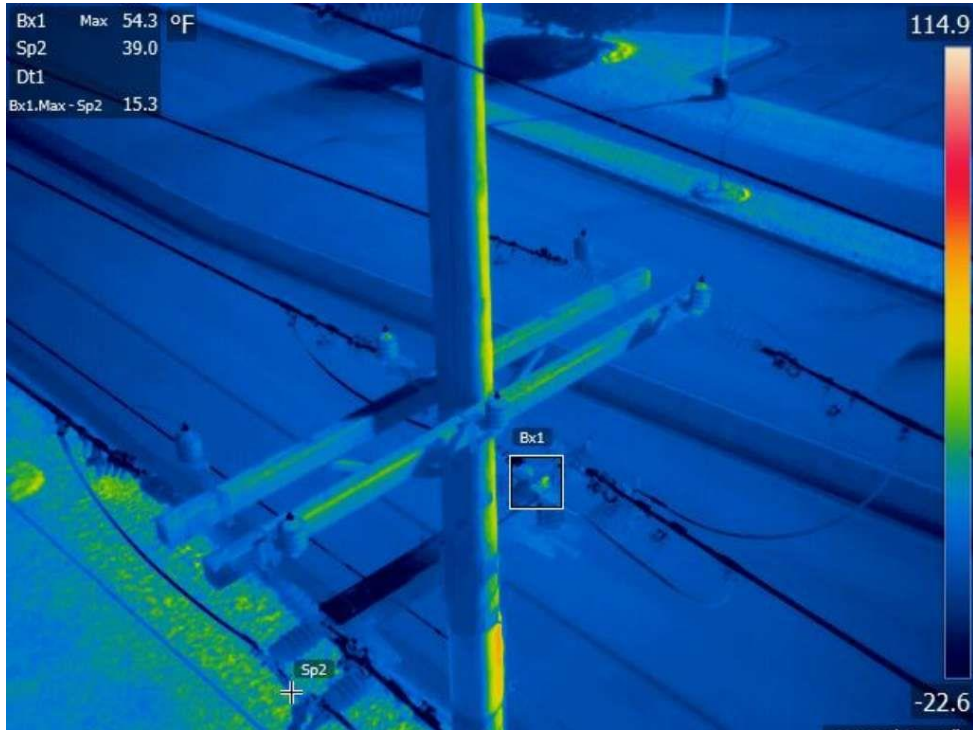
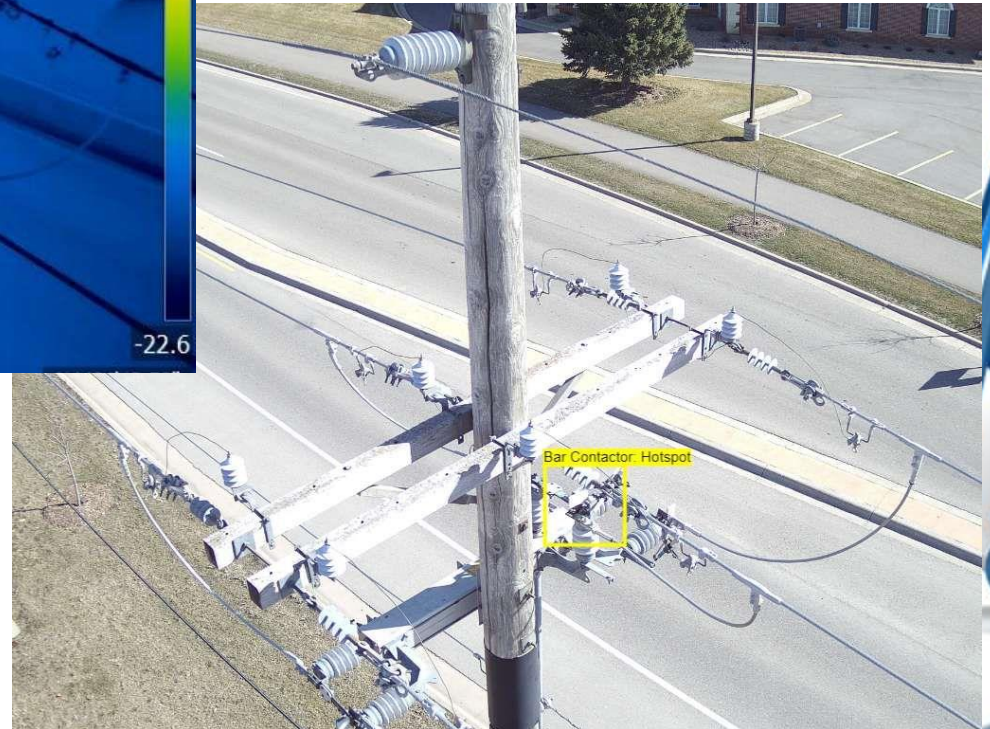
CONDITION BASED MONITORING (CBM)				 	 								
34.5kV Hydro Line													
TOWER NAME	23554	TOWER TYPE	Wood										
INSPECTION DATE	01/04/2021	COORDINATE	44.0787686388889, -92.4889218333333										
TIME	11:11	AMBIENT TEMPERATURE	-1.00 °C										
HUMIDITY	39%	WEATHER	Partially cloudy										
THERMAL INSPECTION	Distribution												
	-												
BAR CONTACTOR		FORMULA	$\Delta = \text{Max temp} - \text{Min temp}$										
THERMAL IMAGE

<table border="1"> <thead> <tr> <th colspan="2">MEASUREMENTS</th> </tr> </thead> <tbody> <tr> <td>SPOT 1 / BX 1</td> <td>12.39 °C</td> </tr> <tr> <td>SPOT 2 / BX 2</td> <td>3.9 °C</td> </tr> <tr> <td>DELTA (Δ)</td> <td>8.5 °C</td> </tr> </tbody> </table>						MEASUREMENTS		SPOT 1 / BX 1	12.39 °C	SPOT 2 / BX 2	3.9 °C	DELTA (Δ)	8.5 °C
MEASUREMENTS													
SPOT 1 / BX 1	12.39 °C												
SPOT 2 / BX 2	3.9 °C												
DELTA (Δ)	8.5 °C												
<table border="1"> <thead> <tr> <th>SEVERITY</th> <th>MONITOR</th> <th>MINOR</th> <th>CRITICAL</th> </tr> </thead> <tbody> <tr> <td>ΔT</td> <td>7.2 - 14.4</td> <td>14.5 - 27.0</td> <td>> 27.0</td> </tr> </tbody> </table>						SEVERITY	MONITOR	MINOR	CRITICAL	ΔT	7.2 - 14.4	14.5 - 27.0	> 27.0
SEVERITY	MONITOR	MINOR	CRITICAL										
ΔT	7.2 - 14.4	14.5 - 27.0	> 27.0										
THERMAL ANALYSIS													
Abnormal Hotspot (ΔT : 15.3°C) detected at the unknown phase bar contactor connection area. (It might due to current leakage and aging e.g. wear and tear, e.g. poor connection, overtighten / loose contact issue).

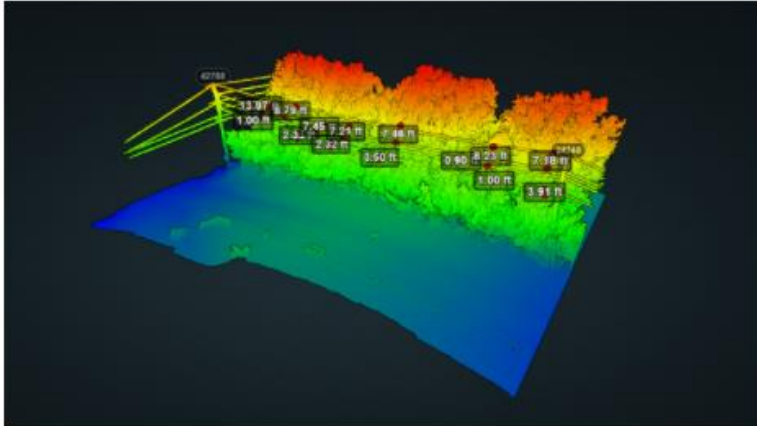
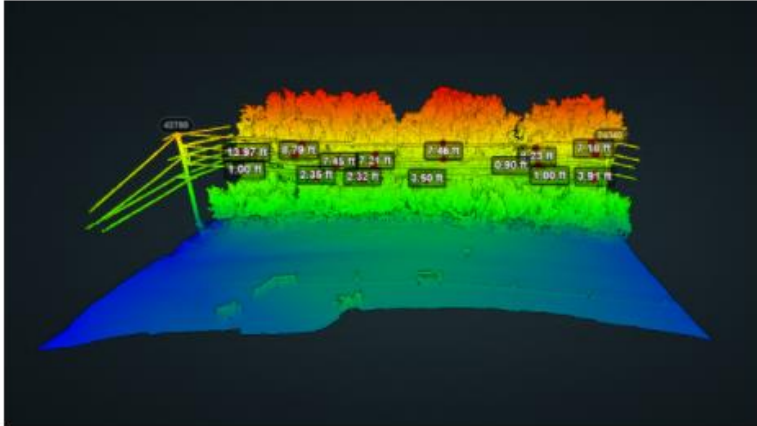
34.5kV Hydro Line			
TOWER NAME	24340	FEEDER	34.5kV Hydro Line
COORDINATE	540817.438,4893201.06	INSPECTION DATE	01/04/2021
LIDAR SPAN	24340- 42788		
OVERALL SEVERITY	Critical	DISTANCE	0.90 feet
DATA CLASSIFICATION - OVERALL TREE CLEARANCE
