PILOT LADDER SAFETY - LESSONS LEARNT FROM INCIDENTS WHERE EQUIPMENT FAILURE WAS DEEMED TO HAVE PLAYED A PART.

This Marine Alert provides an overview of lessons learnt from recent incidents when persons fell from a pilot ladder into water during Pilot boarding, Pilot disembarking and crew change operations, where equipment failure and lack of maintenance was partly to blame.

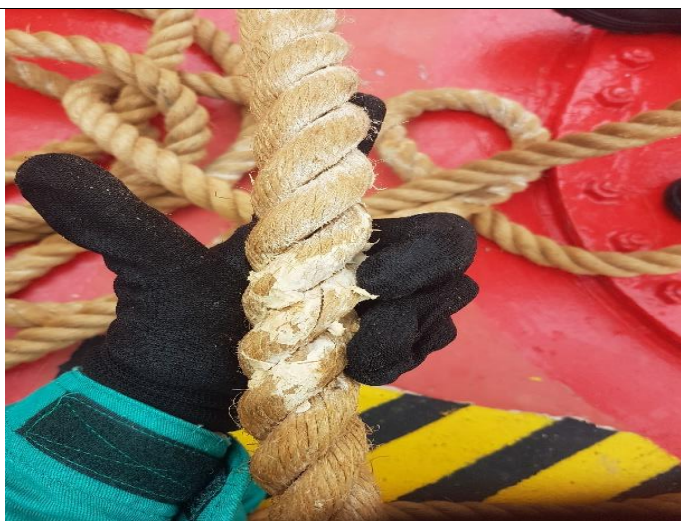
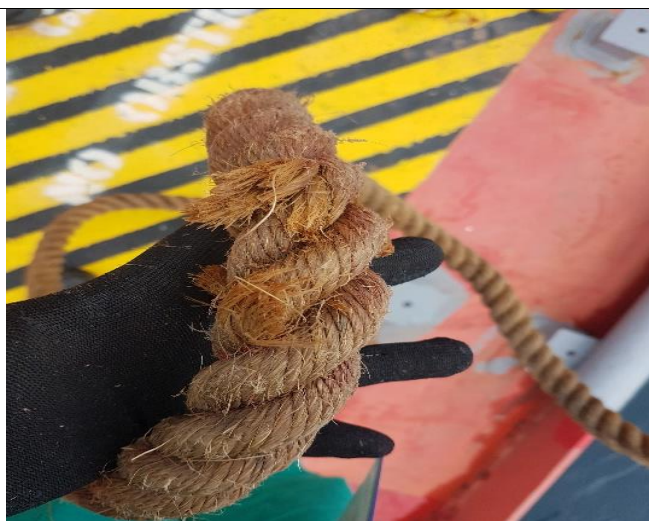
Incident 1: Occurred on a vessel leaving the Port of Durban on 28 April 2020.

Upon confirmation from the Master of the vessel that the pilot ladder was rigged, the Pilot proceeded down to the ladder. Pilot then climbed down the ladder prior to the launch coming alongside. While the Pilot was climbing down, one of the MAN ROPES parted which resulted in the Pilot losing his balance on the ladder and subsequently falling into the water.

Upon investigation it was found that the ladder had a white chemical residue on it. It is suspected that this residue might have contributed to the deterioration of the rope and eventual parting. It was also found that the on board records of inspection indicated that the ropes were in good condition.

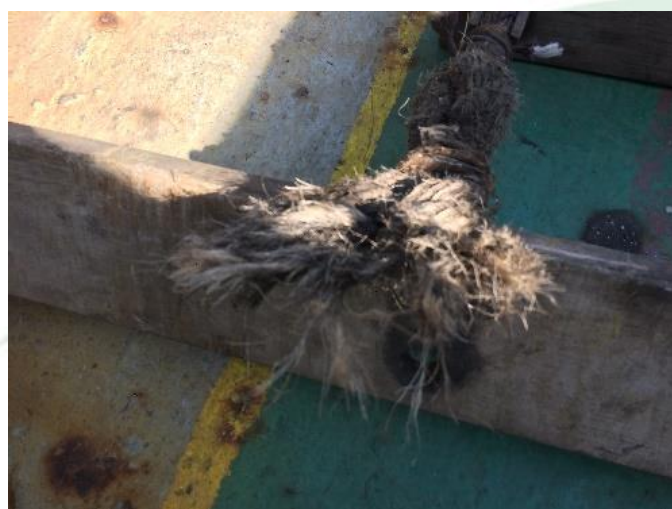
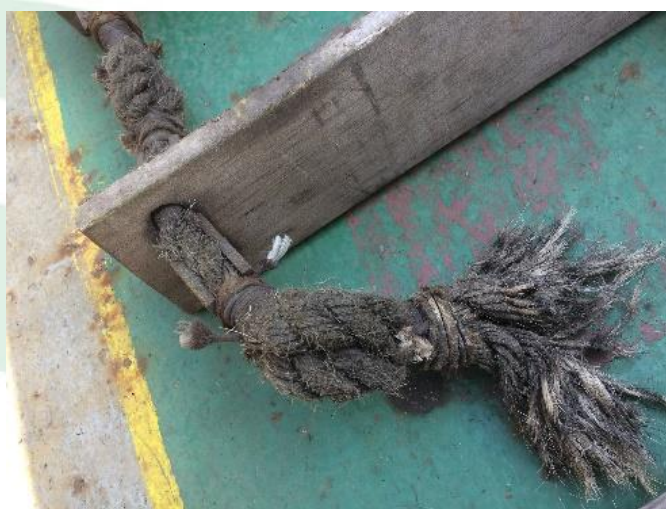
Incident 2: Occurred on a vessel in the approached to Durban harbour on 16 September 2020.

The pilot ladder parted causing the pilot fall onto the deck of pilot boat.

Investigation outcome found that vessels maintenance plan and purchasing system showed the ladder was deemed not fit for use in their monthly inspection and a new pilot ladder was purchased and was to be received in Durban. It appears that the cause on the incident was the fact that the vessel did not take the defective pilot ladder out of service and failed to ensure the ladder was fit for use.

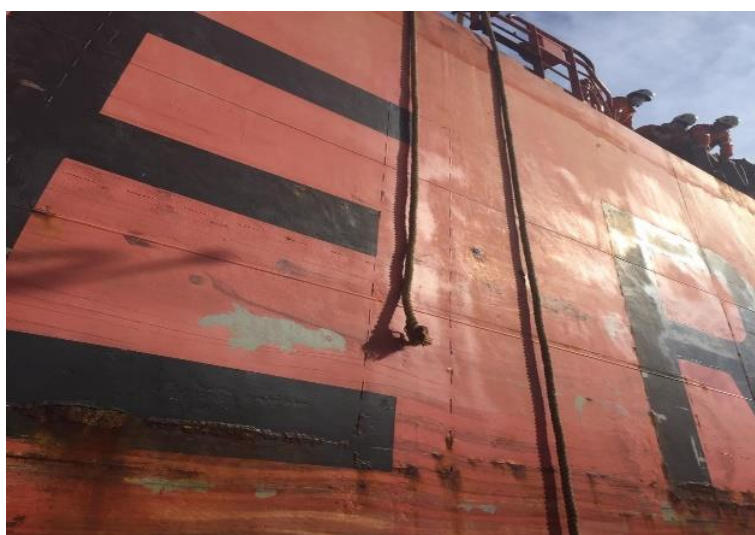
Incident 3: Occurred on a vessel in the approached to Durban harbour on 26 October 2020

One MAN ROPE parted resulting in a pilot falling onto the pilot boat deck while disembarking at the pilot station. The Pilot was taken to the hospital.

During the Investigation it became apparent that there was no MAN ROPE specific maintenance required in the ship maintenance system. It was assumed that the person doing maintenance on a pilot ladder will also inspect the man ropes.

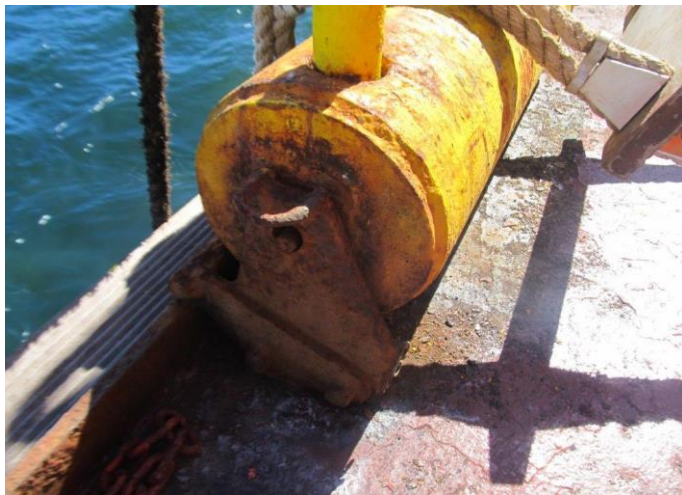
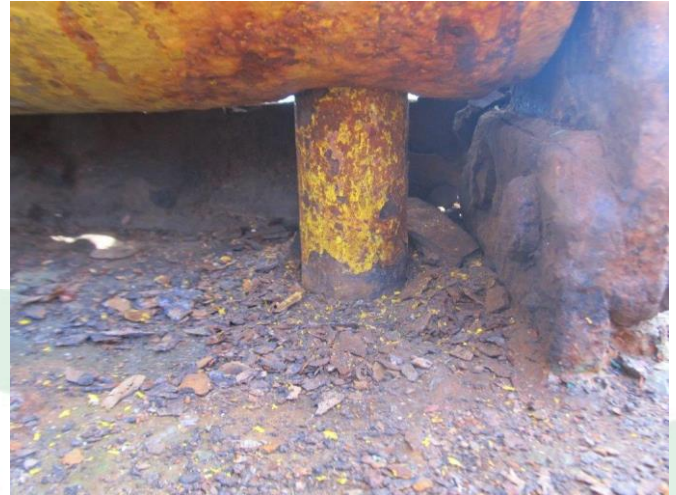
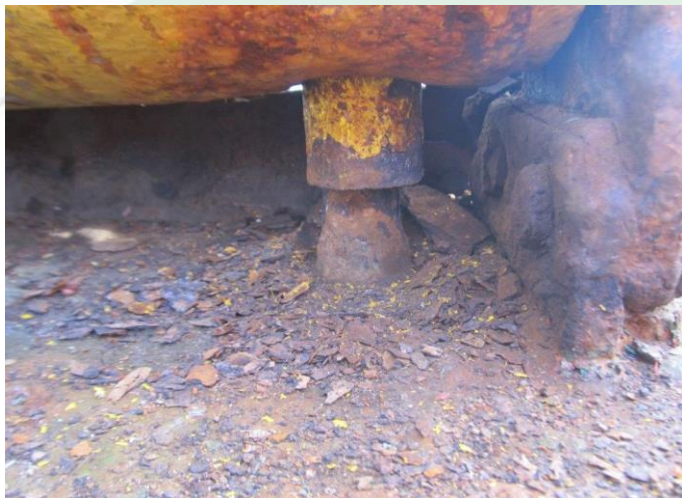
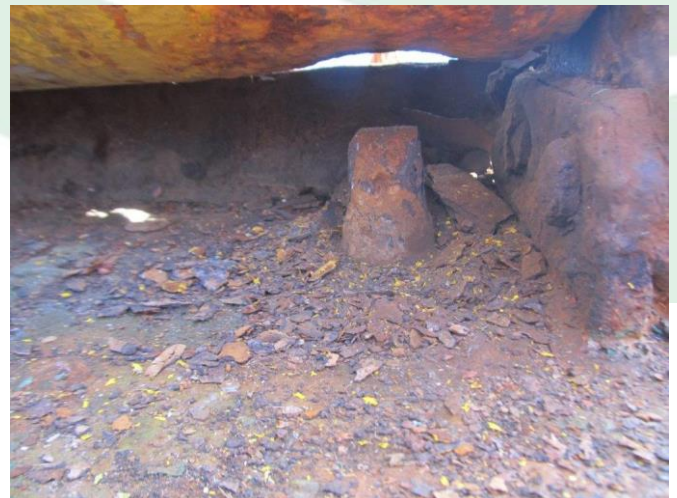
Incident 4: Occurred on a vessel at anchor in Algoa Bay at number 2 anchorage on 21 November 2020.

1. a) The stanchions initially appeared to be very securely located in a deck mounted roller of 200mm in diameter.
b) On closer investigation it was found that the lower part of the stanchions was not secured but were held in place by merely fitting it over a horn welded to the deck.

c) Due to apparent lack of maintenance of the horn below the deck mounted roller, corrosion had caused the horn to reduce in thickness making for a loose fit inside the stanchion.

2. a) The 4th crew member was reportedly nervous of the climb down the ladder. Witnesses to the incident stated that his body stiffened up when he stepped onto the ladder before he started his climb down the ladder. It appears that this stiffing up of his body might have caused him to pull the stanchions right out of the securing horns. This in turn caused the roller with the stanchions to rotate 90 degrees towards him causing him to lose his balance and falling backwards into the water.
