## Home Integrity Home Inspection

## Home Inspection Report

**123 Main Street**

**Anywhere, OH 44123**

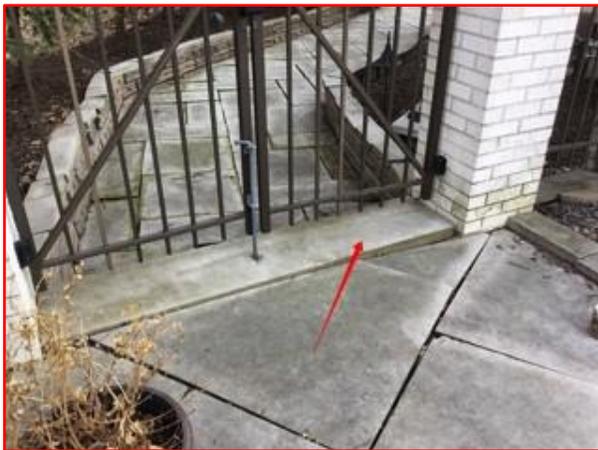
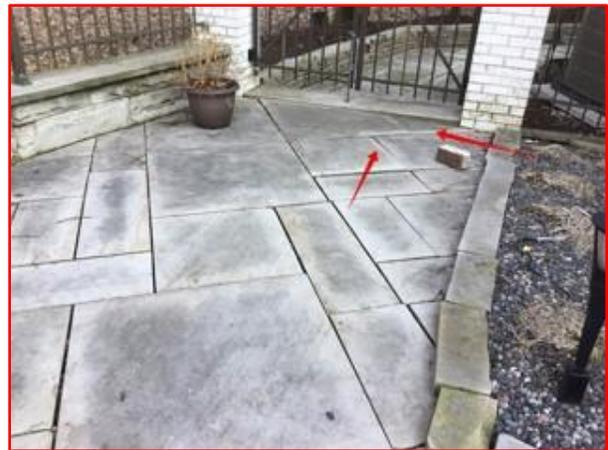
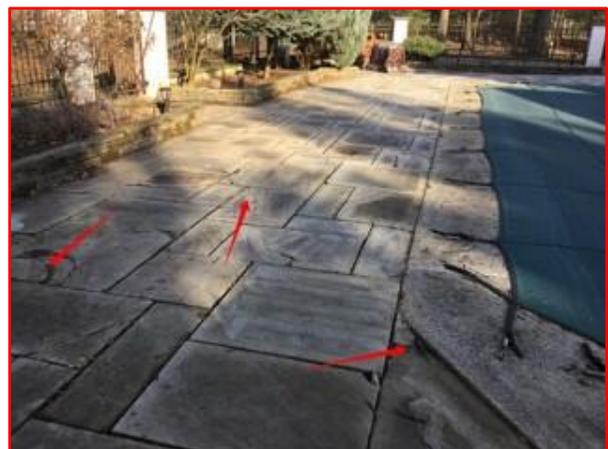
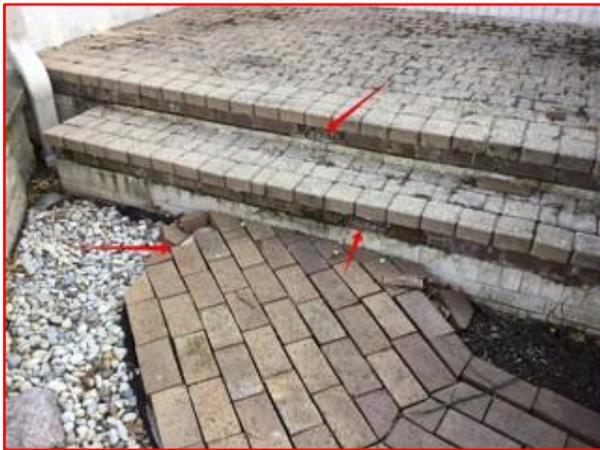
1) In the backyard there are several areas of the sand stone patio that have settled and cracked. There are a few step treads that have movement as you step on them. Recommend repair as needed by a professional patio contractor

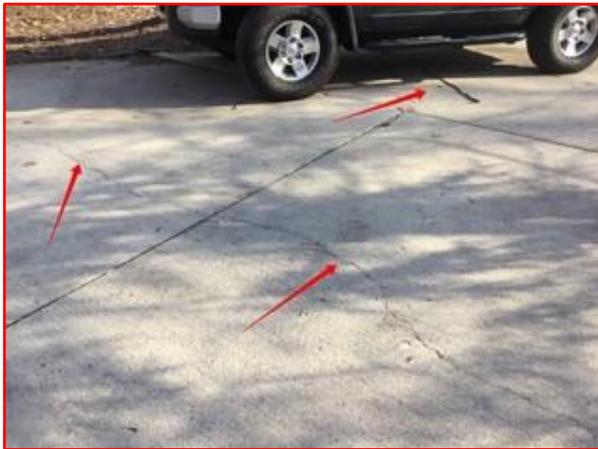
Figure 4-1

4) The driveway has some settling cracks and areas of settling concrete. Recommend sealing these crack with a proper driveway crack sealant and monitoring.

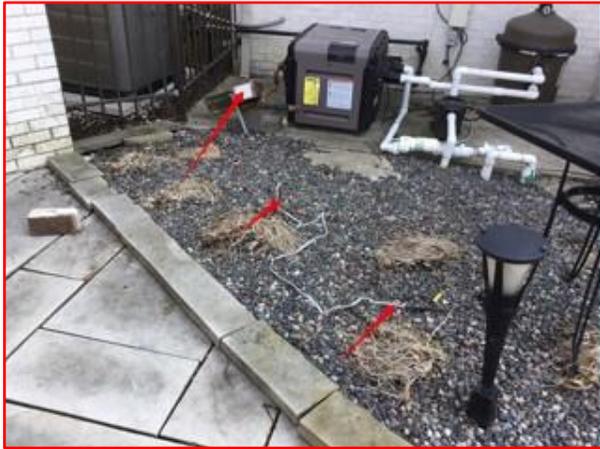
Figure 5-1

5) In the backyard it appears like they used Romex 110 volt wiring to run the low-voltage lighting wiring from the transformers. There is an outlet in the far back garden bed that is not functional. Recommend further evaluation of the wiring by a certified electrician.

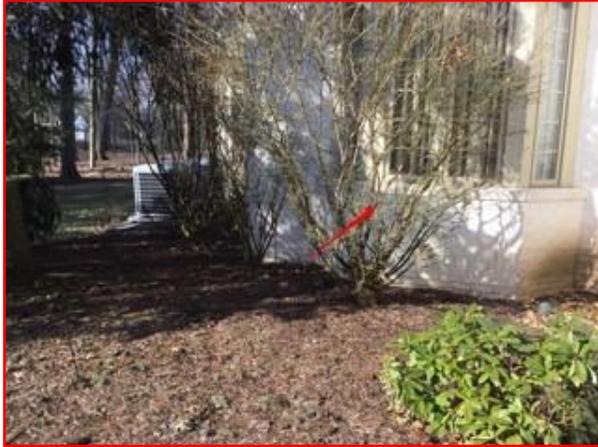
Figure 6-1

6) At the front south corner of the house there is a hole in the brick. Recommend sealing this hole properly.

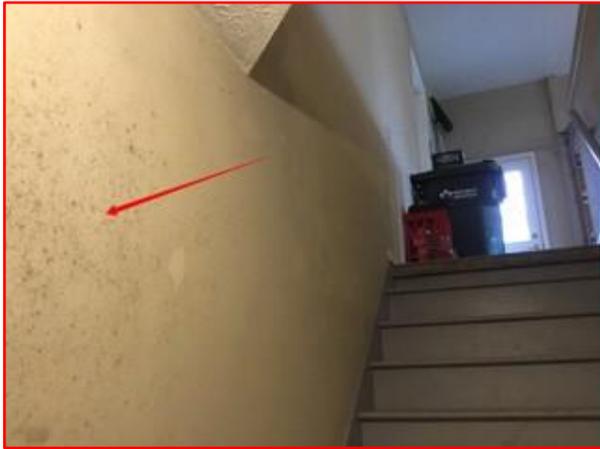
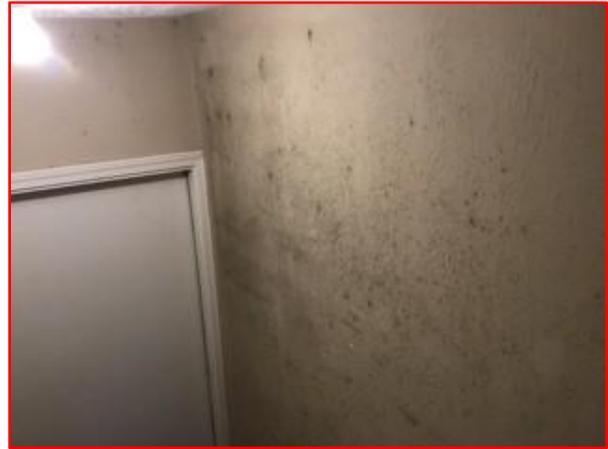
7) In the garage on the drywall at the base of the walkout stairway is some discoloration that may be mold. This can be easily treated and removed by a professional. Recommend further evaluation and mediation by a mold specialist.

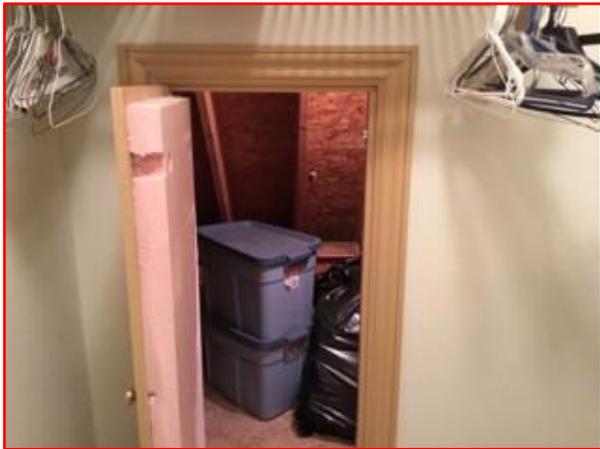
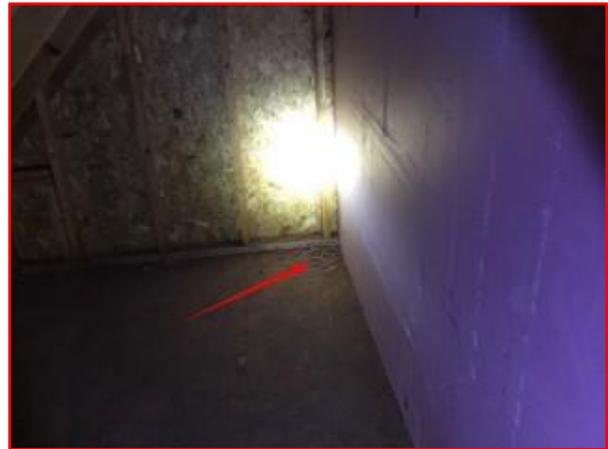
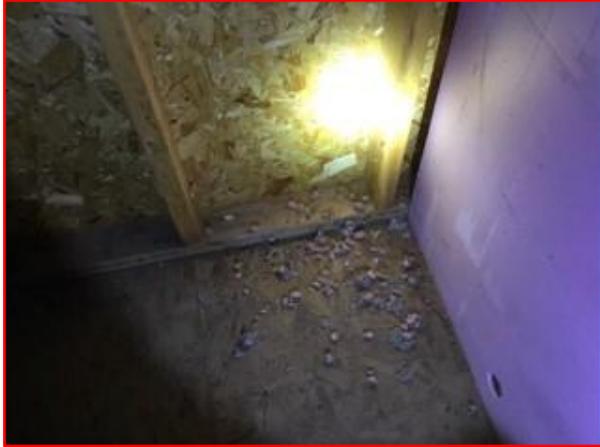
8) In the attic there are indications of mice present. Recommend having a pest control specialist evaluate and treat the home as needed.

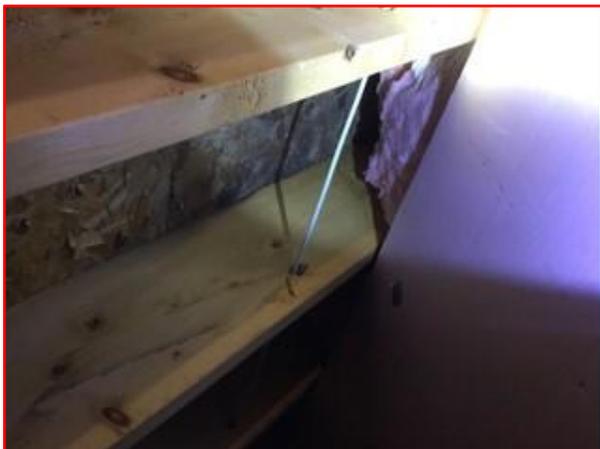
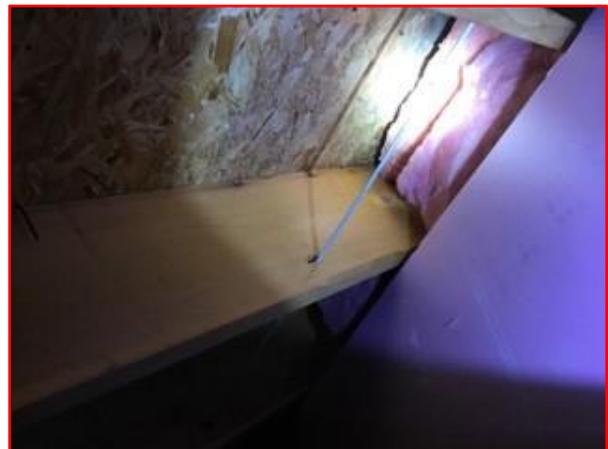
9) In the attic off the front bedroom over the driveway on the sheathing is some discoloration that may be mold. This is common to find in attics in Northeast Ohio. This can be easily treated and removed by a professional. Recommend further evaluation and remediation by a mold specialist. Recommend further evaluation by a professional roofing contractor to make sure the attic has the proper airflow and ventilation to prevent further issues.

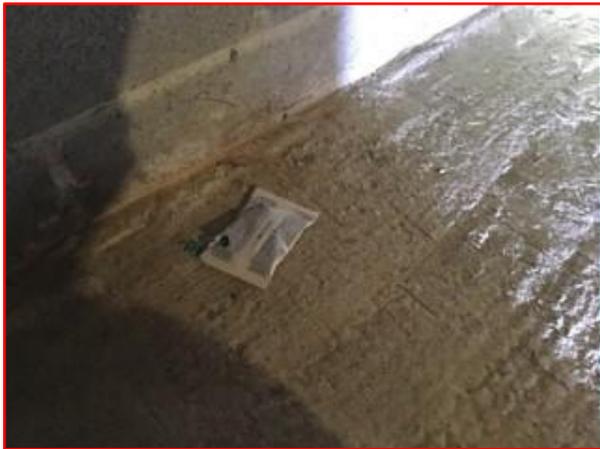
Figure 14-1

11) In the crawlspace there are some bait traps present. There are mouse droppings present. Recommend further evaluation by a pest control specialist

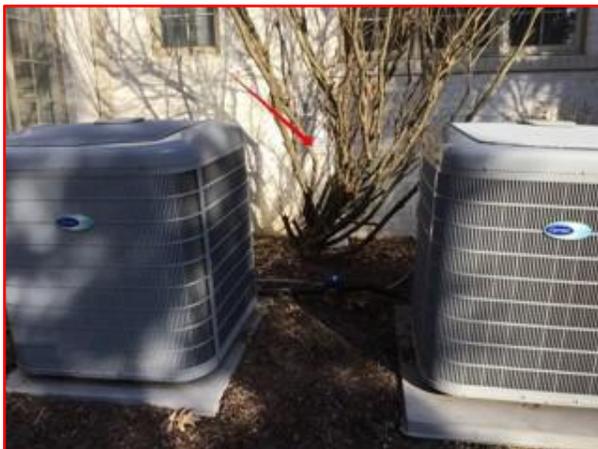
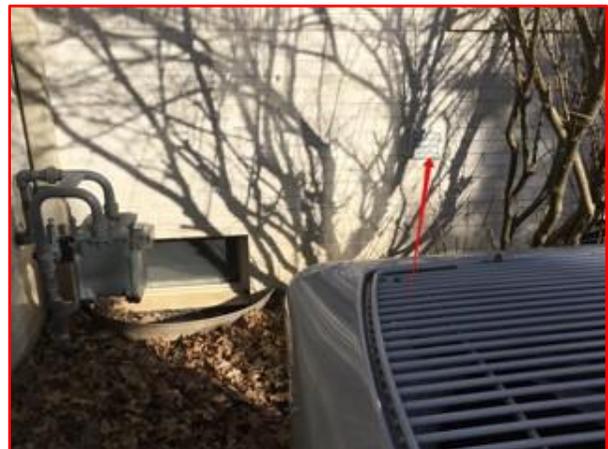
17) The back outside AC Condenser is close to the dryer vent. This condenser is an air cooled unit and it can get covered in lint and debris which can lower the efficiency and life of the unit. Recommend maintaining this condenser a few time per summer to keep these cooling fins cleaned by a professional HVAC technician

The dryer vent siding cap is loose. Recommend securing it properly to the brick.

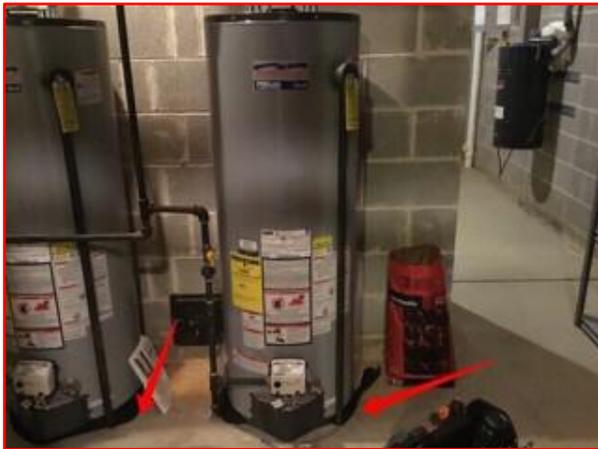
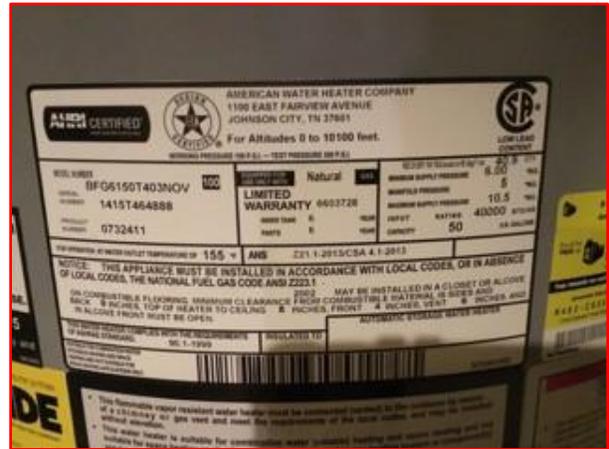
The hot water tanks in the basement is missing the drain pan below the unit. As this tank ages it can leak and drain into the finished living area causing damage. Recommend repair by a professional plumber

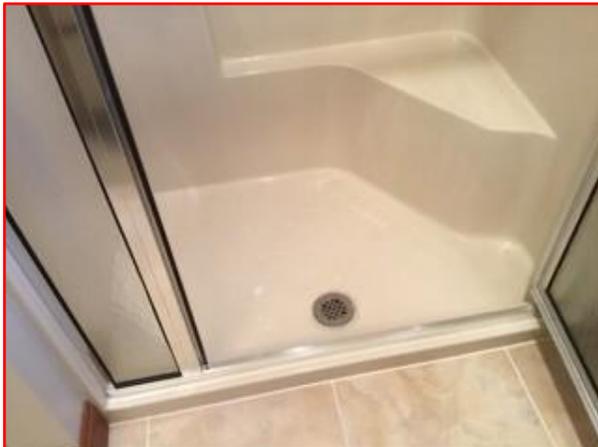
Figure 25-1

20) The fiberglass shower floor is a bit spongy in the back bathroom off the pantry area. Recommend further evaluation or repair as needed

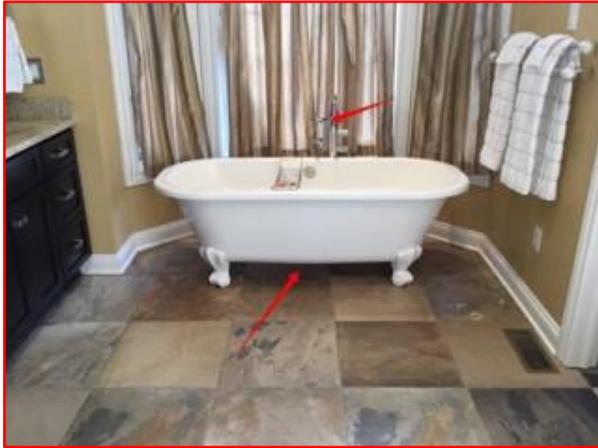
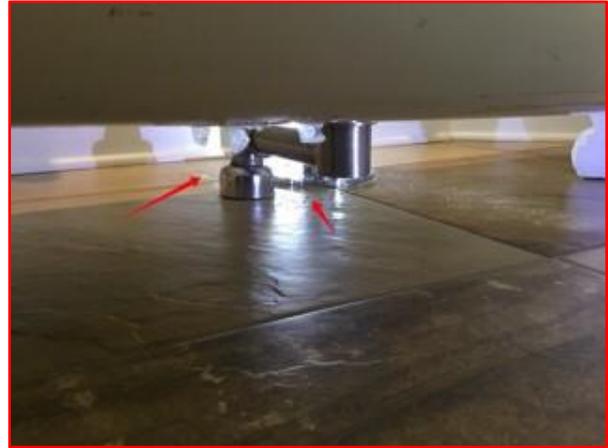
21) The showerhead and drain for the claw foot bathtub in the master bath is leaking. Recommend further evaluation and repair as needed by a certified plumber

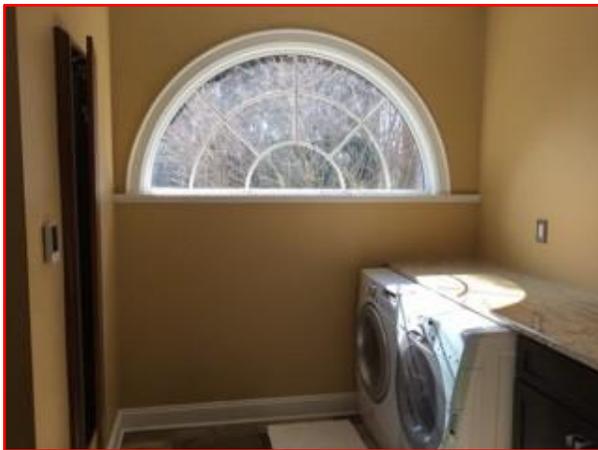
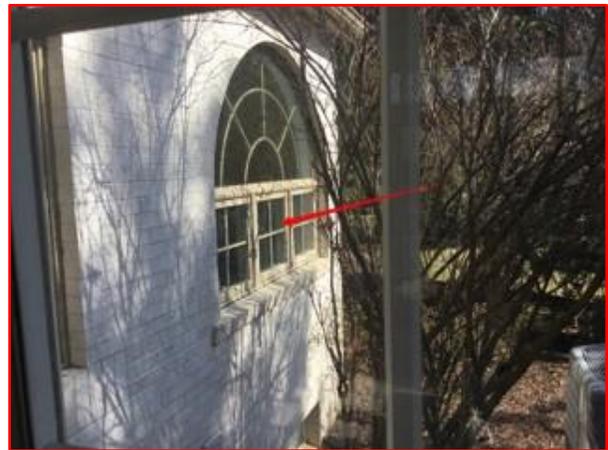
22) FYI- The lower three windows from the outside are covered with drywall on the inside of the back master bathroom area. Recommend monitoring

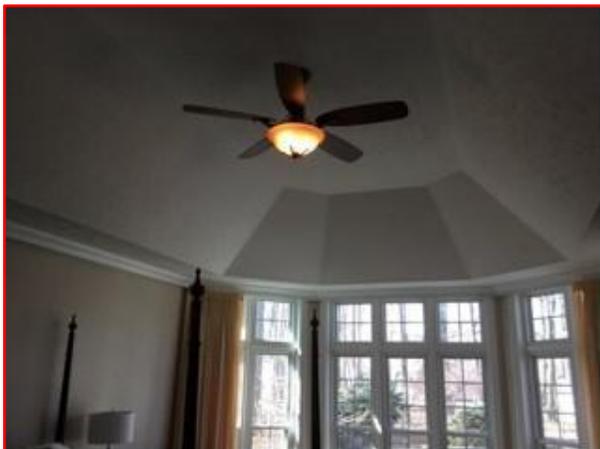
Figure 30-1

23) The fan in the main floor master bedroom was not tested. Recommend further evaluation

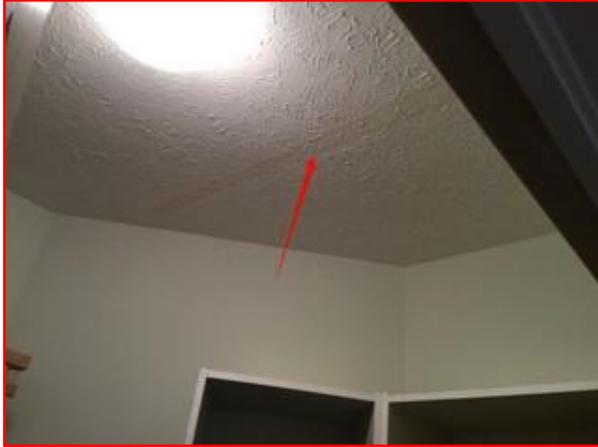
Figure 31-1

24) In the bedroom closet ceiling in the front north corner bedroom there are water stains present. There are also stains on the floor in the attic area just off of the closet. Recommend further evaluation and repair as needed by a professional roofing company.

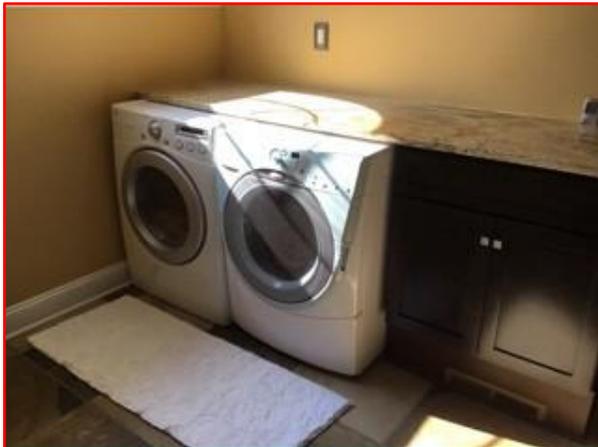
Figure 32-1

25) The master laundry room washing machine was not tested. There are clothes in the washer.

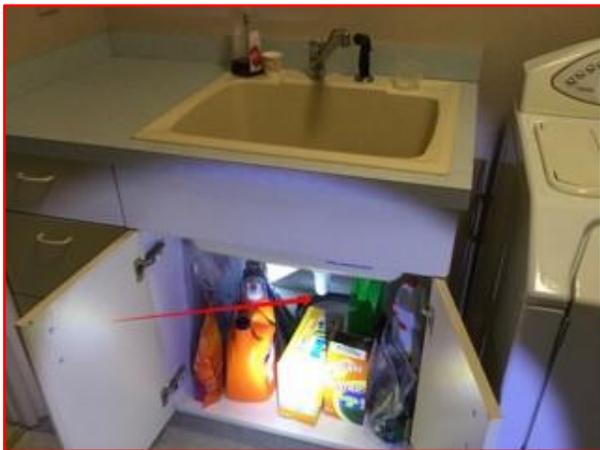
Figure 33-1

26) Underneath the sink in the upstairs laundry room there is a small leak. Recommend repair by a professional plumber

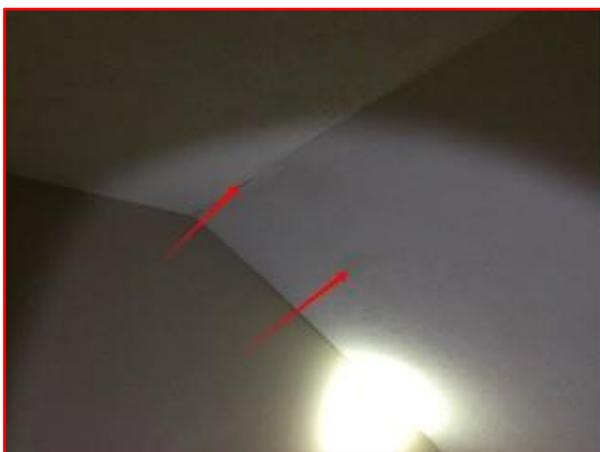
Figure 34-1

27) In the upstairs laundry room there is some water stains on the ceiling. Recommend further evaluation by a professional roofing contractor

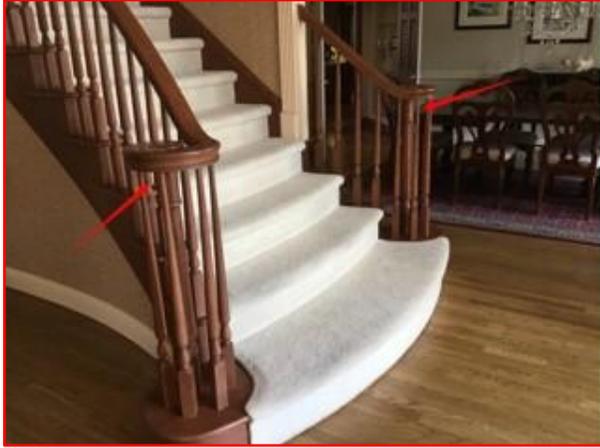
Figure 35-1

28) The front foyer banisters are a bit loose. Recommend monitoring

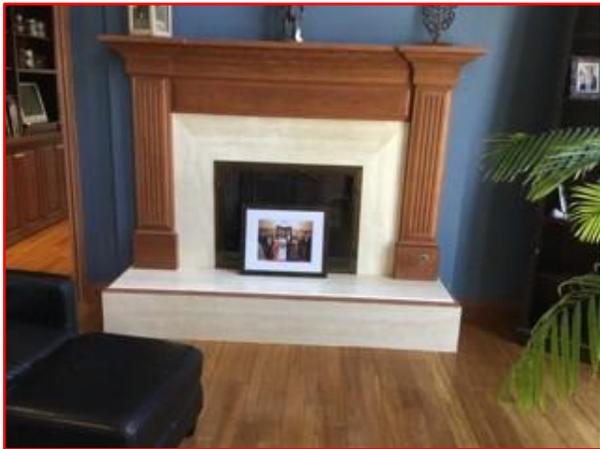
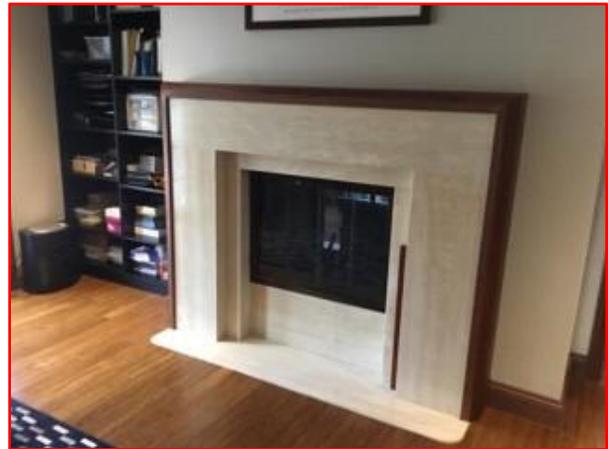
29) With a wood burning fireplace. Recommend having the chimney flue cleaned and evaluated by a professional chimney specialist before the first use. Making an extensive evaluation of the fireplace is beyond the scope of the home inspection. Recommend having the flue evaluated by a chimney professional.

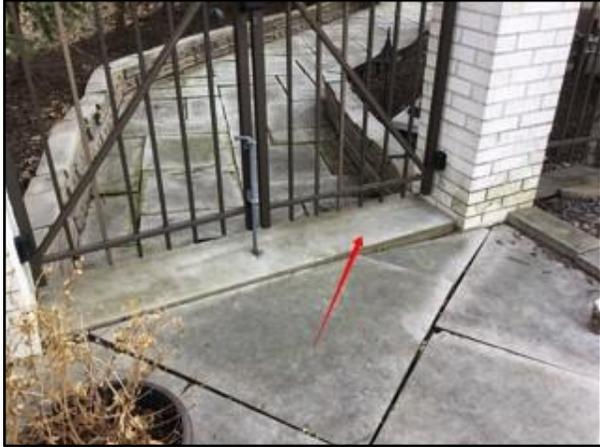
Figure 1-1

In the backyard there are several areas of the sand stone patio that have settled and cracked. There are a few step treads that have movement as you step on them. Recommend repair as needed by a professional patio contractor

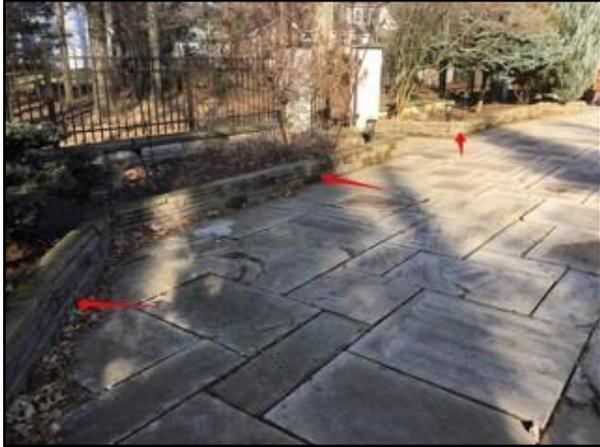
Figure 2-1

**Comment 2:**  
Many of the small walls around the back patio area are leaning and failing.  
Recommend repair as needed by a professional paver company

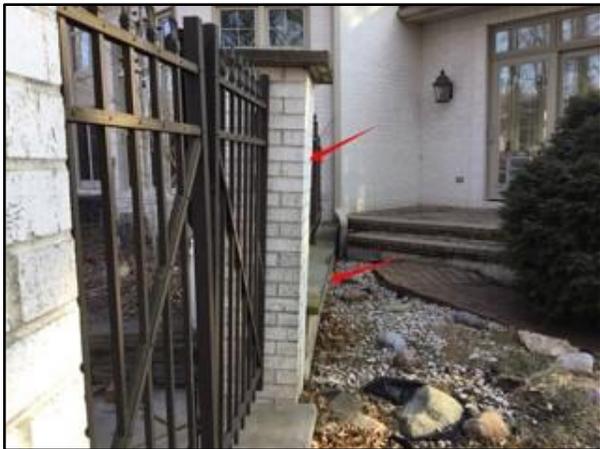
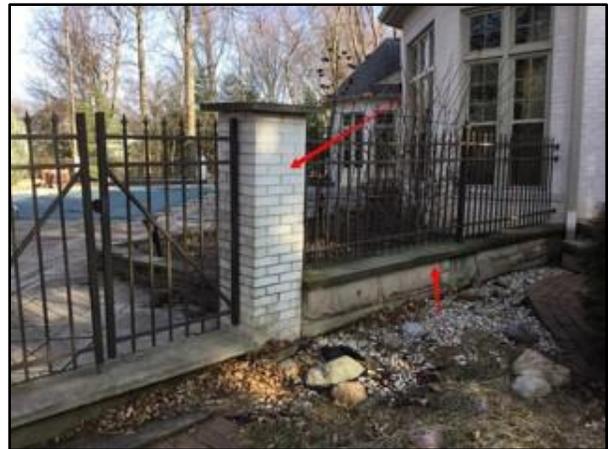
Some of the brick pillars around the pool area and stone walls holding the aluminum fencing are showing signs of settling. Recommend further evaluation and repair as needed by a professional masonry contractor

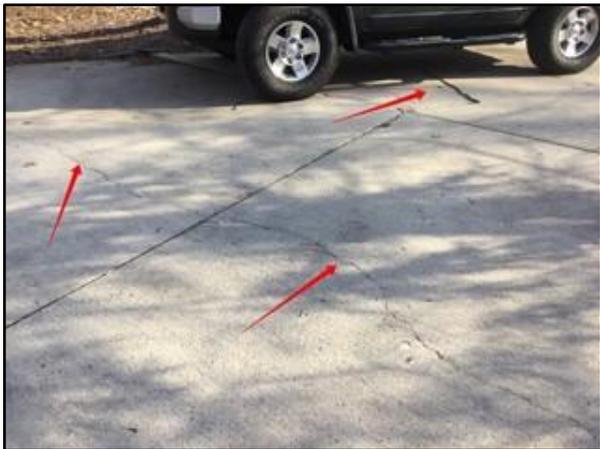
Figure 4-1

The driveway has some settling cracks and areas of settling concrete. Recommend sealing these crack with a proper driveway crack sealant and monitoring.

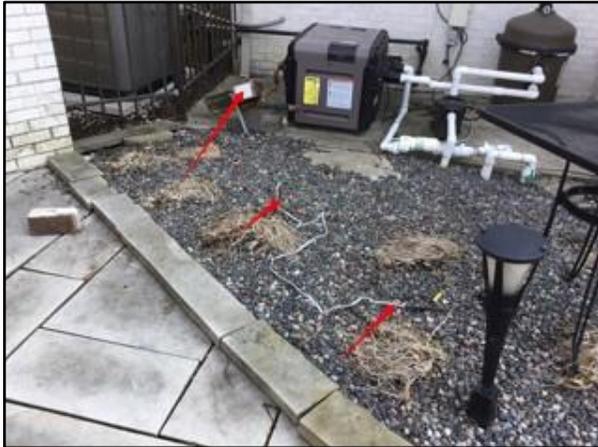
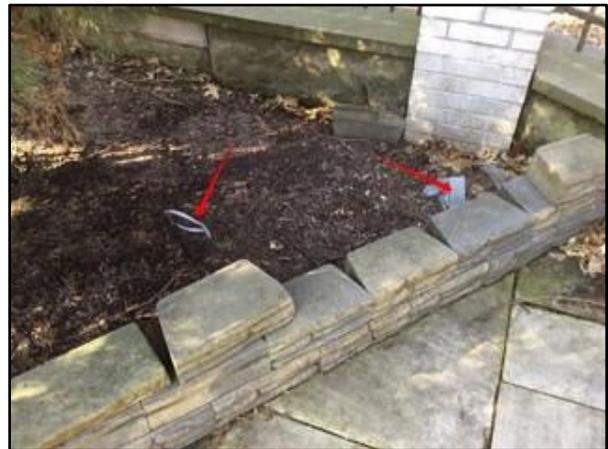
In the backyard it appears like they used Romex 110 volt wiring to run the low-voltage lighting wiring from the transformers. There is an outlet in the far back garden bed that is not functional. Recommend further evaluation of the wiring by a certified electrician.

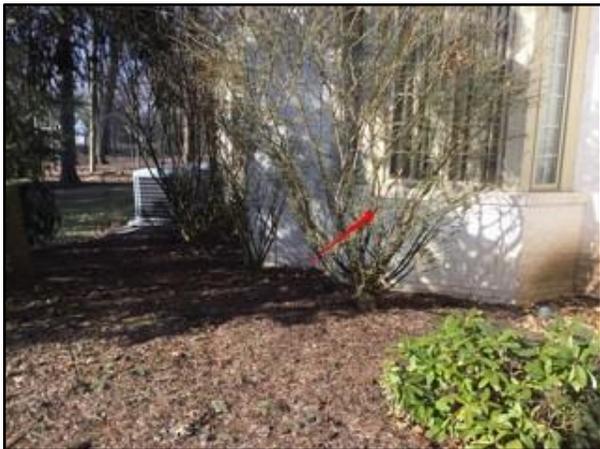
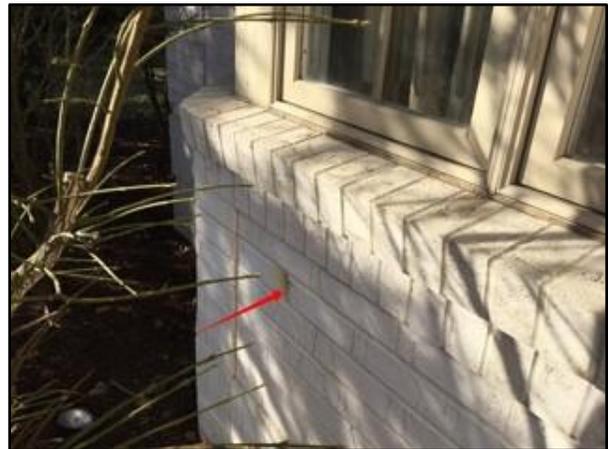
At the front south corner of the house there is a hole in the brick. Recommend sealing this hole properly.

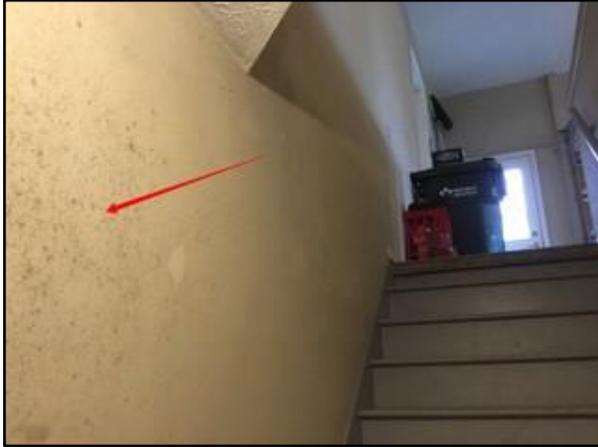
Figure 7-1

In the garage on the drywall at the base of the walkout stairway is some discoloration that may be mold. This can be easily treated and removed by a professional. Recommend further evaluation and mediation by a mold specialist.

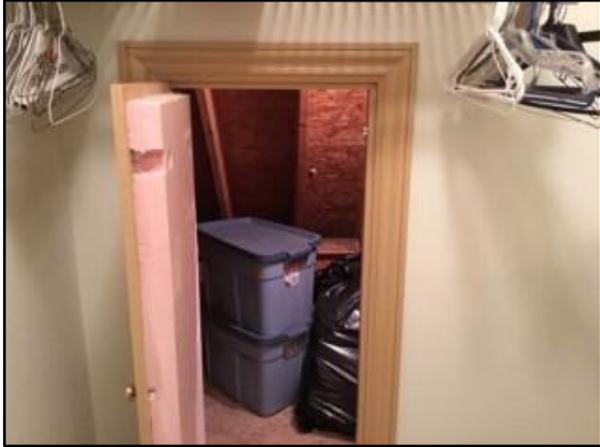
Figure 8-1

In the attic there are indications of mice present. Recommend having a pest control specialist evaluate and treat the home as needed.

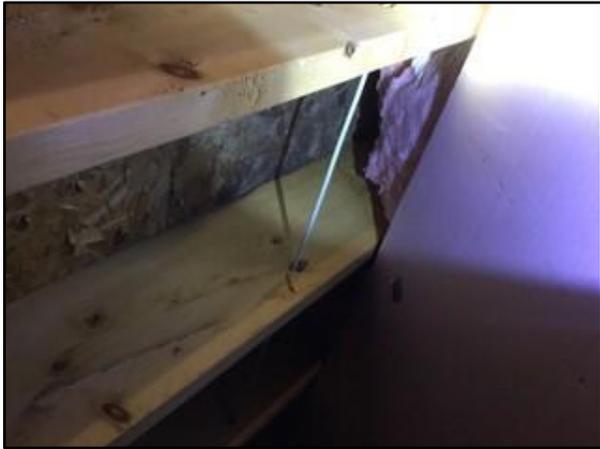
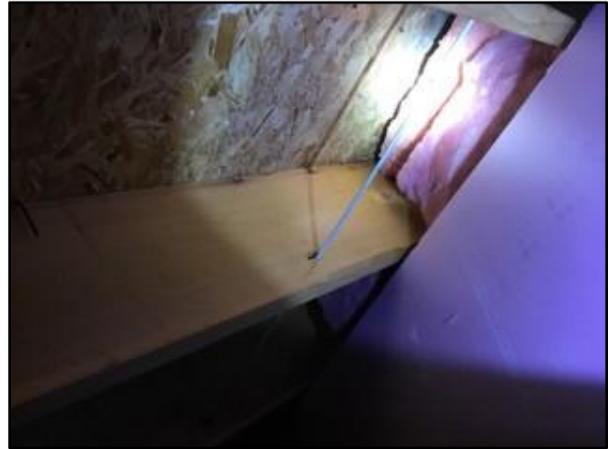
In the attic off the front bedroom over the driveway on the sheathing is some discoloration that may be mold. This is common to find in attics in Northeast Ohio. This can be easily treated and removed by a professional. Recommend further evaluation and remediation by a mold specialist. Recommend further evaluation by a professional roofing contractor to make sure the attic has the proper airflow and ventilation to prevent further issues.

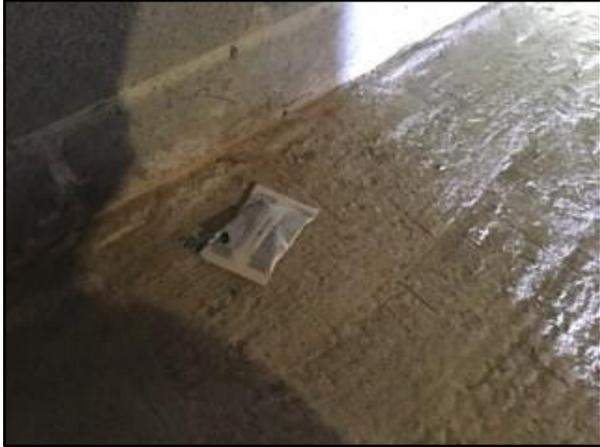
Figure 14-1

In the crawlspace there are some bait traps present. There are mouse droppings present. Recommend further evaluation by a pest control specialist

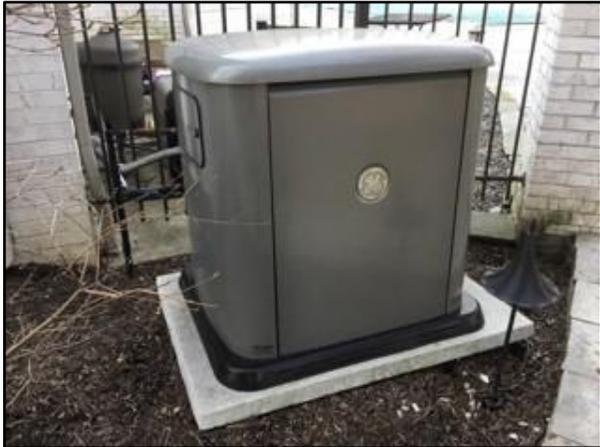
Figure 15-1

The generator is beyond the scope of the general home inspection and is not tested. The generator will typically run weekly and are maintained by a service provider. Recommend checking with the seller for proper servicing and notifications.

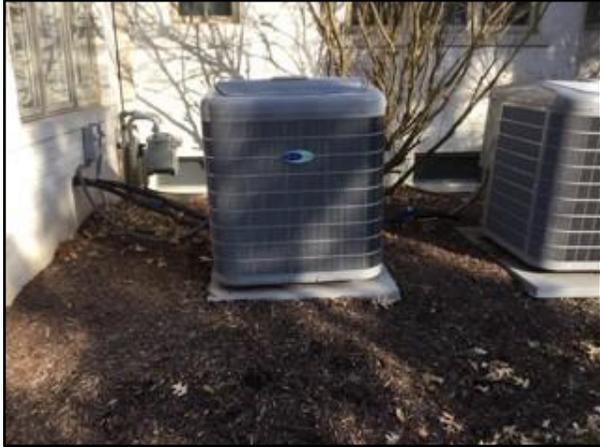
Figure 19-1

The air conditioning was not tested due to the outside temperature. It must be over 65 degrees for several days in order to run the system or damage can be done to the condenser. Recommend further evaluation as needed.

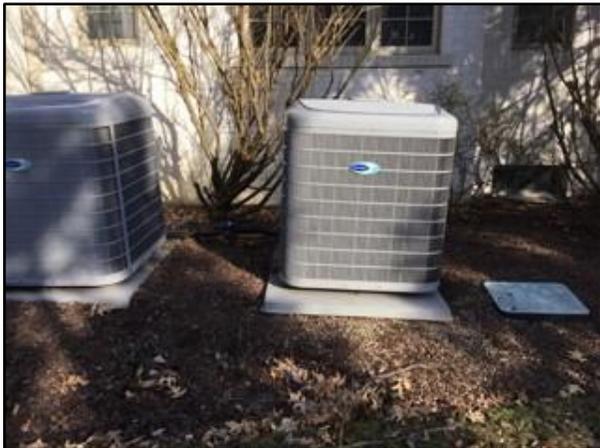
Figure 20-1

**Comment 20:**  
2014 Carrier AC Condenser

The air conditioning was not tested due to the outside temperature. It must be over 65 degrees for several days in order to run the system or damage can be done to the condenser. Recommend further evaluation as needed.

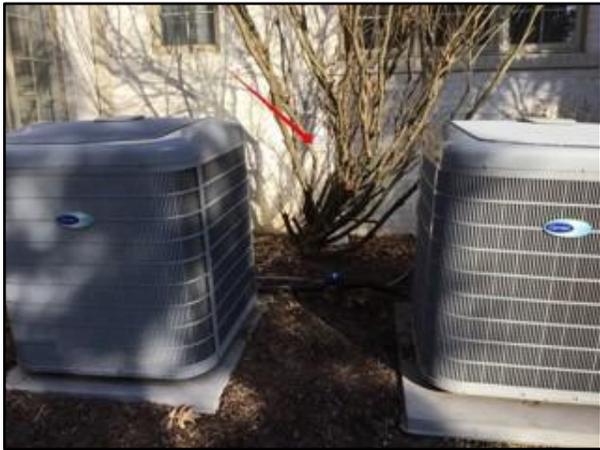
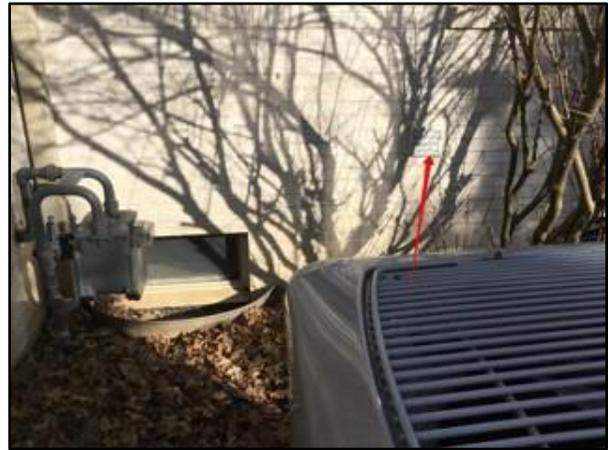
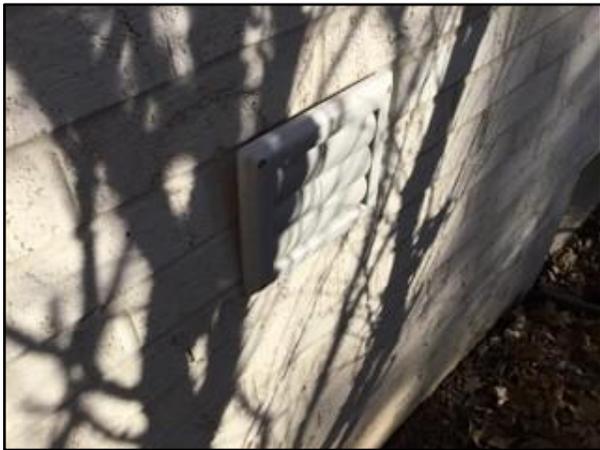
The back outside AC Condenser is close to the dryer vent. This condenser is an air cooled unit and it can get covered in lint and debris which can lower the efficiency and life of the unit. Recommend maintaining this condenser a few time per summer to keep these cooling fins cleaned by a professional HVAC technician

The dryer vent siding cap is loose. Recommend securing it properly to the brick.

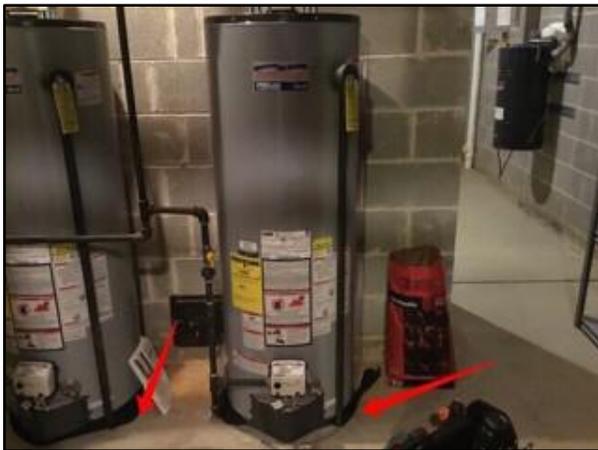
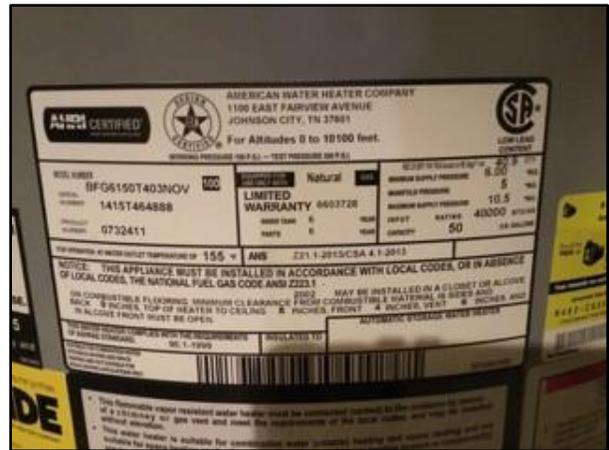
The hot water tanks in the basement is missing the drain pan below the unit. As this tank ages it can leak and drain into the finished living area causing damage. Recommend repair by a professional plumber

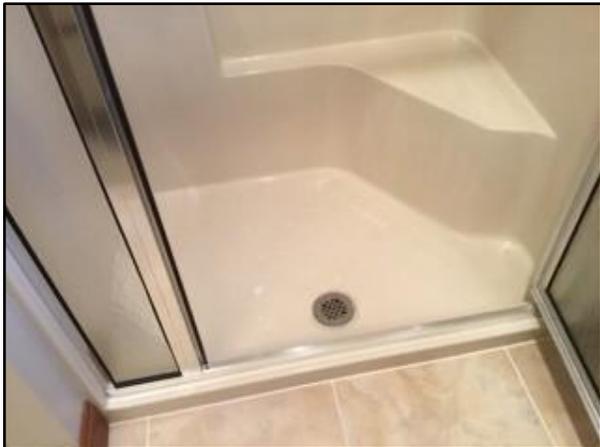
Figure 25-1

The fiberglass shower floor is a bit spongy in the back bathroom off the pantry area. Recommend further evaluation or repair as needed

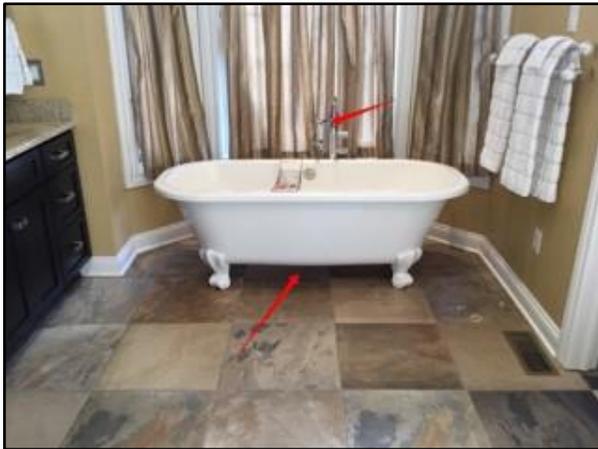
Figure 26-1

The showerhead and drain for the claw foot bathtub in the master bath is leaking. Recommend further evaluation and repair as needed by a certified plumber

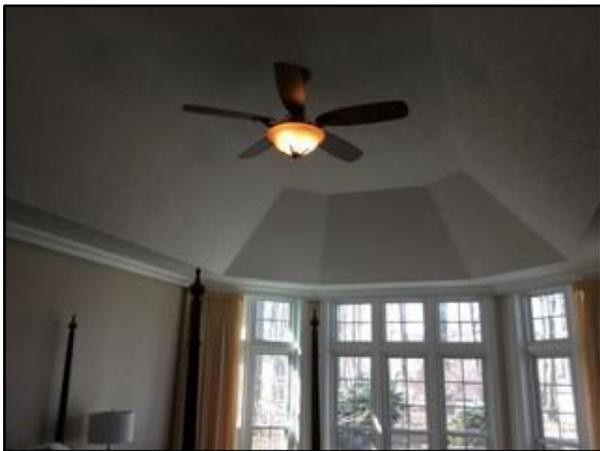
Figure 30-1

The fan in the main floor master bedroom was not tested. Recommend further evaluation

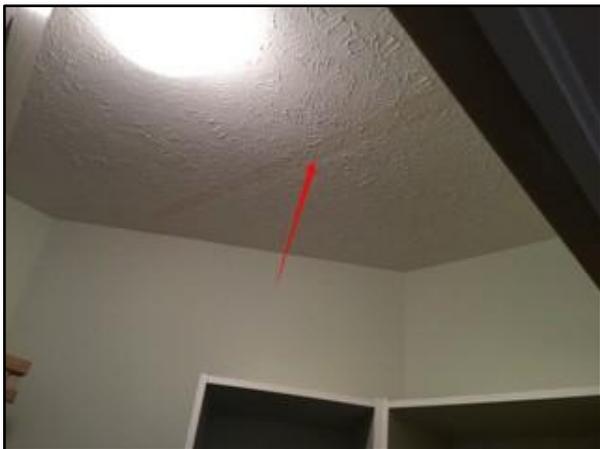
Figure 31-1

In the bedroom closet ceiling in the front north corner bedroom there are water stains present. There are also stains on the floor in the attic area just off of the closet. Recommend further evaluation and repair as needed by a professional roofing company.

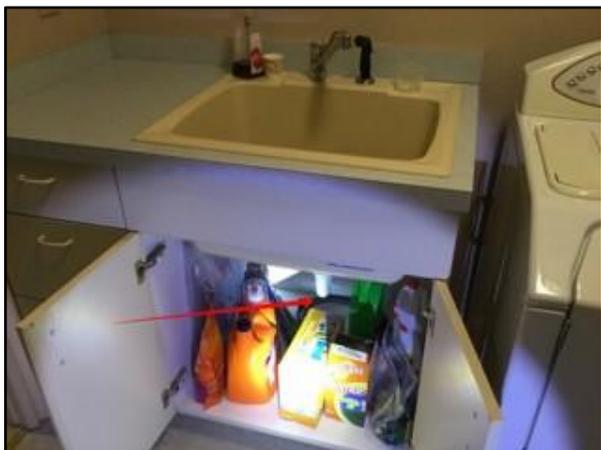
Figure 33-1

Underneath the sink in the upstairs laundry room there is a small leak. Recommend repair by a professional plumber

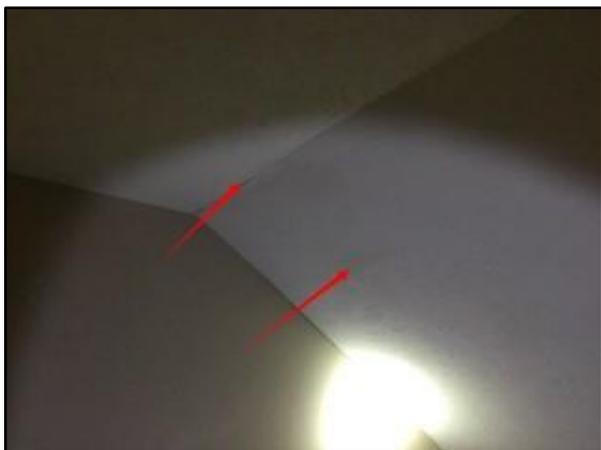
Figure 34-1

In the upstairs laundry room there is some water stains on the ceiling. Recommend further evaluation by a professional roofing contractor

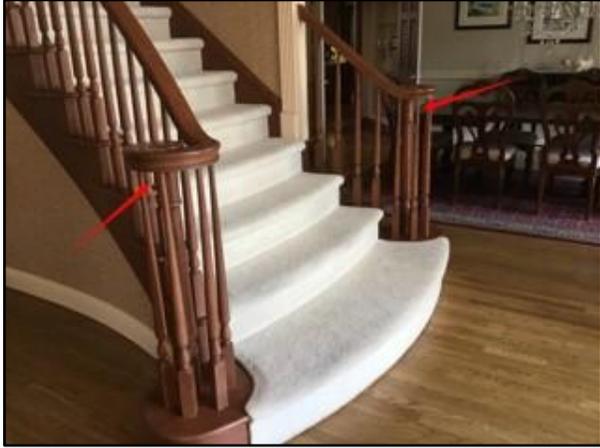
Figure 35-1

The front foyer banisters are a bit loose. Recommend monitoring

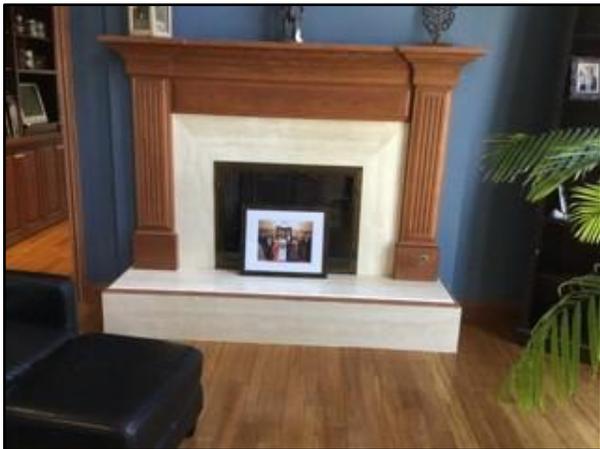
Figure 36-1

With a wood burning fireplace. Recommend having the chimney flue cleaned and evaluated by a professional chimney specialist before the first use. Making an extensive evaluation of the fireplace is beyond the scope of the home inspection. Recommend having the flue evaluated by a chimney professional.
