VILLAS OF TUSCANY HOMEOWNERS ASSOCIATION RESERVE STUDY

Project: Villas of Tuscany Homeowners Association
Macedonia, OH

Report Date: April 25, 2023
Revised: May 4, 2023

JHBC Project No.: 4235_00_2022

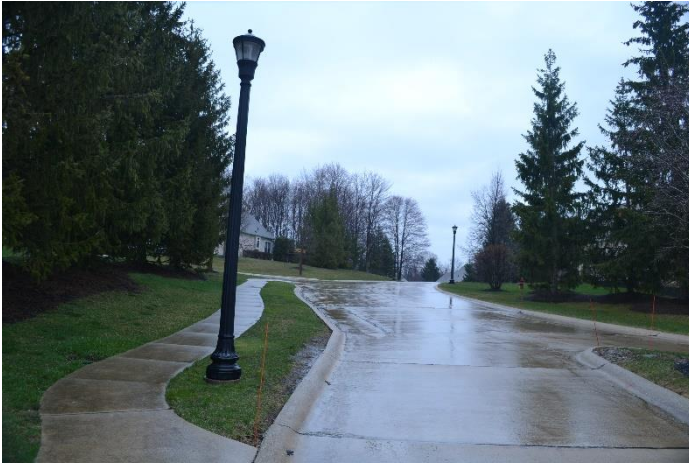
No.	Item	Quantity	Units	Unit Cost	Immediate Cost
1.0	SITE:				
1.1	We observed cracks and sealed joints in the onsite roadways, along with sections of road which have been replaced (refer to photo nos. 5, 6, and 8 - 10). No immediate repair work is considered necessary. Refer to the Replacement Reserve Schedule for future costs.				\$0.00

5. View of the roadway pavement, common walk, and street light pole on the subject property.

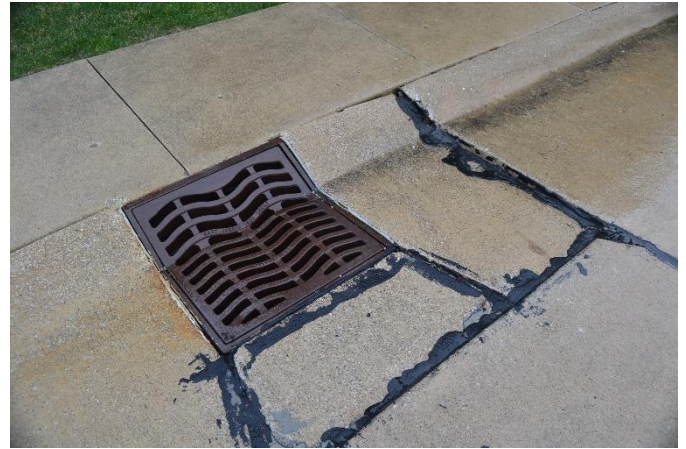
6. View of a storm drain inlet, concrete curb, and common walk along the onsite roadway. Note the black sealant in the roadway joints.

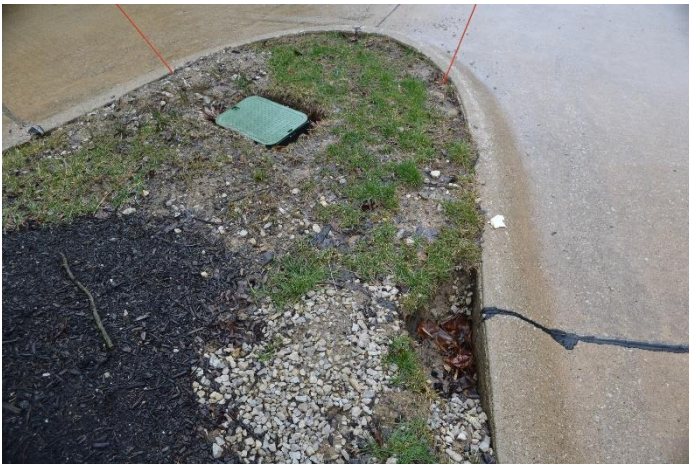
1.2	We observed an area of worn and damaged landscape at the median (refer to photo no. 7). Repairs to the landscape in this area are considered minor maintenance as an operating expense. Therefore, no costs are included herein.				\$0.00

7. View of worn landscape at one end of the landscaped median.

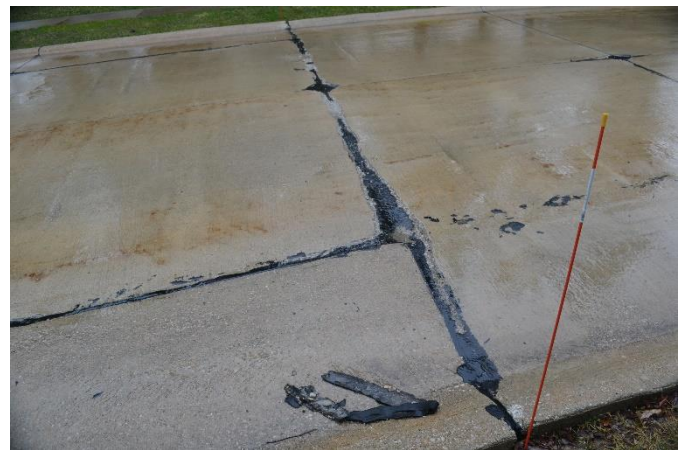
8. View of typical roadway pavement.

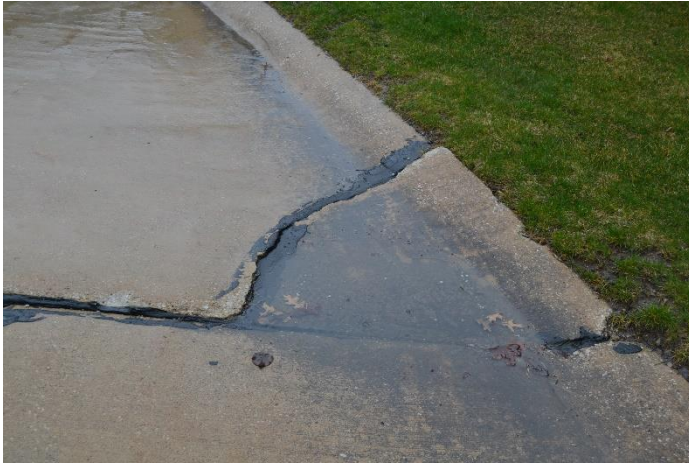
9. View of a damaged section of roadway pavement.

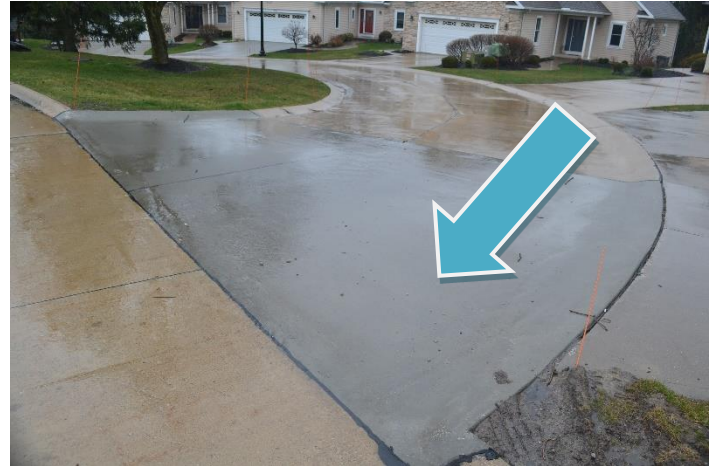
10. View of a patched section of roadway pavement.

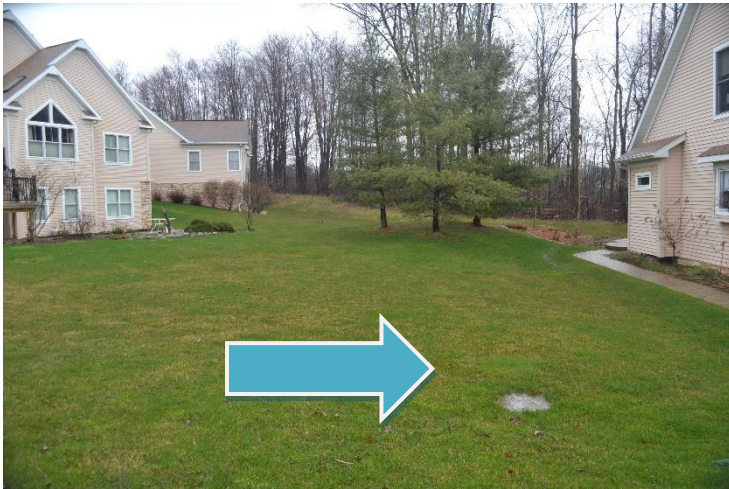
1.3	We observed two areas of common landscape where groundwater ponds (refer to photo nos. 19 and 20). We recommend swales be gut into the ground to direct water to drain. Costs are included for this work.	2	lump sum	\$1,500.00	\$3,000.00

19. View of a common area of landscape. Arrow indicates a low area where water ponds.

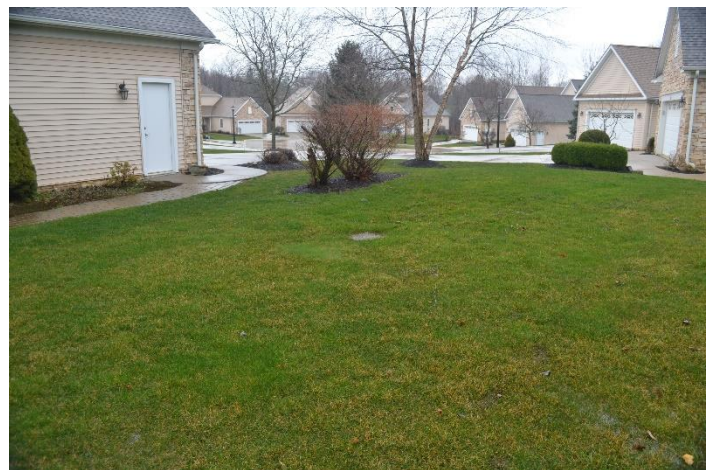
20. View of another area of landscape where ground water ponds.

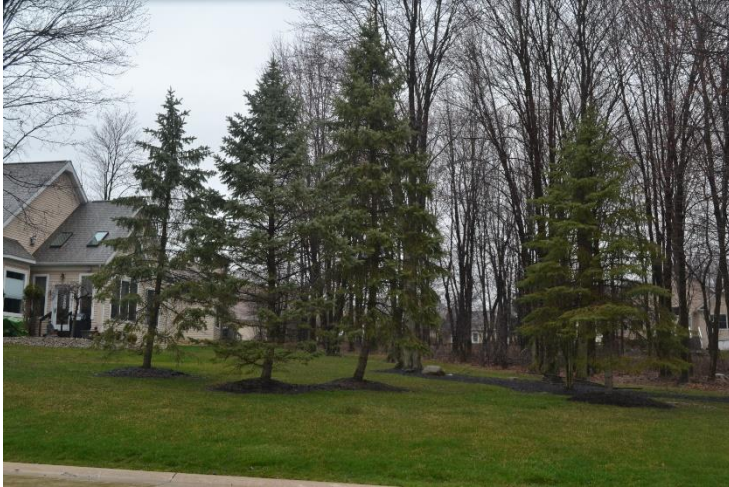
1.4	We observed coniferous trees in a couple areas which appear to be dying (refer to photo no. 21). These trees may be damaged from insects. We recommend the removal of these trees to minimize the spread of any disease to other healthy trees. Costs are included for this work.	1	lump sum	\$2,500.00	\$2,500.00

21. View of several coniferous trees which appear to be diseased.

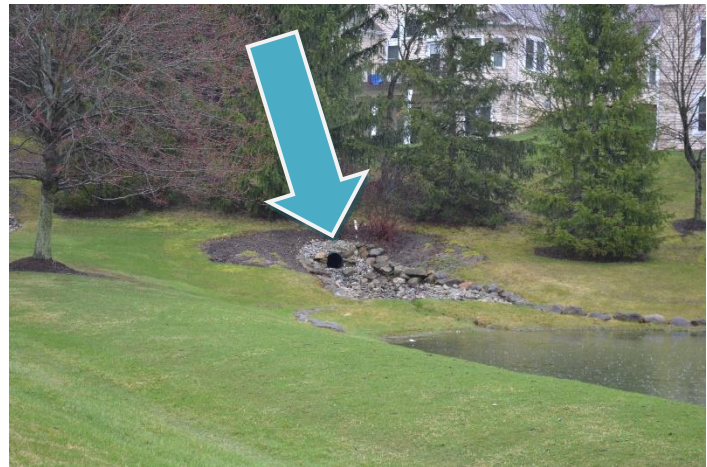
No.	Item	Quantity	Units	Unit Cost	Immediate Cost
1.0	SITE:				
1.1	We observed a pond on the subject property which has no barrier to prevent persons from entering the water (refer to photo nos. 23 - 25). This is considered a life safety issue. We recommend the Association consult with legal counsel to determine if barriers, or other features should be added. No costs are included for this work.				\$0.00
1.2	We observed lawn landscape between some of the homes which does not slope to drain the ground water adequately away from the homes (refer to photo no. 14). We recommend a swale be cut into the landscape to better direct ground water away from the buildings. Costs are included for this work.	1	lump sum	\$3,000.00	\$3,000.00
2.0	BUILDINGS:				
2.1	We did not observe the homes as part of this Report.				
Code Compliance/Life Safety Subtotal					\$3,000.00

1.5	We observed the perimeter of the pond has no rip rap or landscape to prevent ground erosion along the pond perimeter (refer to photo nos. 23 - 25). By having grass ground cover extend up to the water's edge, we find ponds tend have erosion issues and an unnecessary buildup of sediment. We recommend the perimeter of the pond be lined with stone rip rap over a filtration fabric to stabilize the ground perimeter. Costs are included for this work.	540	lineal feet	\$100.00	\$54,000.00

24. View of a storm drain discharge at the pond shown in the previous photo.

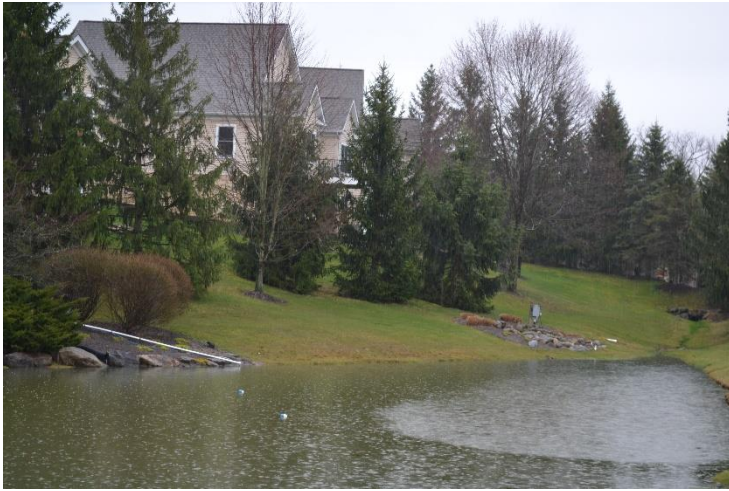
25. Additional view of the pond.

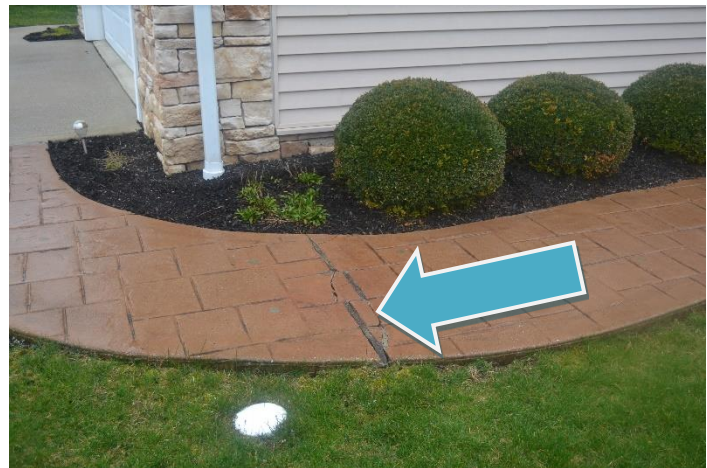
1.6	We observed several cracks in individual walks (refer to photo no. 28). We recommend the damaged sections of walk be replaced to avoid a trip hazard. Costs are included for this work.	2	lump sum	\$1,500.00	\$3,000.00

28. View of a damaged section of walk as observed at several homes.

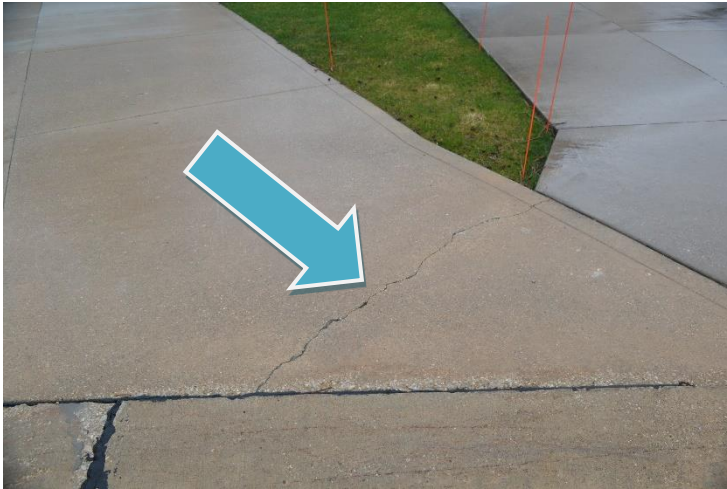
1.7	We observed several cracks in the driveway pavement (refer to photo no. 29). No immediate repair work is considered necessary. Refer to the Replacement Reserve Schedule for future costs.				\$0.00

29. View of a crack in a driveway as observed at several locations.

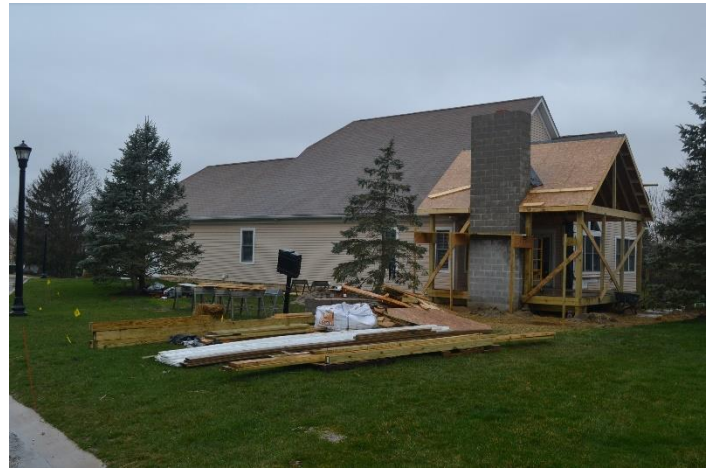
2.0	BUILDINGS:				
2.1	We observed an addition to a home which was under construction (refer to photo no. 30). We were informed the addition was approved by the Association. This information is provided for reference only.				\$0.00
Capital improvement/Property Deficiency Subtotal					\$62,500.00

30. View of a home with an addition under construction.
