Hi-Tide Condominium Association

Report #: 19269-14

Level of Service: Update "With-Site-Visit"

January 1, 2025 through December 31, 2025

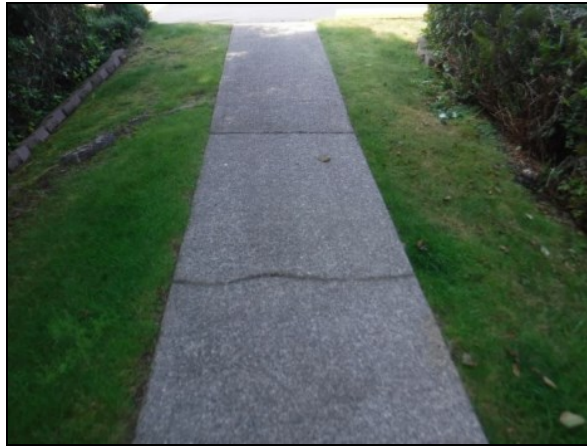
Comp #: 100 Concrete - Repair/Replace

Comments: Concrete appeared in generally fair condition with some localized (minimal) cracking.

Funded?: No. Useful life not predictable, repair/replace as needed from Operating budget
