Hi-Tide Condominium Association

Moclips, WA

Level of Service: Update "With-Site-Visit"

Report #: 19269-14

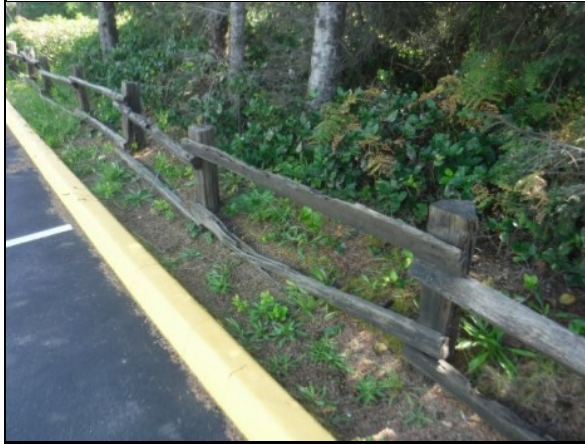
Reserve funding added beginning with this report for full replacement.

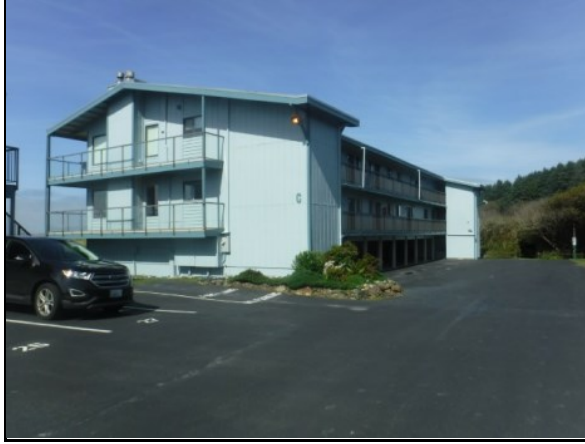
Funding for replacement factored below. See component #520 (Bldg A) for general wood siding replacement notes.

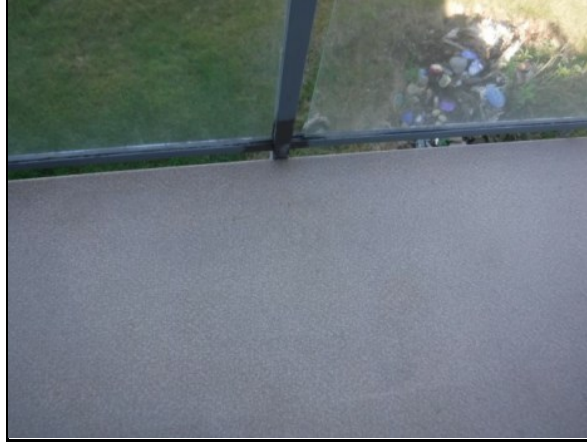
Allowance for replacement included as noted below. For general vinyl deck notes see component #540.
