Eye Spy Home Inspection

Home Inspection Report

2390 Valley View

Inspected on Wed, Oct 7 2020 at 8:00 AM

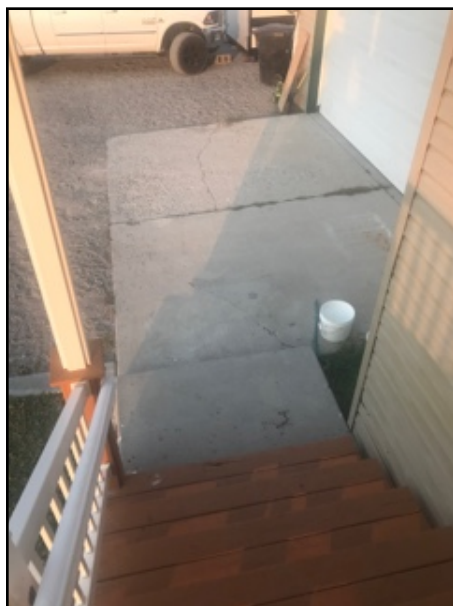
Figure 1-1

Comment 1:
Driveway is cracked and spalling .

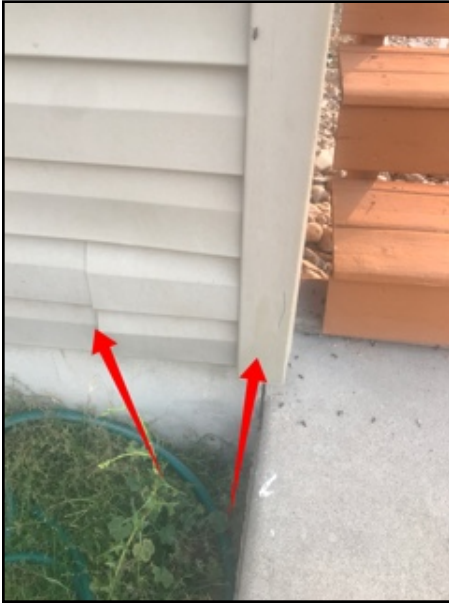
Figure 2-1

Comment 2:
Damaged siding.

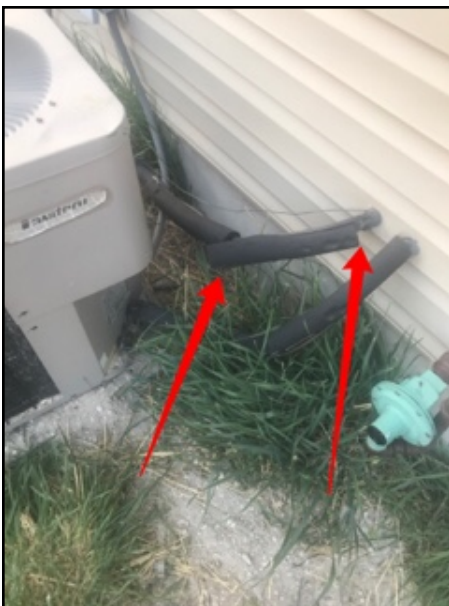
Figure 3-1

Comment 3:
Insulation on AC pipes needs to be repaired.

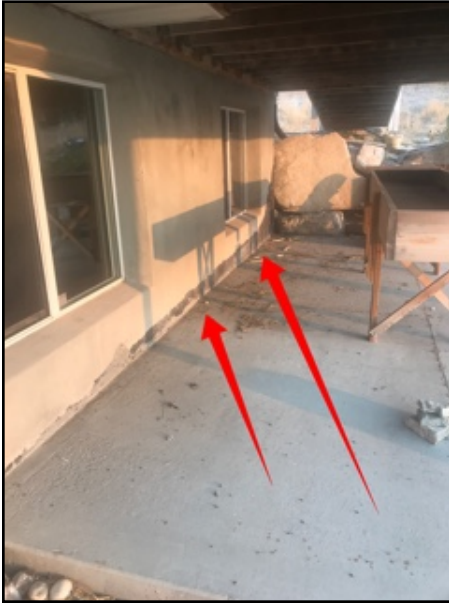
Figure 4-1

Comment 4:
Plaster has fallen off of foundation wall.

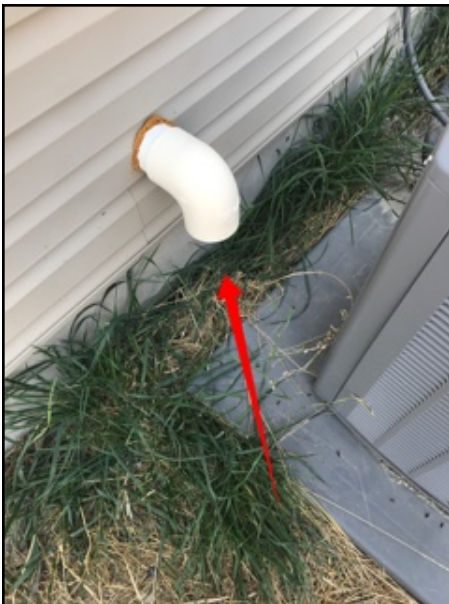
Figure 5-1

Comment 5:
Needs a screen to prevent rodents from entering home.

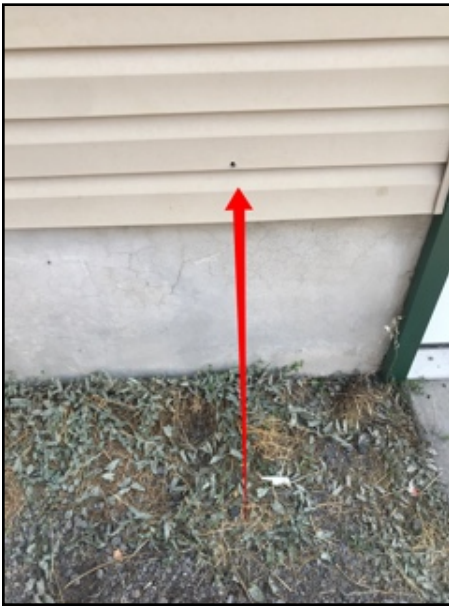
Figure 6-1

Comment 6:
Holes in siding should be sealed.

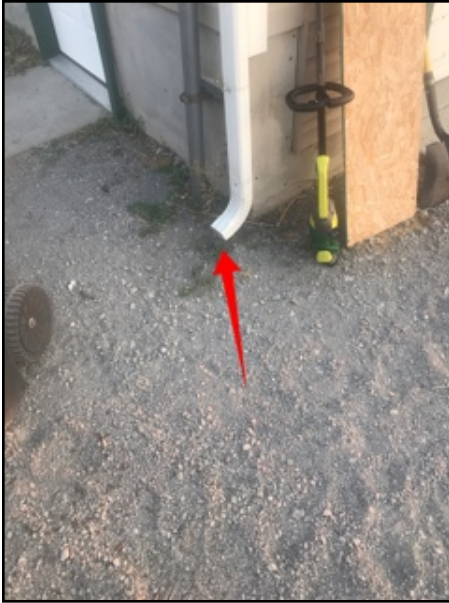
Figure 8-1

Missing down spout extension .

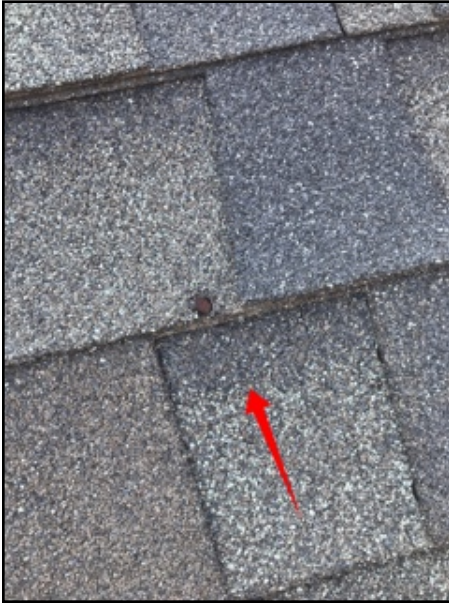
Figure 9-1

Comment 9:
Exposed nails Recommend ceiling with roof tar.

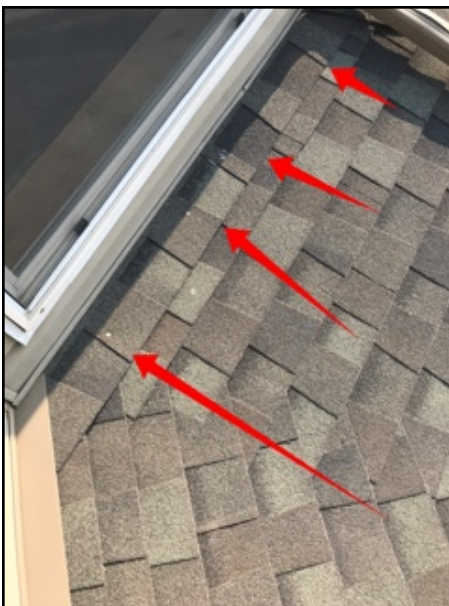
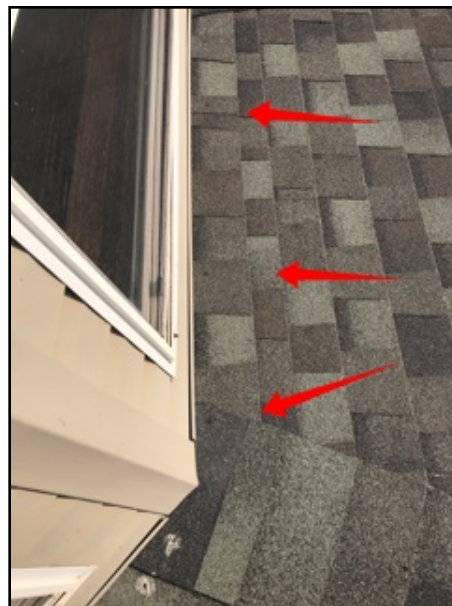
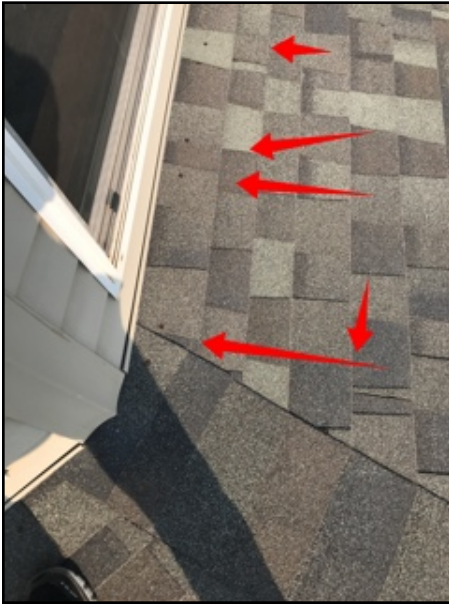
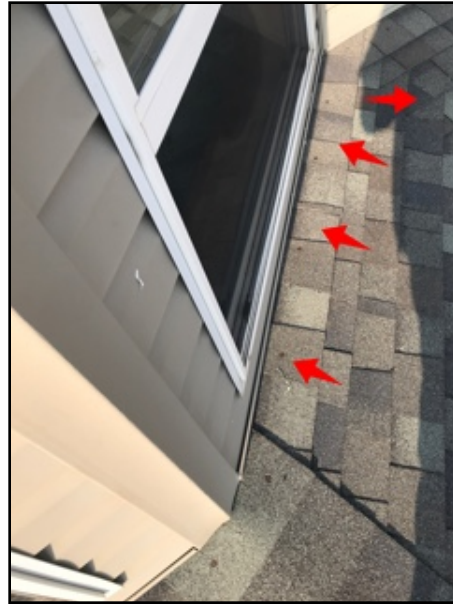
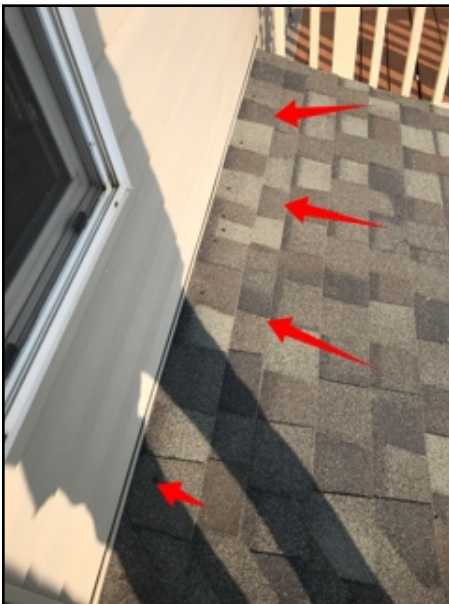
Comment 10:
A lot of exposed nails on porch roof Highly recommend ceiling with roofing tar.

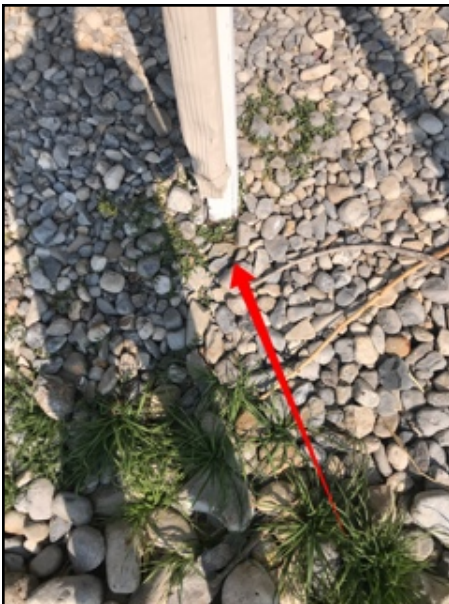
Figure 13-1

Comment 13:
Post base should be above grade.

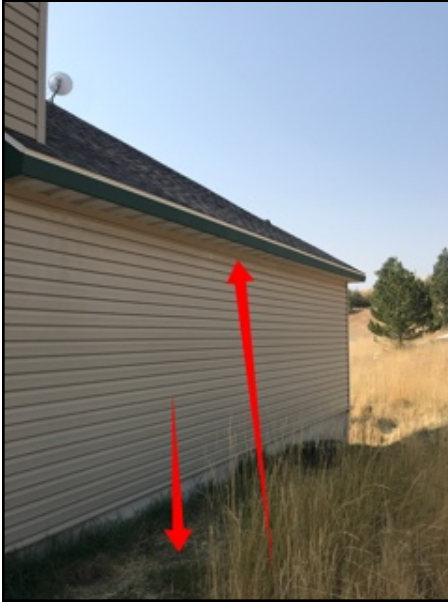
Figure 14-1

**Comment 14:**
Roof edge needs a gutter and downspout to prevent water from running into foundation.

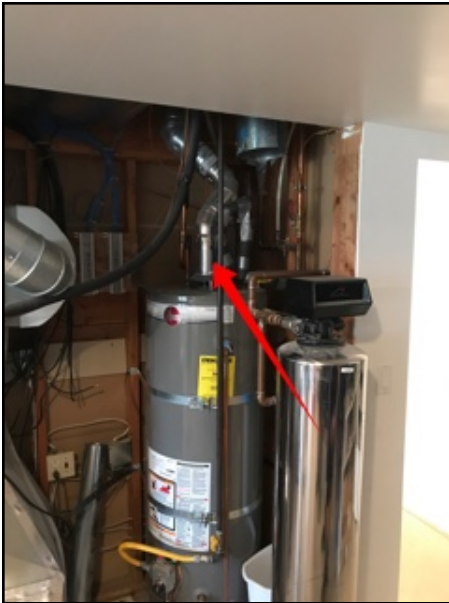
Figure 23-1

Water heater missing expansion tank recommend installing one.

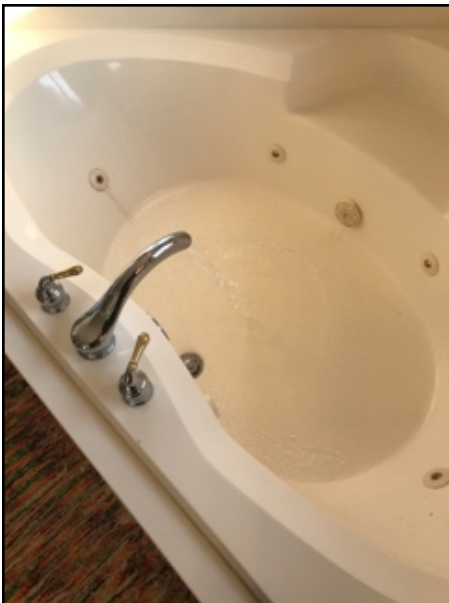
Figure 25-1

I would recommend cleaning the jets before using tub in master.

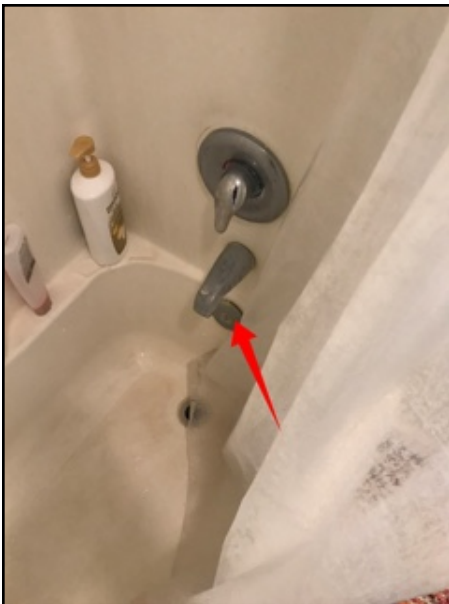
Figure 27-1

Comment 27:
Mixing valve leaks when shower is running.

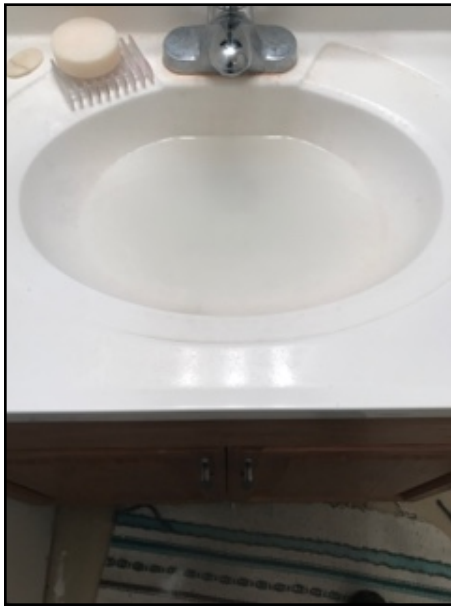
Figure 29-1

Comment 29:
Sink drains very slowly.

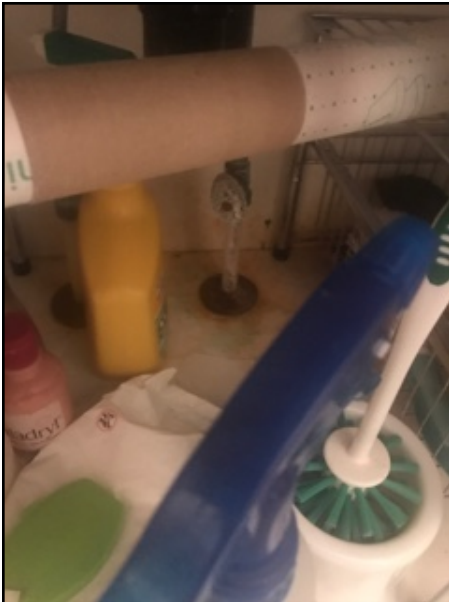
Figure 31-1

Comment 31:
Signs of previous water damage I suggest asking owners to explain.
Currently no leaks found

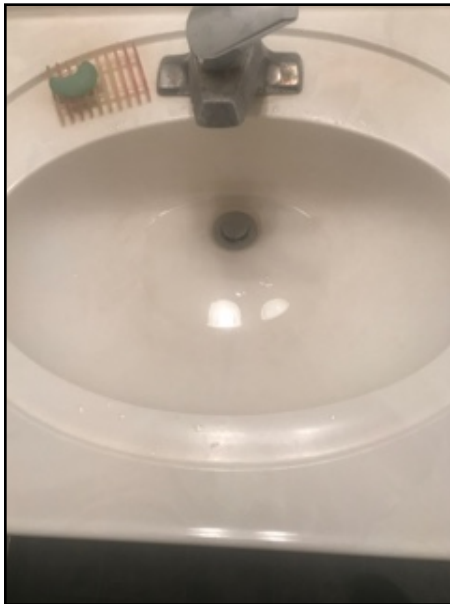
Figure 32-1

Comment 32:
Sink drains slowly.

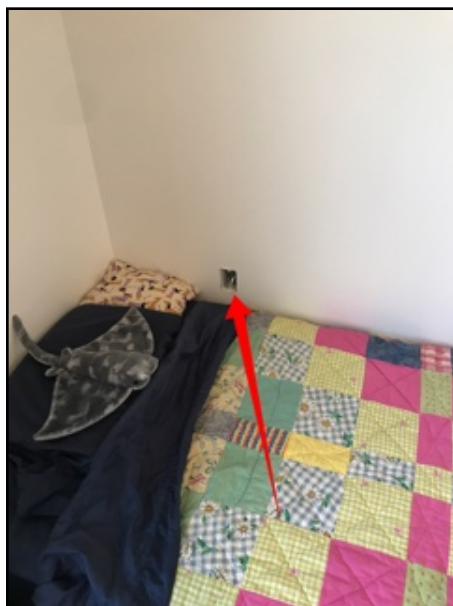
Figure 37-1

Comment 37:
Outlet needs to be covered.

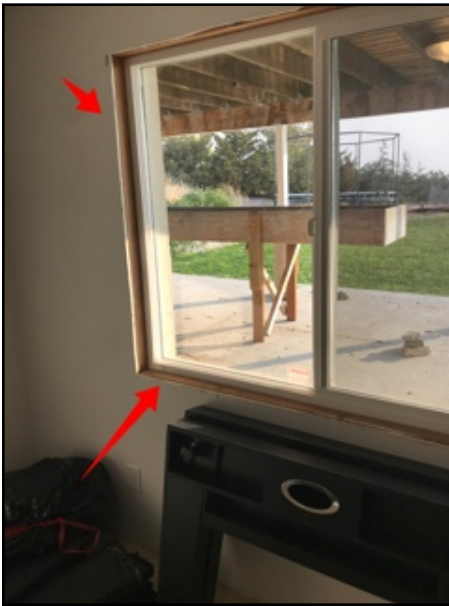
Figure 40-1

Comment 40:
Missing drywall around window .

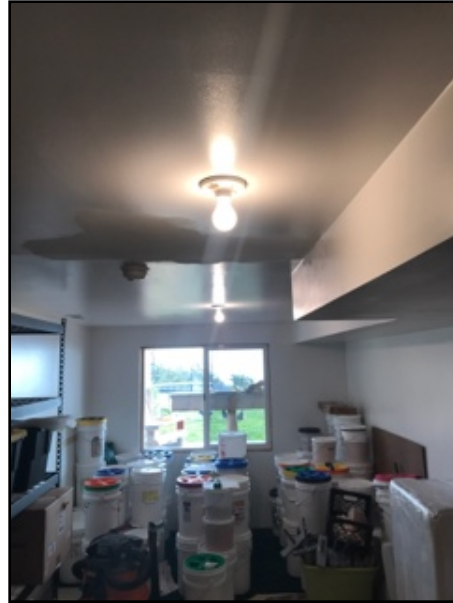
Figure 49-2

Comment 49:
Bare bulbs in basement area need covers.

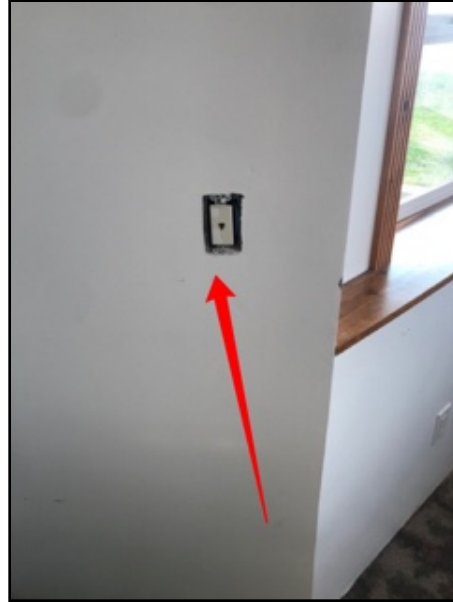
Figure 50-2

Comment 50:
5 window room
Phone jack needs cover .

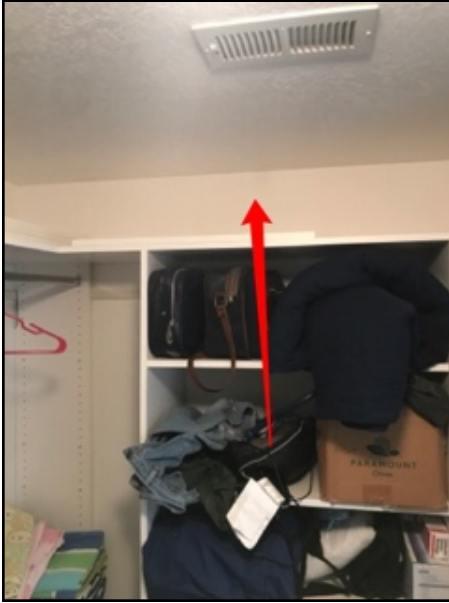
Figure 52-1

Master bedroom closet above top shelf owner said they saw what appeared to be mold they cleaned it and it has not come back and there is no sign of any water penetration or damage.

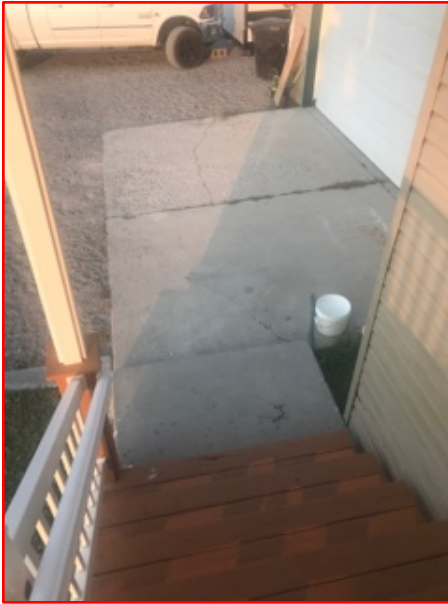
Figure 1-1

1) Driveway is cracked and spalling .

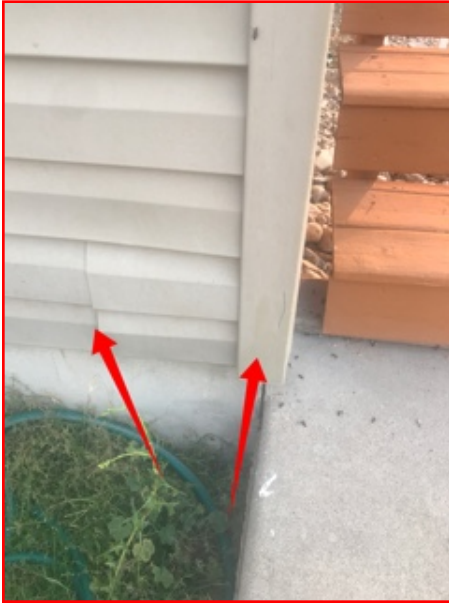
Figure 2-1

2) Damaged siding.

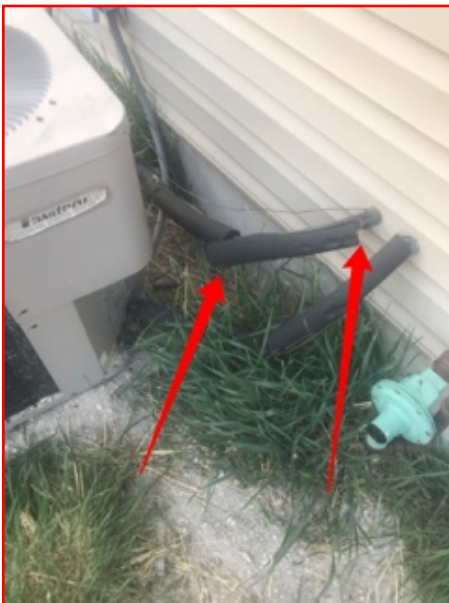
Figure 3-1

3) Insulation on AC pipes needs to be repaired.

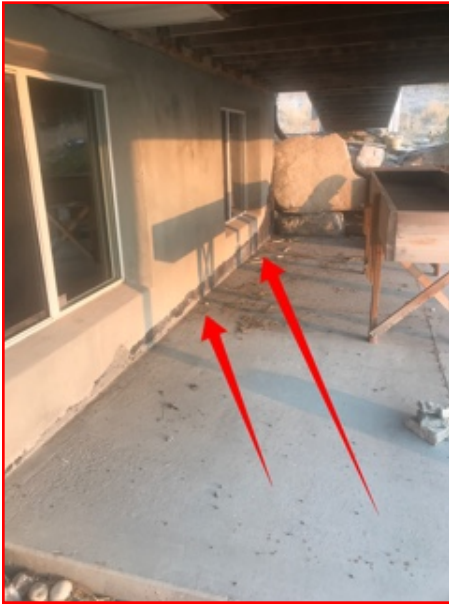
Figure 4-1

4) Plaster has fallen off of foundation wall.

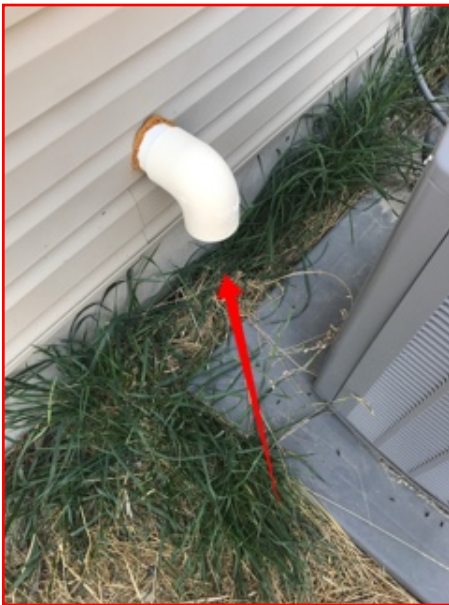
Figure 5-1

5) Needs a screen to prevent rodents from entering home.

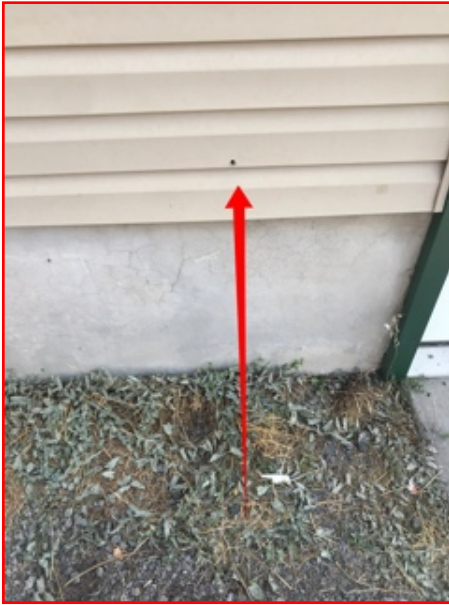
Figure 6-1

6) Holes in siding should be sealed.

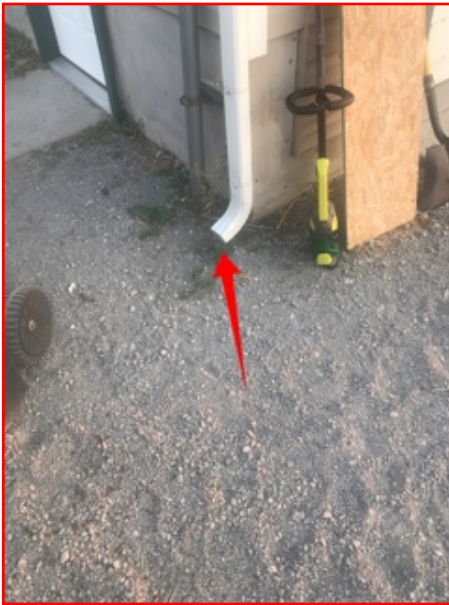
Figure 8-1

7) Missing down spout extension .

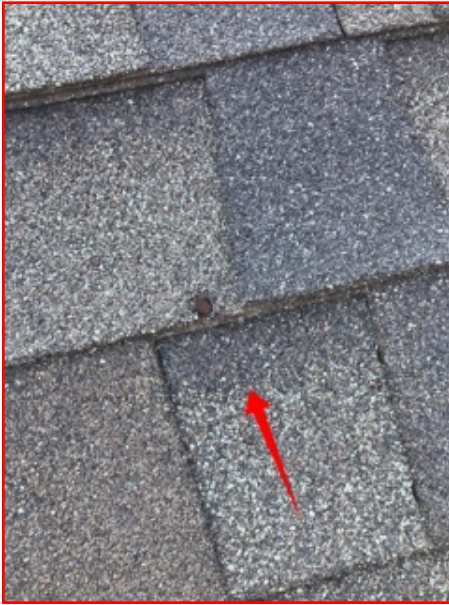
Figure 9-1

8) Exposed nails Recommend ceiling with roof tar.

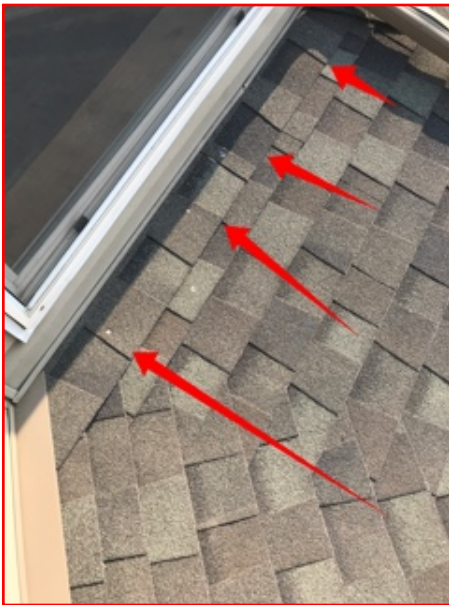
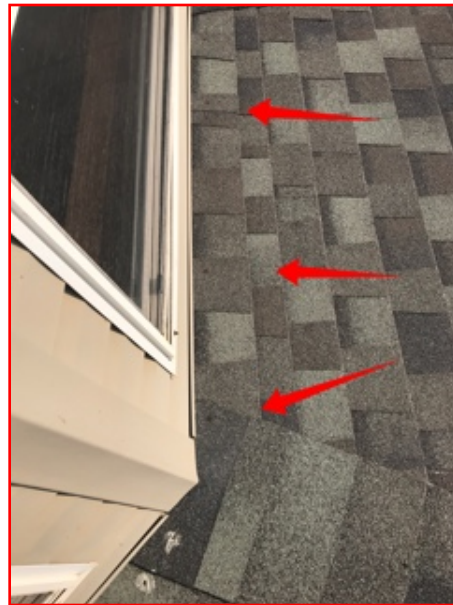
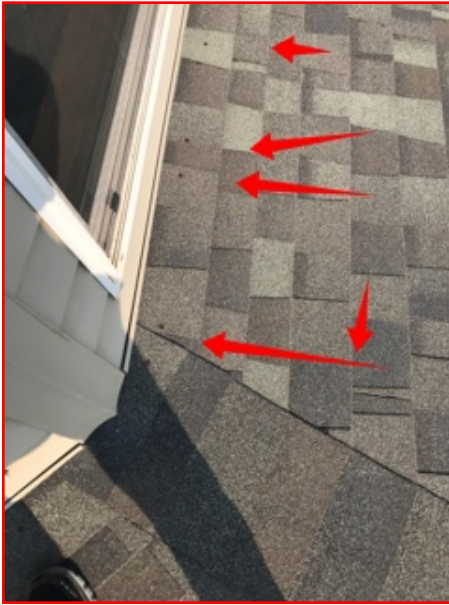
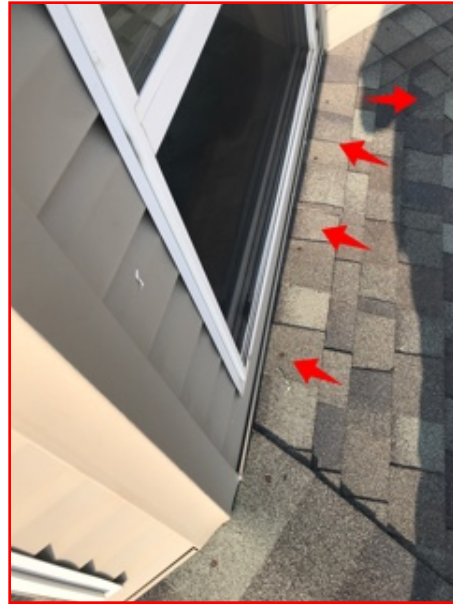
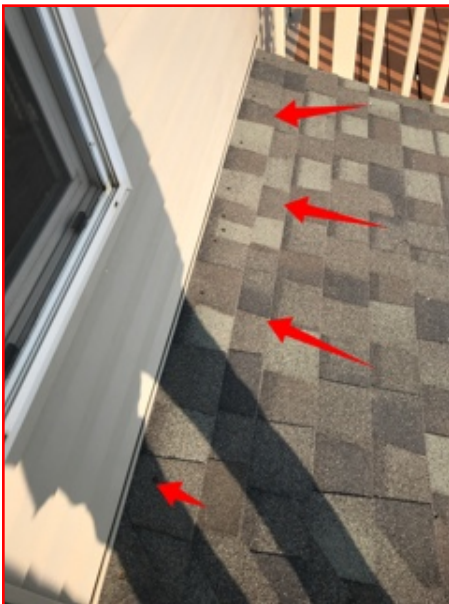
9) A lot of exposed nails on porch roof Highly recommend ceiling with roofing tar.

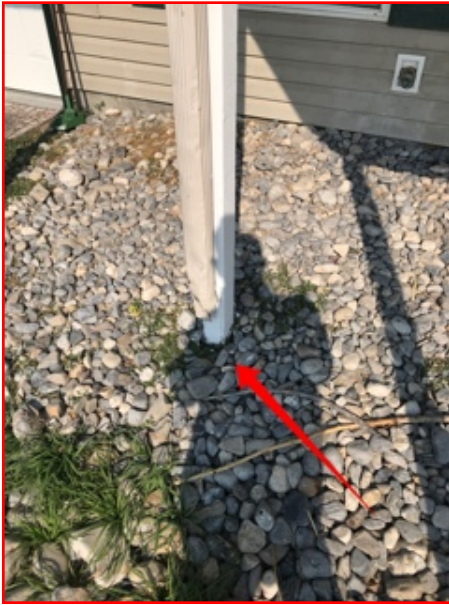
Figure 12-1

10) Recommend truss downspout gets fixed.

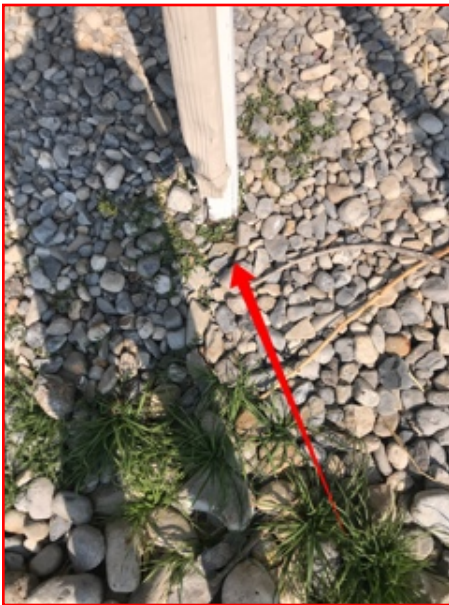
Figure 13-1

11) Post base should be above grade.

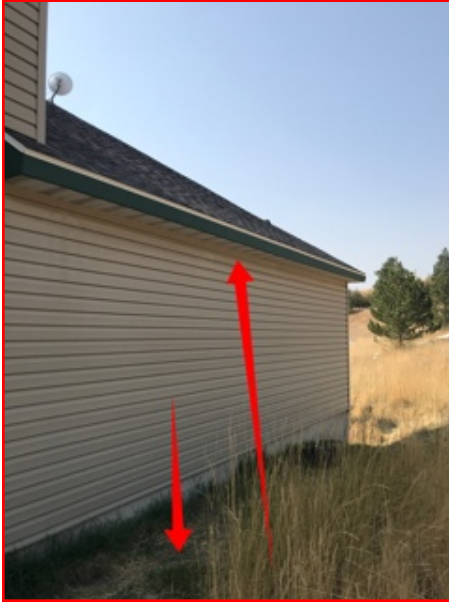
Figure 14-1

12) Roof edge needs a gutter and downspout to prevent water from running into foundation.

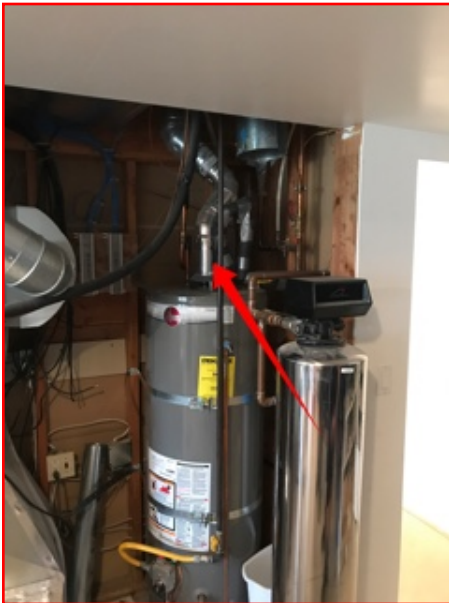
Figure 23-1

13) Water heater missing expansion tank recommend installing one.

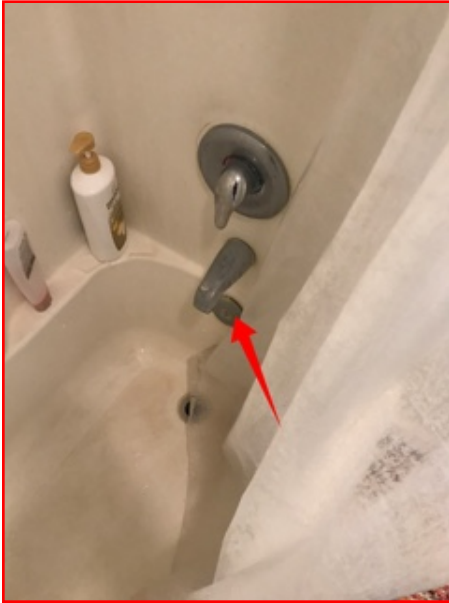
Figure 27-1

14) Mixing valve leaks when shower is running.

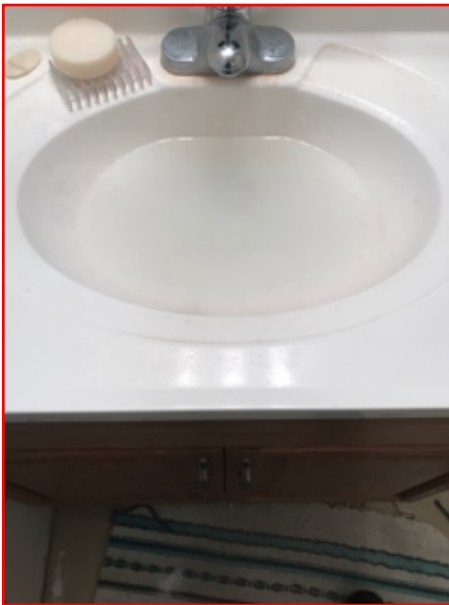
Figure 29-1

15) Sink drains very slowly.

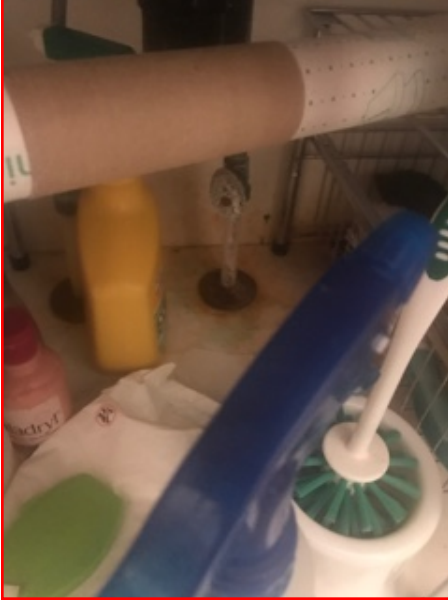
Figure 31-1

16) Signs of previous water damage I suggest asking owners to explain.
Currently no leaks found

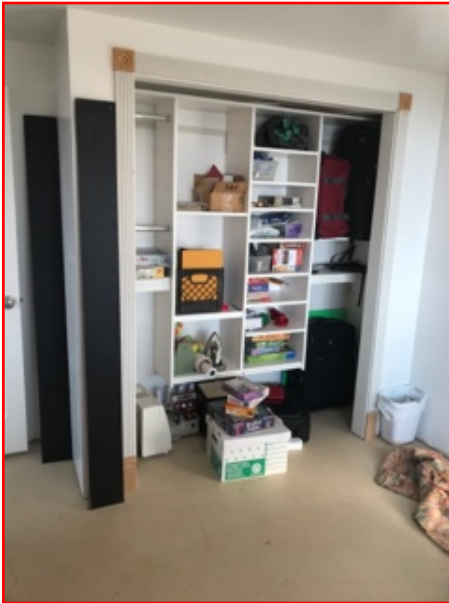
Figure 39-1

19) Closet needs doors.

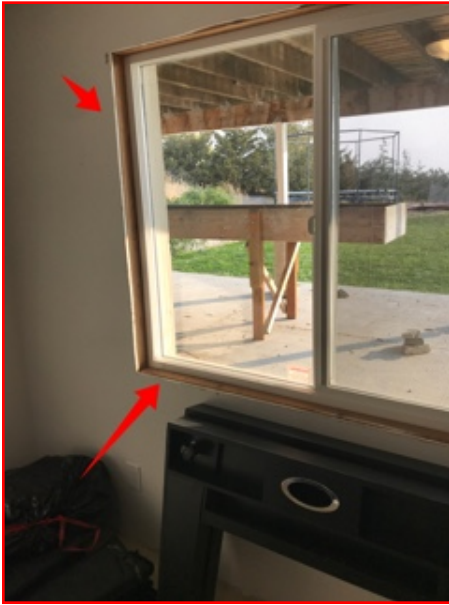
Figure 40-1

20) Missing drywall around window .

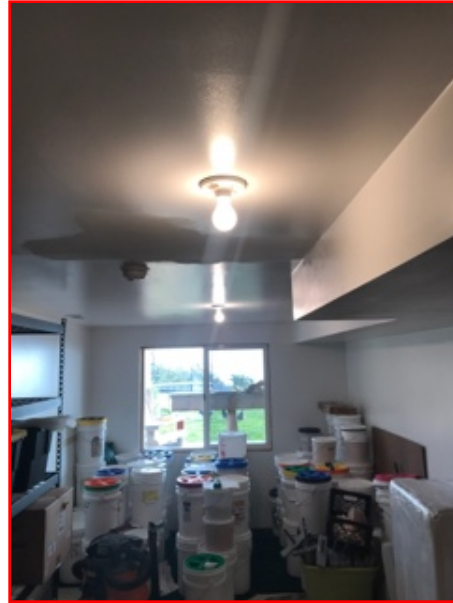
Figure 49-2

22) Bare bulbs in basement area need covers.
